Monastic Margam Community Survey Project

Report for Cadw
by Sam Pamment BA

GGAT report no. 2013/020
NGR: SS 8018 8626
Project no. GGAT 123

Summary

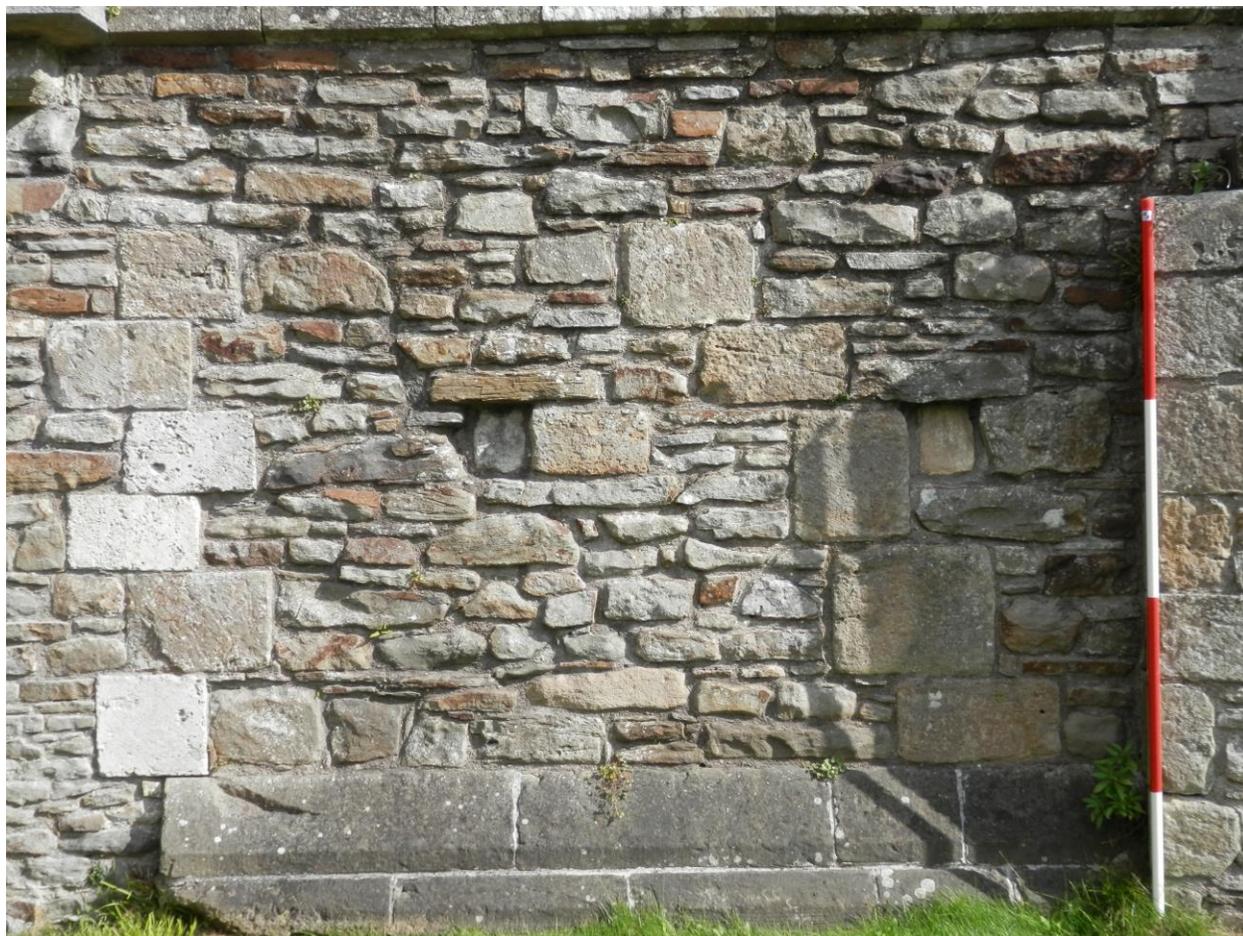
(See figure 2, figure 3 elevation 1)

ID: 1 Site Number: 748 Site Name: Margam Monastic Ruins
Wall Number: 1 Photo Number: F1/1
Location: Chapter House Ext. Lower section
Description: Lower half of wall of chapter house coursed rubble with intermittent vertical and/or diagonal bands of ashlar blocks over a low ashlar plinth. Two putlog holes
Condition summary: A) Water erosion (weathering) to ashlar. B) Small amount of vegetation. growth on wall. C) Base of wall stone chipped away.
Threats: Vegetation, Weathering
Recorded by: Kay Thomas Date: 17/09/2012

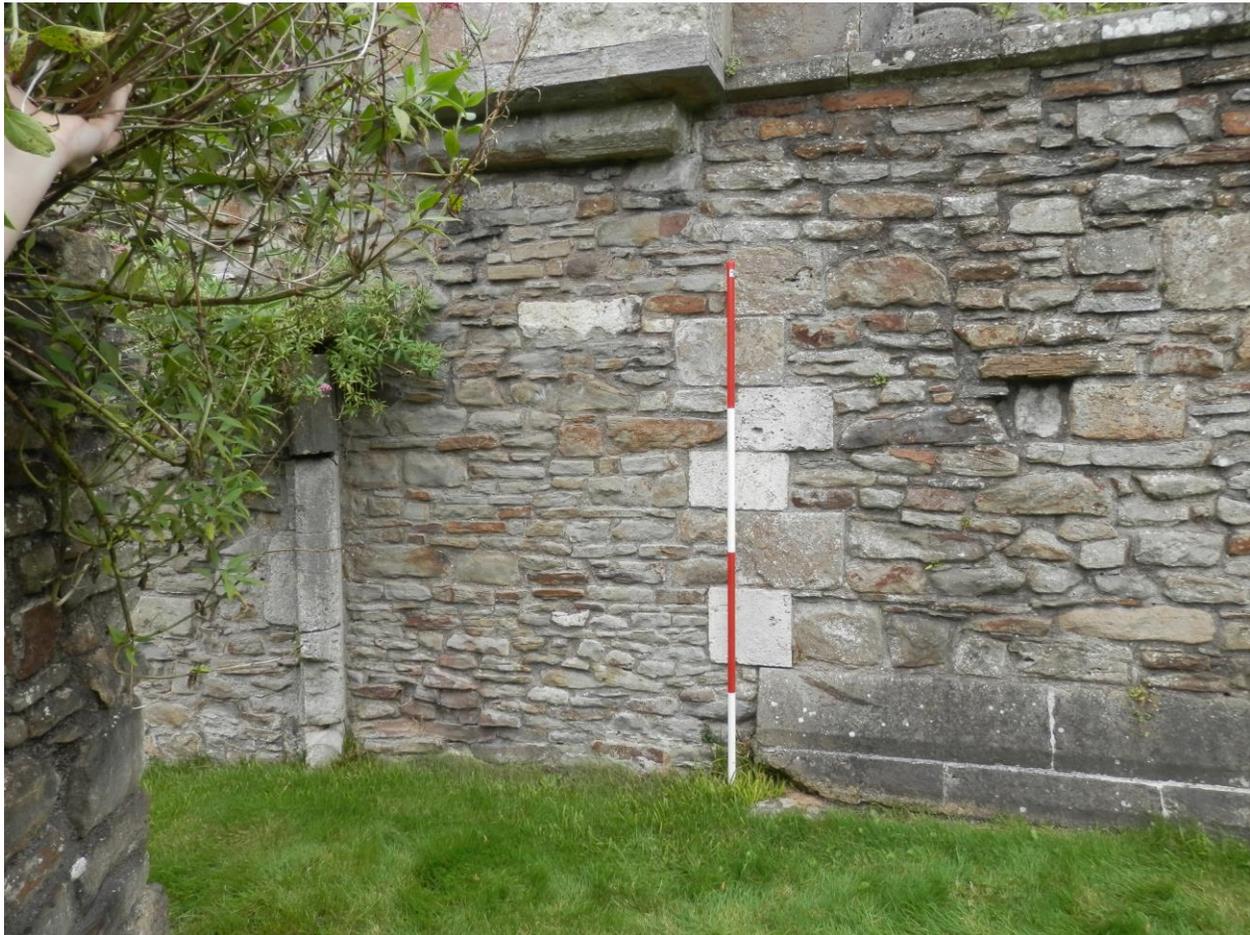
(See figure 2, figure 3 elevation 1)

ID: 3 Site Number: 748 Site Name: Margam Monastic Ruins
Wall Number: 1 Photo Number: F1/3-4
Location: Chapter House Ext.
Description: Lower half of chapter house wall, medium sized stones have been re-mortared. Molding (doorway). Metal fitting (?hinge) present at top; any corresponding hinge at bottom missing
Condition summary: A) Weathering to some of the stonework. B) Dressing to doorway cracked, some sections missing.
Threats: Vegetation growing from top of door moulding
Recorded by: Jeff Jones Date: 17/09/2012

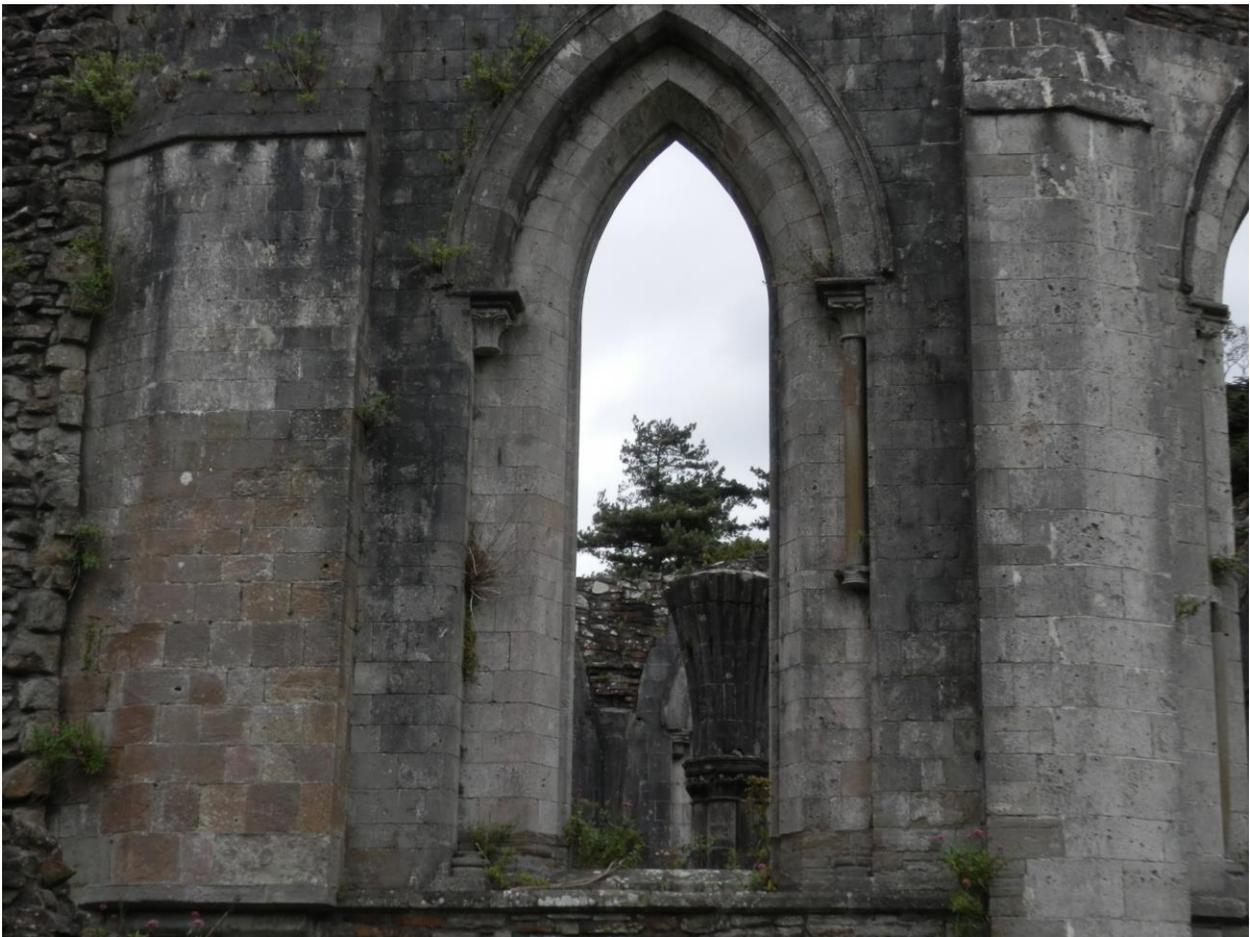
(See figure 2, figure 3 elevation 1)

ID: 4 Site Number: 748 Site Name: Margam Monastic Ruins
Wall Number: 1 Photo Number: F1/5
Location: Chapter House Ext. Window
Description: Upper window section of chapter house consisting of ashlar. Arch window with half of shaft on bottom right hand side missing left hand side totally missing.
Condition summary: A) Vegetation sprouting from stonework left hand corner of window bay. B) Vegetation Sprouting from stonework at base of window. C) Vegetation sprouting from apex of arch
Threats: Vegetation damage, water erosion/weathering
Recorded by: Kay Thomas Date: 17/09/2012

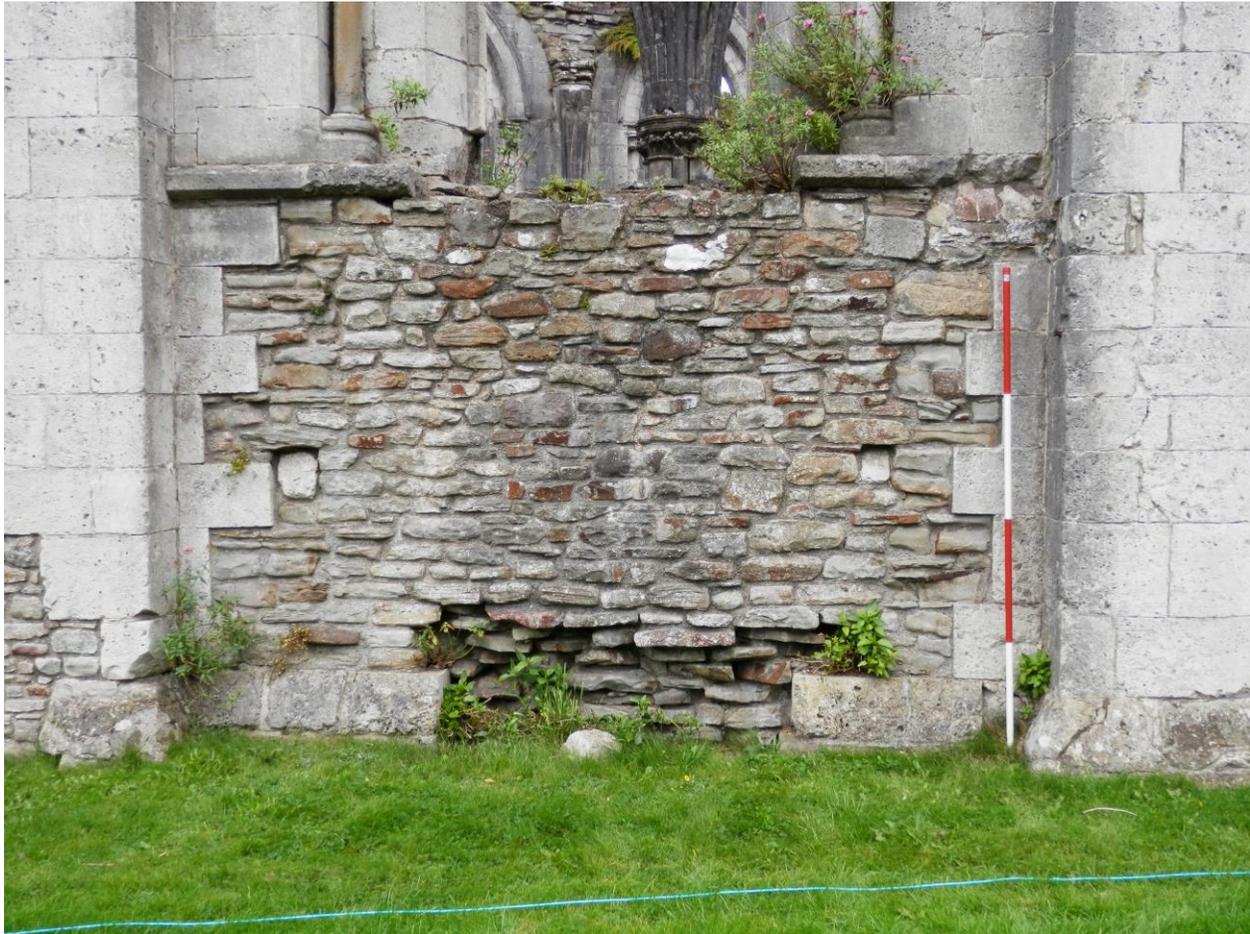
(See figure 2, figure 3 elevation 2)

ID: 6 Site Number: 748 Site Name: Margam Monastic Ruins
Wall Number: 2 Photo Number: F1/7
Location: Chapter House Ext
Description: Lower section of wall underneath window (roughly coursed rubble)
Condition summary: A) Stonework missing from bottom middle of wall exposing the inner core to the elements (2m x 0.5m). B) Part of window sill is missing.
C) Some erosion to stone work. D) Vegetation growing in gaps.
E) Cracks to ashlar work on right.
Threats: Vegetation, Weathering
Recorded by: Ray Savage Date: 17/09/2012

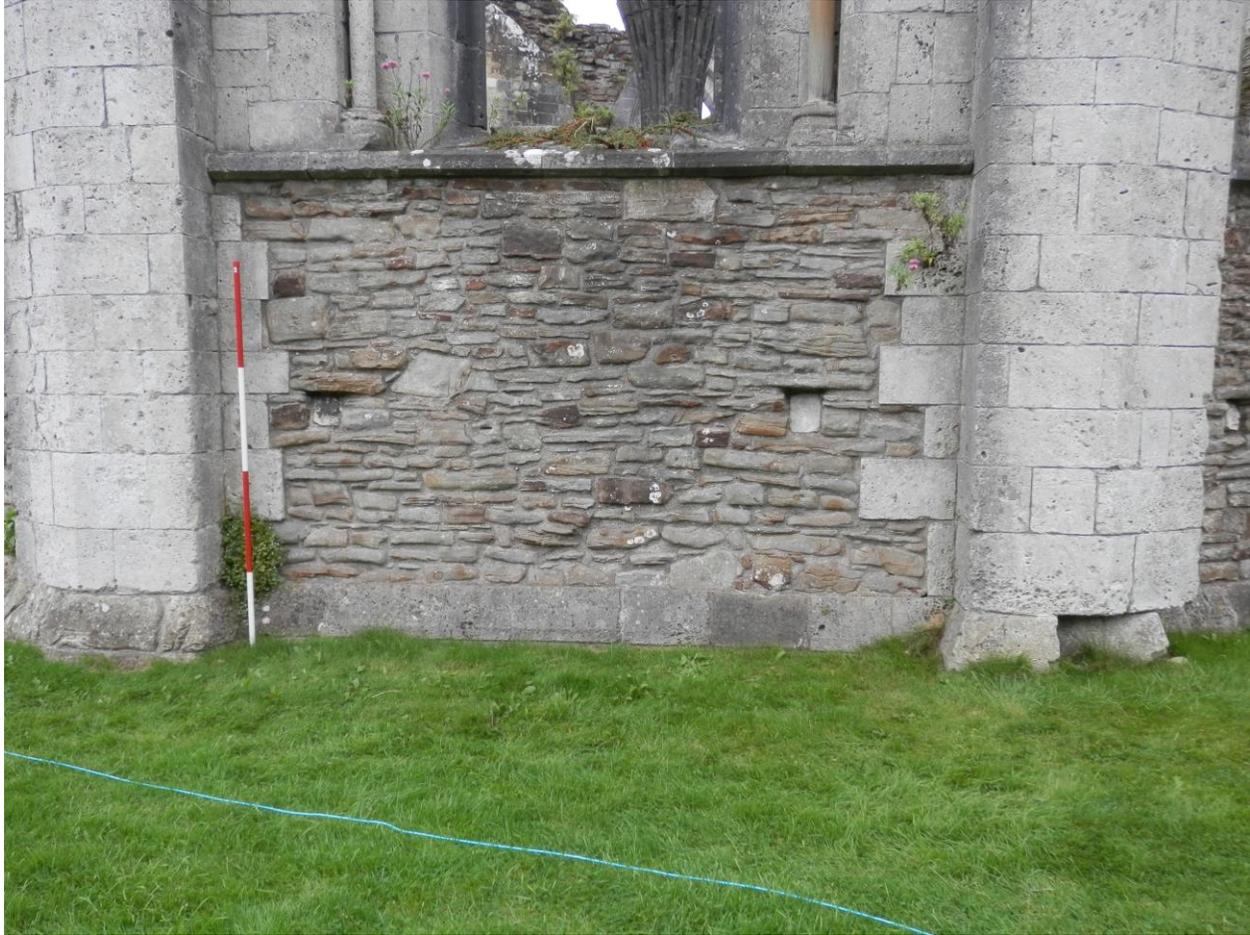
(See figure 2, figure 3 elevation 3)

ID: 8 Site Number: 748 Site Name: Margam Monastic Ruins
Wall Number: 3 Photo Number: F1/9
Location: Chapter House Ext
Description: Very similar to previous bay (wall no.2) but in better condition. Pointing is in reasonable condition.
Condition summary: A) Vegetation in gaps. B) Some erosion of blocks
Threats: Vegetation, Weathering
Recorded by: Ray Savage Date: 17/09/2012

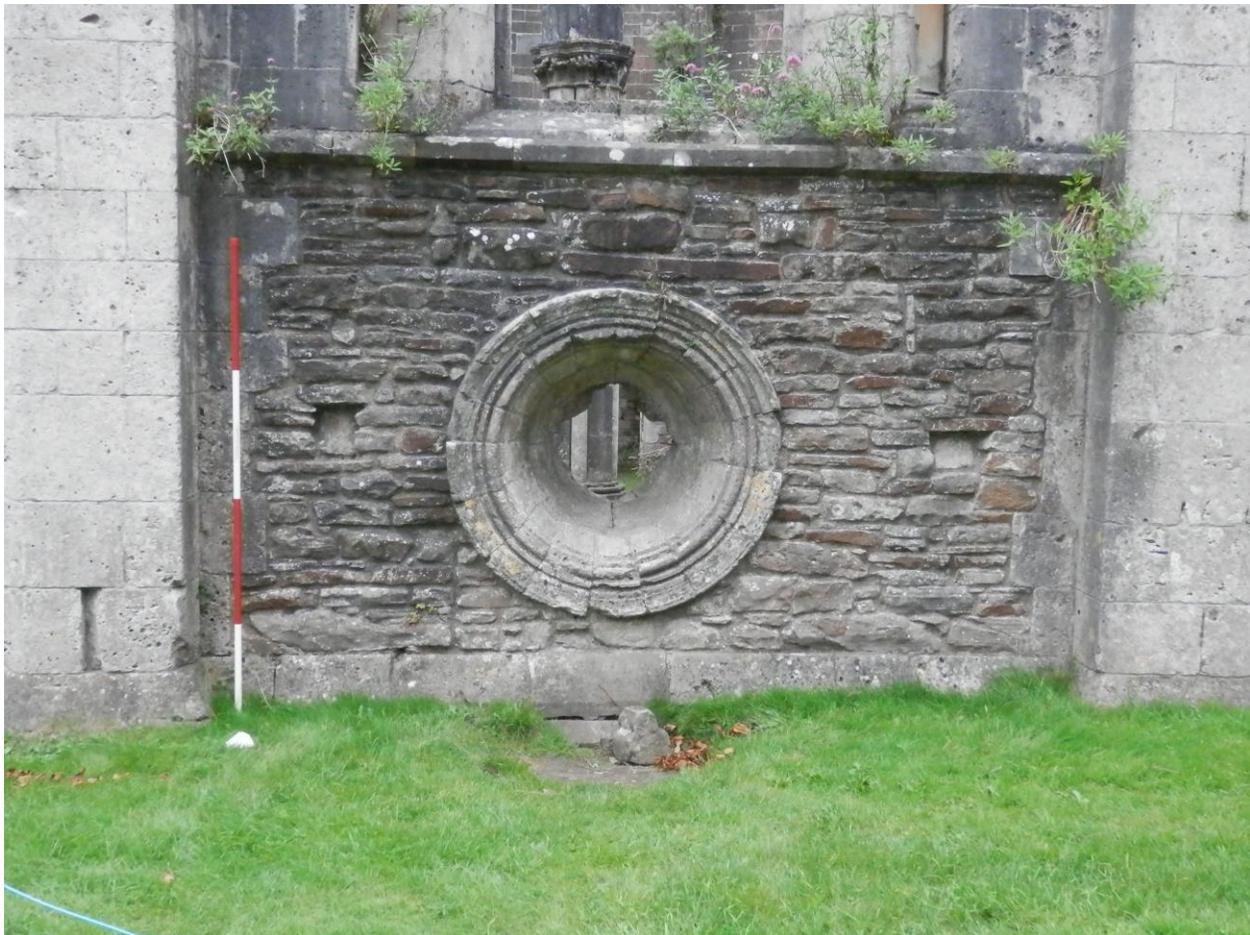
(See figure 2, figure 4 elevation 5)

ID: 12 Site Number: 748 Site Name: Margam Monastic Ruins
Wall Number: 5 Photo Number: F1/13
Location: Chapter House Ext.
Description: External wall with circular inset (quatrefoil) in middle of wall (off-center); constructed of Sutton stone. Wall is constructed from local stone roughly coursed rubble with ashlar on each side. Local stone work is of irregular size and shape.
Condition summary: A) Weather damage to the center of circular feature (quatrefoil).
B) Some erosion of ashlar blocks. C) Vegetation in cracks in wall.
D) Mortar missing from middle lowest block. E) Damage to ashlar
Threats: Vegetation, missing mortar, weathering.
Recorded by: Ray Savage Date: 17/09/2012

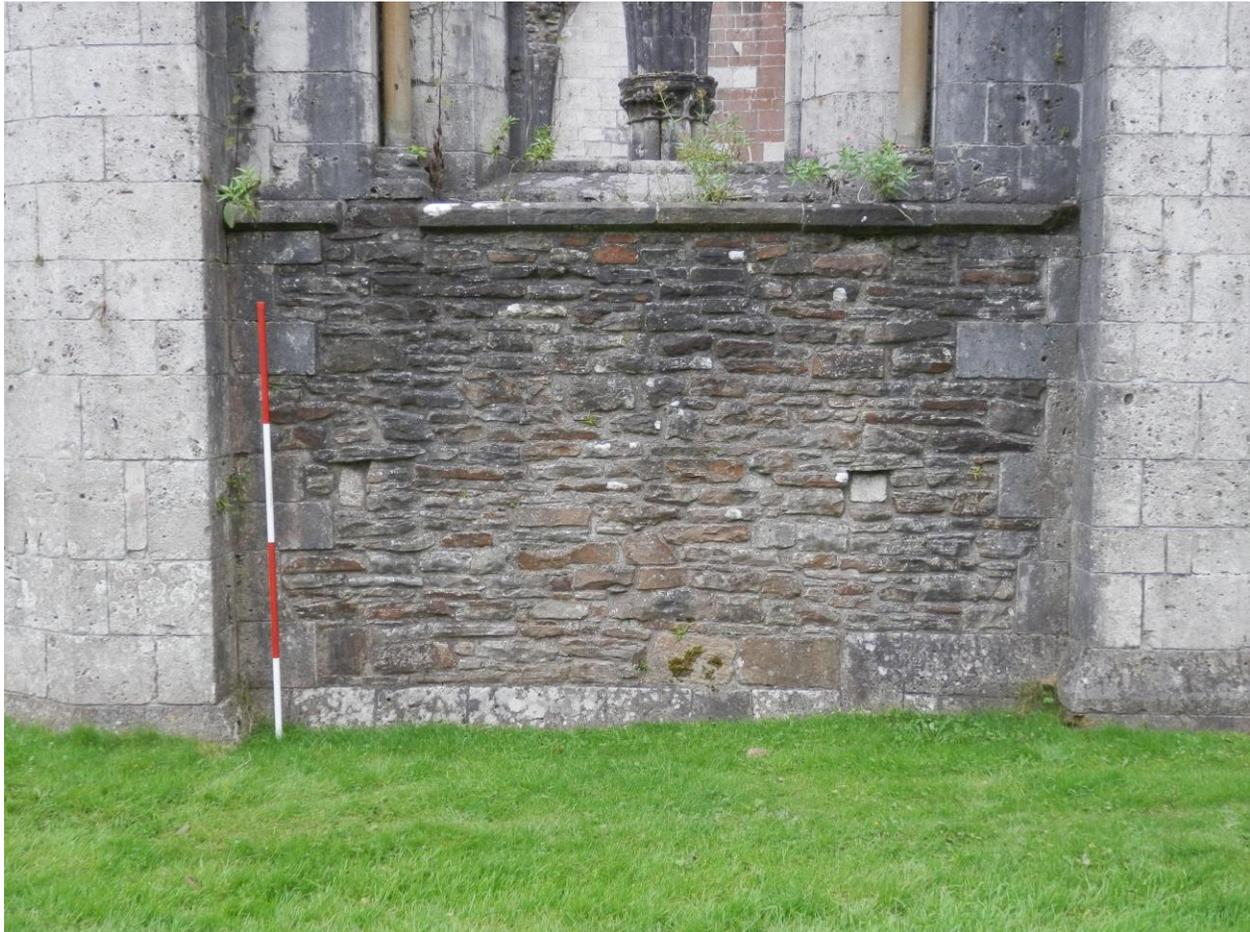
(See figure 2, figure 4 elevation 6)

ID: 14 Site Number: 748 Site Name: Margam Monastic Ruins
Wall Number: 6 Photo Number: F1/16-17
Location: Chapter House Ext.
Description: Lower section. Roughly coursed rubble in local sandstone with ashlar on flanks and bottom. 2 putlog holes large horizontal blocks forming window ledge. Mason mark on ashlar to left.
Condition summary: A) Section of window sill missing from left hand side. B) Piece of sill missing from right hand side. C) Weathering of ashlar.
Threats: Weathering, Vegetation damage
Recorded by: Jeff Jones Date: 18/09/2012

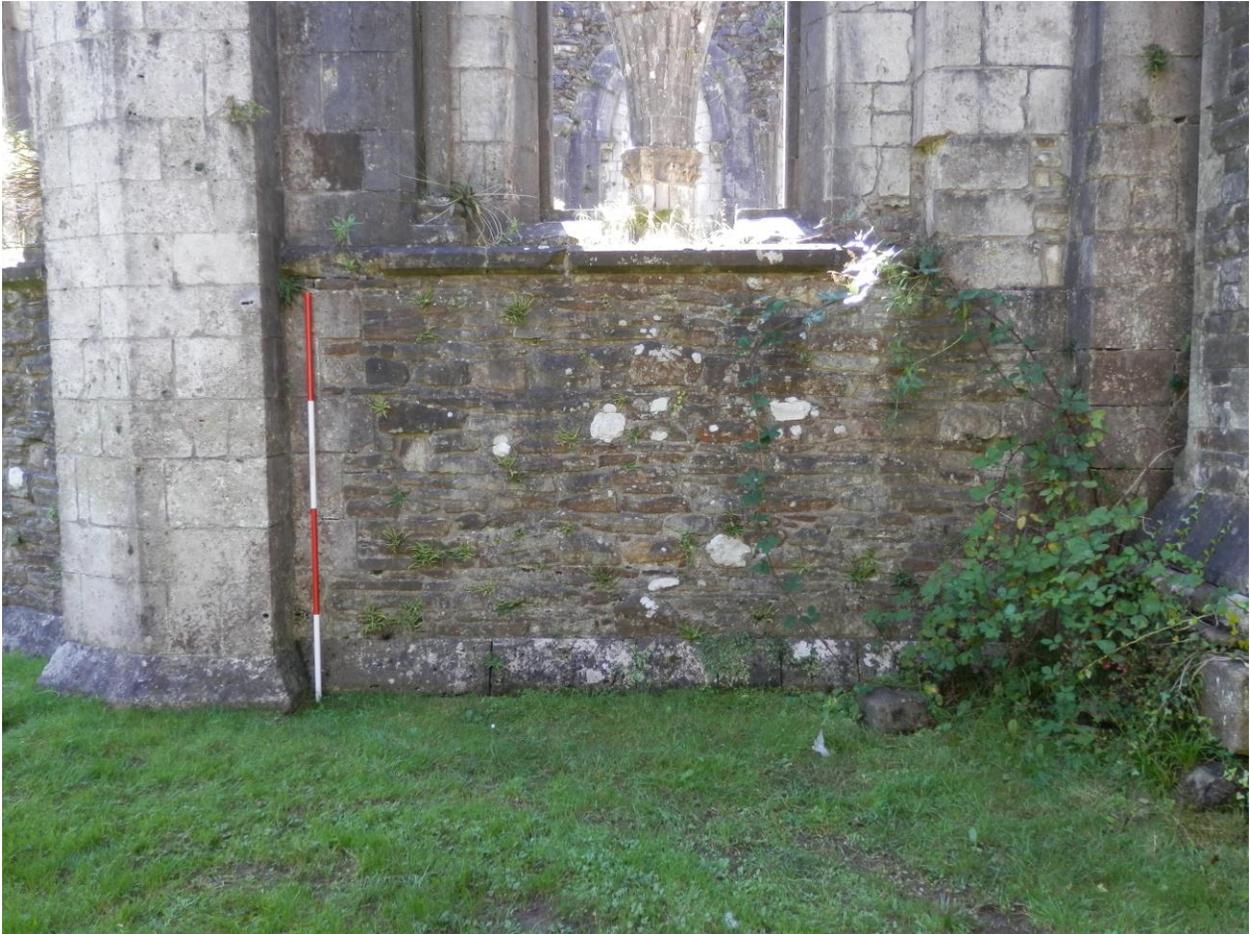
(See figure 2, figure 5 elevation 8)

ID: 18 Site Number: 748 Site Name: Margam Monastic Ruins
Wall Number: 8 Photo Number: F1/25
Location: Chapter House
Description: Buttress rises to 3/4 height of wall. Ashlar.
Condition summary: A) Loose mortar on lower half of base.
Threats: Vegetation, Weathering
Recorded by: Maggie Cornelius Date: 18/09/2012

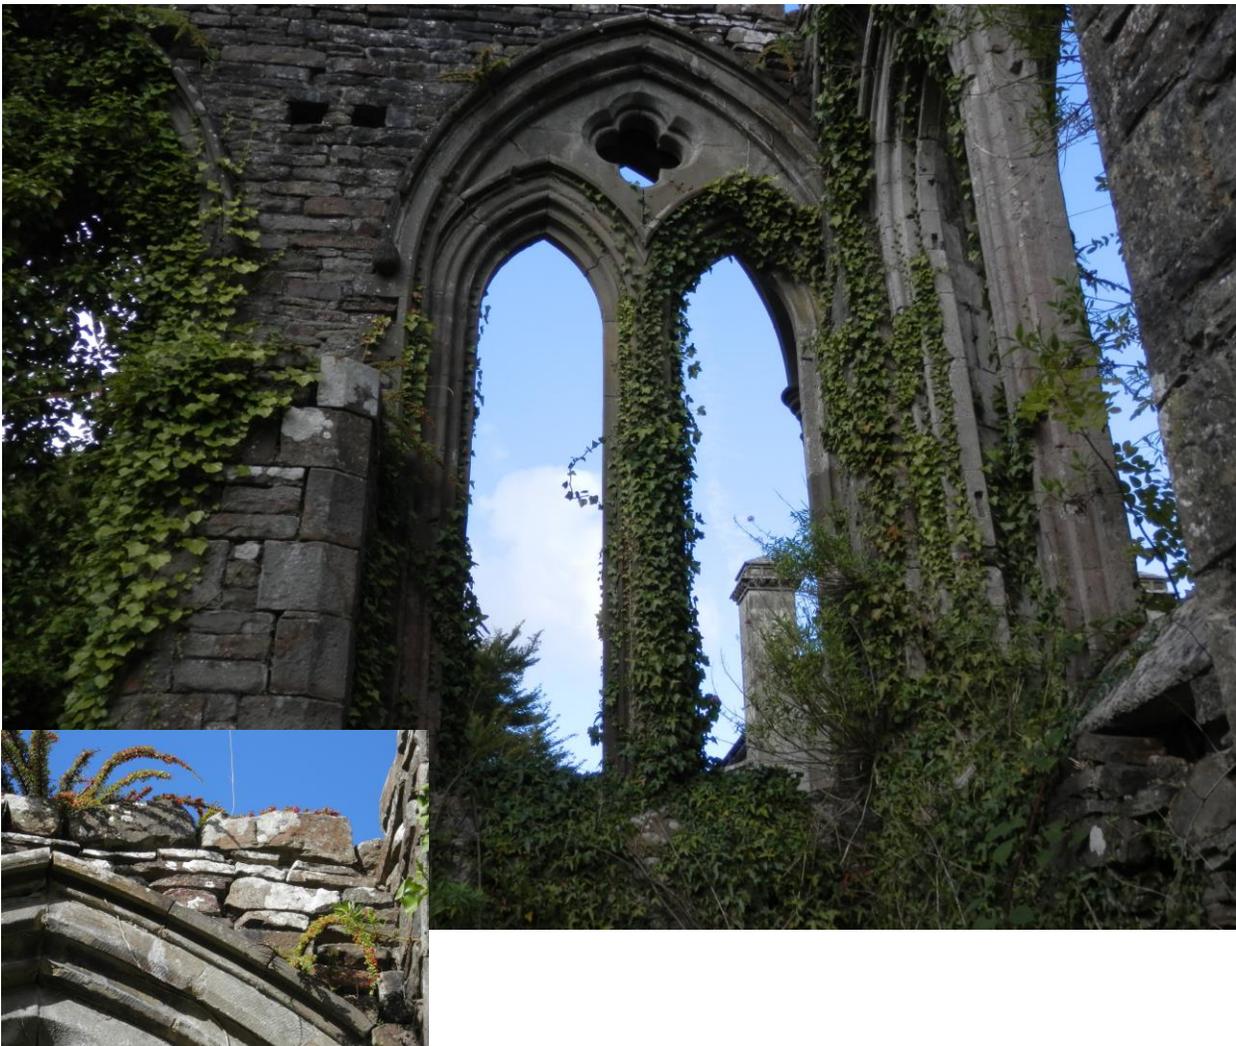
(See figure 2, figure 6 elevation 12)

ID: 23 Site Number: 748 Site Name: Margam Monastic Ruins
Wall Number: 12 Photo Number: F1/38-40
Location: South Transept East Wall Ext.
Description: Window with two-centred head, two lights and quatrefoil above.
Orb head stop carving at end of hood molding. Mullion covered in ivy, plus sill (which is at 45 degree angle to lower wall.)
Upper part of wall constructed of sandstone rubble.
Condition summary: A) Vegetation on top of wall. B) Loose mortar - eroded- loose stones on top of wall. C) Apex of arch hood moulding mortar has eroded.
D) Ivy growing over mullion and right hand window and base.
Threats: Vegetation and Weathering
Recorded by: Maggie Cornelius Date: 18/09/2012

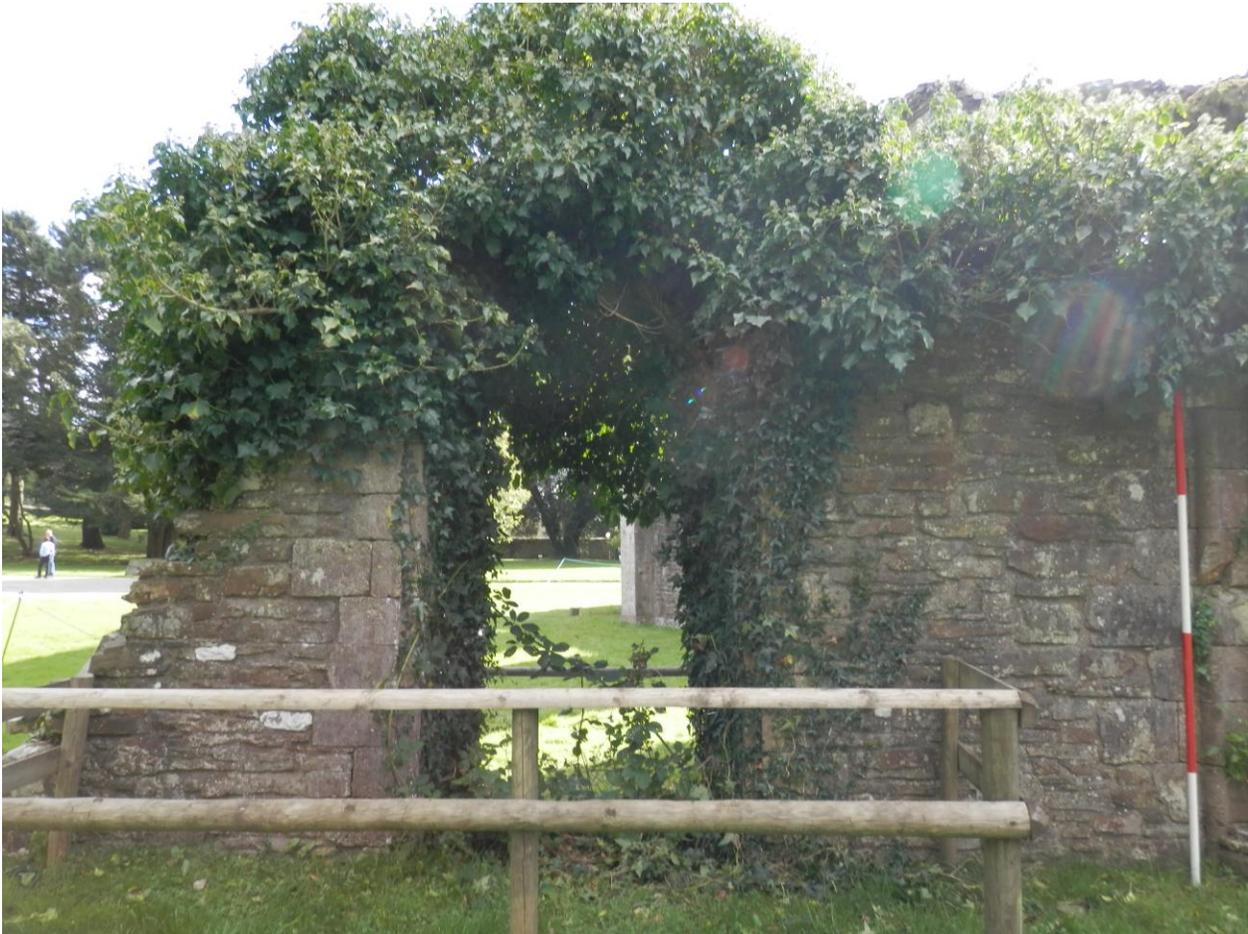
(See figure 2, figure 6 elevation 17)

ID: 29 Site Number: 748 Site Name: Margam Monastic Ruins
Wall Number: 17 Photo Number: F1/57
Location: South Chancel Wall Int. (Abbot's Door)
Description: Arch doorway (Abbots Door). Wall either side of door in fairly good condition
may have been re-pointed. Filled in putlog to the right. Ivy greatly covering doorway and inside and tops of walls. Arch is coming away from the wall (see 17.1 & 17.2)
Condition summary: A) Mortar is starting to weather on the edges of the corner of the east door frame. B) Weathering to the corner of east side of door on moulding and base. C) Ivy causing damage to stone work although it is difficult to see extent. D) Arch moving away from wall
Threats: Vegetation.
Recorded by: Sarah Baker Date: 19/09/2012

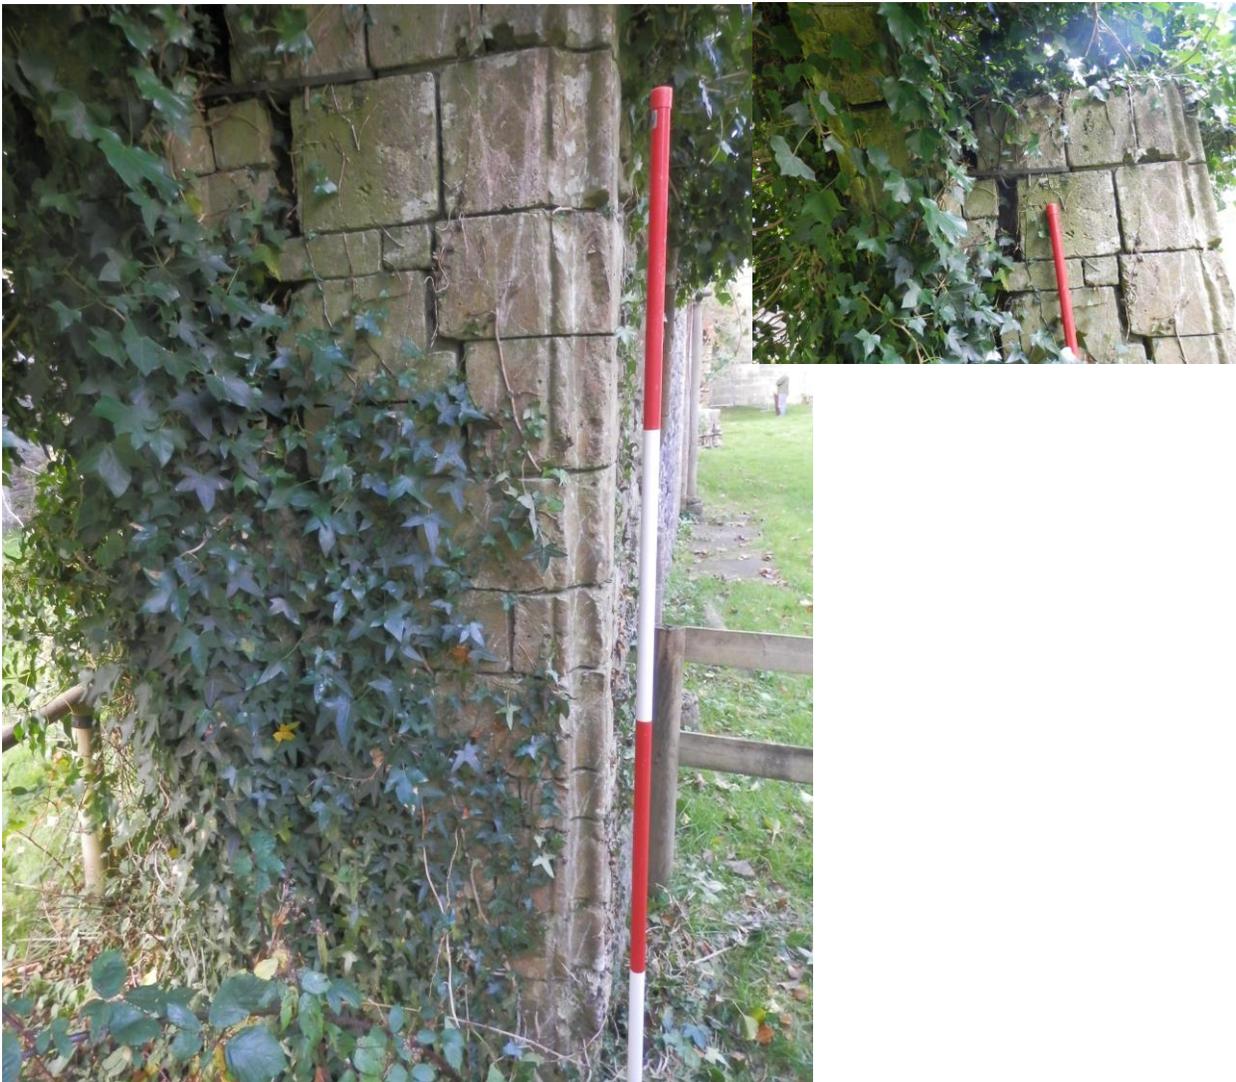
(See figure 2, figure 6 elevation 17.2)

ID: 31 Site Number: 748 Site Name: Margam Monastic Ruins
Wall Number: 17.2 Photo Number: F3/2-3
Location: South Chancel Wall Int. (Abbot's Door)
Description: West inside face of door way in chancel wall. Known as abbot's door. Constructed of Sutton stone ashlar with moulding on left side that rises to arch. Ivy growth on wall face not as extensive as wall 17.1.
Condition summary: A) Loss of mortar between stone work all the way down wall face. B) Moulded decoration and arch that form ext. face is falling away from structure, held in place with metal strap, but not effective. C) Rusting and weakening of metal strap. D) Ivy growth.
Threats: Vegetation, Weathering, Structural weakening.
Recorded by: Sam Pamment Date: 28/09/2012

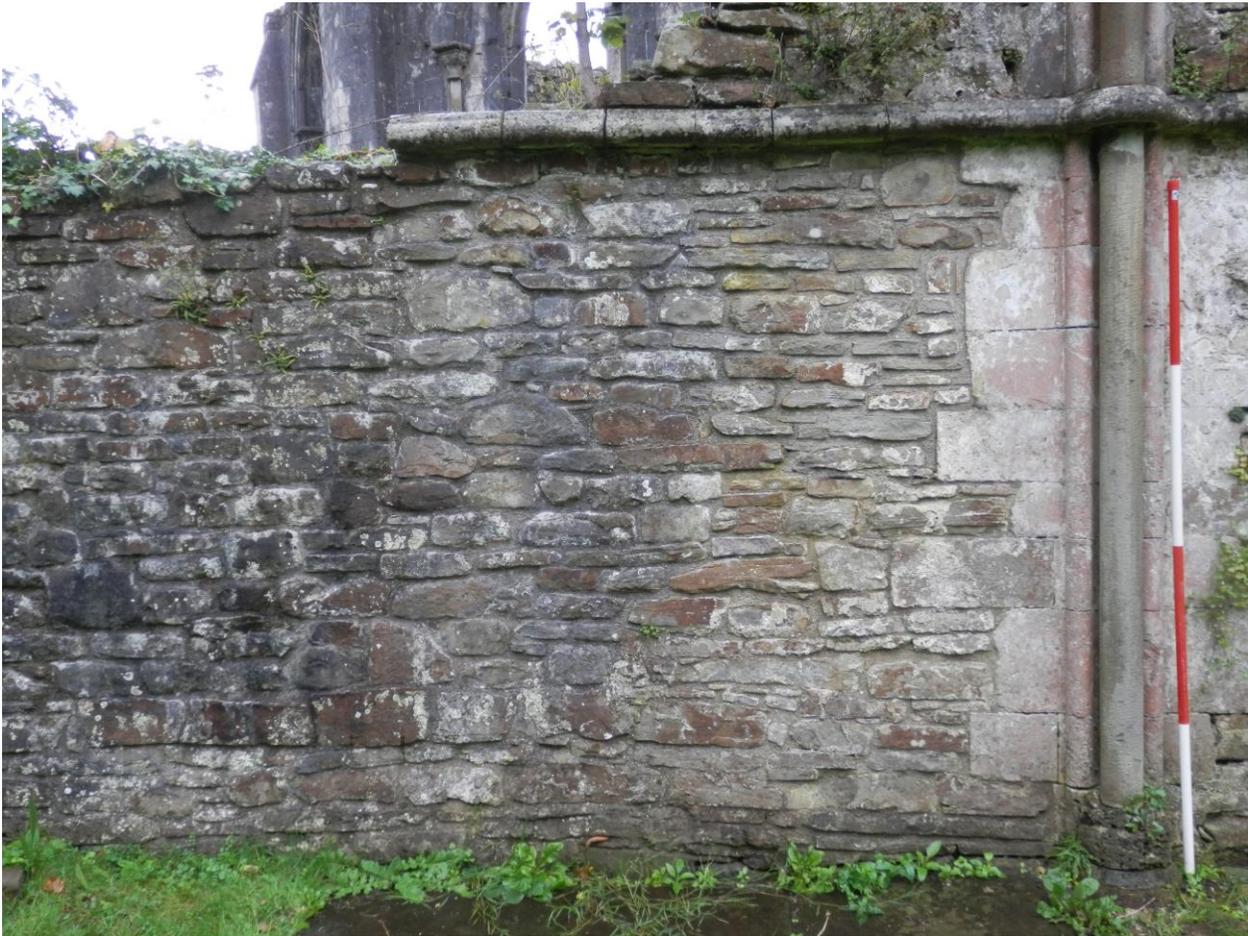
(See figure 2, figure 6 elevation 18)

ID: 33 Site Number: 748 Site Name: Margam Monastic Ruins
Wall Number: 18 Photo Number: F1/59
Location: South Chancel Wall Int.
Description: Constructed of local sandstone, possibly re-pointed. Possible traces of lime render present on wall. Mouldings surround *in situ* shaft; moulding and shaft made of Sutton stone, 2 blocks of which have mason's marks
Condition summary: A) Severe weathering to shaft base. B) Top of ashlar moulding: cracks have appeared between the stones. C) On right side of (shaft) there is a chunk of the moulding missing, approx 1ft above base.
Threats: Vegetation, Weathering
Recorded by: Julian James Date: 20/09/2012

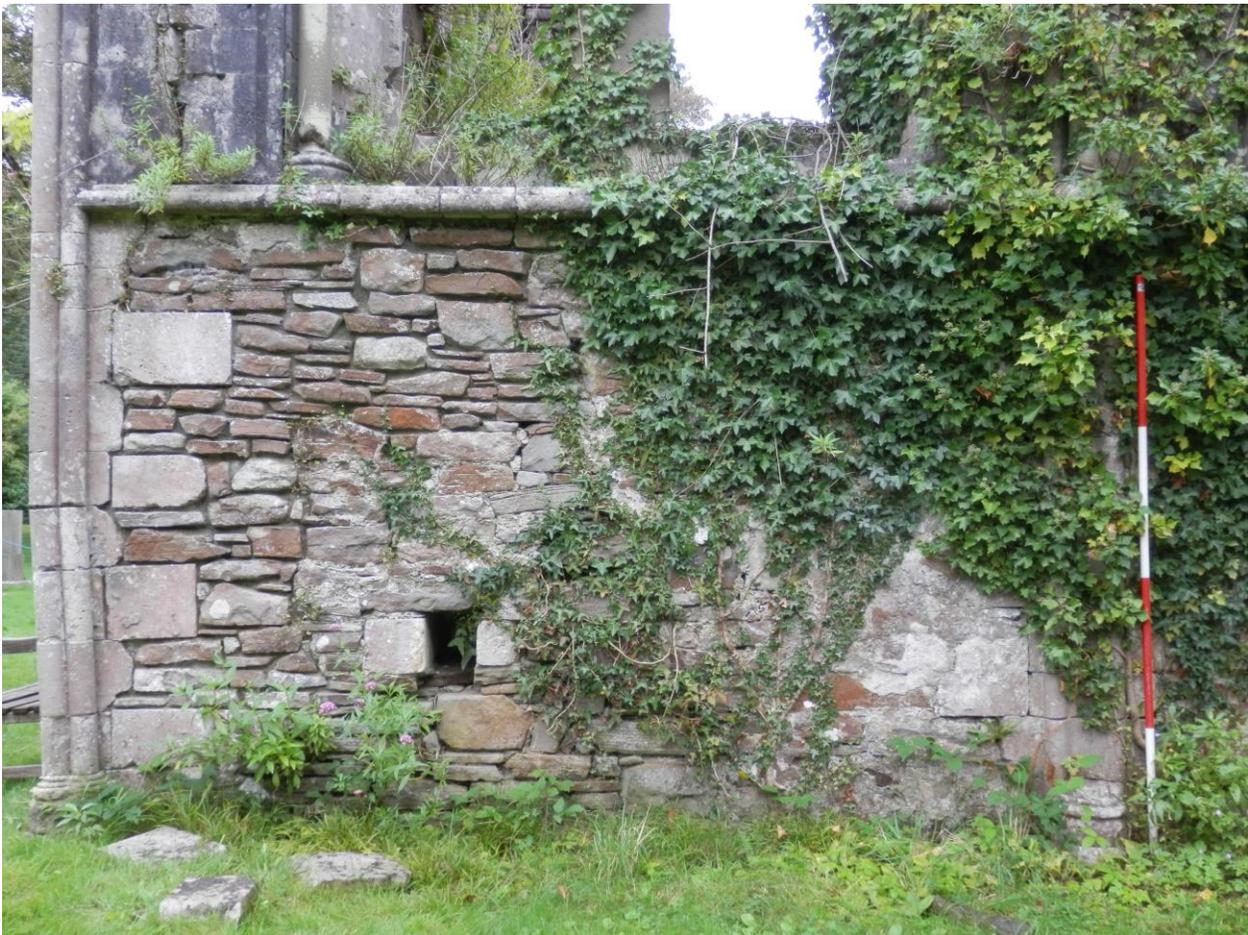
(See figure 2, figure 7 elevation 20)

ID: 37 Site Number: 748 Site Name: Margam Monastic Ruins
Wall Number: 20 Photo Number: F1/68
Location: South Transept East Wall Int.
Description: Lower Wall. Ashlar quoin and shaft on north corner of wall. Otherwise Local sandstone rubble. Moulded ashlar sill. Putlog holes. Masons mark on 3rd ashlar block. Right half covered in ivy obscuring wall.
Condition summary: A) Corner of wall bowing out crack 0.02m between 4th and 5th blocks, shaft base weathered. B) Crack top left of sill & stonework below. C) Left side of wall mortar weathered from local sandstone. D) Right side covered in ivy, exploiting gaps in stonework. E) Right shaft base weathered.
Threats: Vegetation, Weathering
Recorded by: Paul Minton Date: 21/09/2012

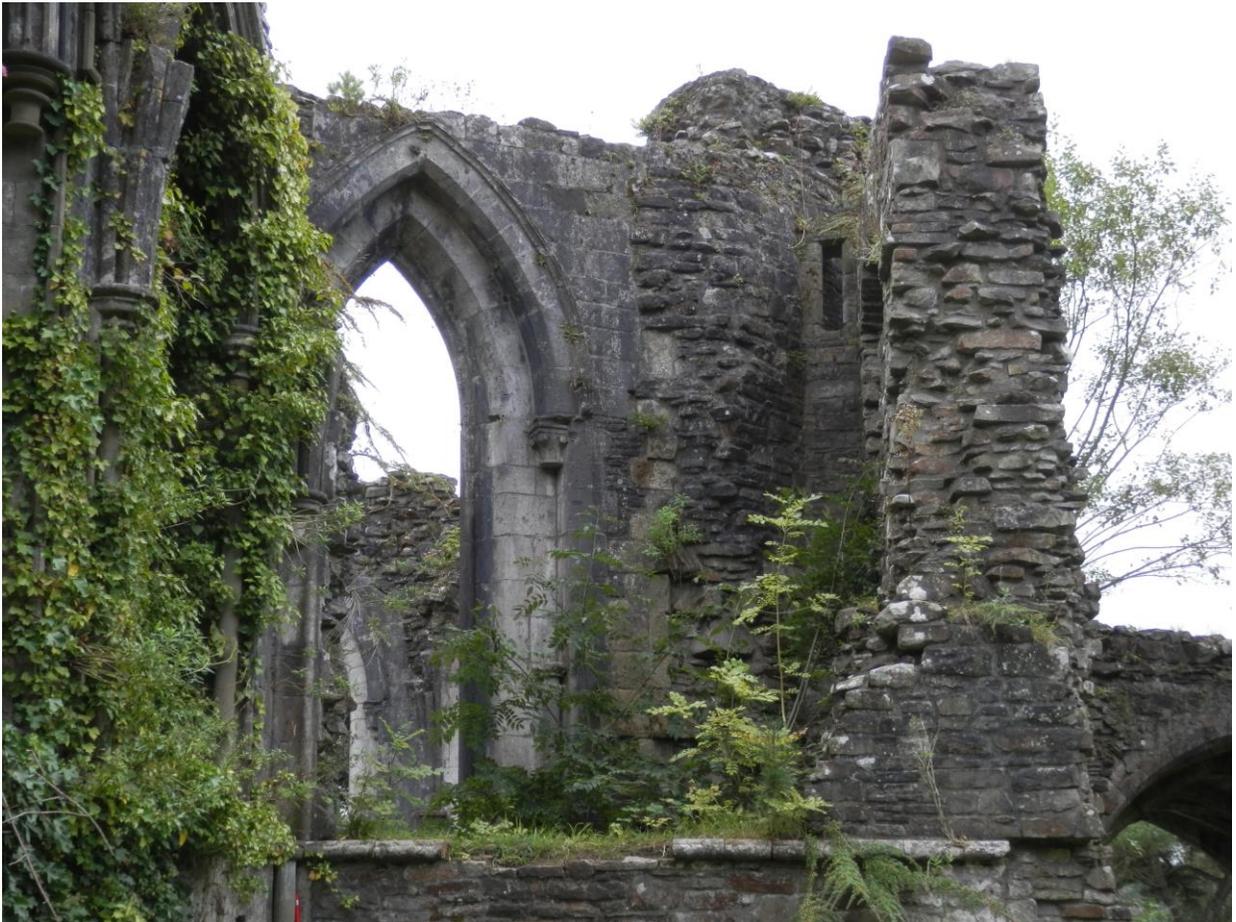
(See figure 2, figure 7 elevation 22)

ID: 42 Site Number: 748 Site Name: Margam Monastic Ruins
Wall Number: 22 Photo Number: F1/84
Location: South Transept South Wall Int. NOTE: This is the wall in foreground of photograph: the visible window belongs to wall 25.
Description: Upper Wall. Window opening missing. The only parts of the wall that survive are the dressing at the left-hand side of bay, including the springing for the vault (shaft is missing), and small section of the right-hand side, which is in local sandstone rubble, faced at the bottom. (Section visible above is Wall 23.)
Condition summary: A) Window sill missing. B) No window. C) Missing shaft. D) Vegetation
Threats: Vegetation, Weathering.
Recorded by: Paul Minton Date: 21/09/2012

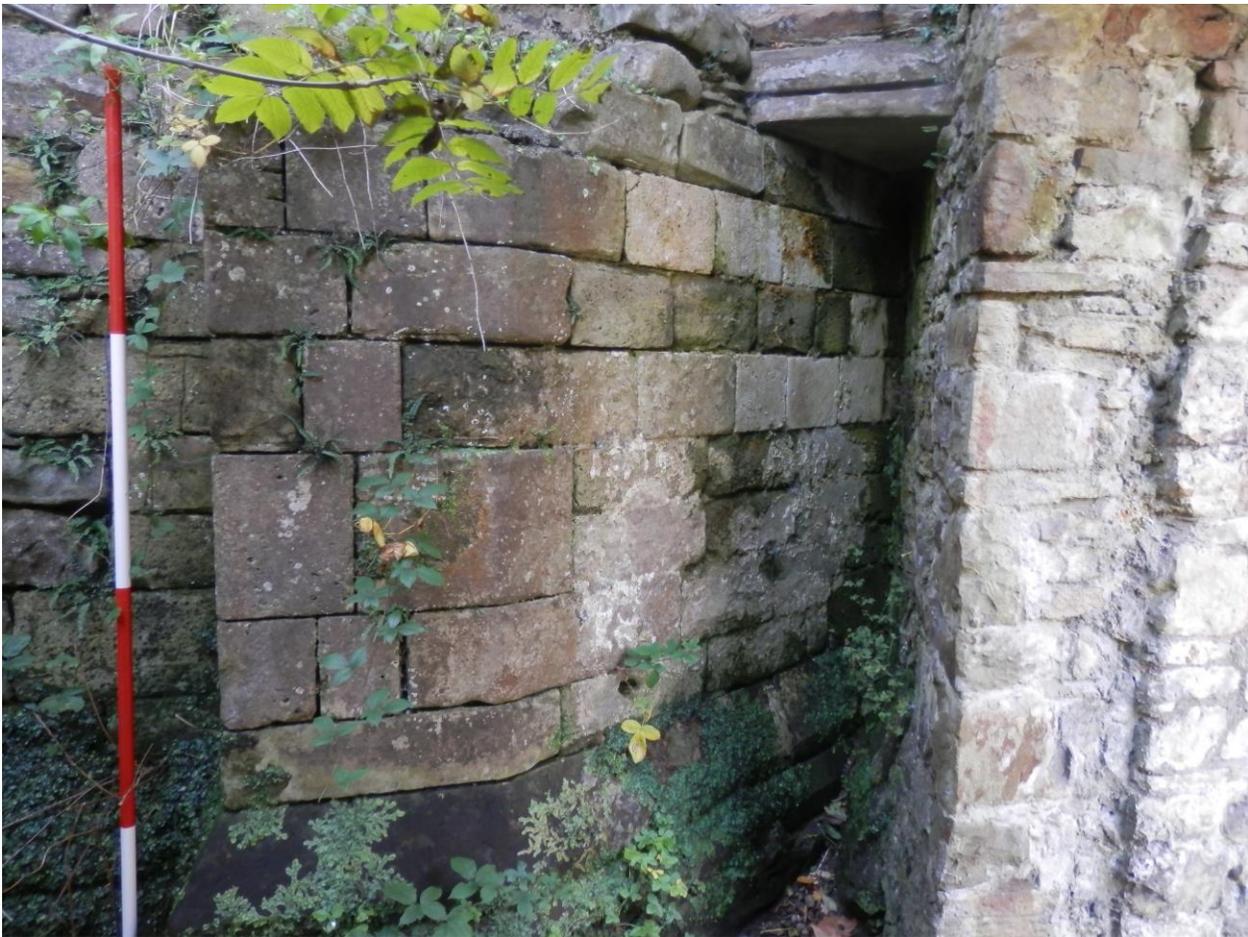
(See figure 2)

ID: 47 Site Number: 748 Site Name: Margam Monastic Ruins
Wall Number: 26 Photo Number: F3/13
Location: Chapter House Wall Ext.
Description: Lower Wall. Ashlar wall angles from left hand side 0.6m to corner. Top course loose; 2-3 blocks missing. Mortar missing in places; 2 blocks showing saw marks. Bottom 0.6m covered in vegetation. Lichen-affected mortar potentially on right hand side which is damper, some moss.
Condition summary: A) Damp right hand side of wall. B) Sill missing 2 blocks and loose stones on top. C) Vegetation. D) Lichen affecting mortar. E) Mortar missing.
Threats: Vegetation, Weathering, Damp.
Recorded by: Paul Minton Date: 21/09/2012

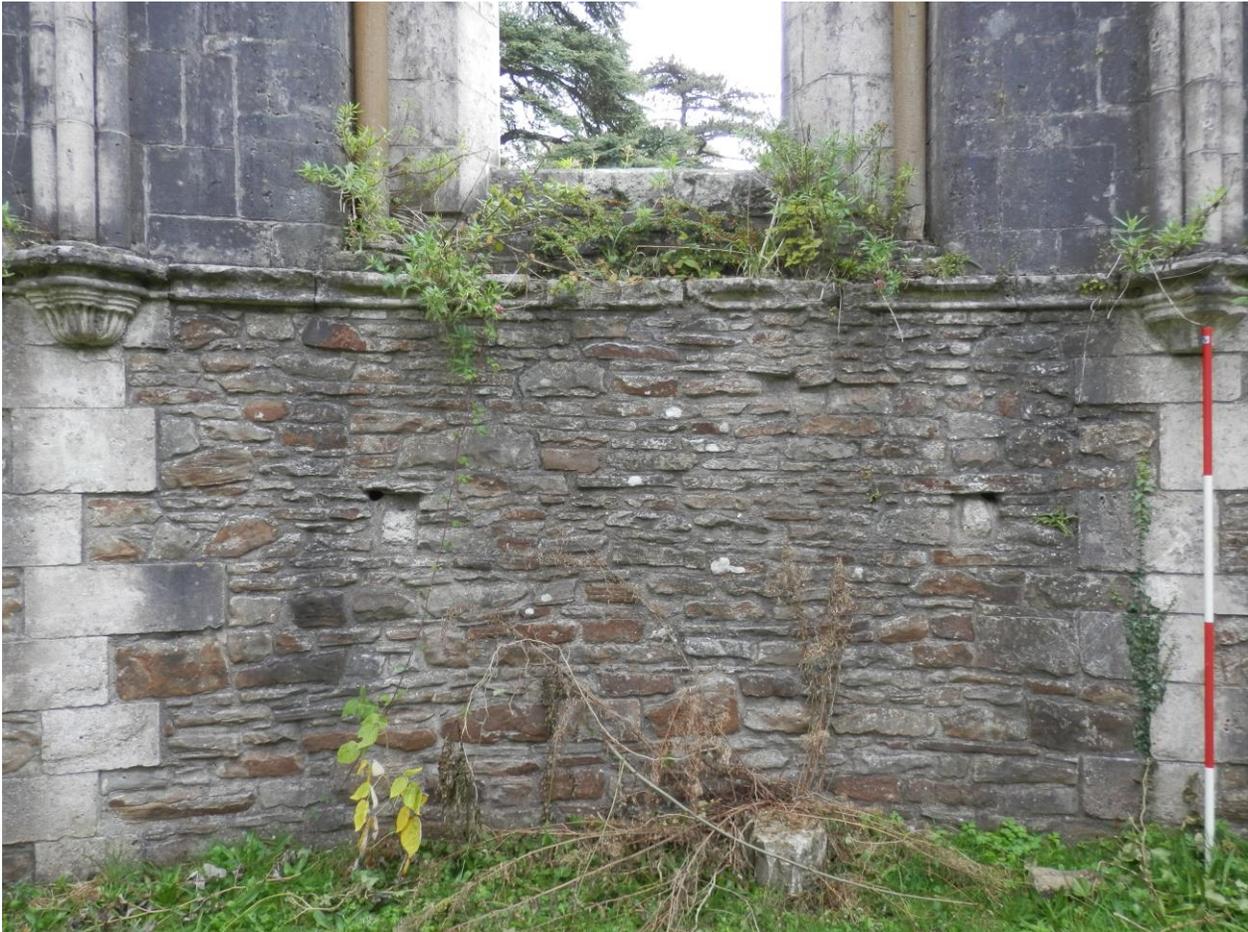
(See figure 2, figure 9 elevation 37)

ID: 64 Site Number: 748 Site Name: Margam Monastic Ruins
Wall Number: 37 Photo Number: F2/22
Location: Chapter House Wall Int.
Description: Lower section. Ashlar blocks under shaft groups; otherwise sandstone rubble sand stone. Two putlog holes, filled with stone and mortar ?repair. Carving of shaft base to left well defined (fluted); plain mouldings on base to right. Sill moulding well defined (some chips and damage). Ashlar blocks at both sides have mason's marks. Mortar in sound condition possibly restored? Large stone (fallen and possibly moved) on grass at base of wall.
Condition summary: A) Right-hand shaft base moulding has damage to upper section.
B) Both shaft bases have weathering evidence. C) Sill moulding damage - badly chipped and evidence of weathering.
Threats: Vegetation, Weathering.
Recorded by: Fiona Richards Date: 25/09/2012
