Monastic Margam Community Survey Project

Report for Cadw
by Sam Pamment BA

GGAT report no. 2013/020
NGR: SS 8018 8626
Project no. GGAT 123

Summary

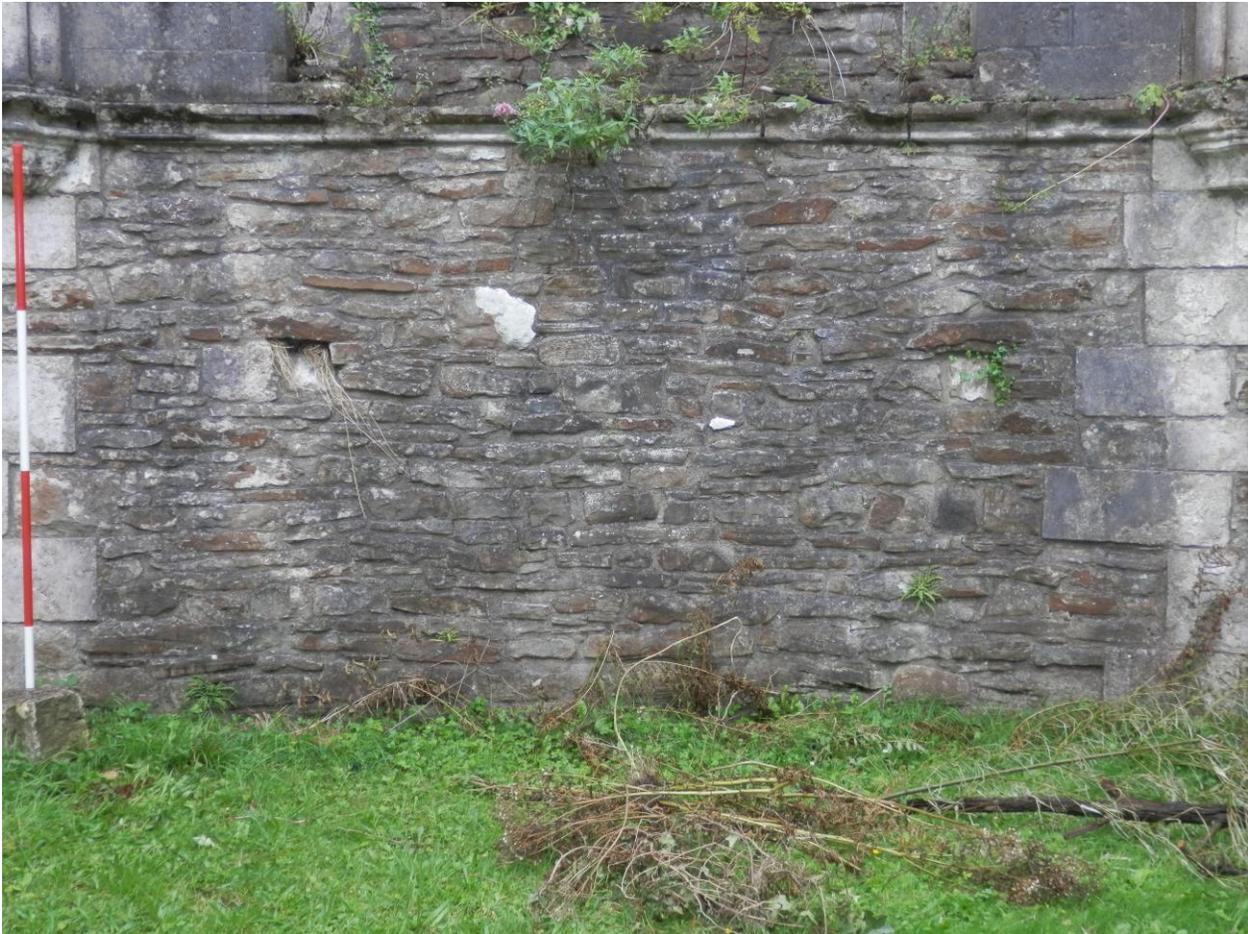
(See figure 2, figure 10 elevation 39)

ID: 68 Site Number: 748 Site Name: Margam Monastic Ruins
Wall Number: 39 Photo Number: F2/28
Location: Chapter House wall int.
Description: Lower section. Sandstone rubble, with ashlar blocks to left and right below groups of triple shafts. Two putlog holes, very little vegetation. Bad weathering to sill. Vegetation all through sill stones. Water discoloration down wall. At least three masons marks on dressed stone-right. Wall is in fairly good condition. Re-touching of cement in-between the ashlar blocks on the right.
Condition summary: A) Weathering on sill, plus vegetation. B) Mortar missing between stones in sill C) Vegetation in putlog holes. D) Weathering on base of columns.
Threats: Vegetation, Weathering
Recorded by: Ruth Hopkins Date: 25/09/2012

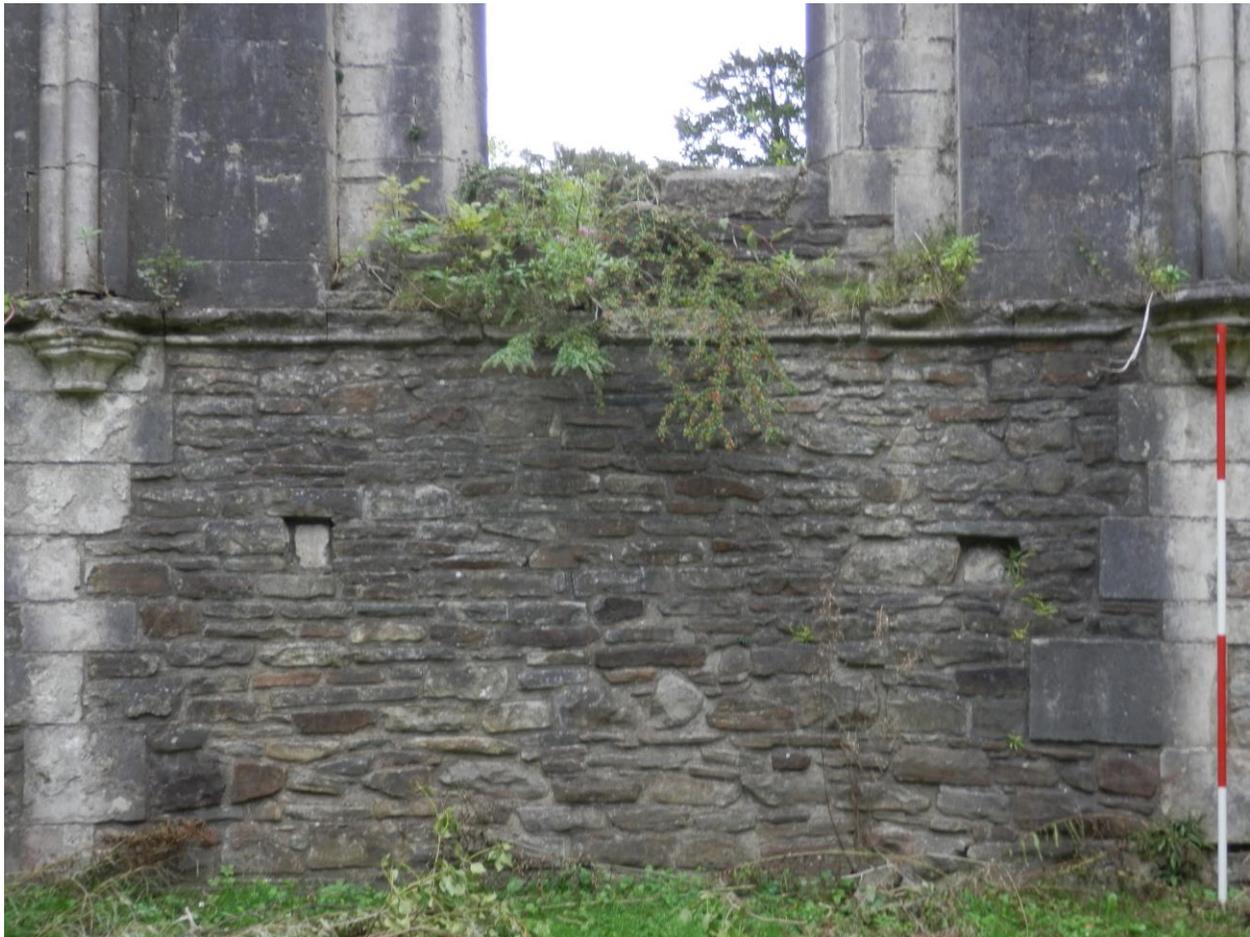
(See figure 2, figure 10 elevation 40)

ID: 70 Site Number: 748 Site Name: Margam Monastic Ruins
Wall Number: 40 Photo Number: F2/32
Location: Chapter House internal wall
Description: Lower section. Sandstone rubble wall flanked by ashlar blocks, with 3 mason's marks on ashlar blocks to left and 3 masons marks to right. 2 putlog holes - filled possibly during renovations. 2 stones on grass at foot of wall. Moulded sill obscured in center by vegetation. Moulding to base of each group of triple shafts (right and left) - plain style. Mortar in good condition – ?renewed.
Condition summary: A) Moulded sill at top of sandstone wall damaged by weather erosion. B) Putlog holes filled with single stone and modern mortar. C) Some weather erosion to moulding at base of groups of triple shafts. D) Fallen stones from above?
Threats: Vegetation, Weathering.
Recorded by: Fiona Richards Date: 25/09/2012

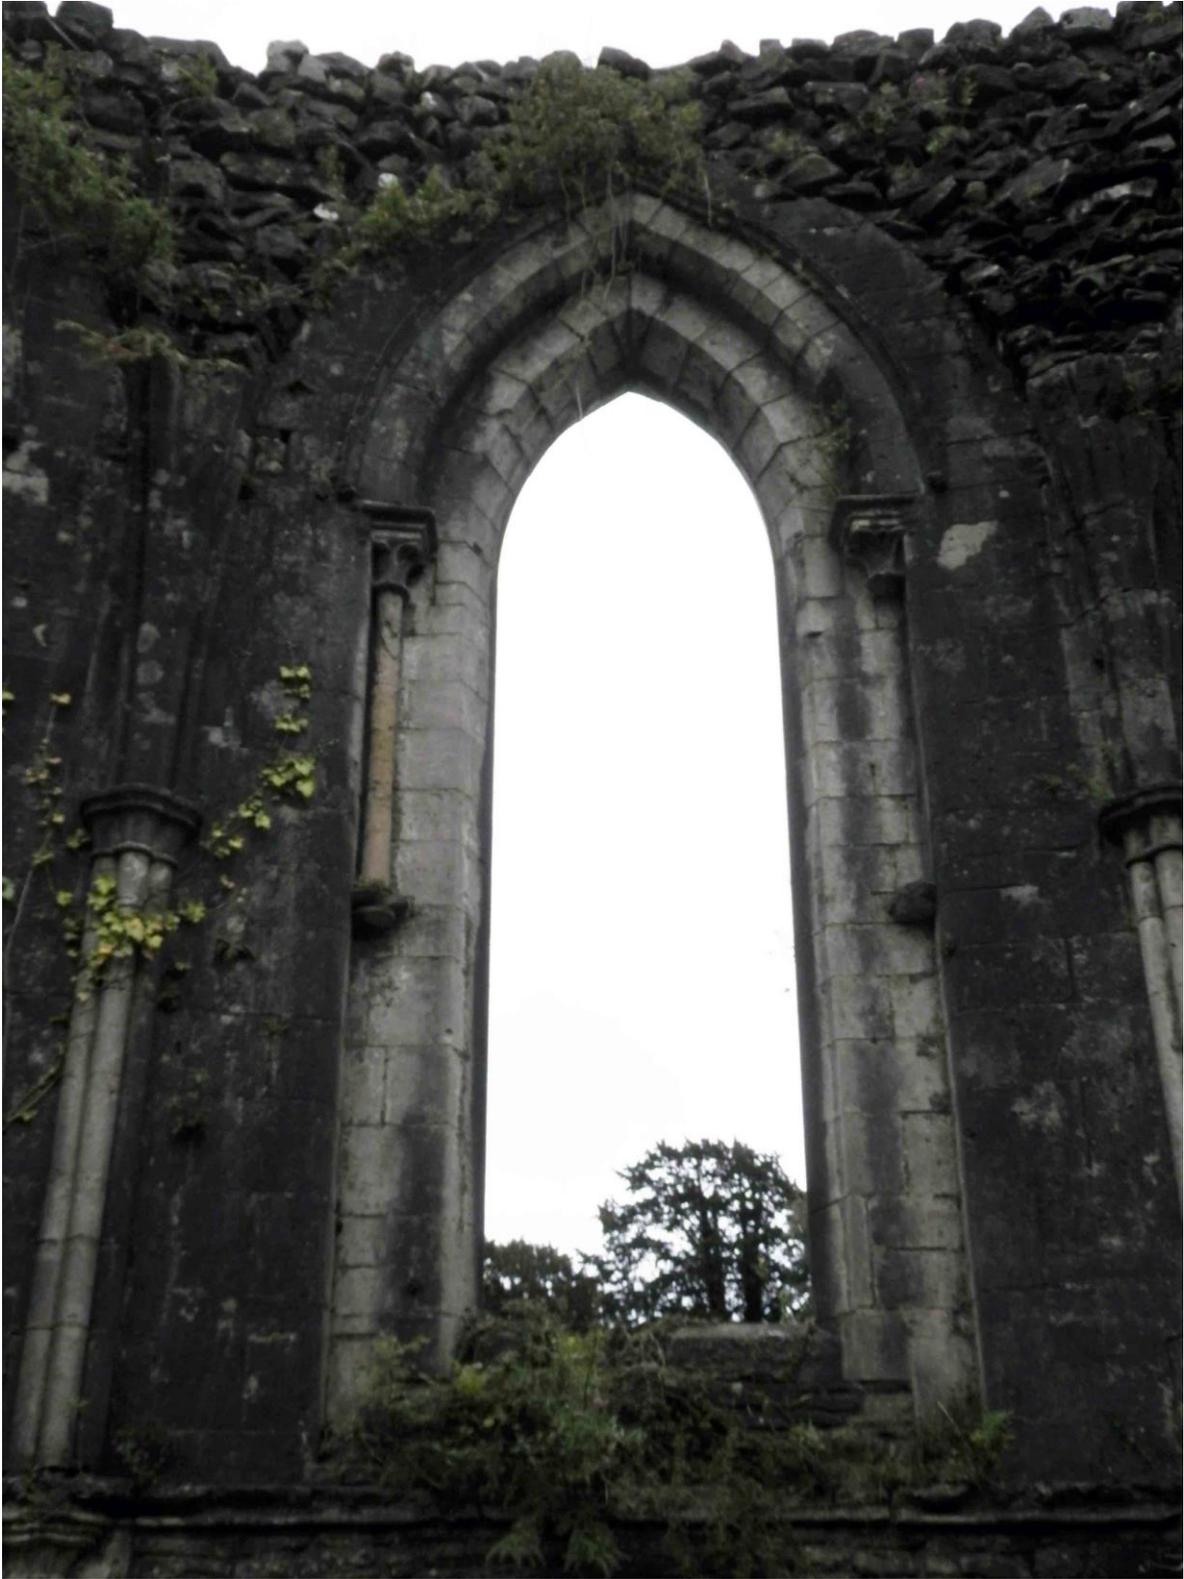
(See figure 2, figure 10 elevation 40)

ID: 71 Site Number: 748 Site Name: Margam Monastic Ruins
Wall Number: 40 Photo Number: F2/33
Location: Chapter House wall int.
Description: Upper Section. Ashlar wall with pointed lancet flanked by shafts, also two groups of triple shafts present.
Condition summary: A) Vegetation present at bottom of window. B) Bottom section of left hand shaft missing, upper section badly eroded, central moulding has chunk missing. Right hand shaft - both top and bottom sections missing, central moulding damaged. C) Section of ashlar blocks missing from bottom of window. D) Vegetation (excessive) growing from top of arched window. E) Stone work above arch of window requires inspection, suspect loose stone present.
Threats: Vegetation, Weathering
Recorded by: Jeff Jones Date: 25/09/2012

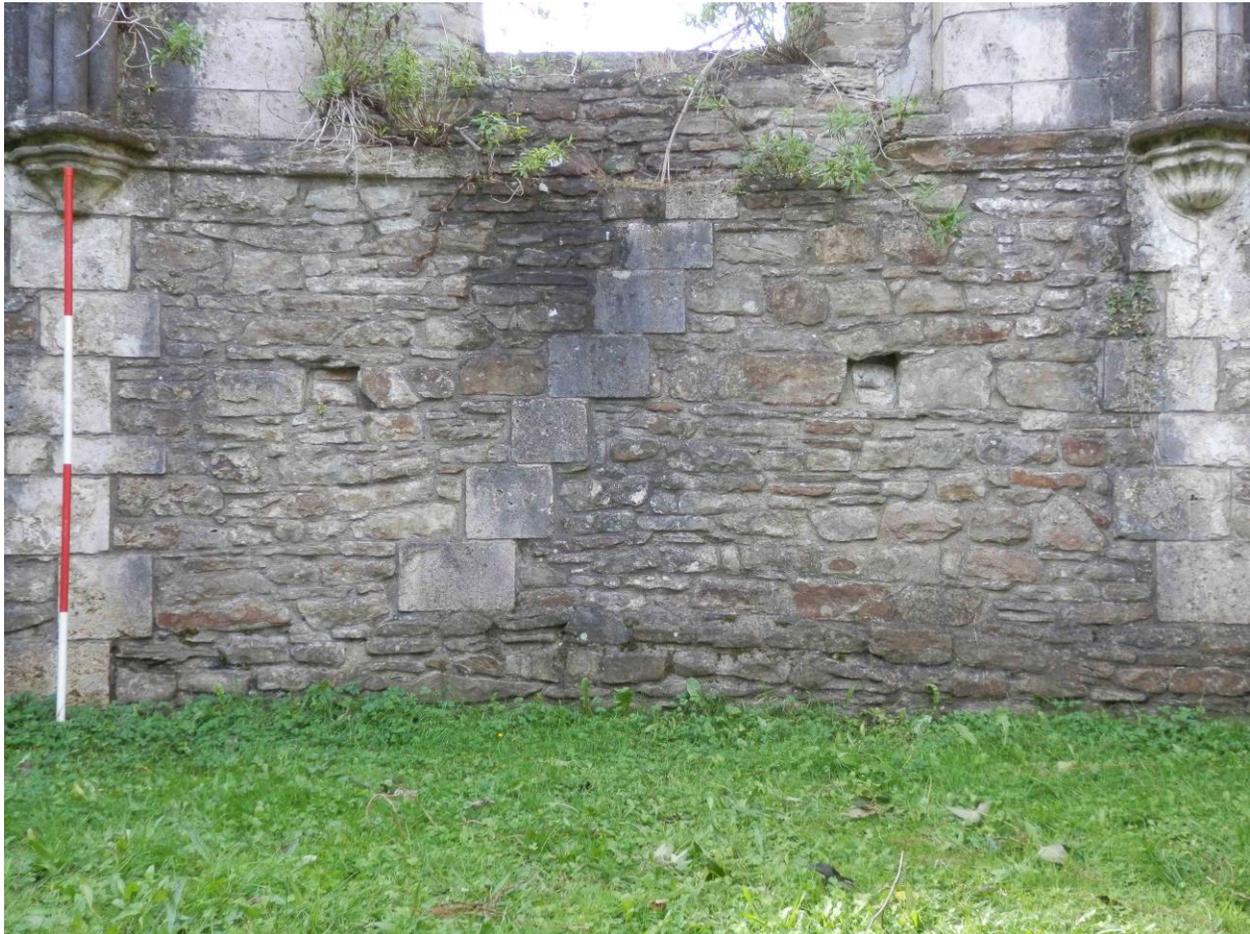
(See figure 2, figure 11 elevation 42)

ID: 74 Site Number: 748 Site Name: Margam Monastic Ruins
Wall Number: 42 Photo Number: F2/44
Location: Chapter House wall int.
Description: Lower Section. Sandstone rubble wall flanked by ashlar blocks, also ashlar arranged as a diagonal in middle of wall. Mason's mark on left-hand ashlar blocks. Two putlog holes present, sill to top of wall.
Condition summary: A) Ashlar on sill missing, moulding to front of stone present. B) Vegetation growing from sill (valerian). C) Mortar ?in good condition.
Threats: Vegetation, Weathering
Recorded by: Jeff Jones Date: 25/09/2012

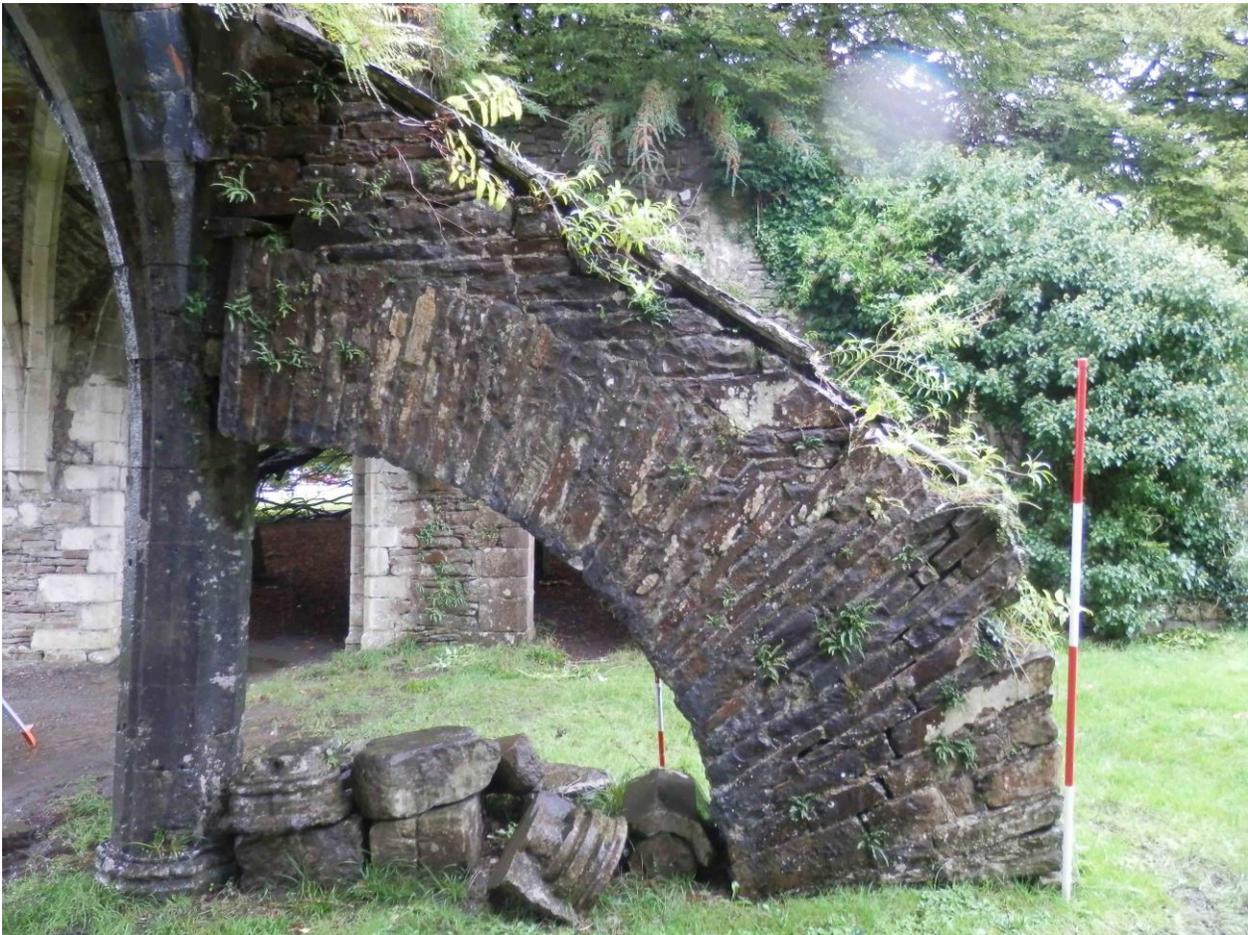
(See figure 2)

ID: 82 Site Number: 748 Site Name: Margam Monastic Ruins
Wall Number: 47 Photo Number: F2/40
Location: North Buttress (not part of original abbey fabric) east cloister, east face.
Description: Flying buttress supporting pillar in east cloister.
Sandstone construction with slate[?] on top with, iron drain pipe underneath slab. End slab missing at end above iron pipe. [?]Lime mortar used in construction, vertical horizontal facings.
Condition summary: A) Loose stone horizontal above vertical stone work. B) Slabs on top buttress worn. C) Vegetation an and under slabs. D) Crack right-hand side stones.
Threats: Weathering, Vegetation
Recorded by: (not filled in) Date: 26/09/12

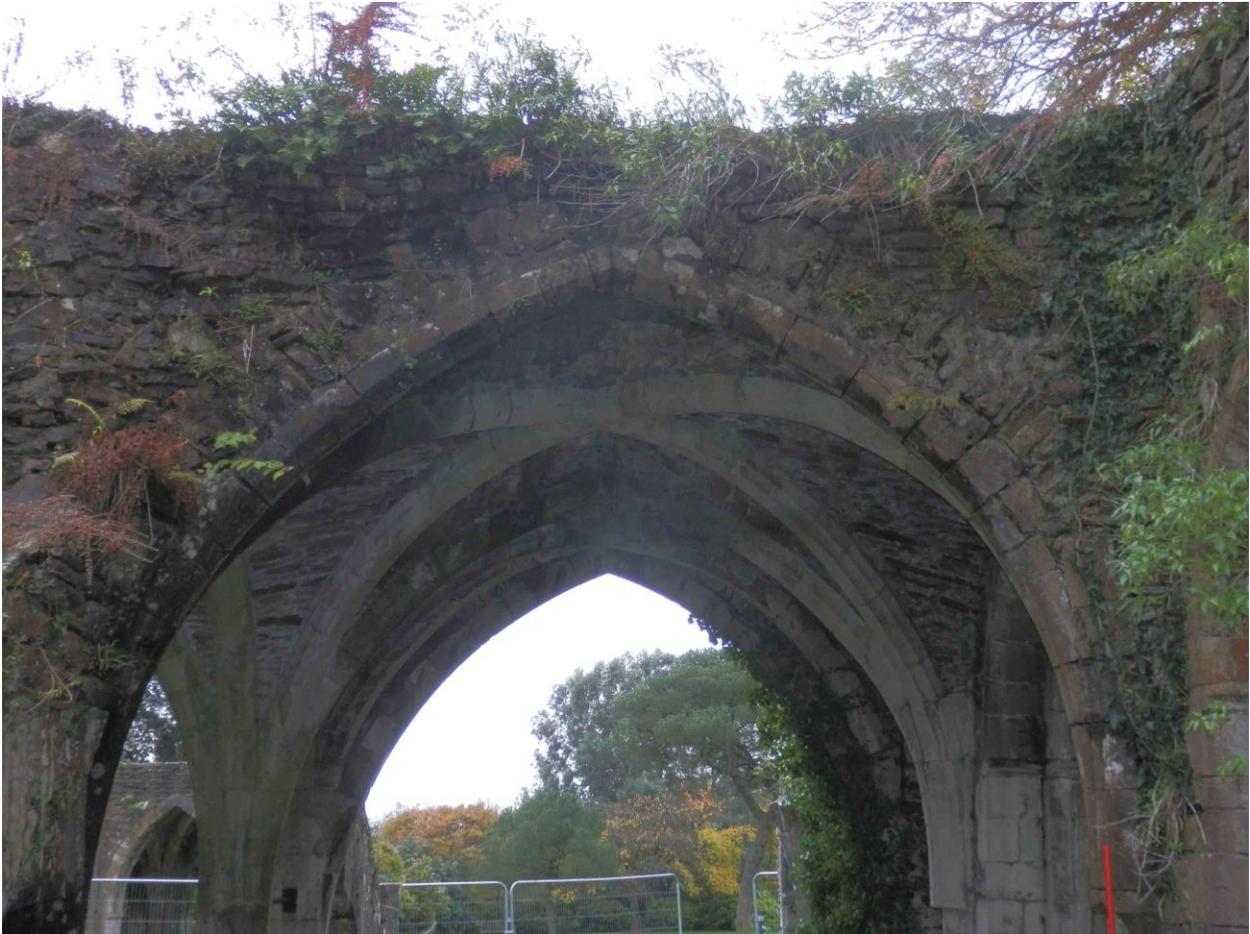
(See figure 2)

ID: 85 Site Number: 748 Site Name: Margam Monastic Ruins
Wall Number: 50 Photo Number: F2/36-39
Location: Vaulted arch east cloister, north side right-hand side
Description: Vaulted arch in ashlar, local sandstone rubble above. Top of wall obscured by vegetation. Some cracks right-hand side of arch, loose stone, with no mortar near the remains of the vaulting. Above this on wall more cracks and missing mortar. Vaulting rib is cracked along length. Gaps between stone work weathered. Seepage.
Condition summary: A) Loose and mortar free stone. B) Ashlar in arch crack right-hand side C) Vegetation on top. D) Loose stone work on top. E) Weathering on ashlar. F) Seepage left-hand side.
Threats: Weathering, Vegetation, seepage
Recorded by: Paul Minton Date: 26/09/12

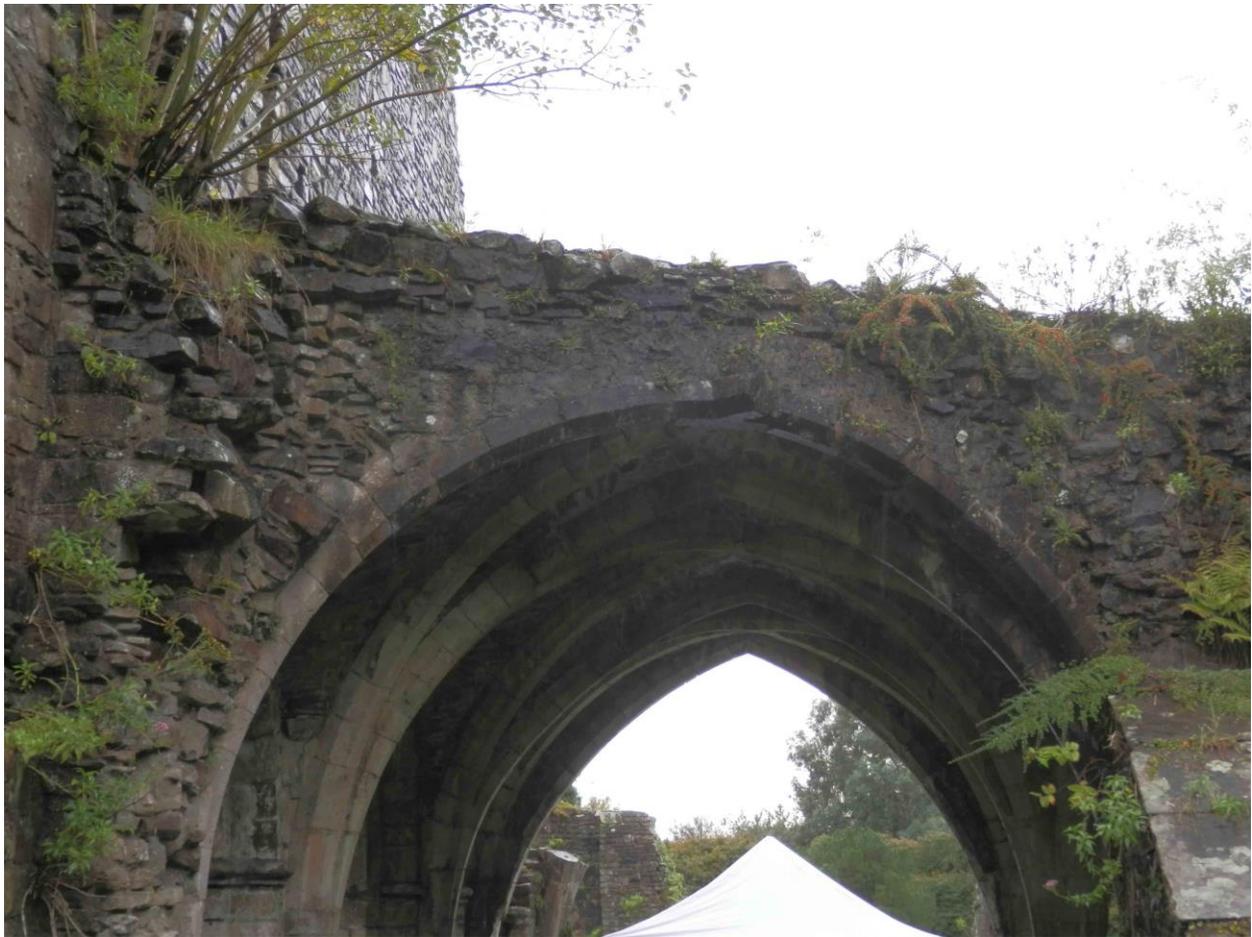
(See figure 2)

ID: 86 Site Number: 748 Site Name: Margam Monastic Ruins
Wall Number: 50 Photo Number: F3/28-31
Location: Vaulted arch east cloister, north side left hand side
Description: Vault arch in ashlar. The longitudinal rib of the vault projects slightly, indicating where there would originally have been another bay; some of the rubbles of haunches of this survives to project from the face of the standing bay. Right-hand side is supported by buttress (wall no.49). Right-hand side heavy water seepage.
Condition summary: A) Left-hand side arch; lower 1/2 some stones missing mortar. B) Left-hand side arch; protruding stone potential to weather, loose - danger to visitors. C) Loose stone on top. D) Vegetation. E) Seepage
Threats: Weathering, Vegetation, seepage
Recorded by: Paul Minton Date:26/09/12

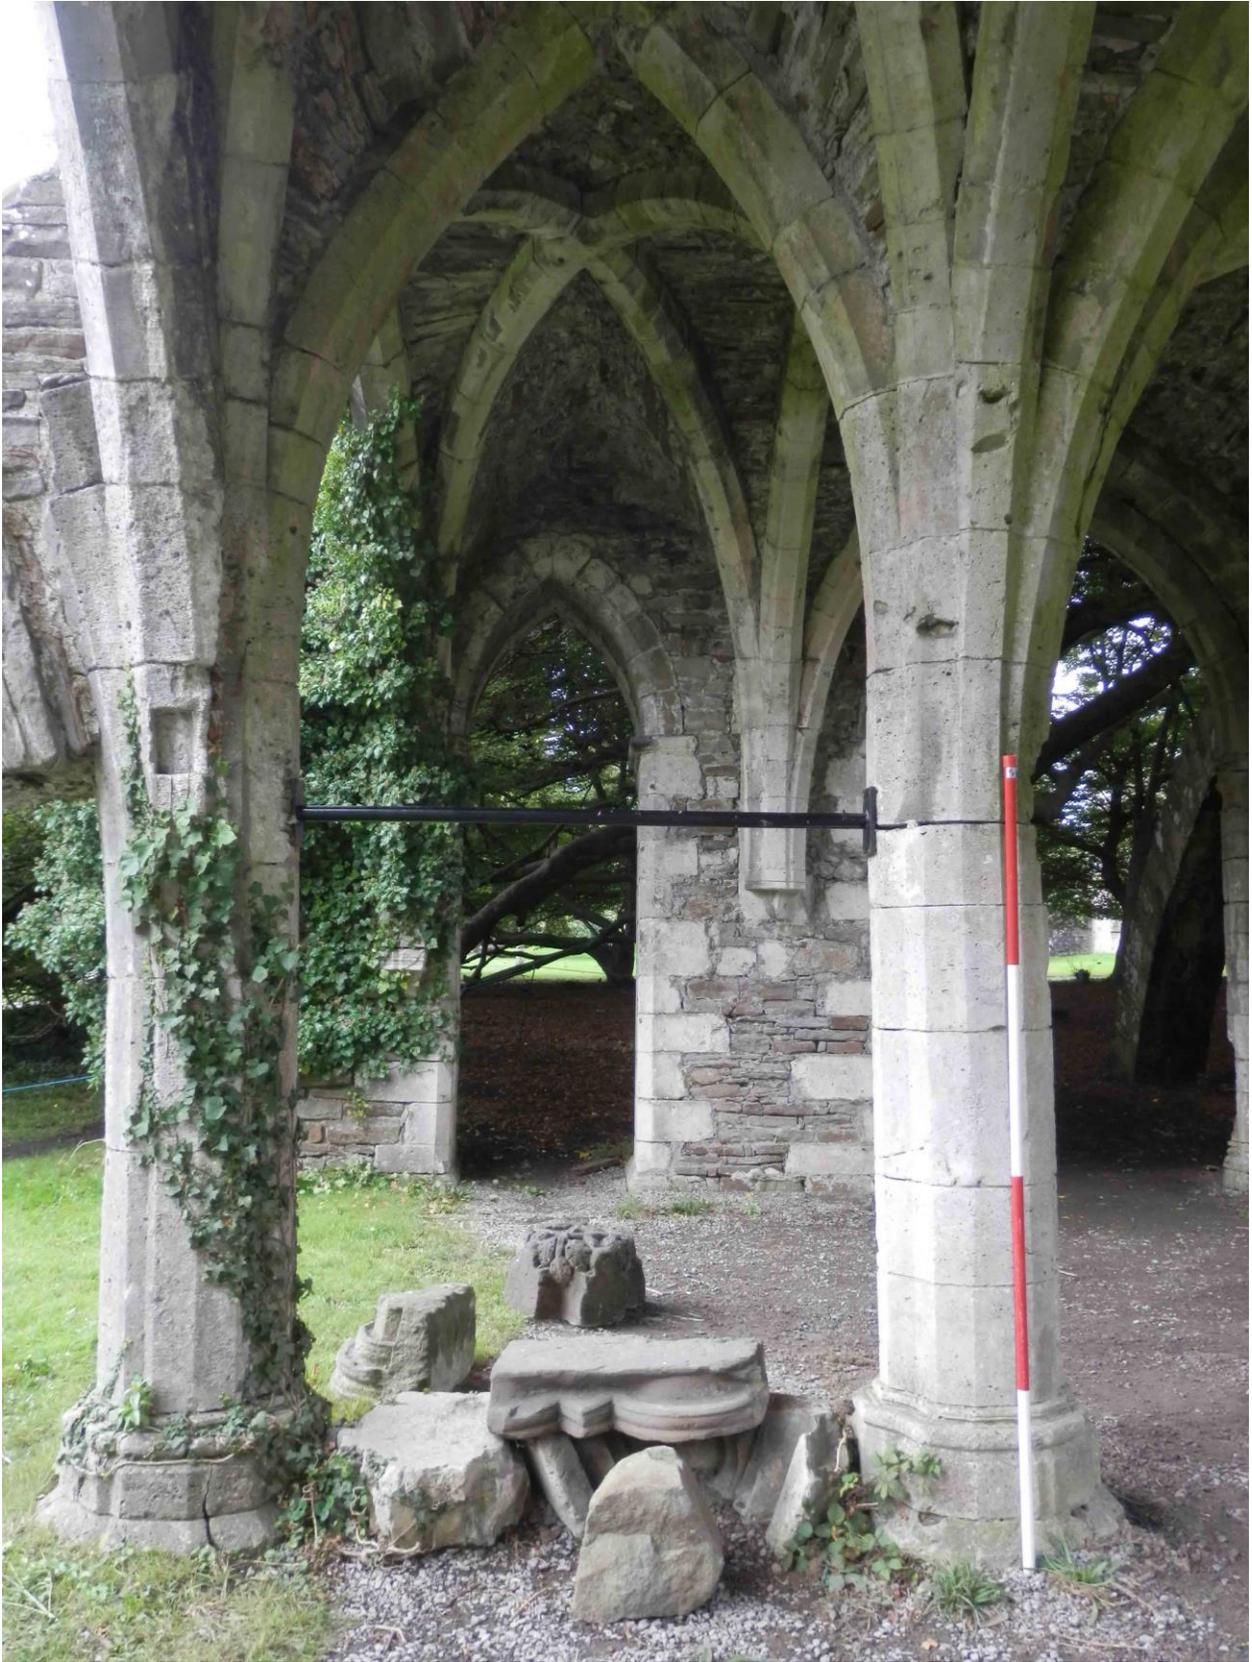
(See figure 2)

C) Right-hand pillar, gap at bracing bar. D) Damaged blocks right-hand pillar Seventh and eighth courses. E) Weathering on right-hand pillar sixth, seventh And eighth courses. F) Right-hand side of left-hand pillar has damaged stones in fifth and sixth courses. G) Vegetation left-hand pillar
Threats: Weathering, Vegetation, People
Recorded by: (not filled in) Date: 26/09/2012

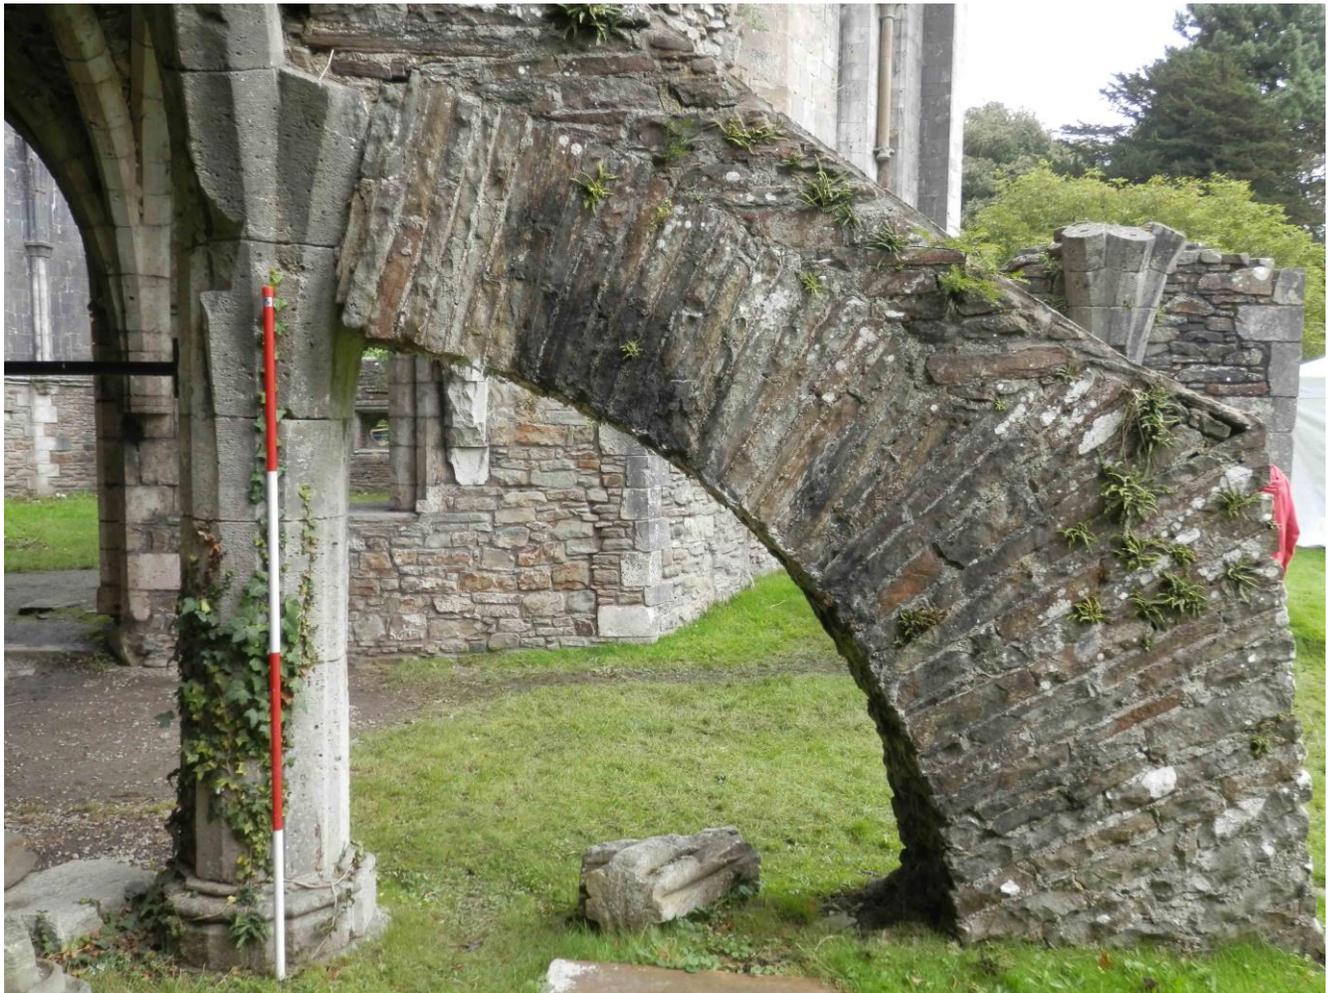
(See figure 2)

ID: 93 Site Number: 748 Site Name: Margam Monastic Ruins
Wall Number: 57 Photo Number: F2/61
Location: South Buttress, east cloister (not part of original abbey fabric), west face
Description: Same as 55 - opposite side of buttress
Condition summary: A) Wet patch on underside of buttress arch. B) Intermittent vegetation growth. C) Sapling (well rooted) growing at top of arch near sloping surface (0.075m from top). D) Sapling (well rooted at uppermost point of buttress side.
Threats: Weathering, Vegetation, yew sapling growth water retention
Recorded by: Julian T. James Date: 27/09/2012

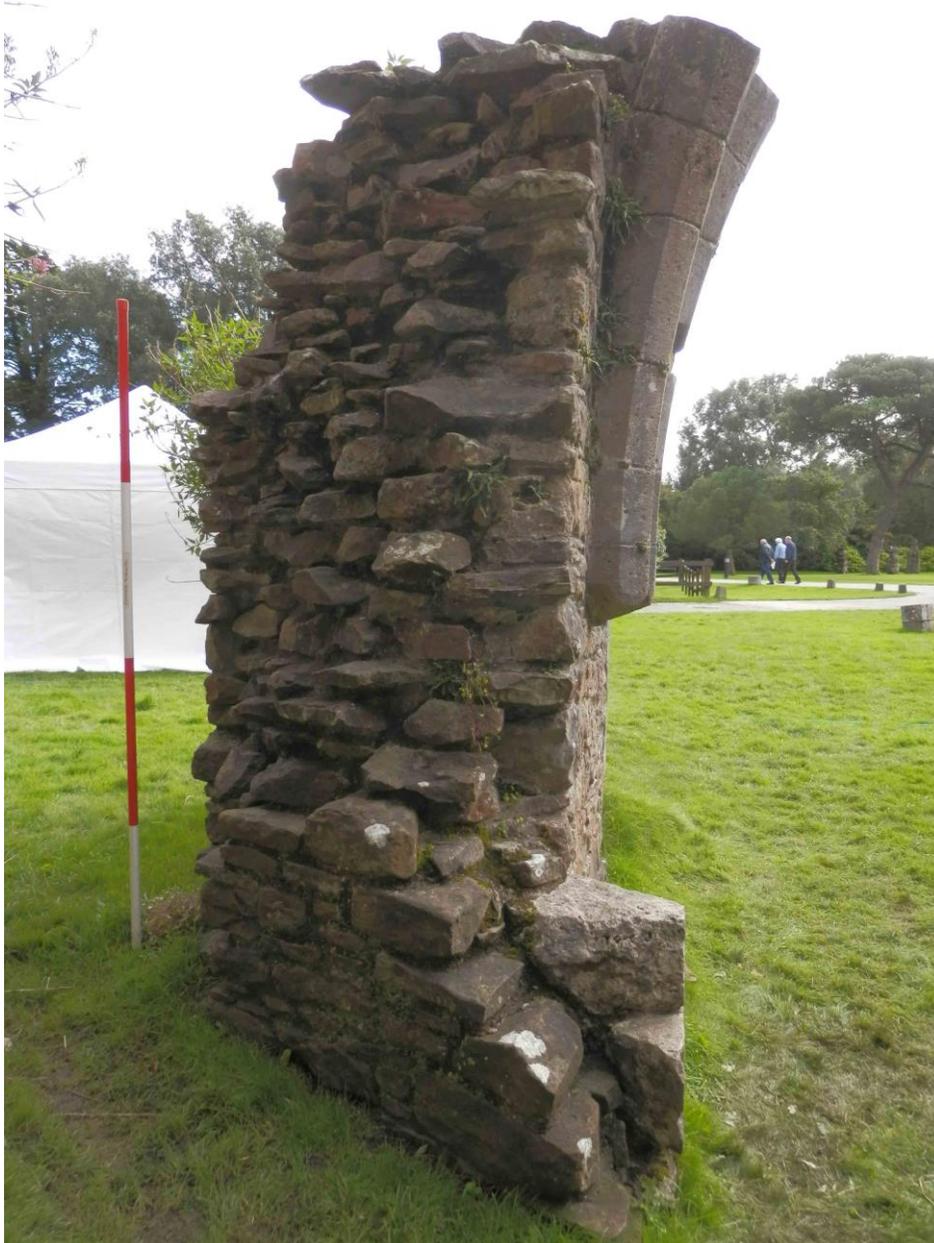
(See figure 2)

ID: 97 Site Number: 748 Site Name: Margam Monastic Ruins
Wall Number: 61 Photo Number: F2/70
Location: East cloister west wall north end
Description: Facing of wall survives about 0.75cm, above that is core, little plant life growing in-between the stones. Loose stones on top. New mortar
Condition summary: A) Loose stones on top. B) children can climb on it. C) Plant growing
Threats: Weathering, Vegetation, Children could climb on it
Recorded by: Ruth Hopkins Date: 29/09/2012

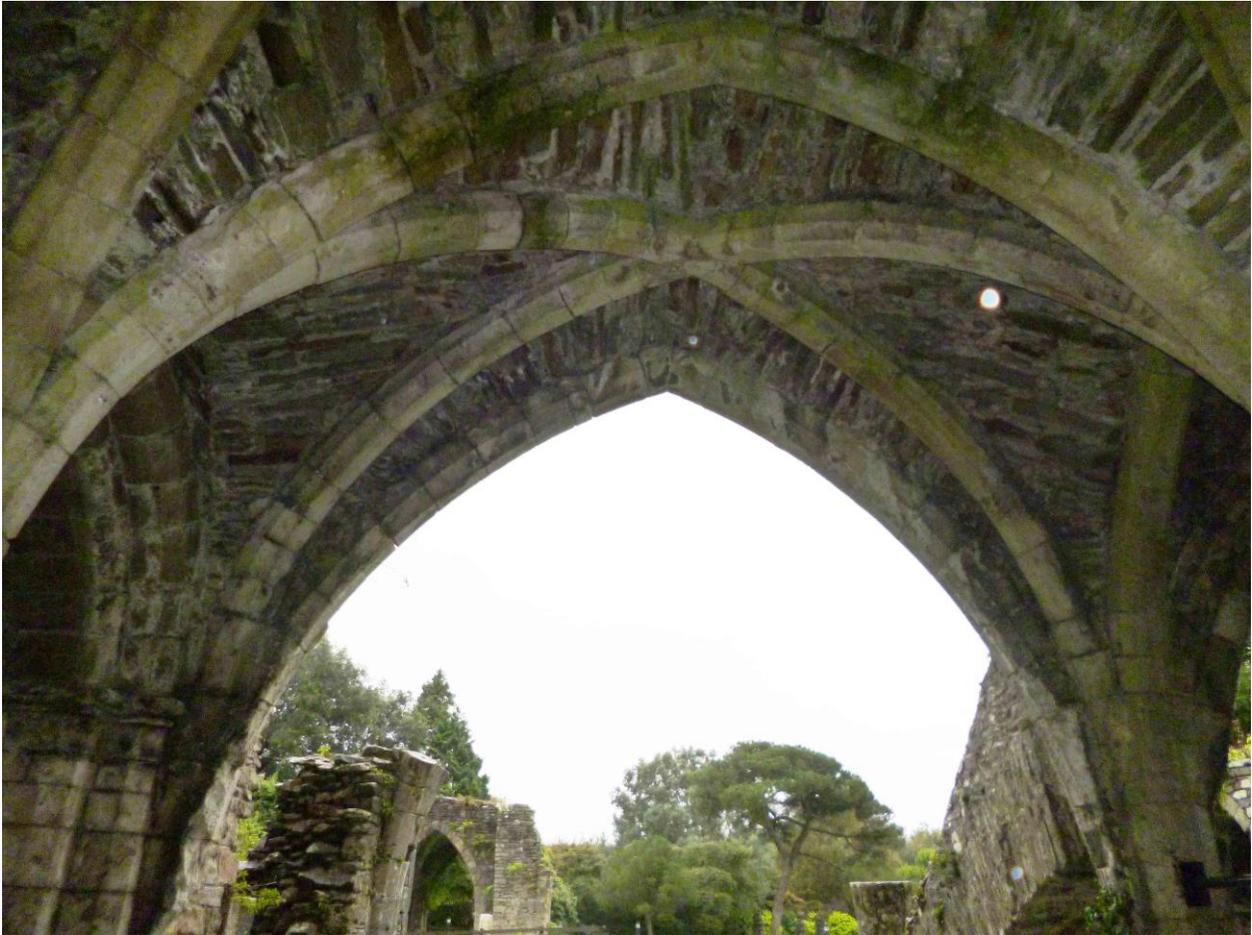
(See figure 2)

ID: 100 Site Number: 748 Site Name: Margam Monastic Ruins
Wall Number: 64 Photo Number: F2/193-104
Location: Vaulted arch east cloister south end east vault Int.
Description: Supported vaulted ceiling made of sandstone rubble, with ashlar ribs supported on pillars to west and brackets to east. One of brackets (wall no.62/64) is broken or missing. The whole structure is supported by a buttress (wall no.55) attached to the outside of the centre pillar.
Condition summary: A) Broken/split bracket at the base of rib at southeast corner. B) Gap in between blocks of ribbing on east side. C) Gap in between blocks at apex of arch. D) Vegetation on right centre pillar. E) Crack on base of centre pillar.
Threats: Weathering, Vegetation
Recorded by: Ruth Hopkins Date: 28/09/2012

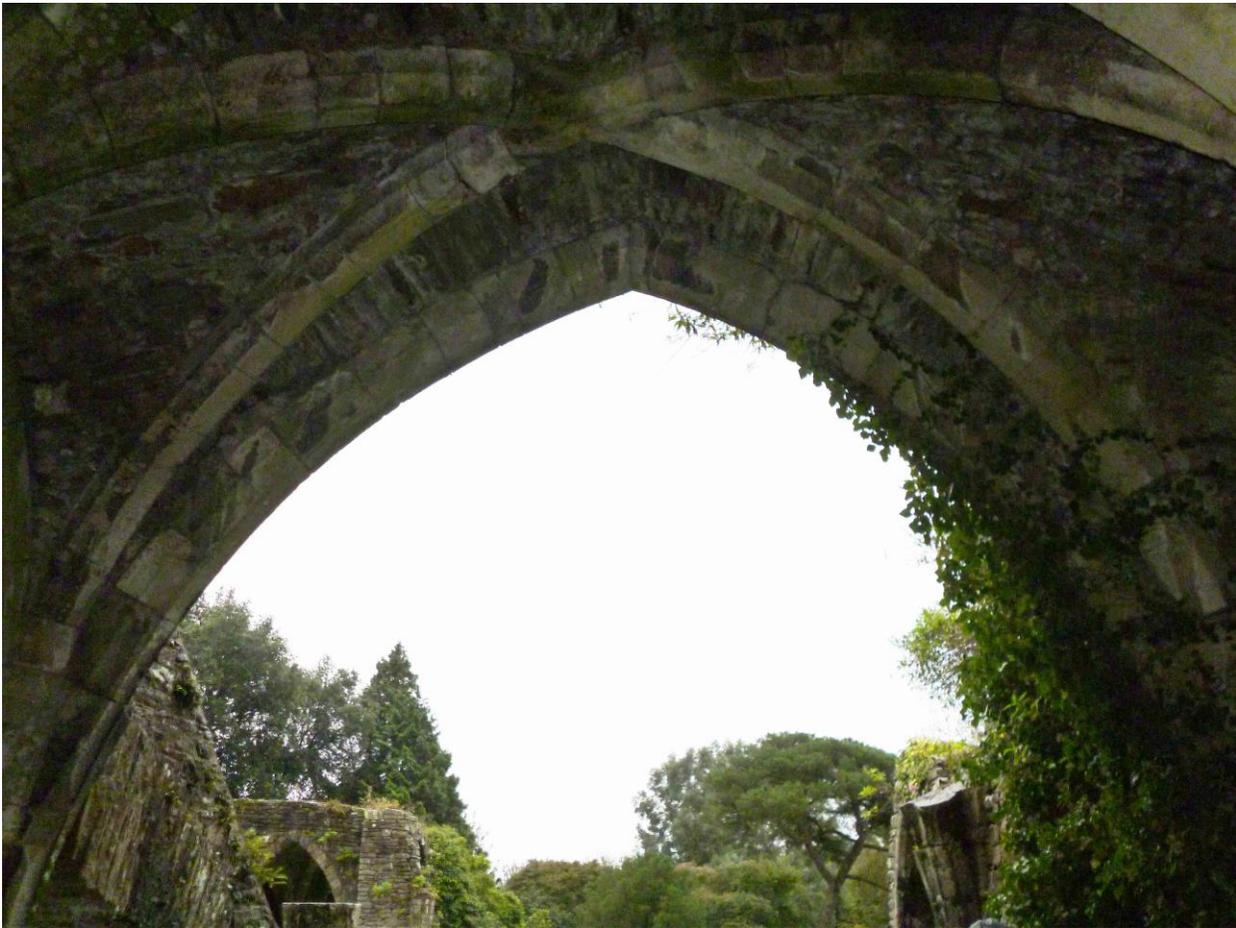
(See figure 2)

F) Base of pillar on left hand side is cracked.
Threats: Vegetation (ivy), Weathering
Recorded by: Jeff Jones. Date: 28/09/2012

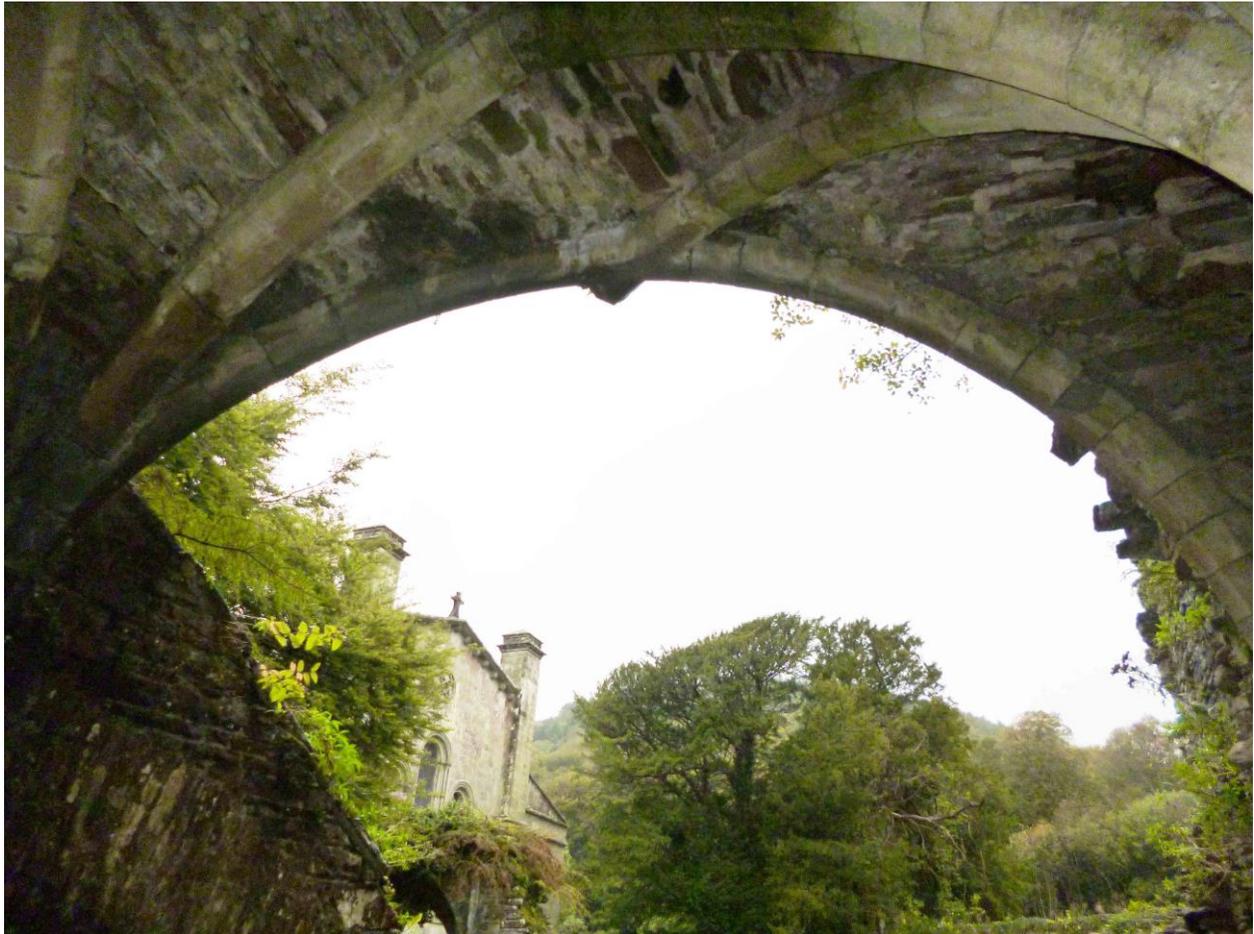
(See figure 2)

ID: 102 Site Number: 748 Site Name: Margam Monastic Ruins
Wall Number: 66 Photo Number: F2/99-102
Location: East cloister north, east arch Int.
Description: Large archway of dressed stone. The right-hand pillar is the part of the central arcade of the east cloister walk. This pillar, and left side of arch are damp with seepage. Buttress (wall no.47) supporting centre pillar.
Condition summary: A) Chip in voussoirs. B) Gaps between ashlar blocks. C) Water damage on pillar and left side of archway. D) Centre pillar is sinking.
Threats: Vegetation, Weathering (water damage)
Recorded by: Ruth Hopkins Date: 28/09/2012

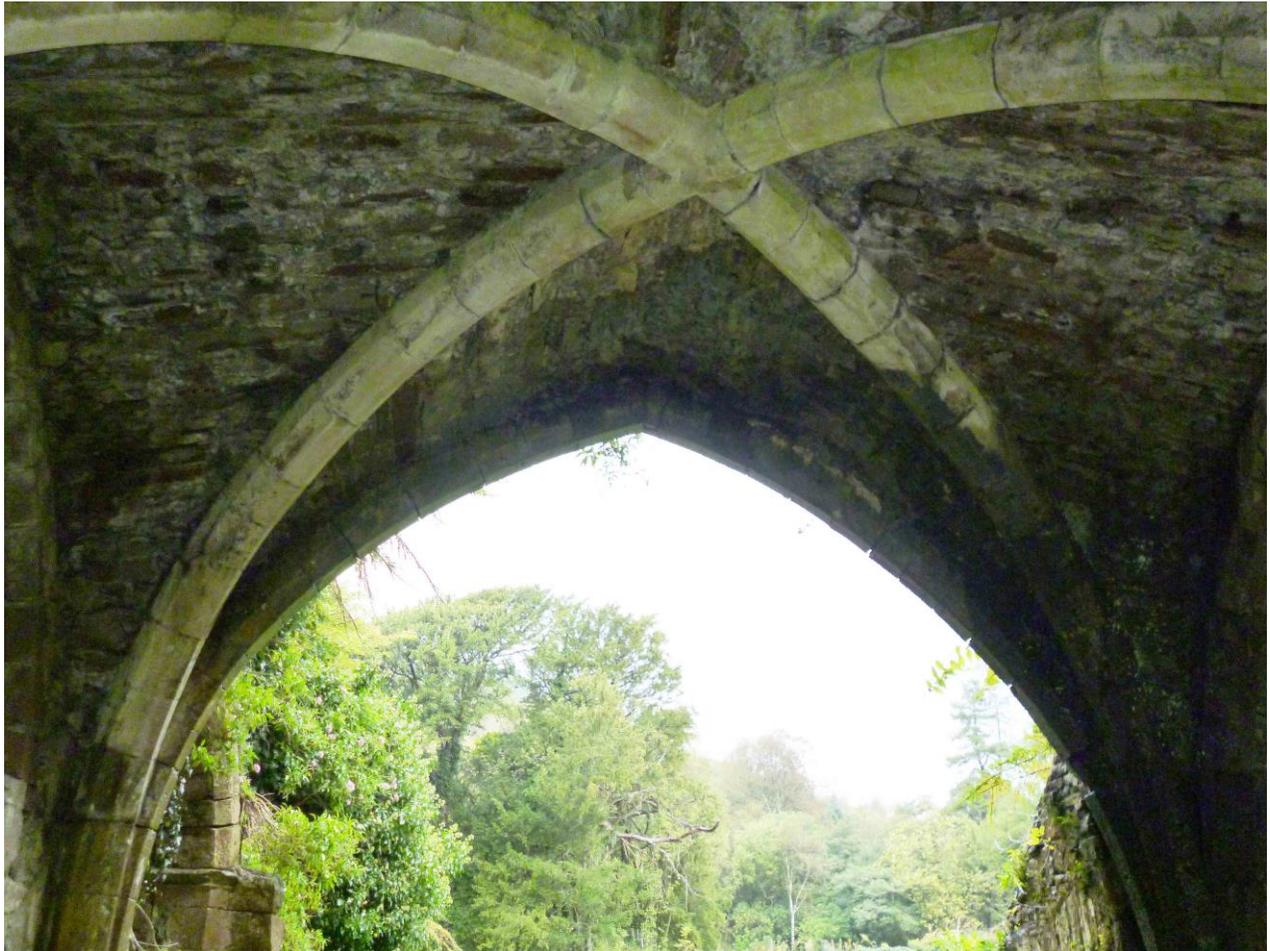
(See figure 2)

ID: 103 Site Number: 748 Site Name: Margam Monastic Ruins
Wall Number: 67 Photo Number: F2/97-98
Location: East cloister north, west arch Int.
Description: Archway consists of ashlar blocks with chamfered corners; supporting the upper section of the cloister arcade. On the right hand side it is supported by ashlar pillar and on the left hand side by a bracket halfway up the wall. Pointing between blocks of pillar has fallen away in places.
Condition summary: A) Water filtering through stone work from top of vestibule. B) Pointing requires inspection between ashlar blocks, as some is falling away. C) Right hand support pillar leaning badly to the west and is supported to the outside by a stone buttress (no.47) which itself is in a bad state of repair.
Threats: Weathering, structural weakening, Vegetation.
Recorded by: Jeff Jones Date: 28/09/2012

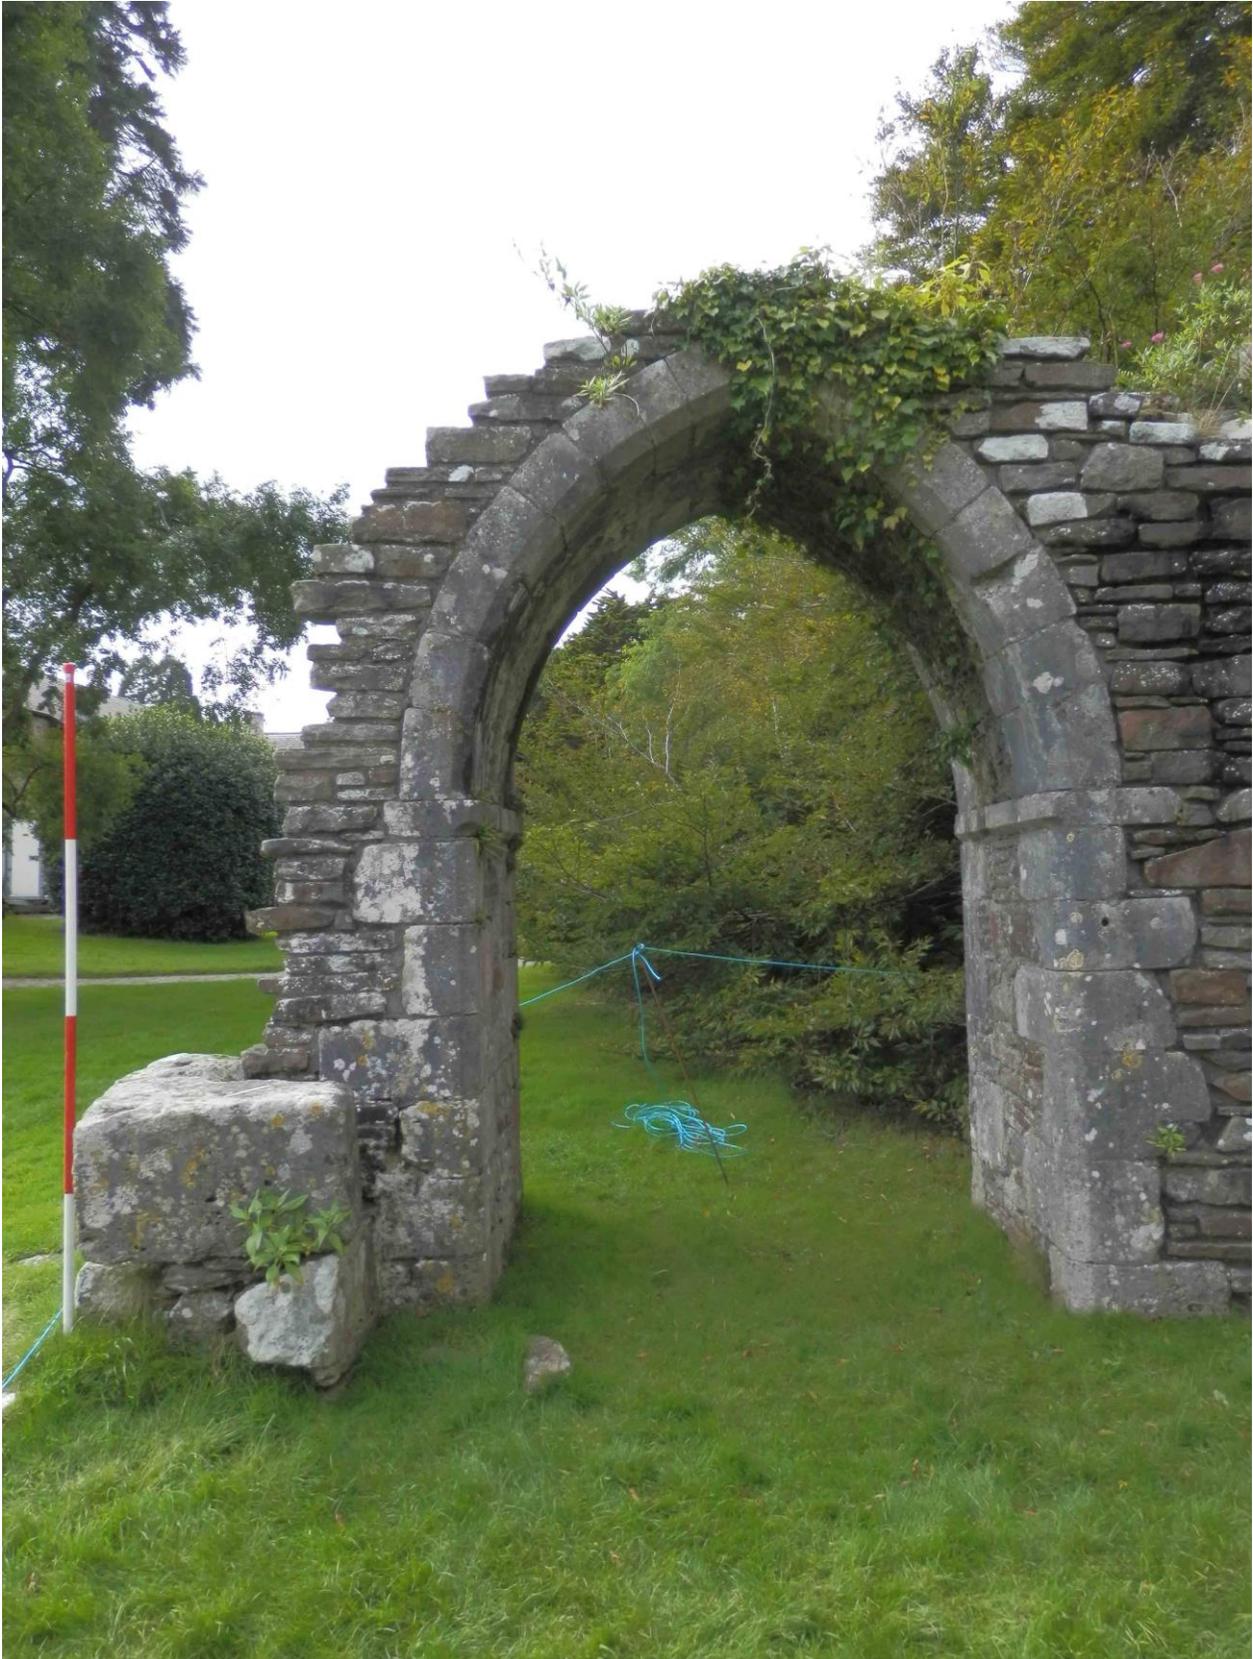
(See figure 2, figure 13 elevation 68)

D) Chip in dressed stone of arch (right hand side). E) weathering out of
mortar between all stone work.
Threats: Vegetation, weathering, human interaction.
Recorded by: Julian James Date: 28/09/2012
