Monastic Margam Community Survey Project

Report for Cadw
by Sam Pamment BA

GGAT report no. 2013/020
NGR: SS 8018 8626
Project no. GGAT 123

Summary

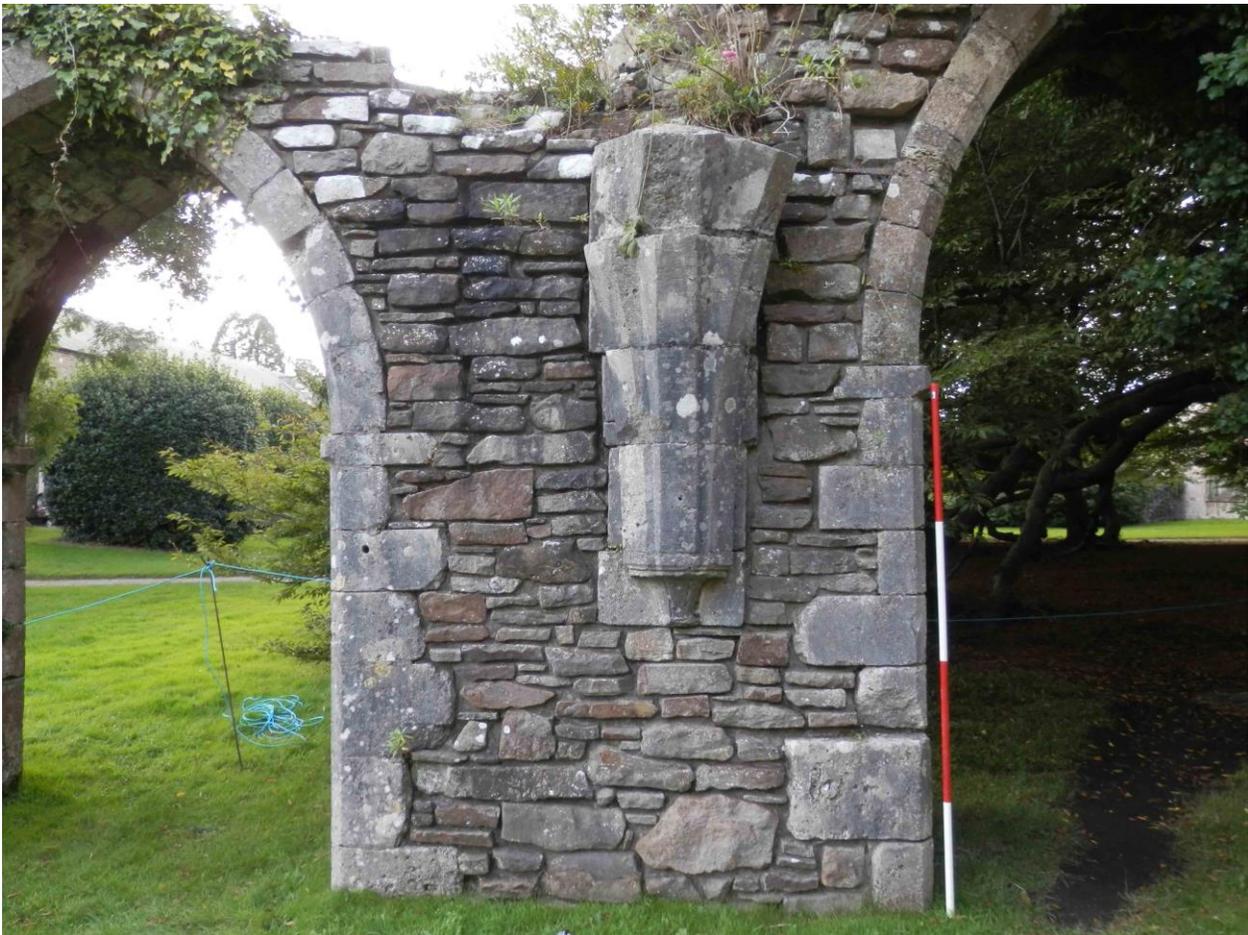
(See figure 2, figure 13 elevation 69)

ID: 105 Site Number: 748 Site Name: Margam Monastic Ruins
Wall Number: 69 Photo Number: F2/79
Location: East cloister West Wall Int.
Description: Wall in coursed rubble quoined by the ashlar blocks that form the arches into the cloister. Just off-centre of the wall is a bracket supporting the springing of the ribs for the vault, also all in ashlar. Pointing blocks in good condition but requires inspection at top of wall.
Condition Summary: A) Pointing at top of wall requires inspection, could be loose stonework present. B) Section of vaulting support missing. C) Vegetation growing from top of wall (Valerian, Fern etc.).
Threats: Vegetation, Weathering.
Recorded by: Jeff Jones Date: 28/09/2012

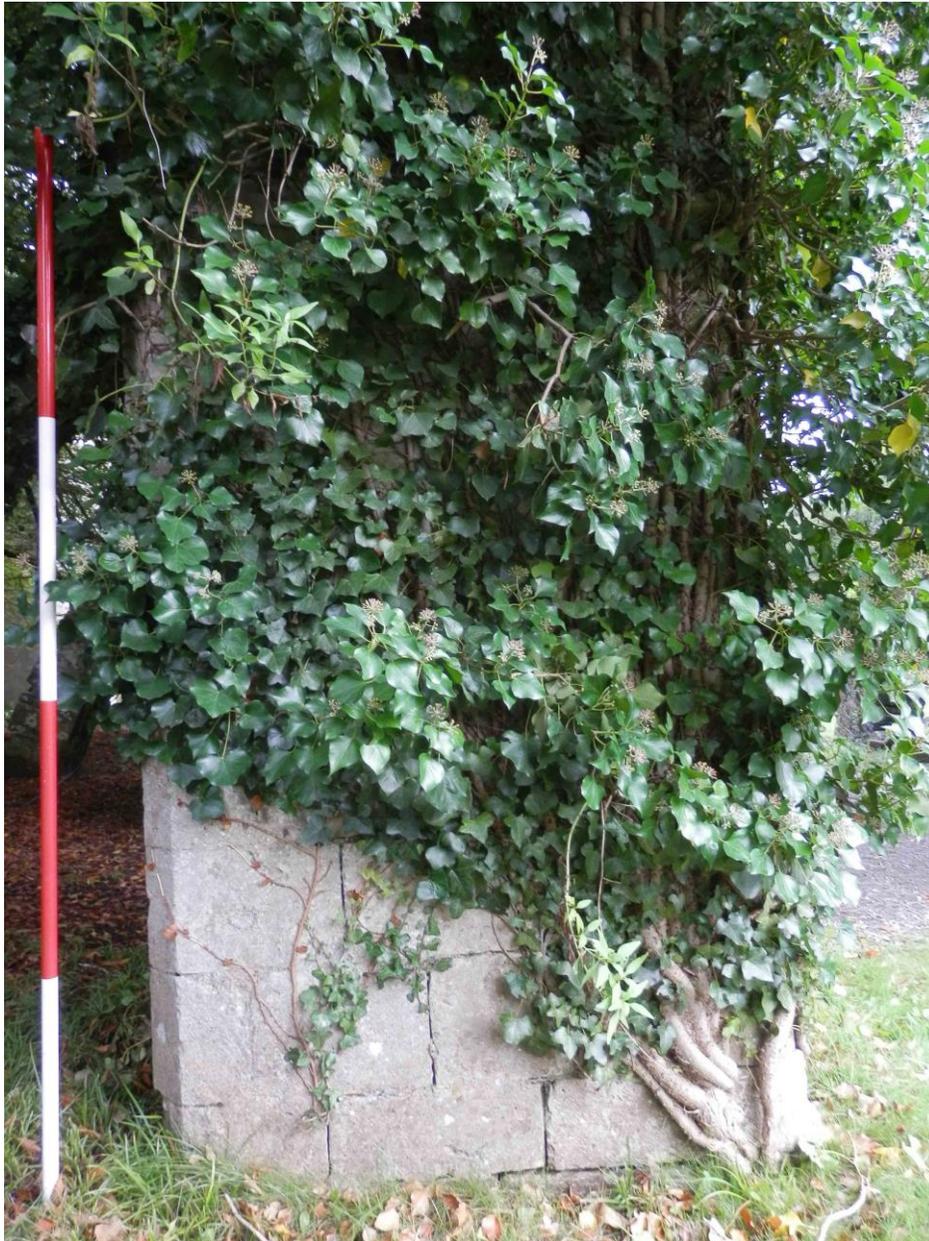
ID: 108 Site Number: 748 Site Name: Margam Monastic Ruins
Wall Number: 71.2 Photo Number: F2/82
Location: East cloister West wall arch (wall 70) north face
Description: North inside face ashlar 98% covered in ivy- covers any faults.
Bottom left hand corner stone work exposed.
Condition Summary: A) Extensive ivy growth heavily rooted bottom right hand corner and climbing up wall. B) Mortar damage (ivy and weathering).
Threats: Vegetation and Weathering
Recorded by: Bob Hardwick Date: 01/10/2012

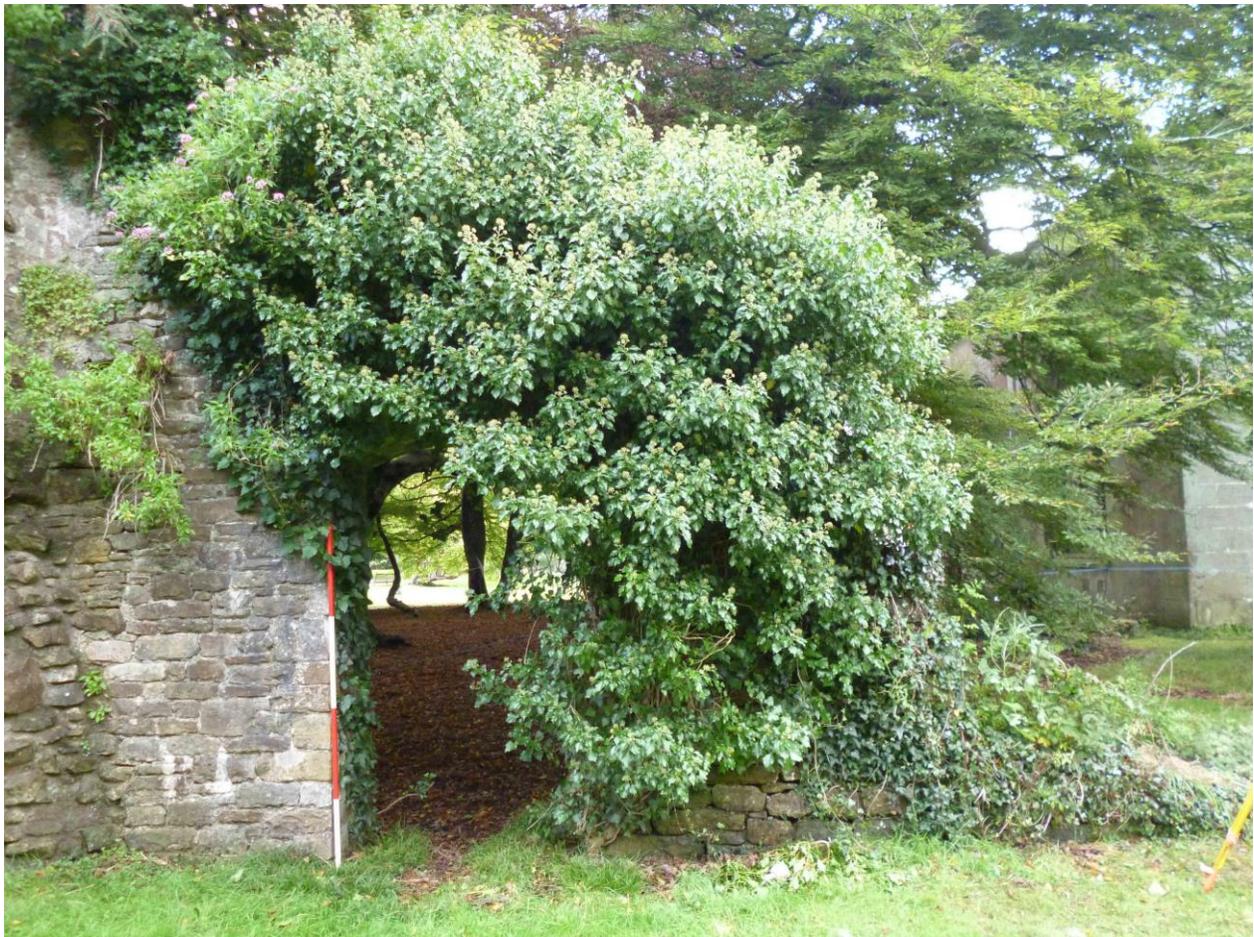
(See figure 2, figure 13 elevation 82)

ID: 122 Site Number: 748 Site Name: Margam Monastic Ruins
Wall Number: 82 Photo Number: F2/137-138
Location: East cloister west wall Int.
Description: Very little survives of this section of wall, and c 99% of it is covered in ivy. What little remains is in rubble. There is a doorway at the left-hand side, of which the left-hand side has been rebuilt. Where stonework is visible at base of wall, it can be seen that the mortar has weathered out. Ivy coverage obscuring features & damage.
Condition Summary: A) Extensive ivy penetration and growth. B) Base stone weathered out. C) Collapsed wall to right-hand side arch
Threats: Weathering, Vegetation
Recorded by: Bob Harwick Date: 01/10/2012
