Hafod Copperworks, Swansea

Hafod Community Excavation Report

June 2014

GGAT report no. 2014/018
Project no. CA004
National Grid Reference:
SS 66129 94981

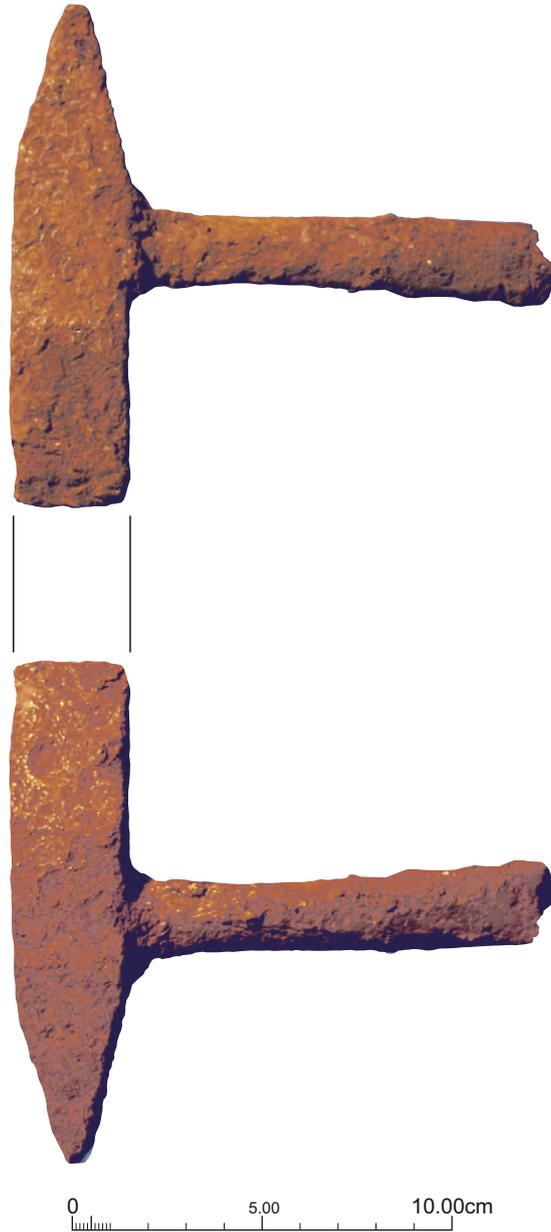
Plate 1. Unstratified iron (Fe) hammer used by metal workers and engineers (shown 50% actual size)

A single unstratified iron (Fe) hammer (Plate 1) was submitted for analysis. The object was subjected to limited cleaning of oxidised surfaces. The object was weighed before cleaning to 790g and after cleaning to 700g, with a total corrosion loss of 1.27%.

The hammer object consists of a double cross peen hammer head and tubular haft. The hammer head is 125mm long, 30mm wide at the cheek and tapering to a vertically aligned peen on one end (30mm long, angled 18°) and an opposing horizontal peen (width of head – 30mm, angled 18°). Both vertical and horizontal heads taper to a flat face 4mm in width. The haft is also iron, 18mm in diameter and hollow; overall width of the haft tubular wall is <4mm. Only 109mm of the haft length survives with an obvious forced break compressing the tubular frame. Unusually, the haft only sits halfway into the eye of the hammer head. Both haft and hammer head show oxidisation on all surfaces.

Double cross peen hammers are used by metal workers and engineers; cross peen hammers are often called engineer hammers. Cross peen hammers are utilised during forging, where the cross peen is used to make the hot metal stretch and for activities such as riveting, where the cross peen is useful for spreading or “peening” rivet heads, and sheet metal working.

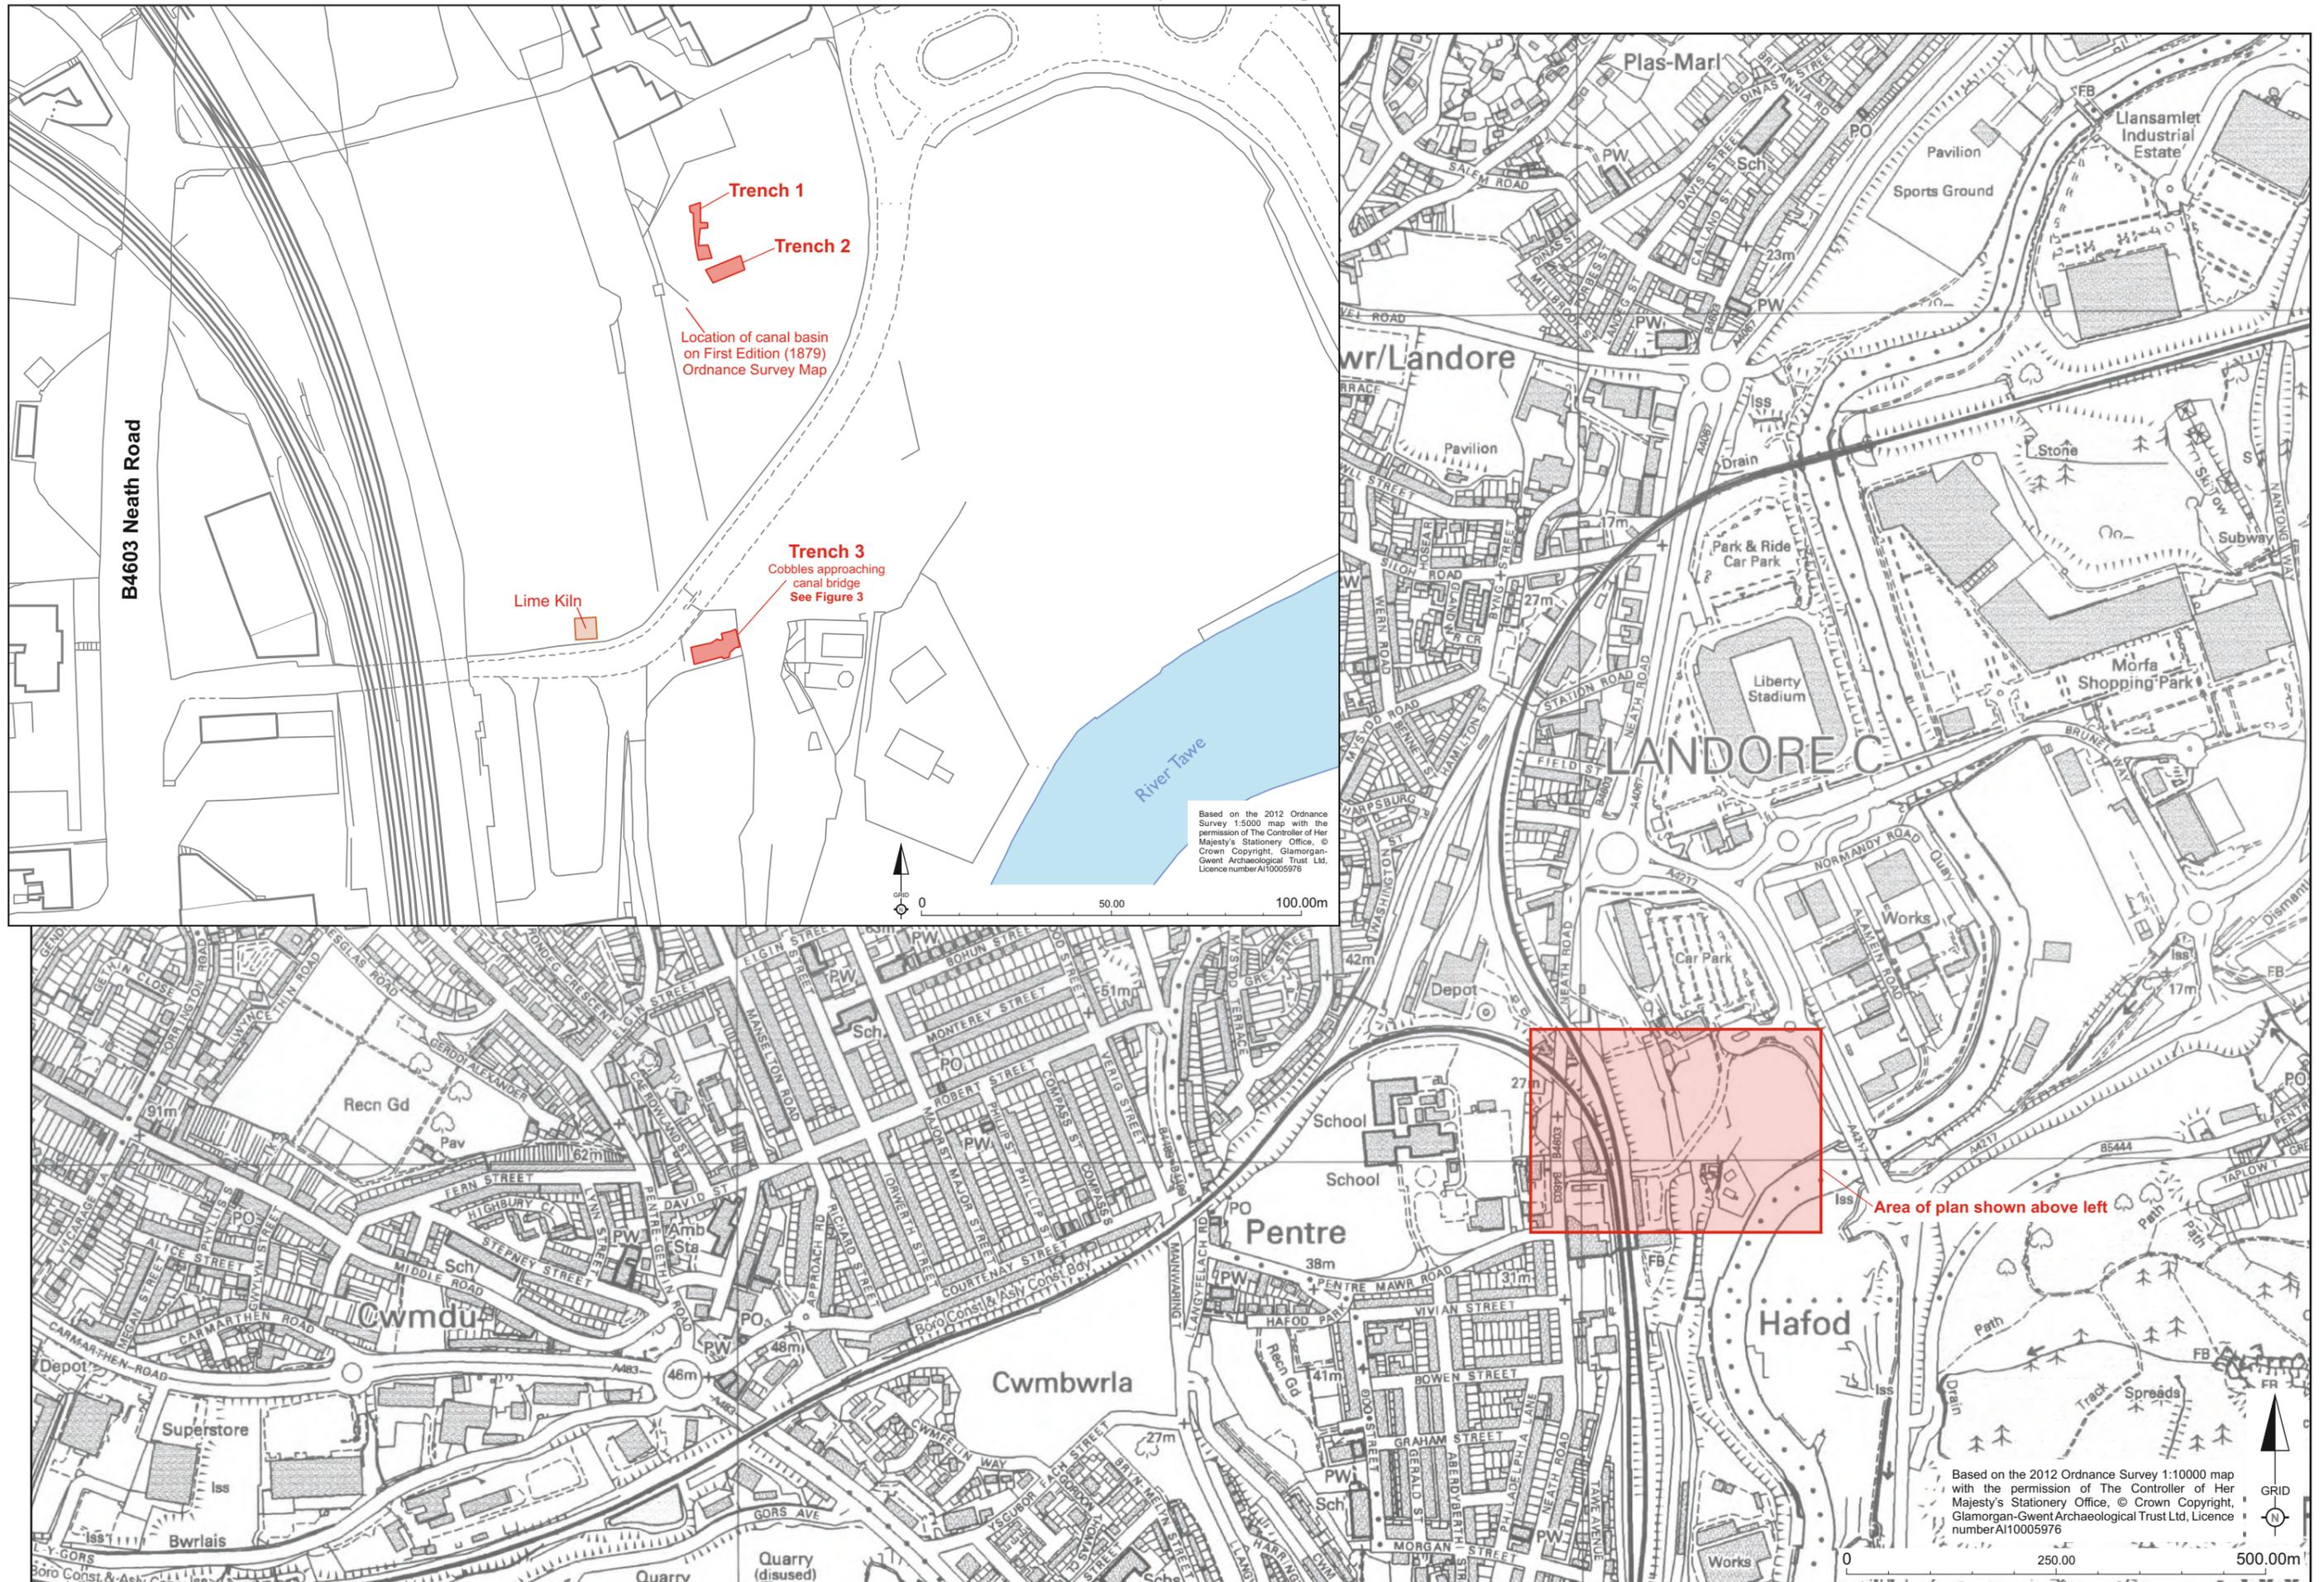
Figure 2. Plan showing significant archaeological structures and trench location (red)

An initial structural report was written which divided the site into three areas. A plan has been produced to show only the most significant features of the site (Figure 2) and a summary description of these contexts can be found with the Site Summary below (Section 4).

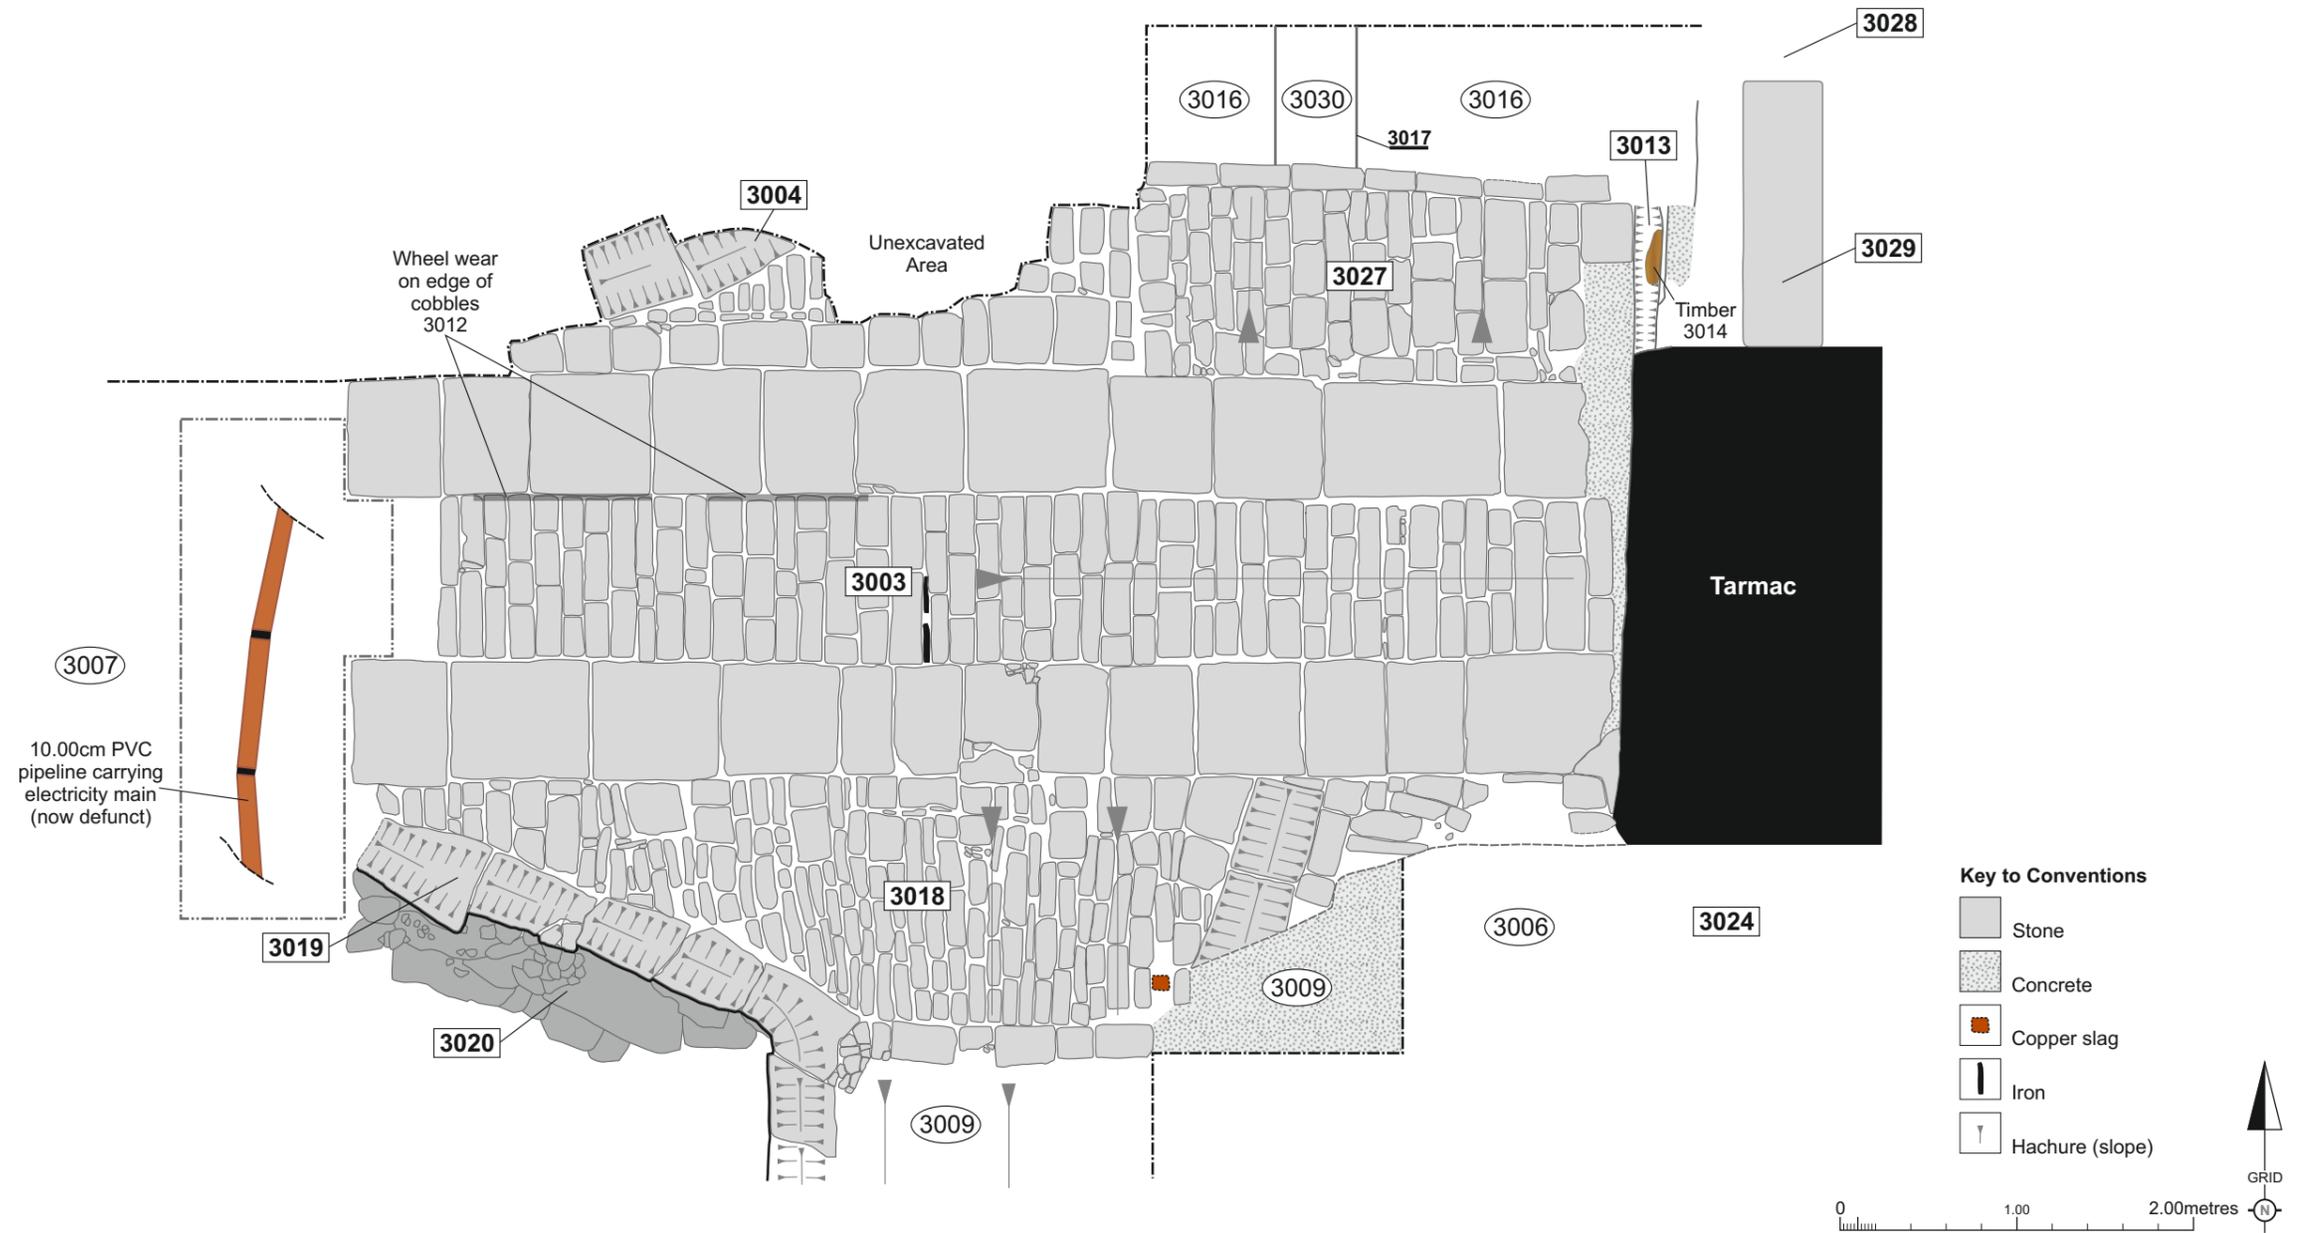
Figure 3. Plan of Trench 3 with context numbers

The Hafod entrance bridge contained a metal bar amongst the cobbles which may have been a catch bar to stop the horses slipping. The bridge also shows wear marks alongside some of the flagstones (see figure 3, Plate 10) where the carts have slipped. The amount of wear on the stones suggests an excessive amount of traffic carrying very heavy loads for the 100 years' worth of horse and cart use across the bridge.

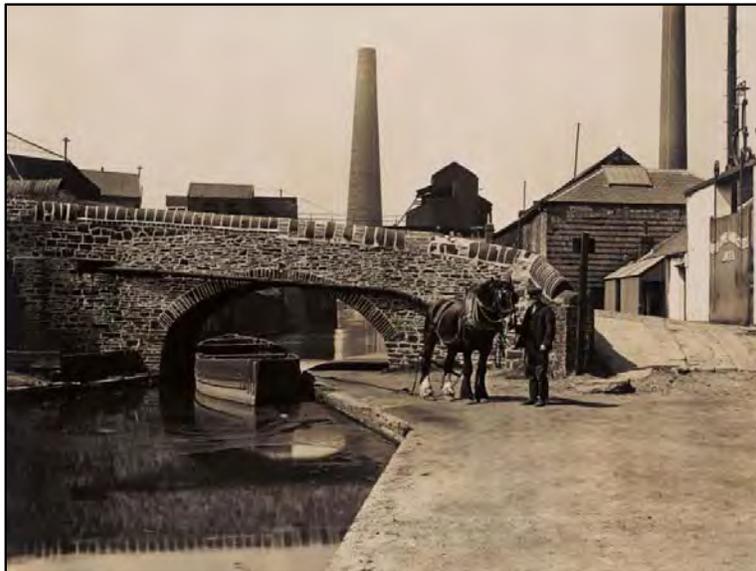
Plate 3: The original entrance to Vivian's Works. Before the works railway was made, connecting to the G.W.R. sidings, all the manufactured copper goods were transported by a team of horse drawn wagons along the canal to the docks. This photograph is taken from a set of albums of the Vivian & Sons Works at Landore, Swansea. The photographs were taken by Colquhoun - Photographers, at the request of Captain Hugh Vivian. There is no date in the albums but other evidence suggests they were taken early in the 1920s. Hafod and Morfa Plant and Process album 2.

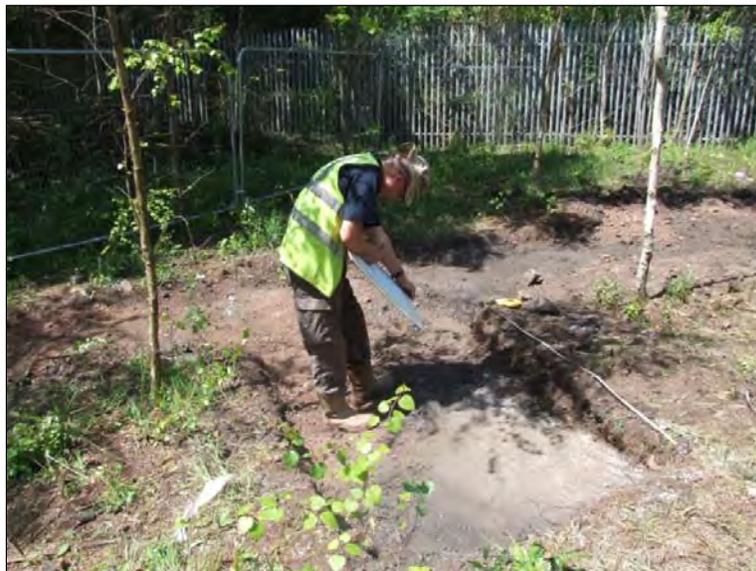
Plate 5: Concrete surface 1005, Trench 1. View to the west.

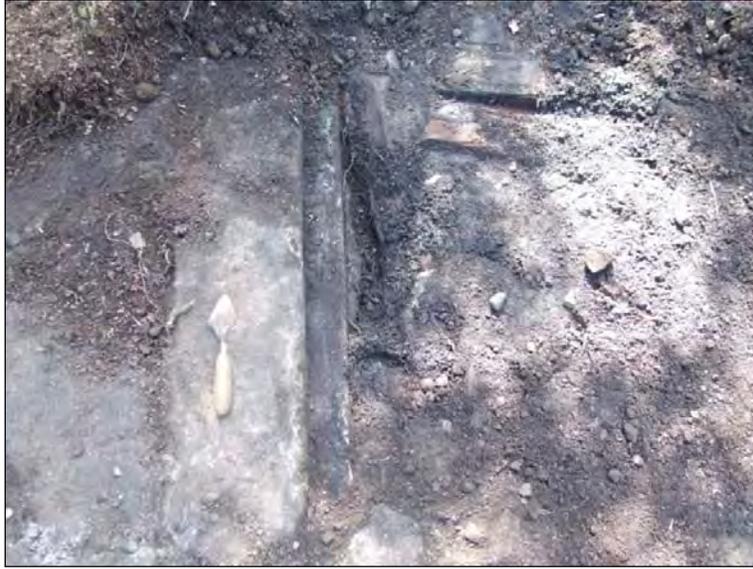
Plate 6: Concrete and stone structure 1006 and modern intrusion 1007, Trench 1. View to the west.

Trench 1 was supervised by Johnny Crawford and was excavated by volunteers. Removal of topsoil had started to reveal an L-shaped concrete and stone structure (**1006**) with evidence for early – mid-19th century mortar which showed some signs of modern intervention in the form of drainage and concrete repairs/capping. Abutting this concrete and stone structure was a deposit of modern, machine-made bricks (**1007**), thought possibly to be the fill of a drain (Plate 6).

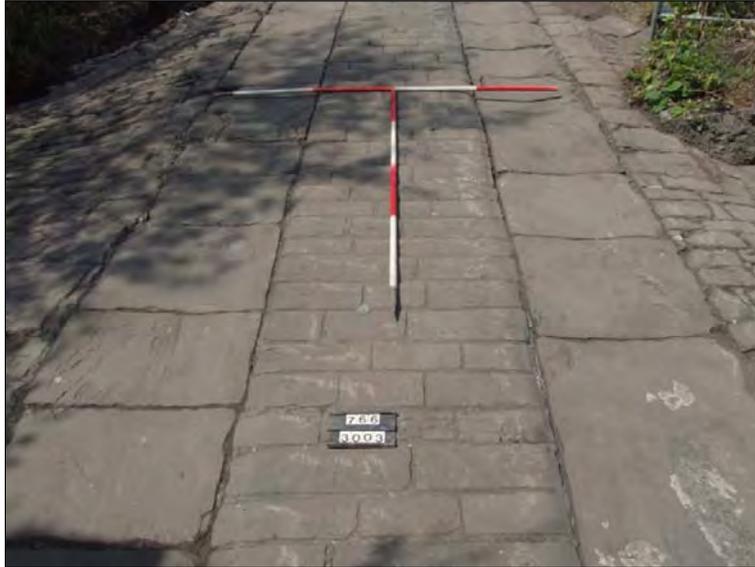
Plate 8: Bridge approach cobbles 3003, Trench 3. View to west.

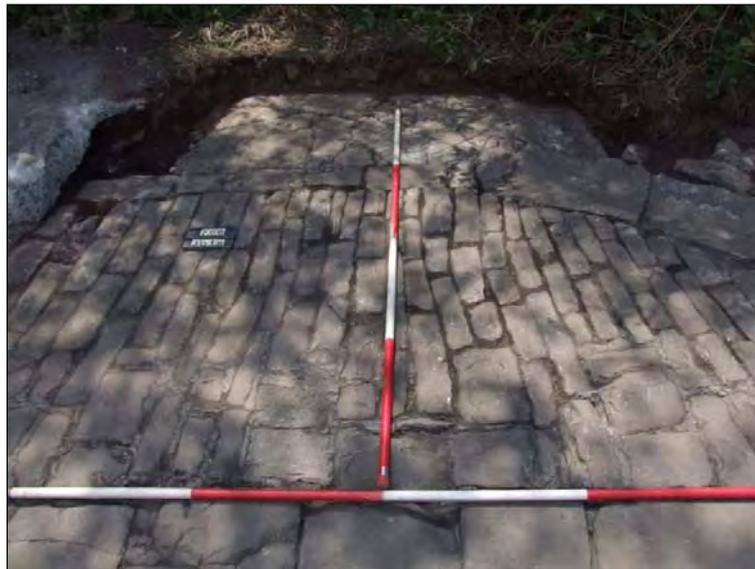
Plate 9: Probable path to canal and towpath 3018, Trench 3. View to south.

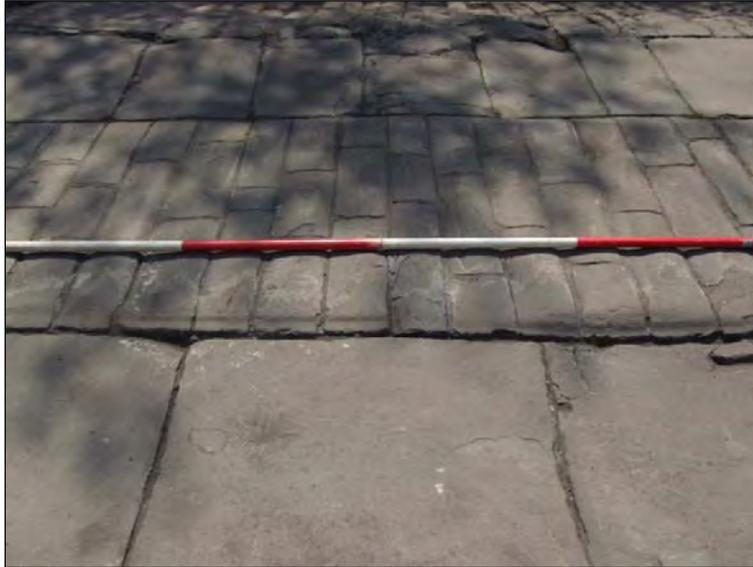
Plate 10: Wagon erosion 3012 on north side of cobbles 3003, Trench 3. View to south.

Evidence for heavy wagon use was noted, in the form of wear marks (**3012**) on the outer edge of a series of cobbles forming the approach to the bridge (Plate 10).

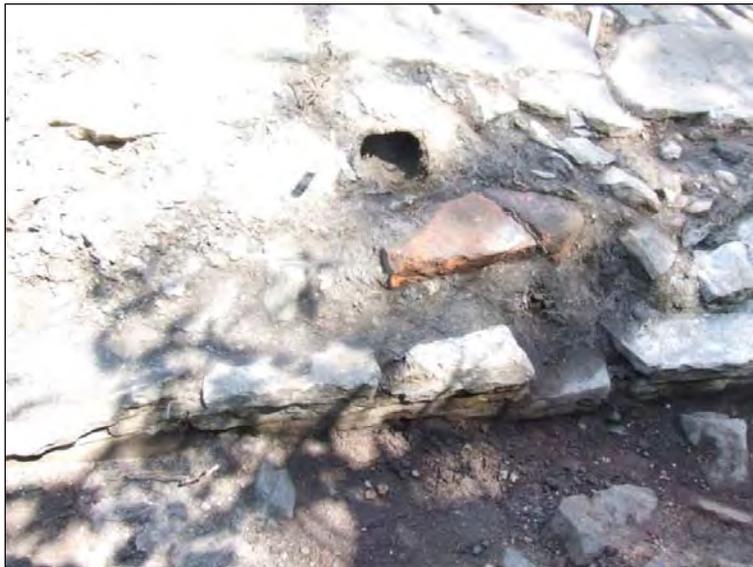
Plate 11: Probable bridge wall 3020, Trench 3. View to the north.

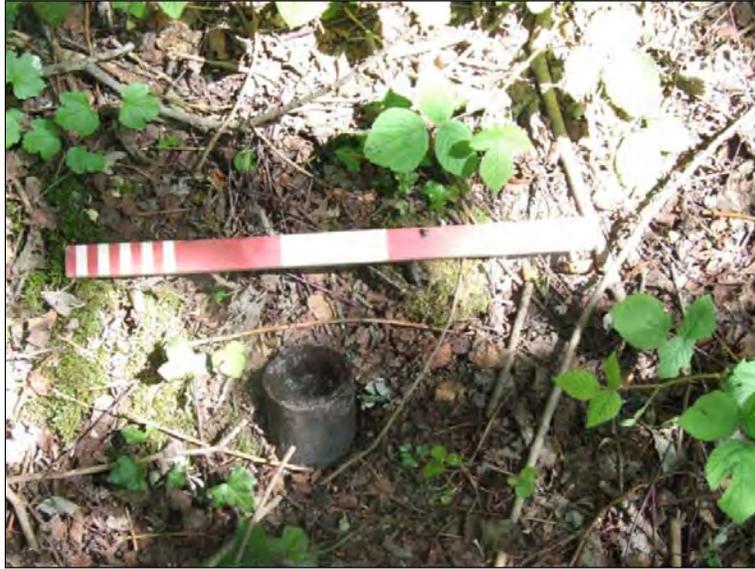
Plate 12: In situ crucible, discover during walk-over of the line of Swansea Canal. View to the east.

During recording of the standing walls that formed of the channel between the canal and the basin, a crucible was noted and recorded *in situ* (Plate 12).

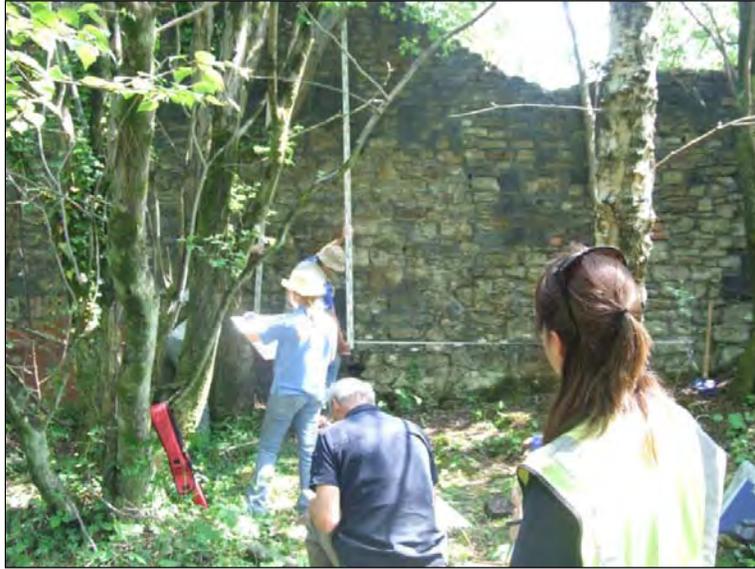
**Plate 14: Volunteers practicing building recording on the standing remain of the canal wall.
View to the south.**

Trenches 1 and 2 (both intended as 10x4m) were excavated in the area of the canal basin, but had to be abandoned after a few days because of contamination problems that had not been previously identified. Trench 3 was then excavated to further examine the area of canal bridge approach at the main entrance to the Hafod Copperworks. The volunteers who were less able-bodied were given finds washing and the opportunity to do some recording of the canal wall (Plate 14, see Appendix IV) which involved scaled drawings and photography.

Vivian slag coping stones are visible in parts of the Hafod entrance bridge in a photograph taken in 1931 (Plate 2). The photograph clearly shows a towpath underneath the bridge along with the cobbled path excavated during the Trench 3 excavation aligned north-south. The photograph also shows the use of pointed copper-slag blocks capping the bridge. Similar pointed copper-slag blocks were also seen during survey work done by the volunteers along the canal wall (Plate 14).

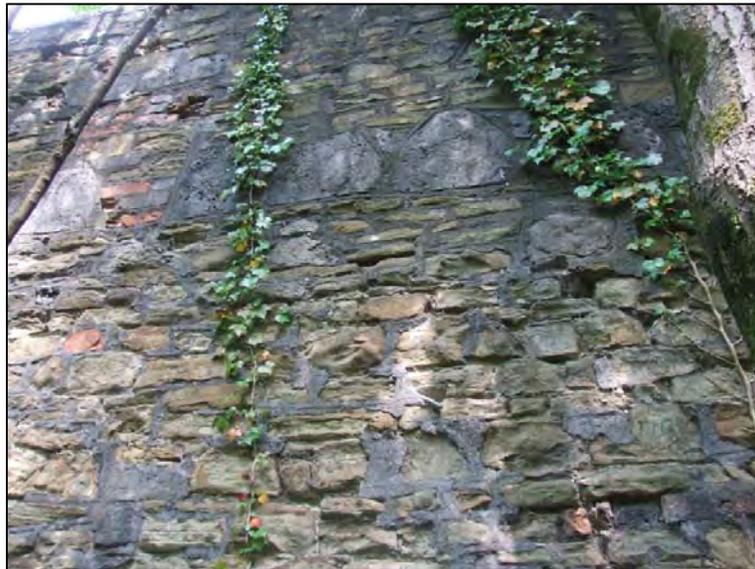
Plate 15: Pointed copper-slag blocks showing original height of the canal wall. A similar copper-slag block capped the bridge walls over the canal (see Plate 3).
