Merthyr College, Merthyr Tydfil: archaeological desk-based assessment

May 2008

**A report for Ove ARUP & Partners Ltd.
by Sven Egloff MPhil.**

**GGAT report no. 2008/034
Project no. P1259**

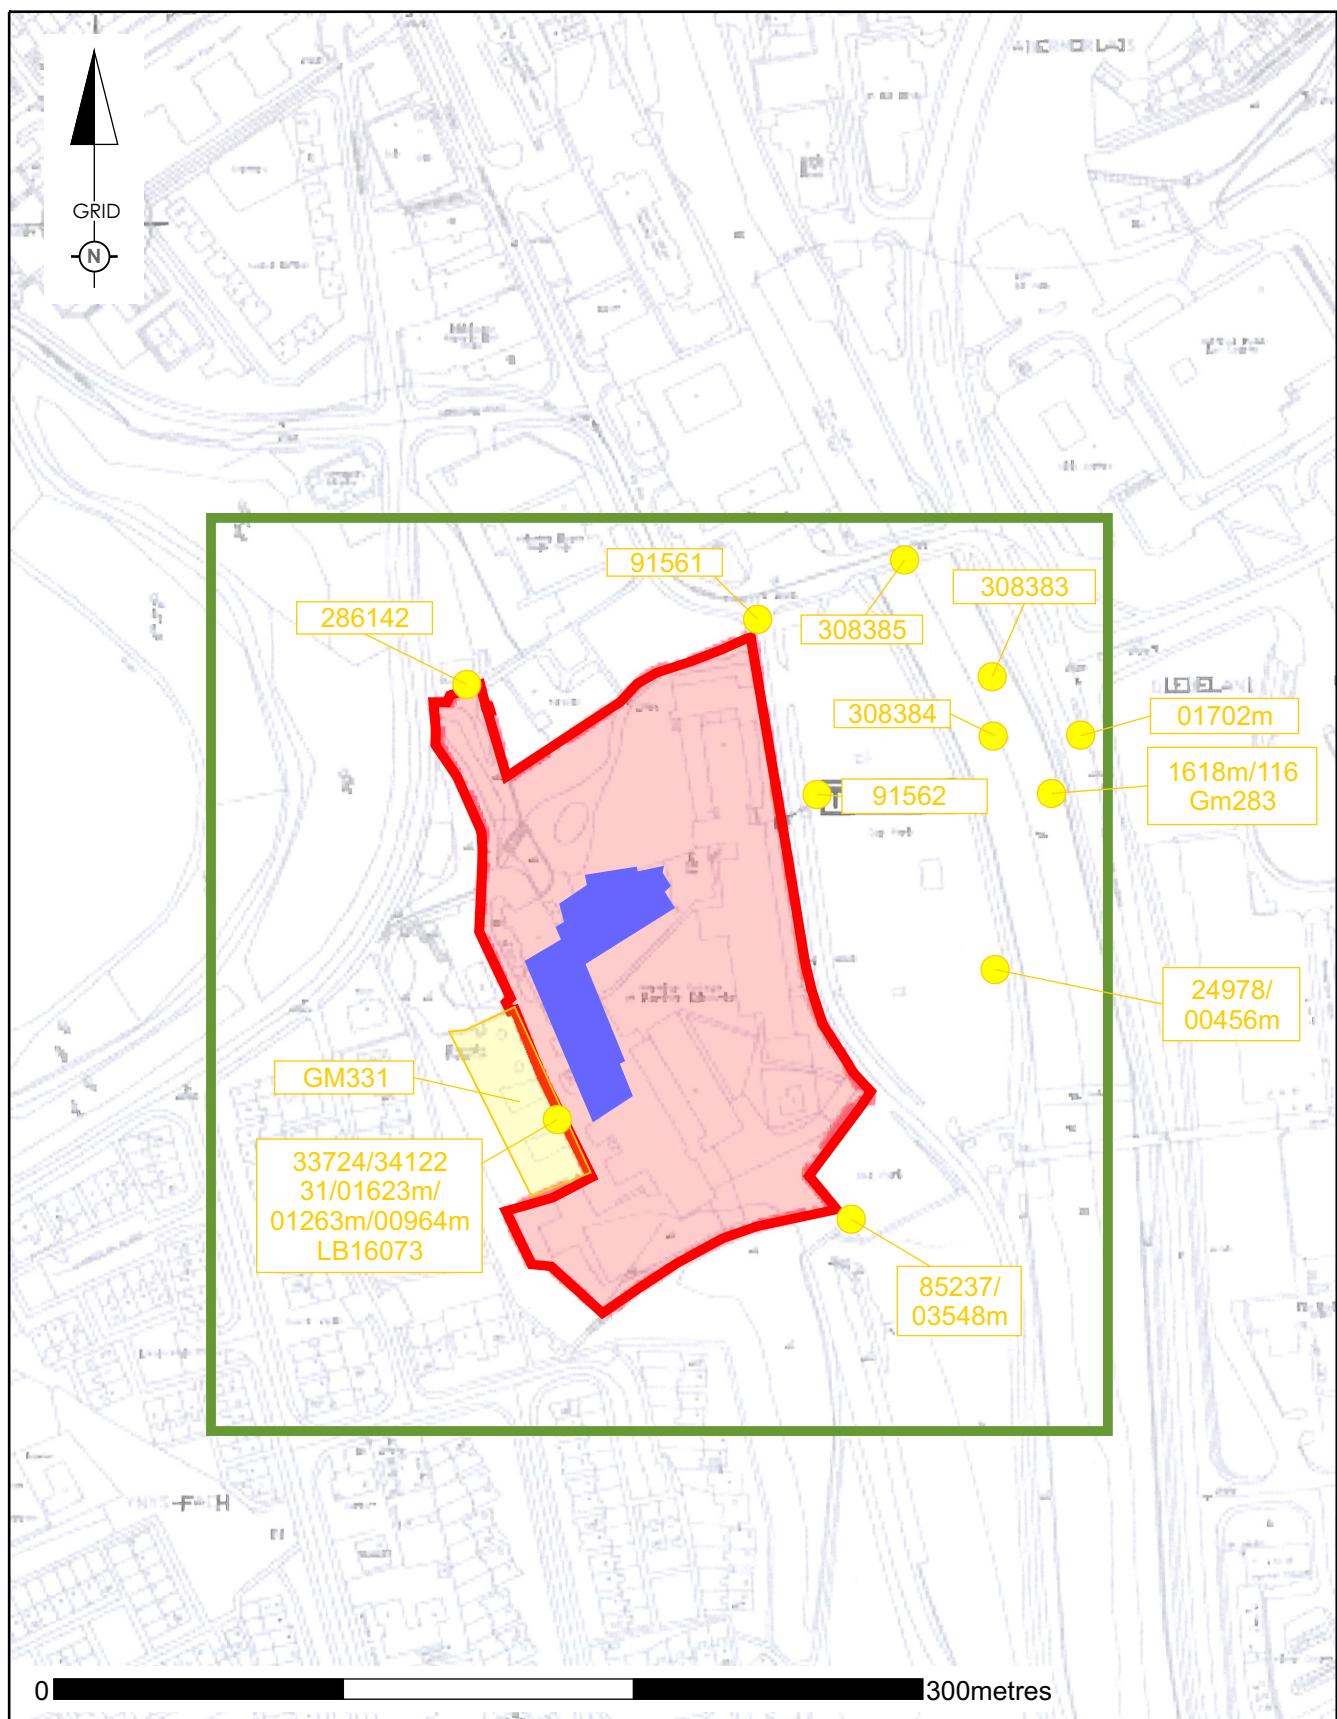
Figure 2. Location of the development area (red), study area (green) and archaeological interests including Scheduled Ancient Monument area (yellow) and building footprint (blue)

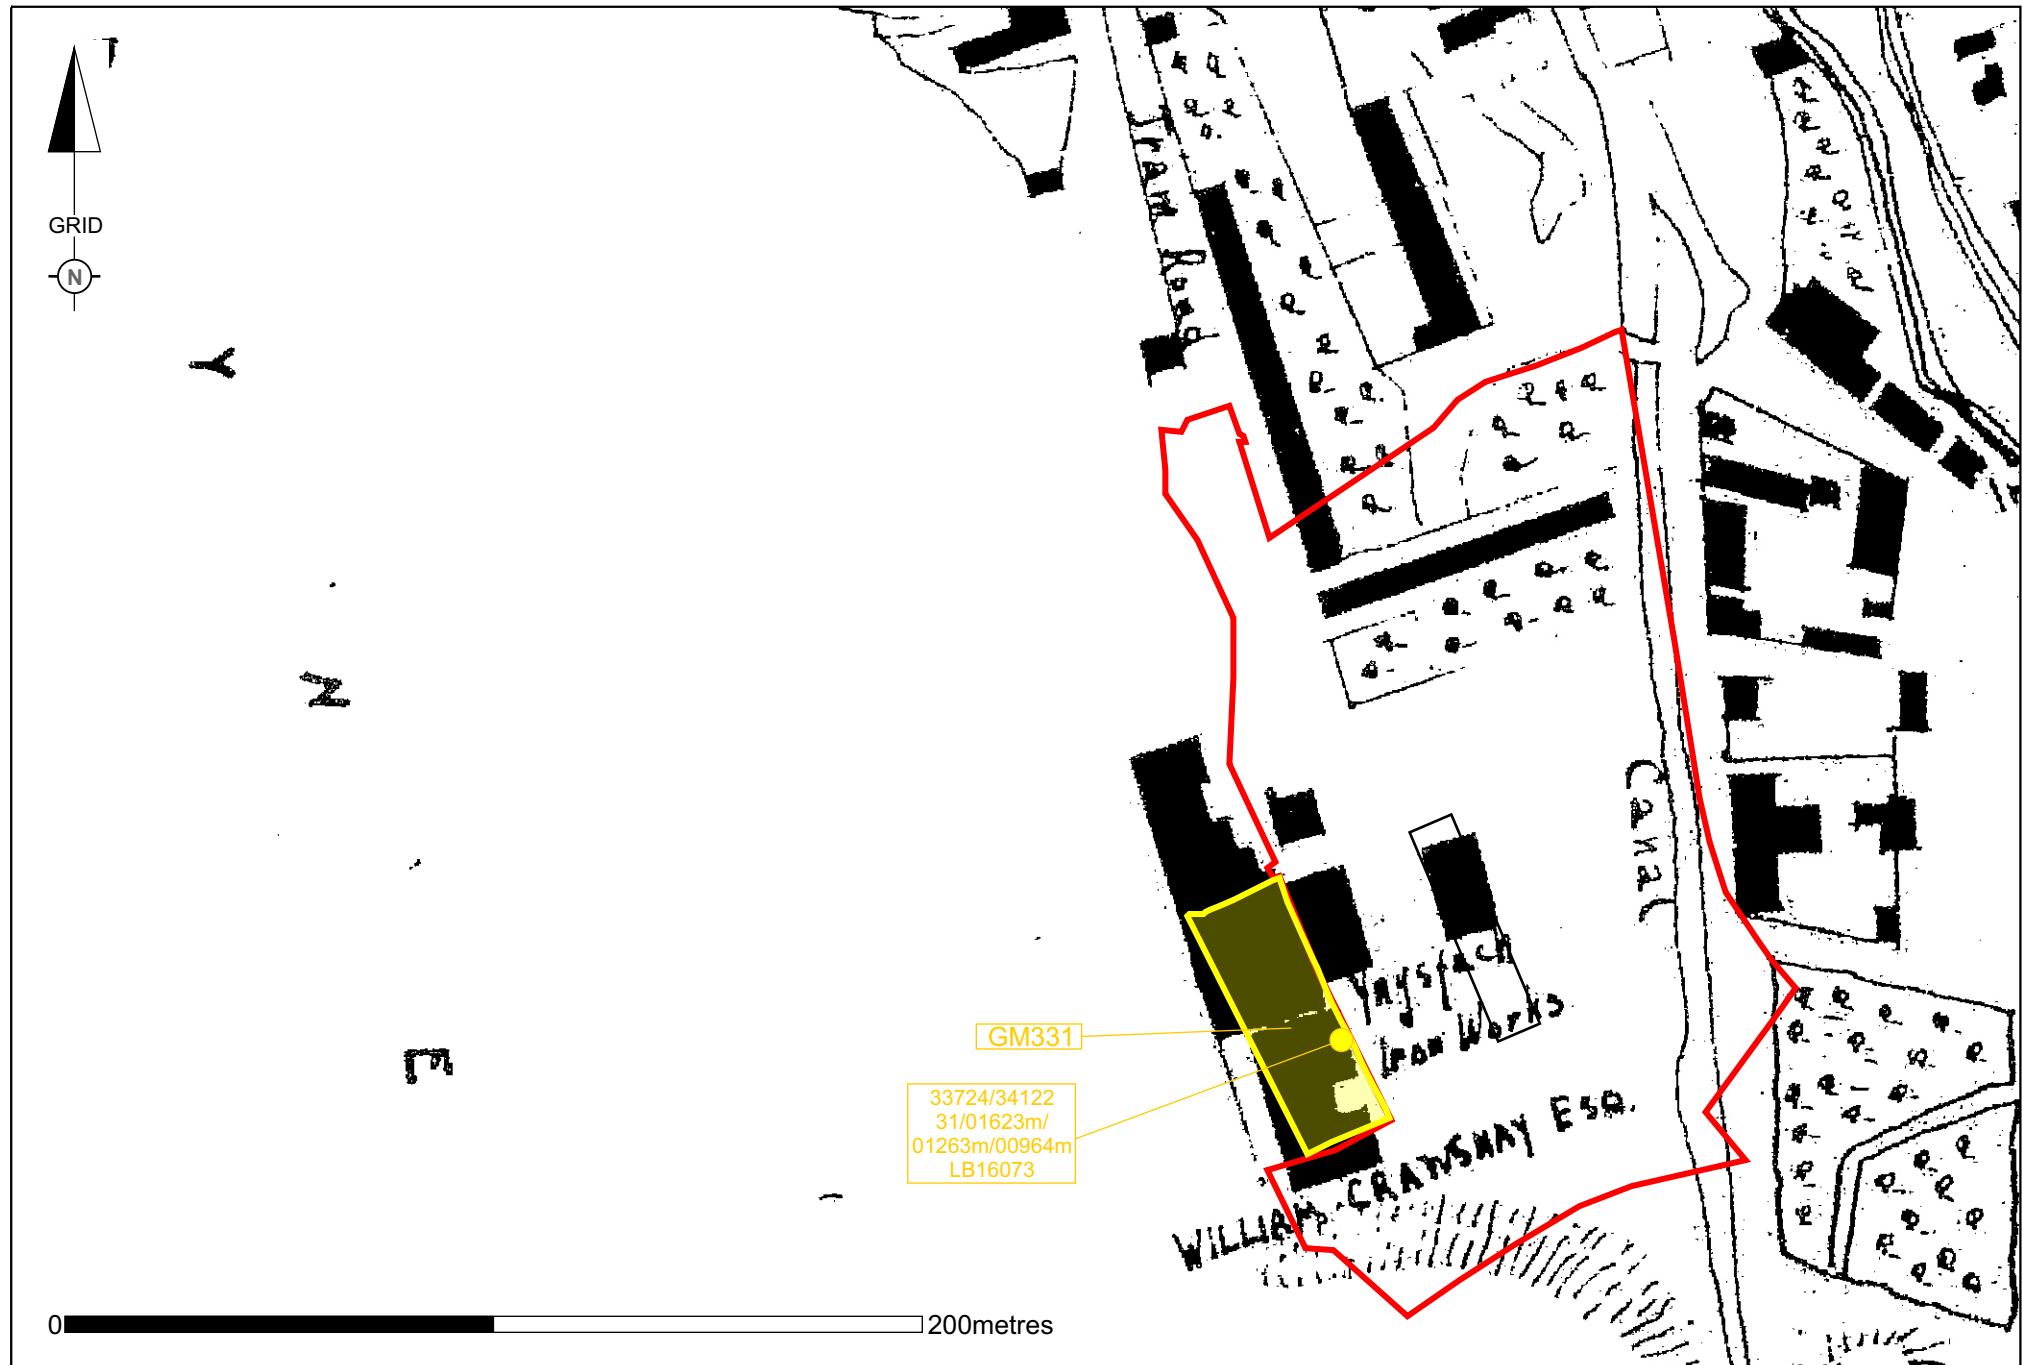
Figure 3. Plan of Merthyr Tydfil From actual survey, 1836

Ynys Fach Ironworks with much precision. However, the Ynys Fach Ironworks displayed on this map does not exhibit its final form, following its aggrandisement in 1836. The two initial furnaces of the ironworks – reused in the second phase of Ynys Fach Ironworks post 1836 – are depicted as forming one block with what is presumably a casting house to the east, and a boiler house to the north of the furnaces. Two new furnaces erected in that same year are depicted to the south of the initial ironworks. The corresponding casting houses are apparently missing, as well as the southern engine house and accompanying boiler house. Also present on the 1836 map mentioned above is, interestingly, the Ynys Fach Row, located north of the Ironworks. Consequently, it can be assumed that the Ynys Fach Row was designed to provide accommodation to the ironworkers of the first generation of Ynys Fach Ironworks.

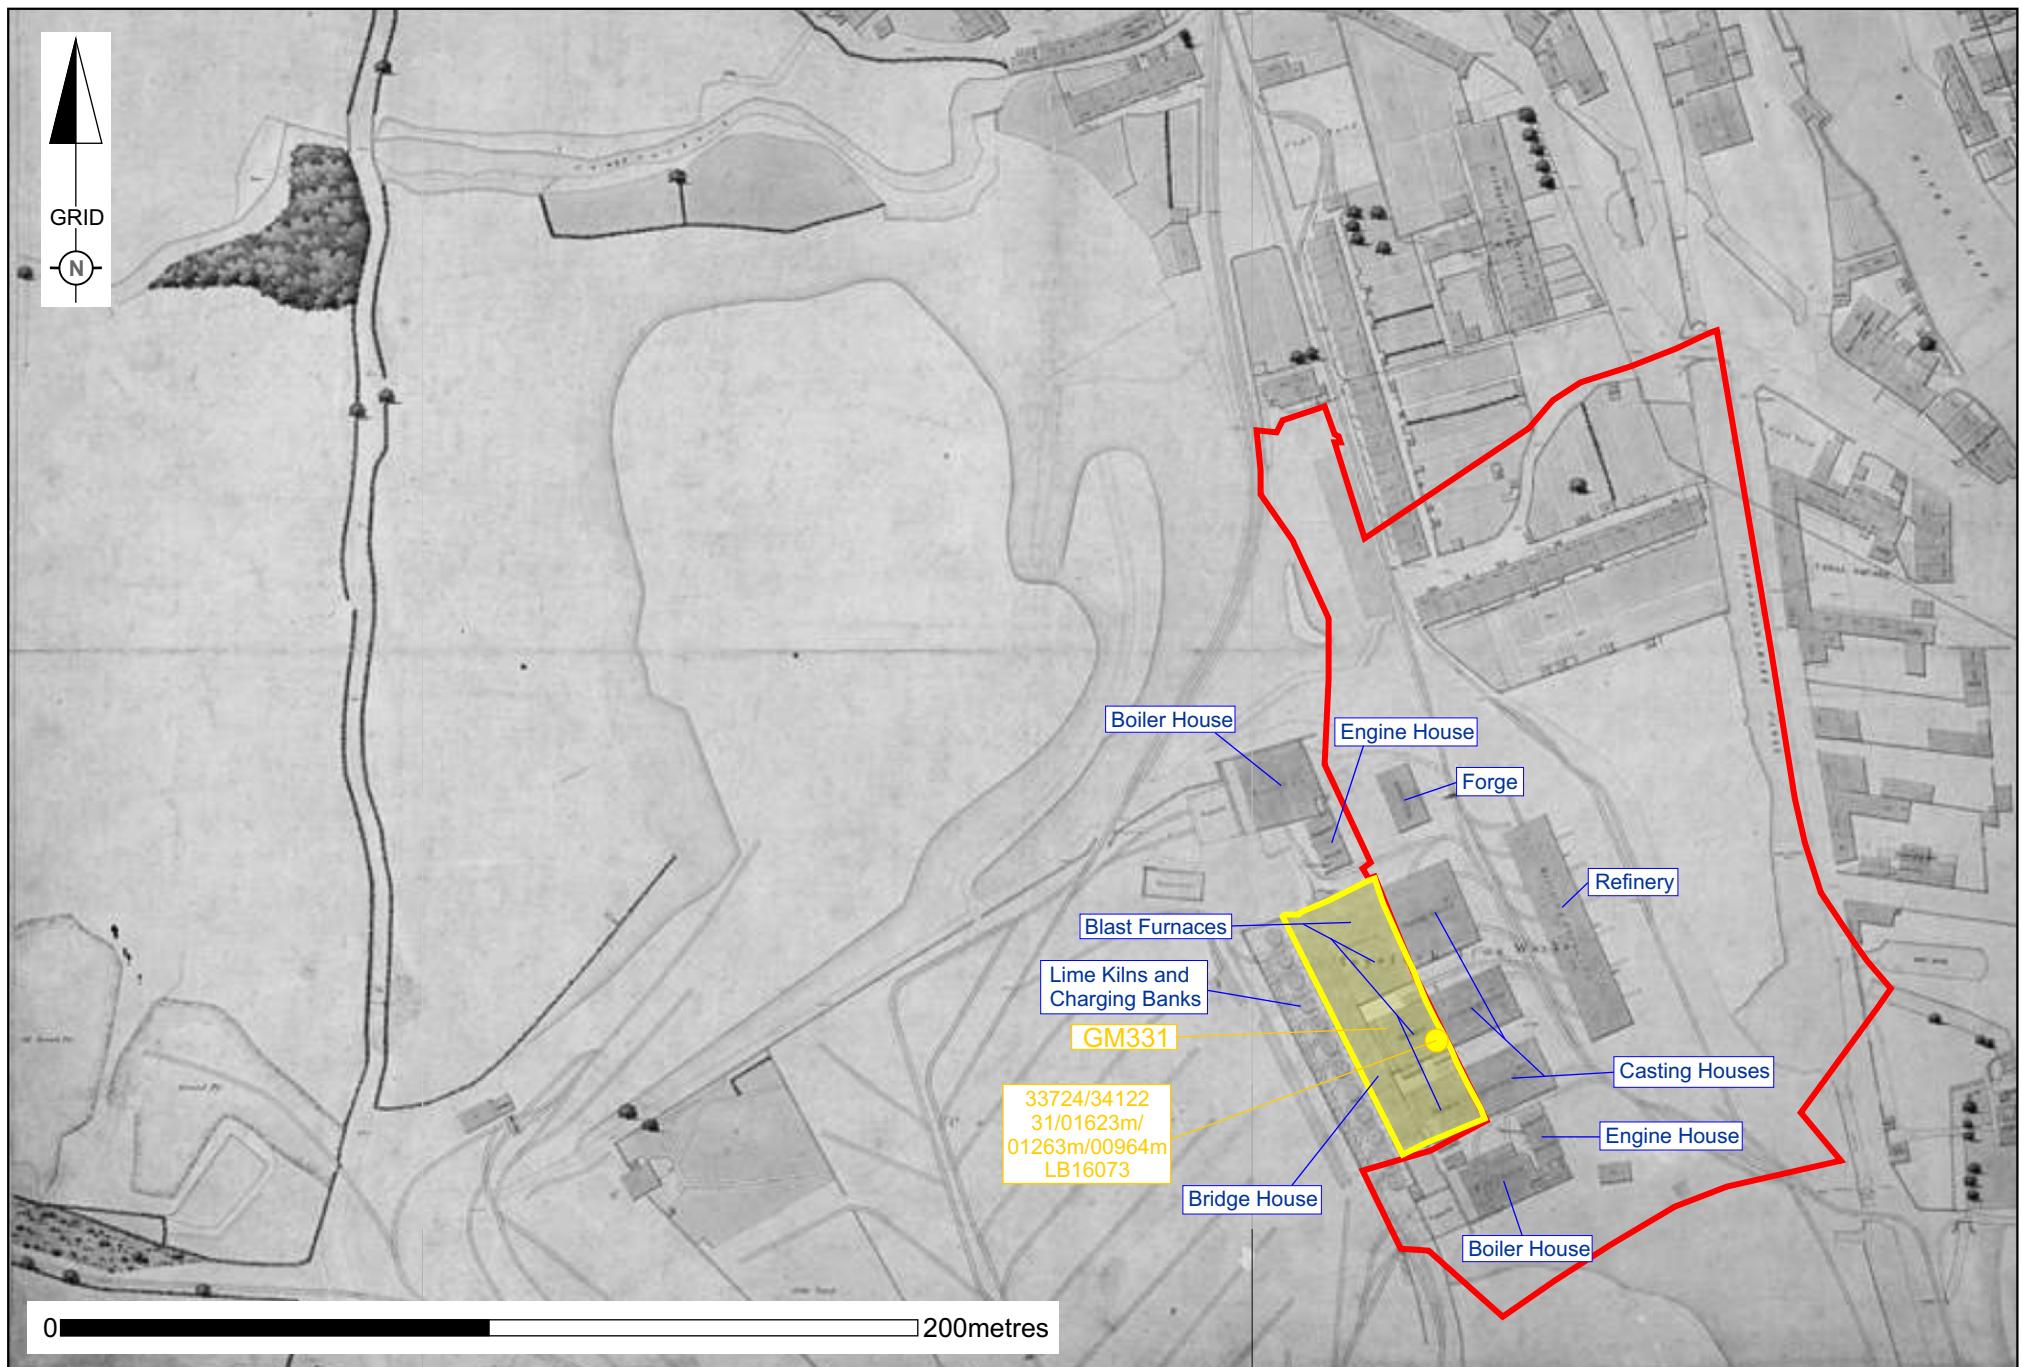
Figure 5. Plan of the Town of Merthyr Tydfil, Surveyed by the Ordnance Survey Department Under the Provisions of the Public Health Act for the Local Board of Health, 1852

A structure depicted on the 1852 map of the Ordnance Survey Department Under the Provisions of the Public Health Act (Figure 5), displayed twelve circular kilns, above the blast furnaces and to the west of these can be seen. These could well be calcining kilns, rather than the limekilns they are referred to as. Due to the limited amount of iron in the Welsh ore, it was common practice in Wales to roast the ore prior to smelting, in order to reduce its carbon and water content. From 1850 on, richer ores were imported.

A rectangular building referred to as “refinery” on the 1852 map of the Ordnance Survey Department Under the Provisions of the Public Health Act, is linked by rail to the casting houses. Given that no engine house is present in the proximity of the refinery, it is unlikely that forging or rolling took place there. The refinery process – an intermediate stage of puddling – might have been carried out on site, while the actual puddling and rolling processes took place at Cyfarthfa.

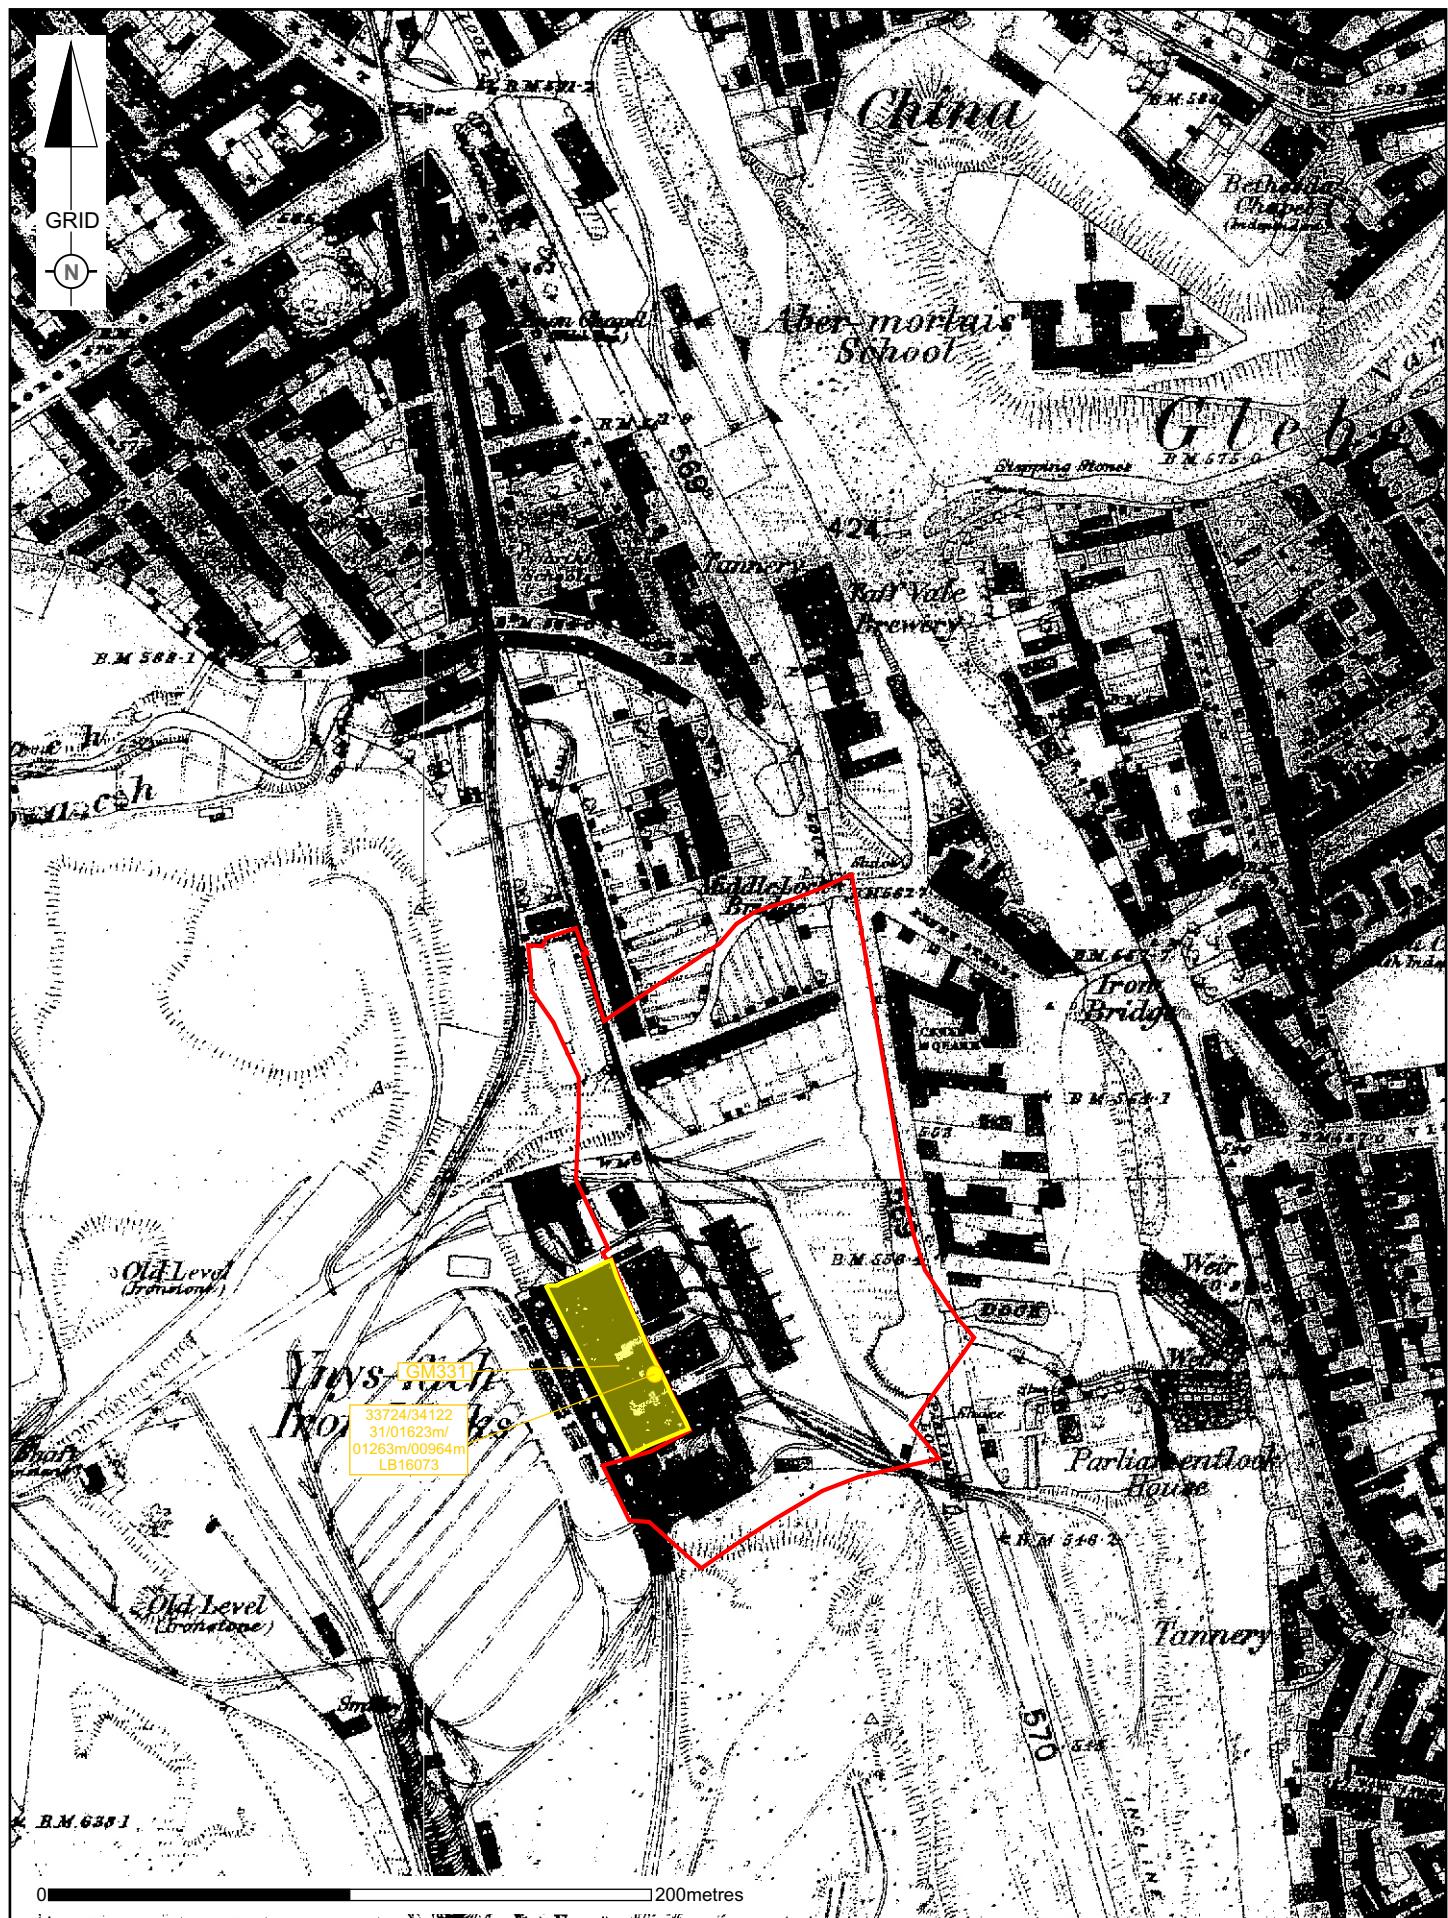
Figure 6. 1876 First Edition Ordnance Survey map showing development area

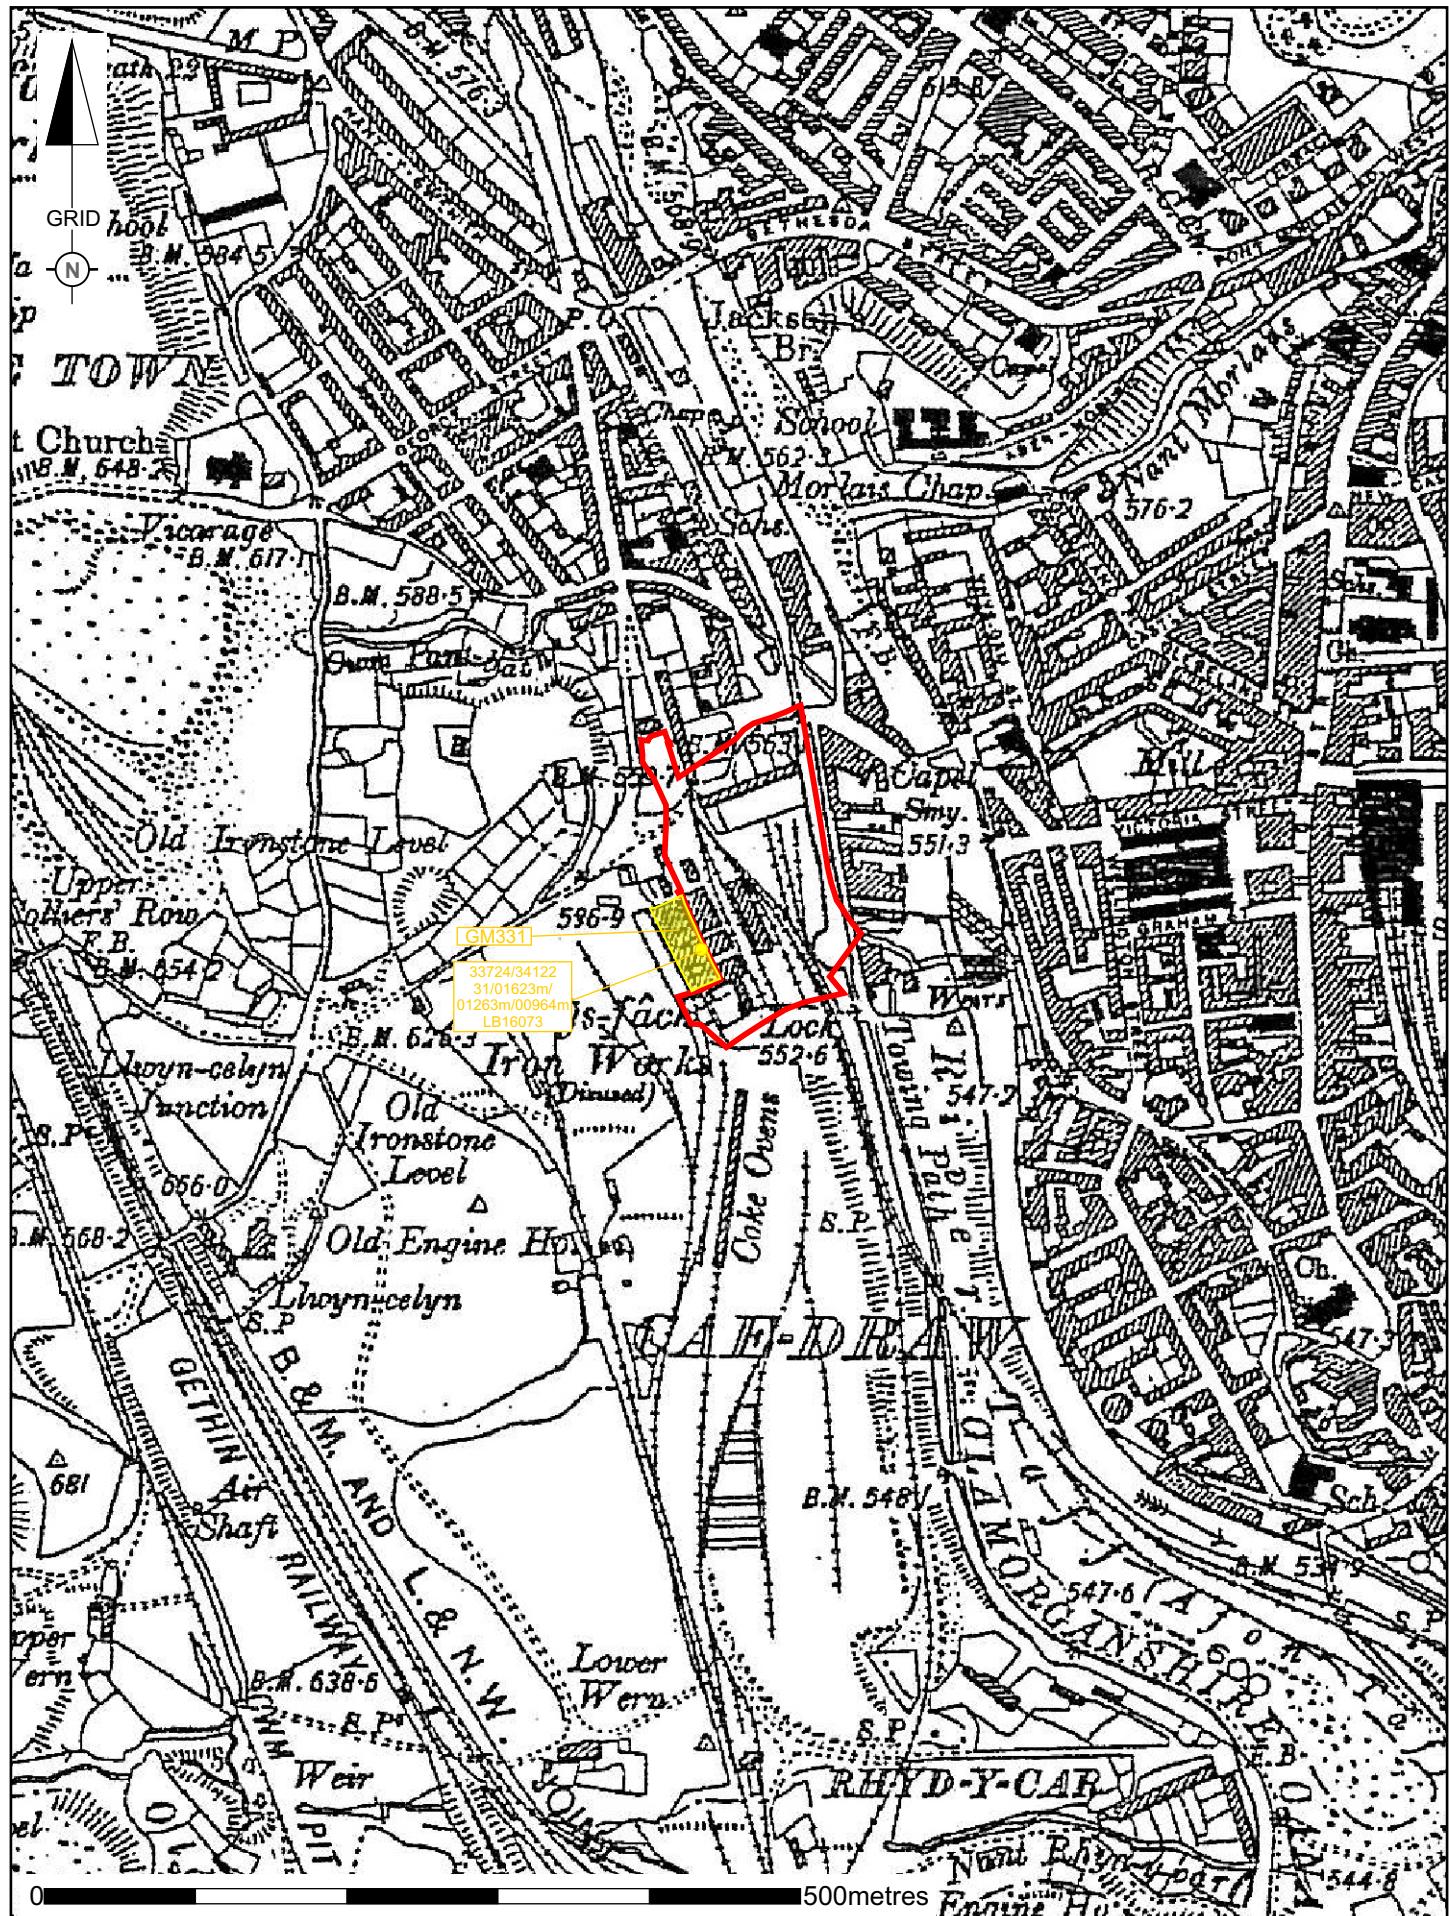
Figure 7. 1904 Second Edition Ordnance Survey map showing development area

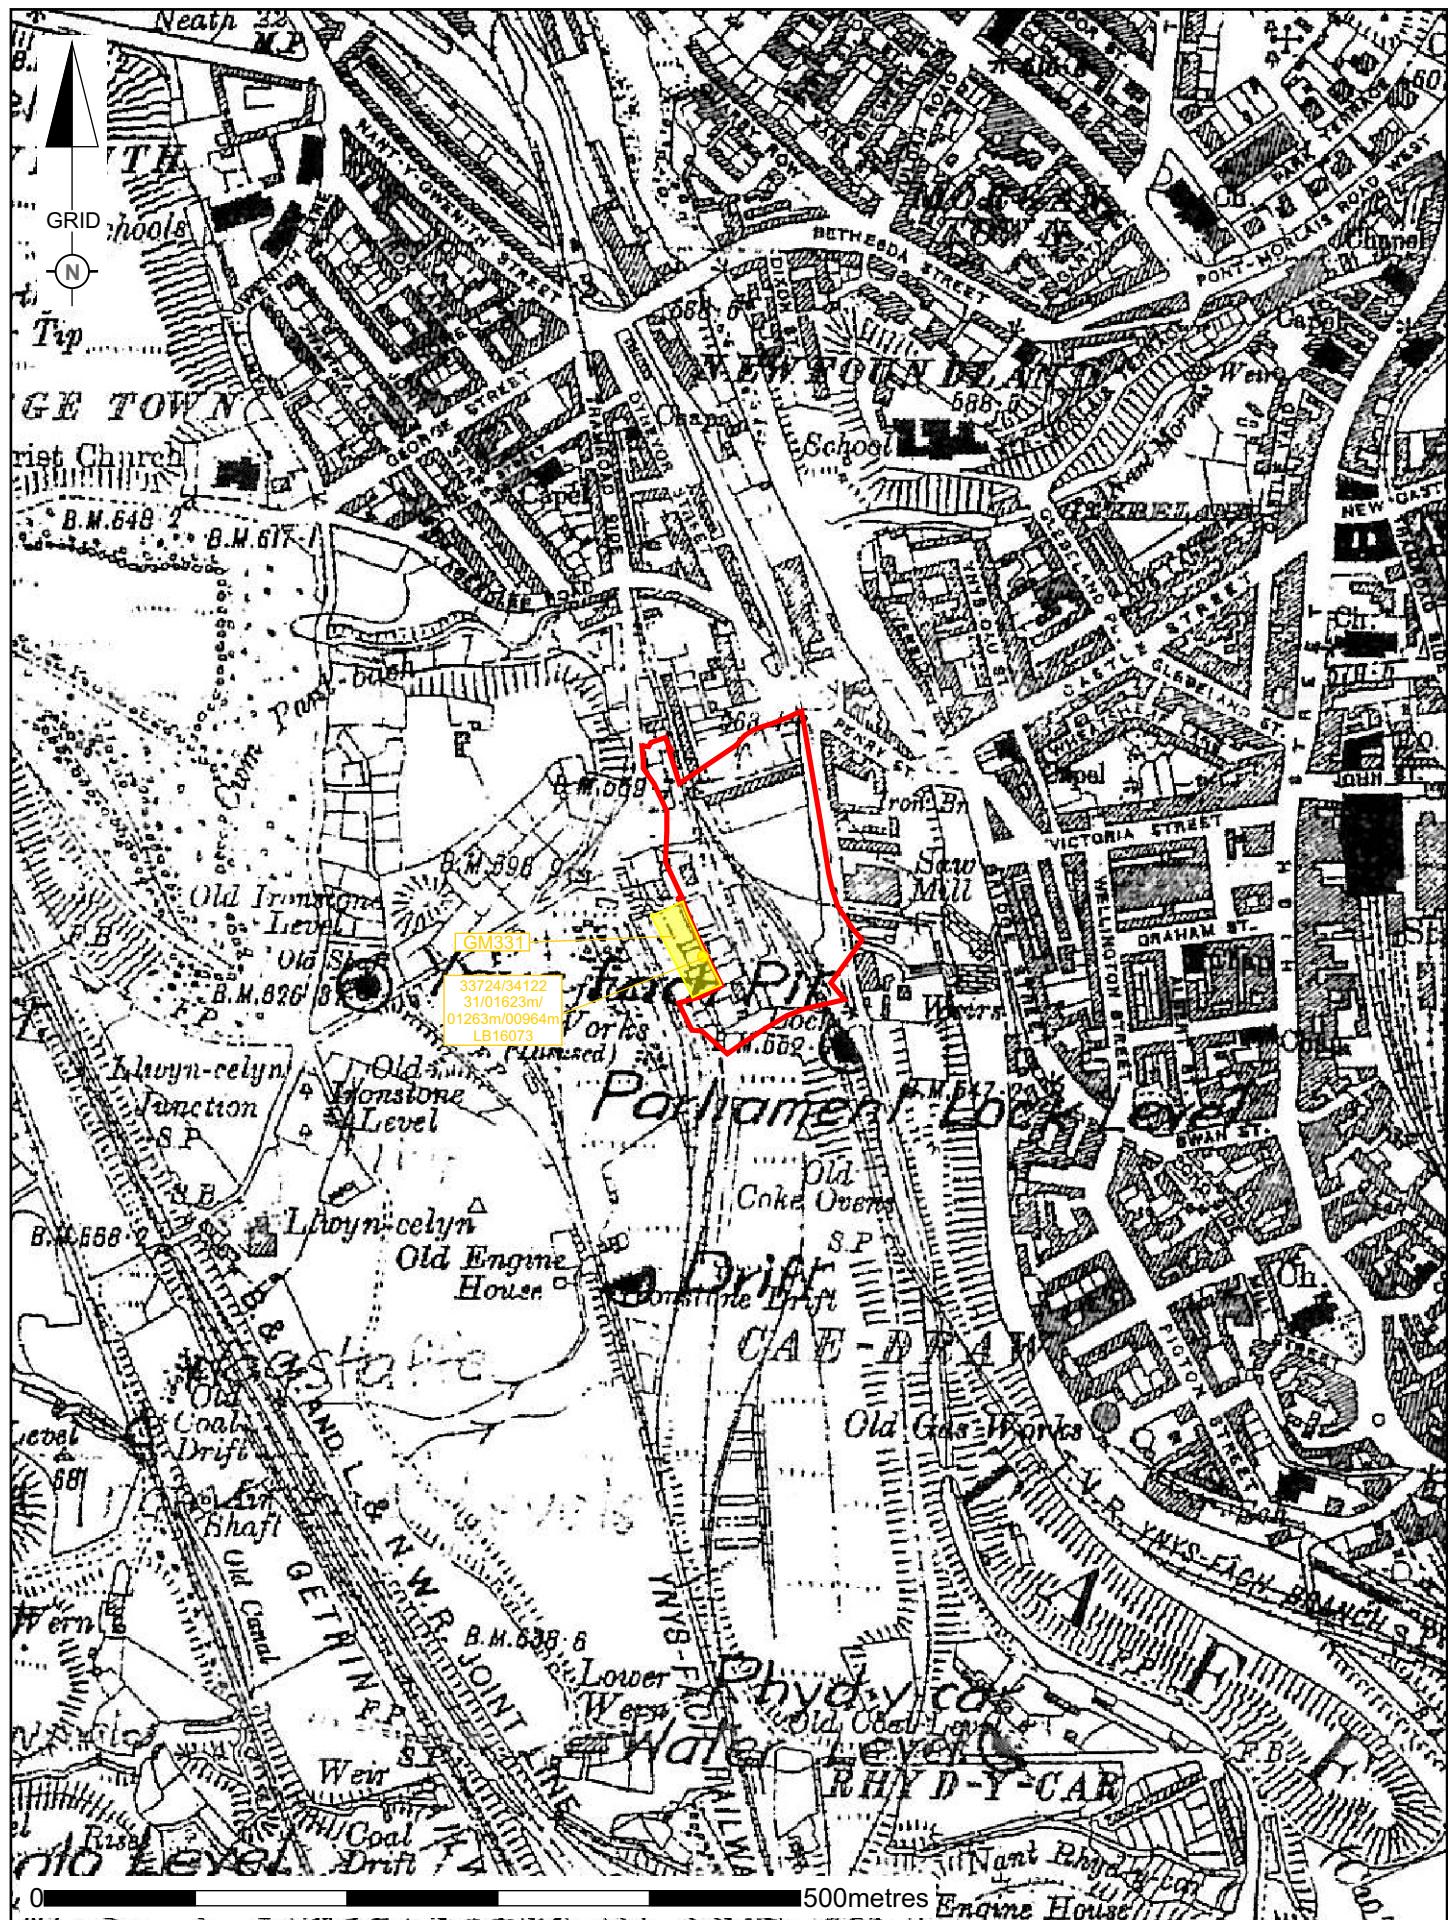
Figure 8. 1919 Third Edition Ordnance Survey map showing development area

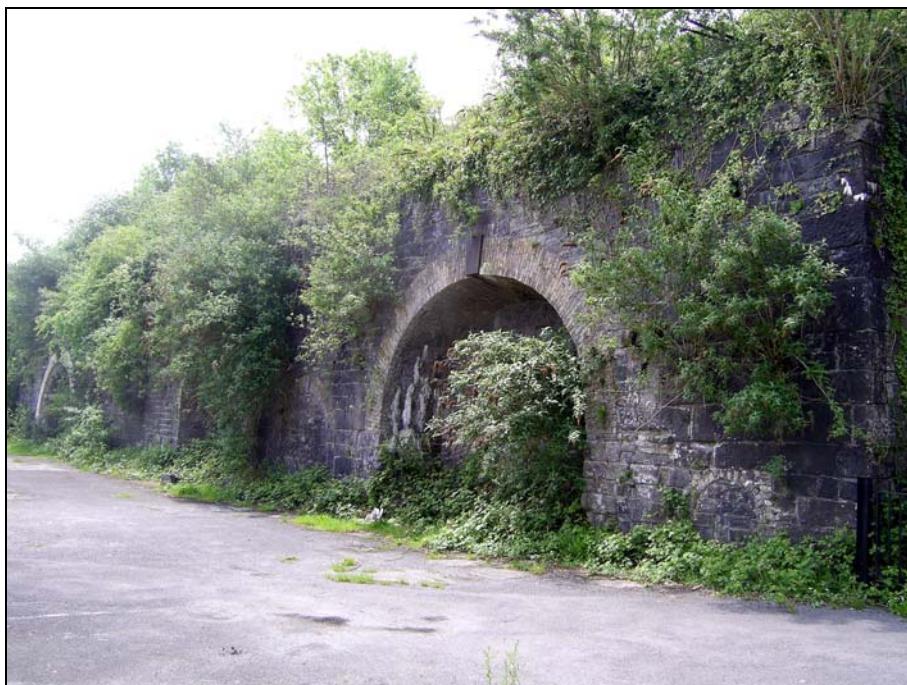
Plate 5: Ynys Fach furnaces looking south.

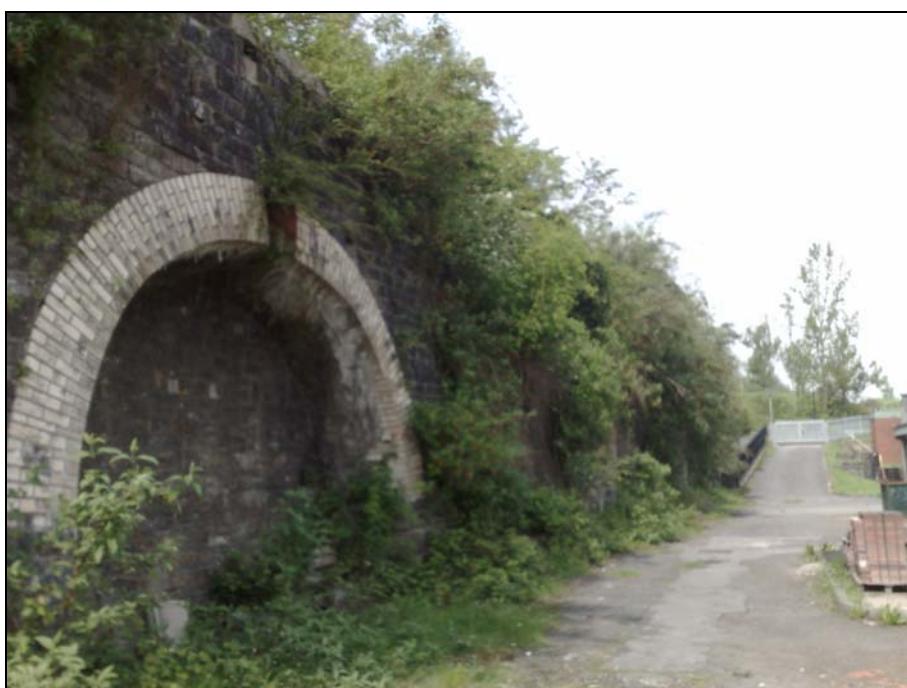
Plate 6: Ynys Fach furnaces looking northwest.

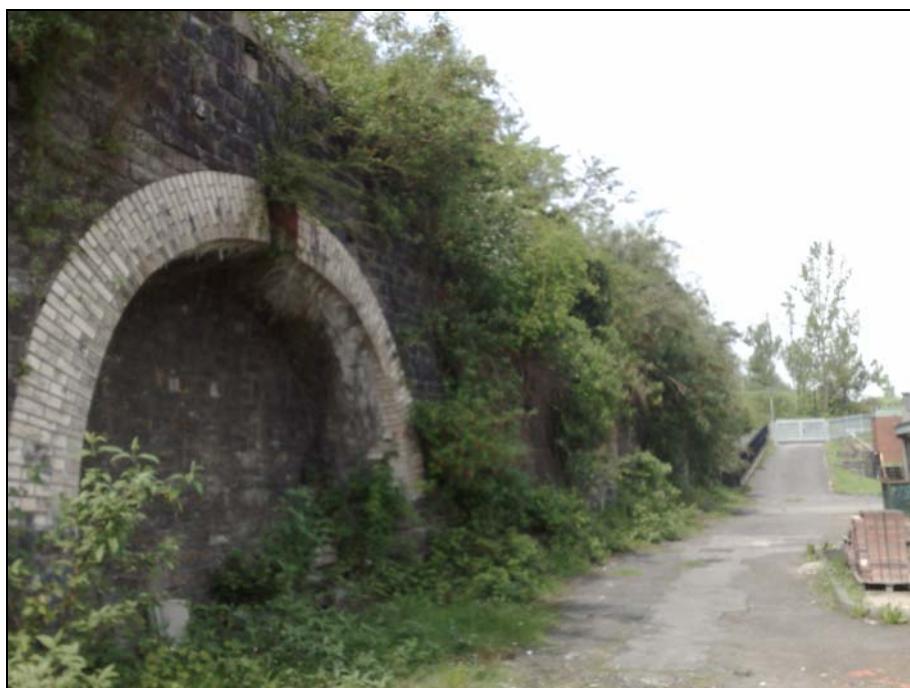
Plate 7: Ynys Fach furnaces looking northwest.
