Merthyr College, Merthyr Tydfil

Archaeological Watching Brief

A report for Ove ARUP & Partners Ltd
by Sven Egloff MPhil

GGAT report no. 2008/066

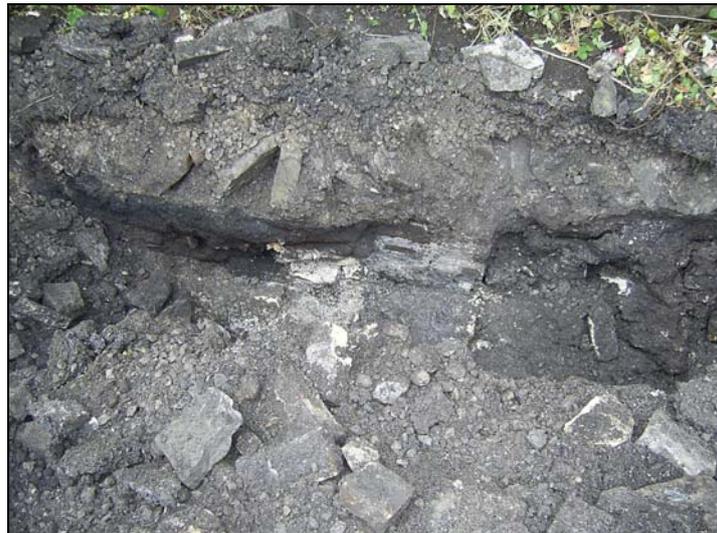
Trial Trench 1 (see Plate 1) was excavated through the tarmac of the rear access road to the back of the workshops. It measured c 7.00m x 1.00m and was excavated mechanically to a maximum depth of 2.80m. The basal deposit encountered was an olive-brown, brittle mudstone bedrock (106). Archaeological structures were present in the form of two abutting walls [104] and [105], running perpendicular to the façade of Ynys Fach Blast Furnace 1. Wall 104 consisted of a mix of sandstones and cream coloured bricks in a dark bluish grey, coarse mortar. Wall 105 was made out of orangey red bricks and cream coloured lime mortar. Walls 104 and 105 were structurally distinct and are likely to represent two construction phases. Overlying this was a hardcore layer of greyish brown stone and sand rubble (102), underlying a tarmac surface (101).

Plate 1: East facing section of Trial Trench 1 with walls 104 and 105 visible in the central area of the photograph.

Substantial archaeological remains were present in Trial Trenches 1 and 2, and in Test Pit 5, all of which can be ascribed to the Ynys Fach Ironworks. Due to the geotechnical nature of the groundworks, access to archaeological deposits and structures was limited. However, the archaeological watching brief revealed that the buildings associated with the Ynys Fach Ironworks were not fully removed or levelled during the construction of Merthyr College and the associated workshops, but are still extant in places, possibly to a height of *c* 1.20m. The walls found in Trial Trenches 1 and 2 are located in an area where the Ynys Fach casting houses once stood. Two distinct typological phases were identified, which could mirror the changes and aggrandisement that Ynys Fach underwent in 1836, when two blast furnaces were added to the two initial ones dating 1801.

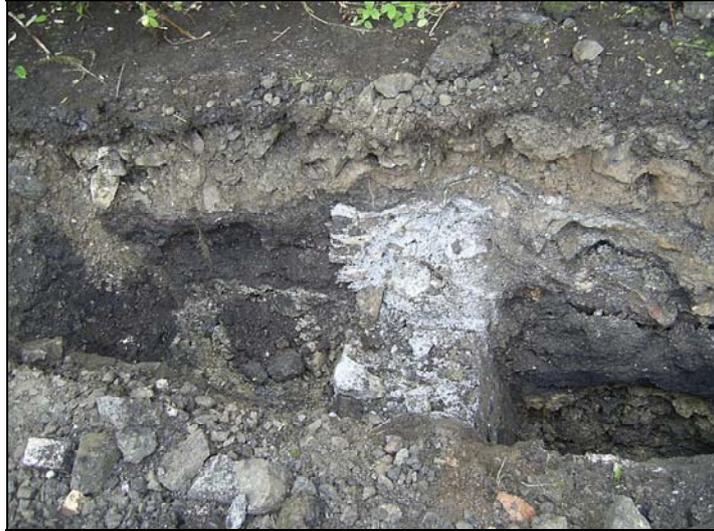
Trial Trench 2 (see Plate 2) was excavated through the tarmac of the rear access road to the back of the workshops. It measured 8.00m x 1.00m and was excavated mechanically to a maximum depth of 3m. The basal deposit encountered was a beige-brown stone and clay layer (206). Archaeological structures were present in the form of two walls ([204] and [205]) running perpendicular to the façade of the Ynys Fach blast furnaces, between Furnace 2 and Furnace 3. Wall 204 was constructed of roughly hewn sandstone blocks and cream coloured bricks in a light blue sandy

Plate 2: East facing section of Trench 2 showing wall 204.

mortar (see Plate 2), and was in line with the northern corner of Furnace 3. It was typologically similar to wall **104** in Trial Trench 1. Wall **205** consisted of orangey red bricks in a creamy lime mortar (see Plate 3), and was situated 1.50m south of the southern corner of Furnace 2. It was typologically similar to wall **105** in Trial Trench 1. Given that Furnaces 3 and 4 were completed 35 years after Furnaces 1 and 2, the two wall phases might reflect the aggrandisement that Ynys Fach Ironworks underwent in 1836. A layer of brown-black coal dust / soot and sand with occasional bricks and infrequent stones (**203**) surrounded walls **204** and **205**. Overlying this was a grey-brown stones and sand rubble (**202**) capped by a tarmac surface (**201**).

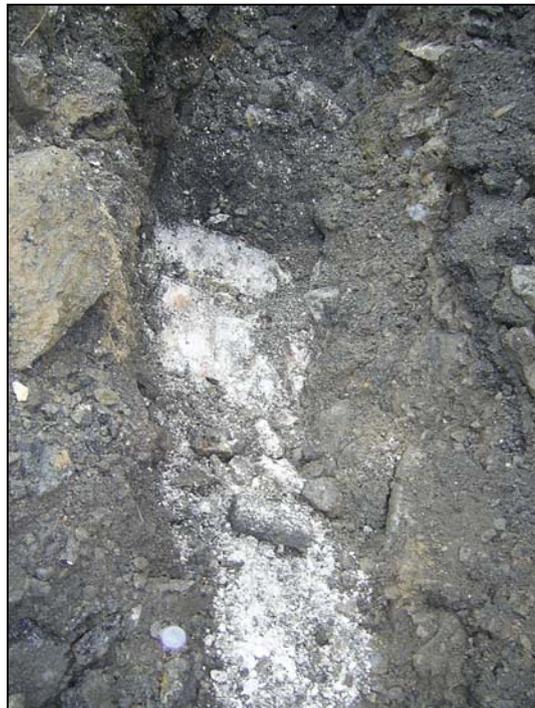
Plate 3: South facing view of Trench 2 showing wall 205.

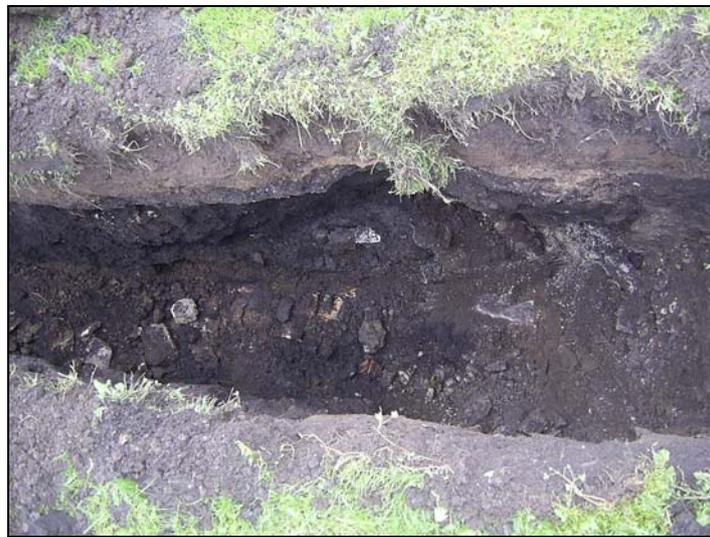
Test Pit 5 was located on the lawn at the rear of Merthyr College main building, to the south of the courtyard. It measured *c* 4.00m x 0.60m and was mechanically excavated to a depth of 1.80m. The excavation was interrupted at the base of the test pit, with what appeared to be a brick laid floor [056] (See Plate 4). The bricks of the floor had an orangey red colour. One large, worked, rectangular, dark-grey stone block [055] – the base of which was possibly level with the brick floor [056] – was sited at the southern end of Test Pit 5 (see Plate 5). This could have been part of a wider structure that was later dismantled. An upright iron bar, which seemed to be anchored in the stone block [055], was also recorded. Overlying 054, 055, and 056 was a layer of black sand, coal dust / soot, and stone rubble (053). The topsoil consisted of humic earth (051).

Plate 4. East facing view of Test Pit 5 showing the brick floor 056 in the centre of the photograph.

Test Pit 5 contained a brick floor and a stone block, with a vertical iron bar rising up from it. The bottom of the block was seemingly level with the top of the brick floor. The test pit was excavated within the perimeter of the former 'Refinery' building, and therefore, the brick floor uncovered may belong to this building.

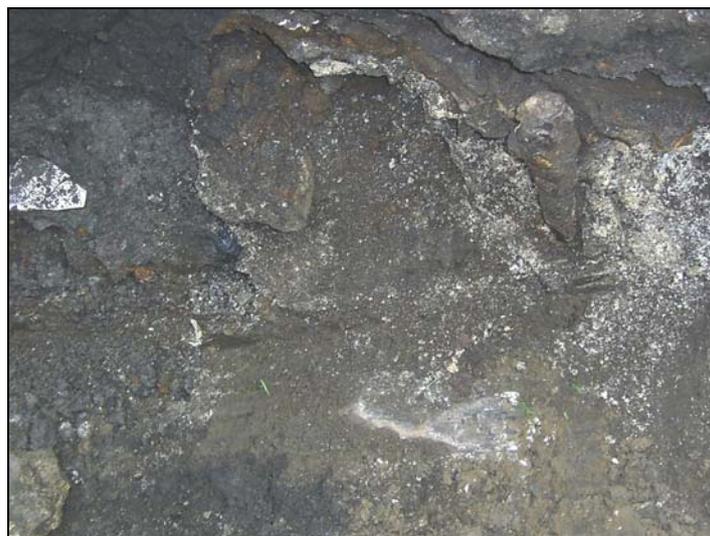
Plate 5. East facing view of Test Pit 5 showing the stone block 055, and the iron bar 054 in the top right quarter of the photograph.

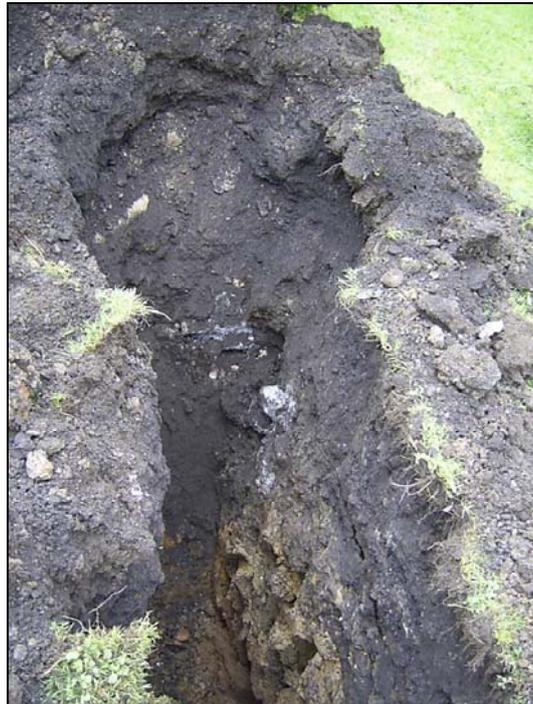
Test Pit 6 was located on the lawn at the rear of Merthyr College main building, in the south-eastern area of the courtyard, to the east of Test Pit 5. It measured c 4.00m x 0.60m and was mechanically excavated to a depth of 3.60m. The deposits encountered were industrial waste probably related to the Ynys Fach Ironworks. The basal layer consisted of glacio-fluvial geology (**066**). Overlying **066** was a green-brown layer of crumbling, packed slag nodules (**064**). A possible structure of orangey red bricks in blue-grey mortar [**065**] was found above the natural geology **066**, in the narrow south facing section (see Plate 6). Overlying this was a dark brown to black layer of clayey silt and coal dust / soot (**063**). A thin layer of sand, crushed bricks, and clay (**062**) was overlaid by the topsoil, which consisted of humic earth (**061**).

Plate 6. North facing view of Test Pit 6 showing the possible structure 065 in the centre of the photograph.

Test Pits 4 and 6 also revealed brick and mortar structures, but due to the location of these potential structures at the narrow end of the test pits, the archaeological value of these remains could not be ascertained. Test Pits 2, 4, 5, and 6 all contained layers of spoil or waste from the Ynys Fach Ironworks.

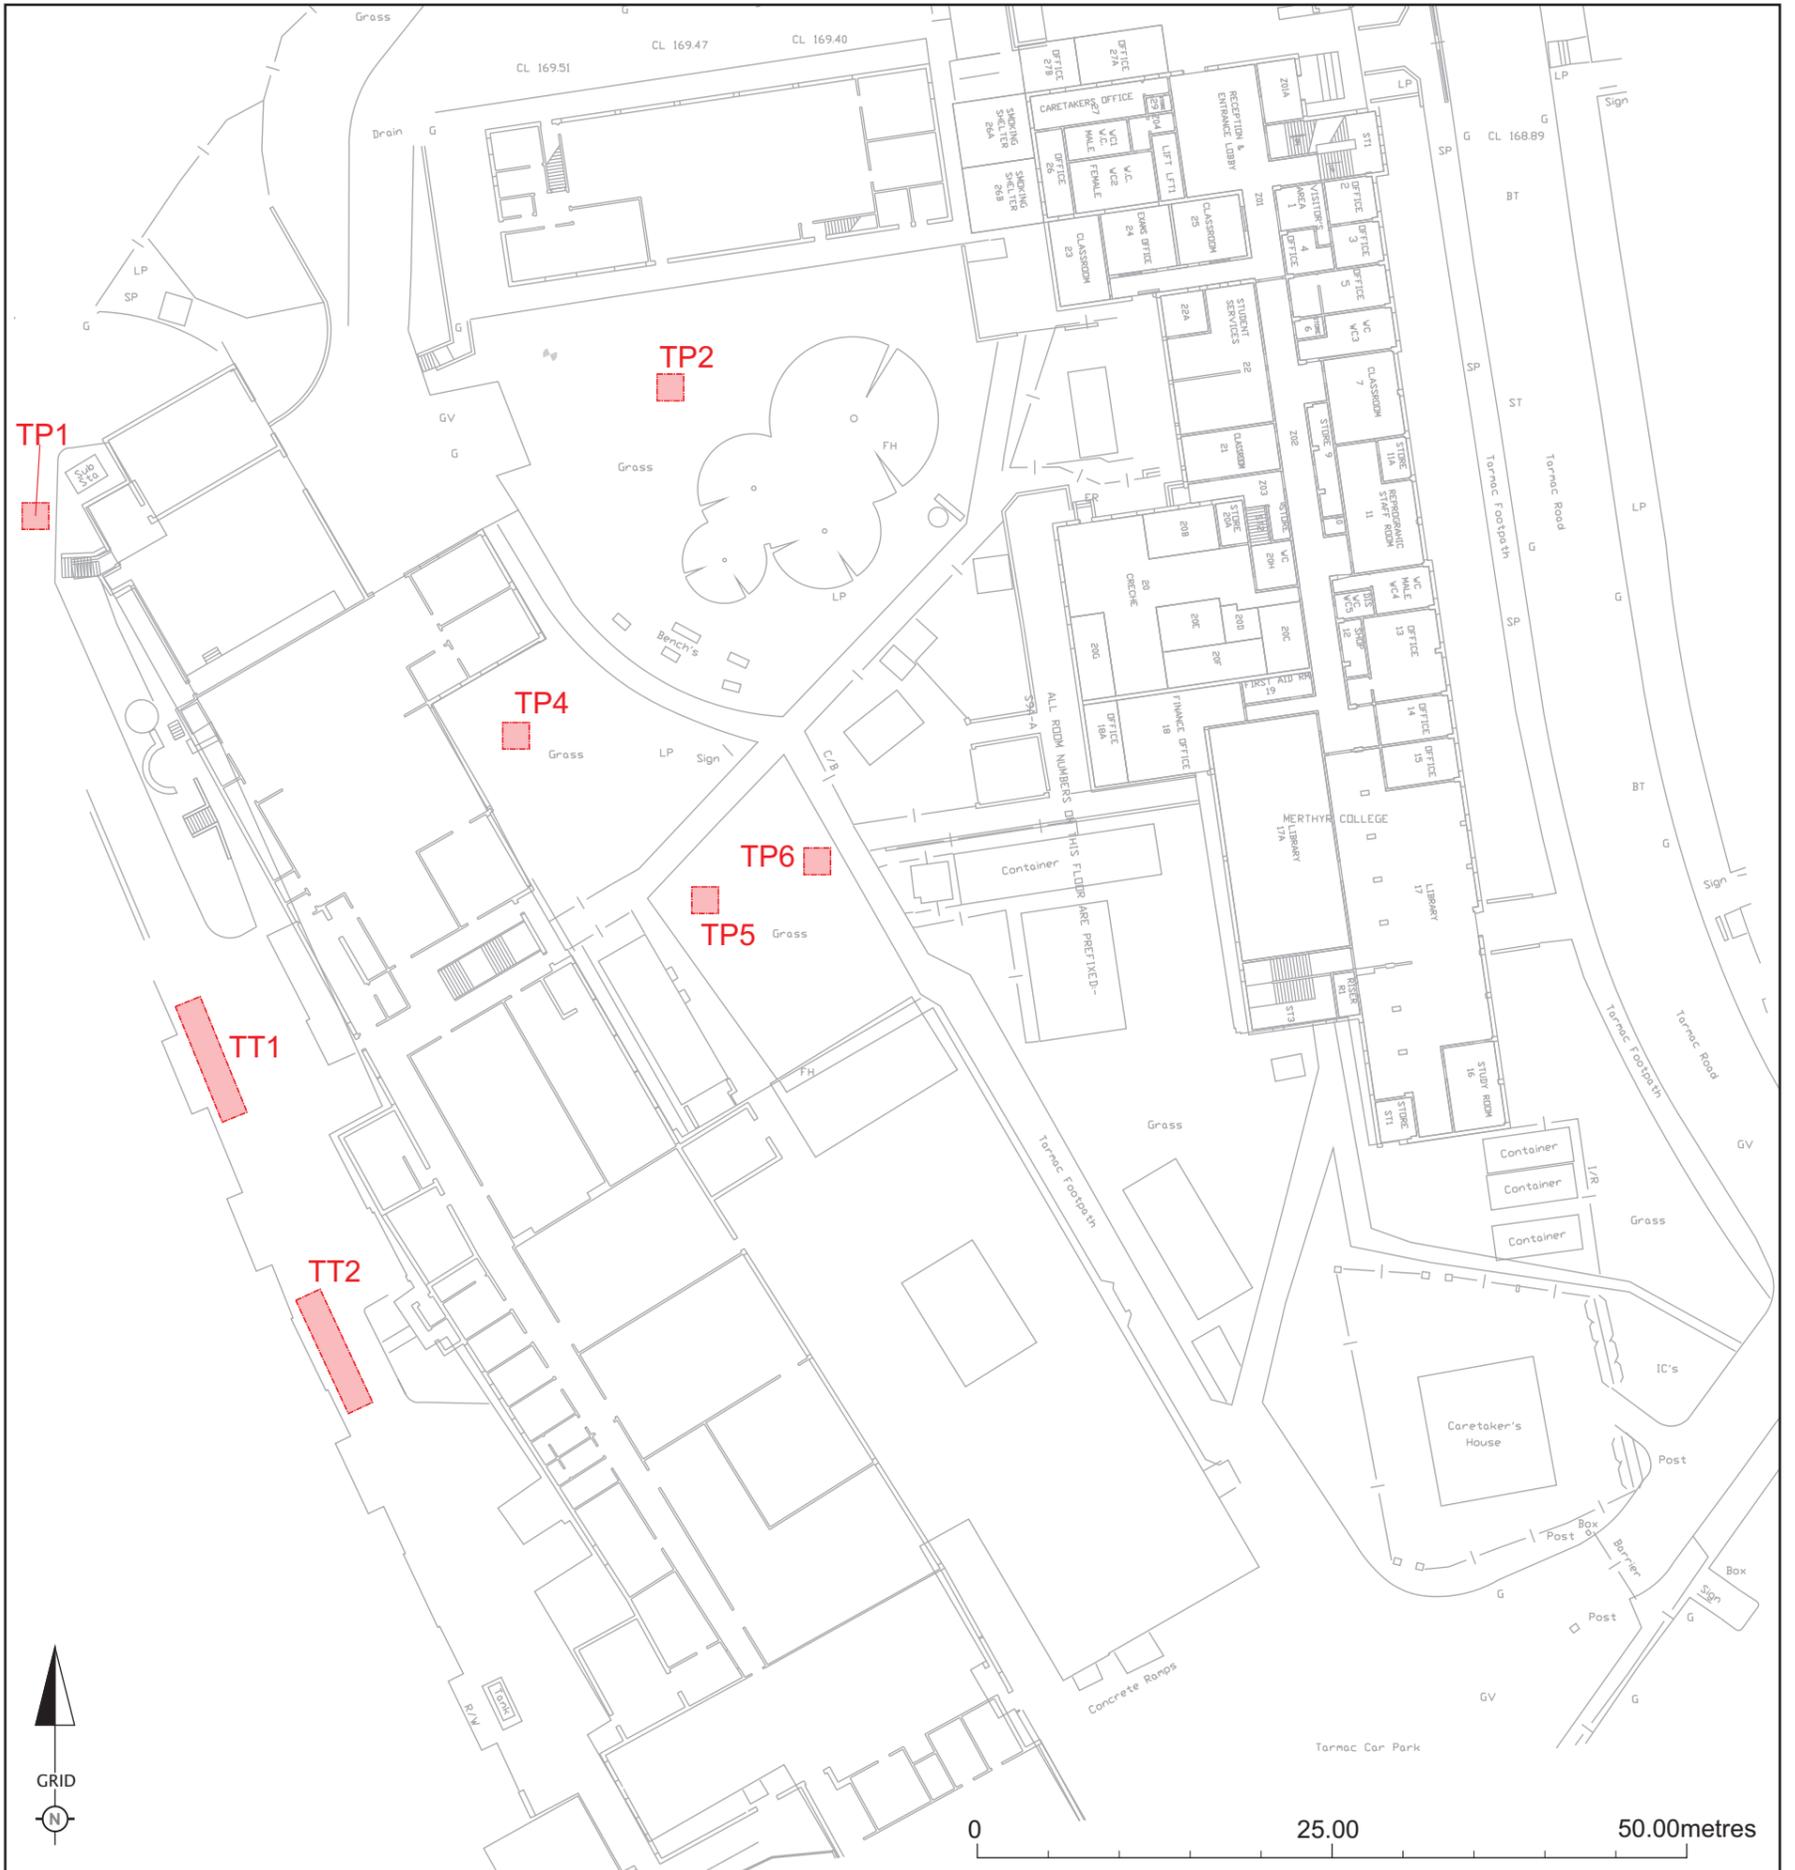
Figure 1. Plan showing Test Pits 1, 2, 4, 5, and 6, and Test Trenches 1 and 2
