Merthyr Learning Quarter, Merthyr Tydfil

Archaeological field evaluation

A report for the University of Glamorgan
by Rob Dunning BSc

GGAT report no. 2011/056
Project no.P1486
National Grid Reference:
centred on SO 0460 0603

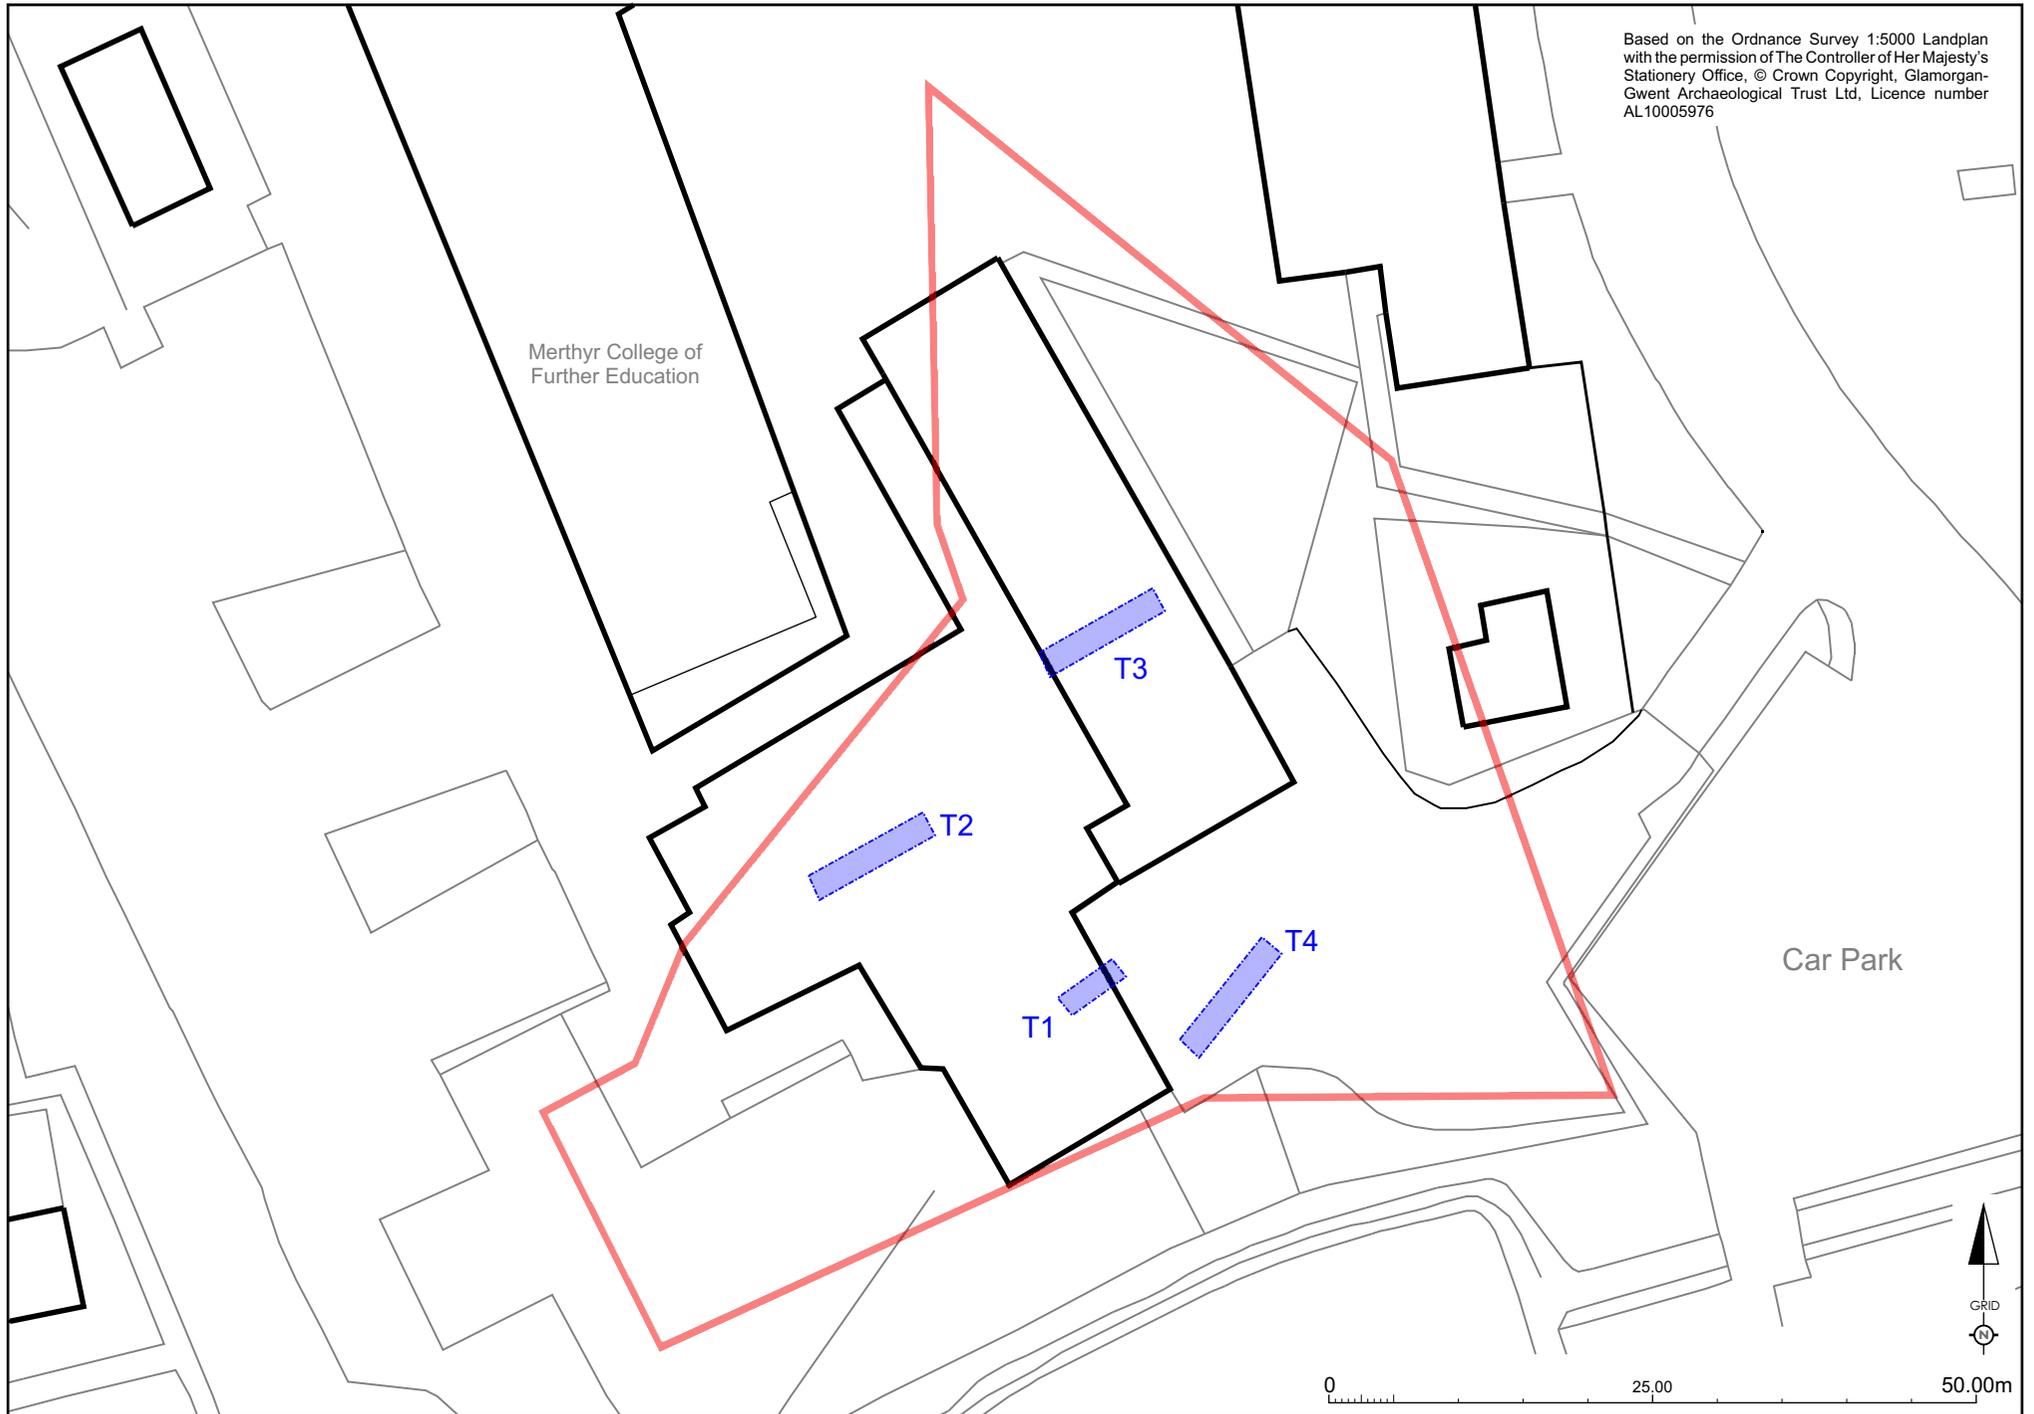
Figure 1. Location of development area (red) and Trenches 1-4 (blue)

The development area is centred on NGR SO 0460 0603, to the southwest of Merthyr College main building (see Figure 1). A housing estate borders its western and southwestern sides, separated by the ruins of the Ynys Fach Ironworks furnaces, which are a Scheduled Ancient Monument (Gm331). The ironworks were constructed against a steep charging bank, but the evaluation area was on flat land, at around 170m OD. Trenches 1,2 and 4 were located within car-parking areas, whereas Trench 3 was located within the footprint of the old workshops.

The project design (Dunning 2011) allowed for four evaluation trenches, all measuring 10m by 1.8m. However, the presence of a large revetment bank and services required the re-location of three trenches (Trenches 1, 3 and 4), one of which (Trench 1) was reduced in size to 5m (see Figure 1).

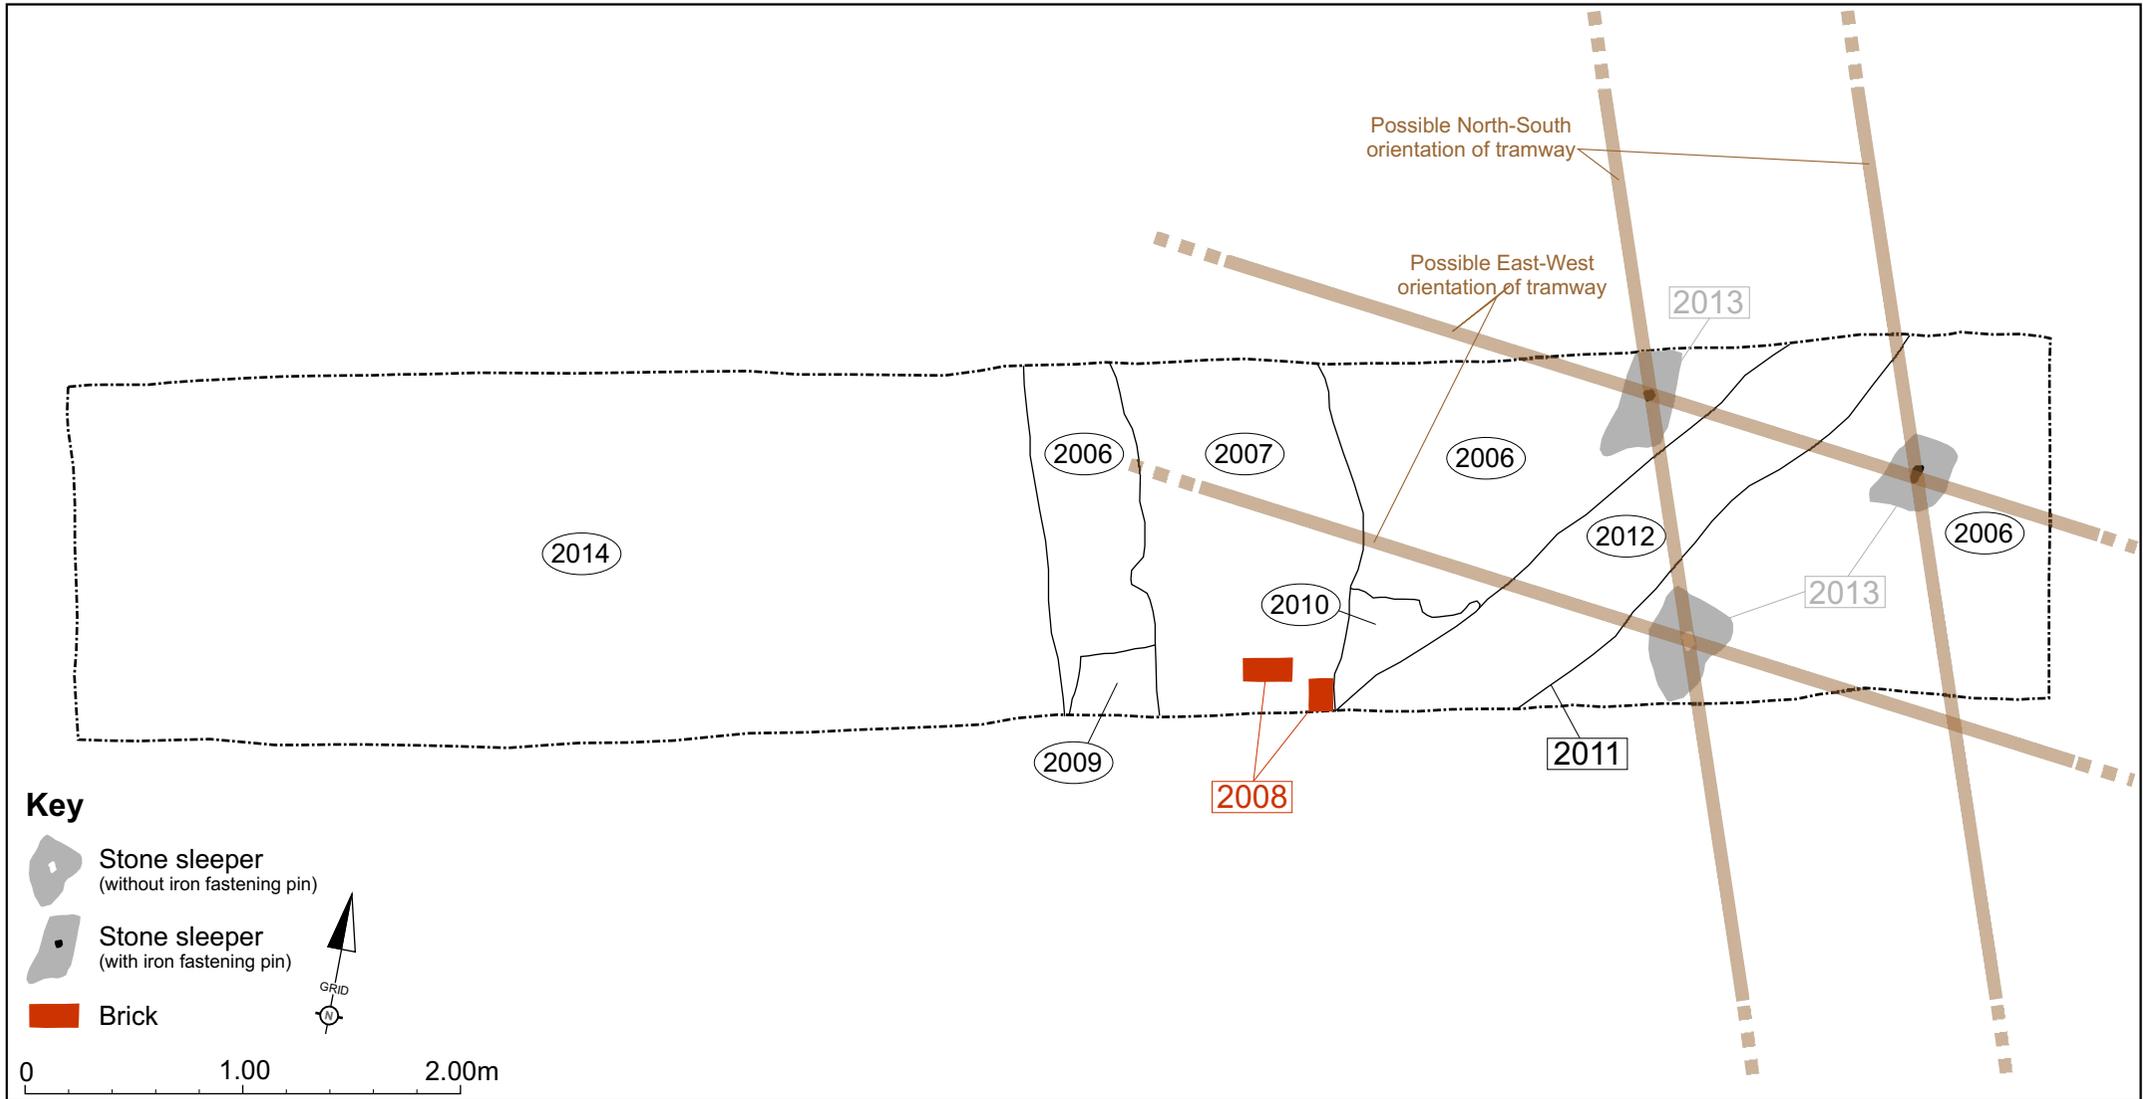
Figure 2. Plan of Trench 2 showing possible orientation of tramway associated with 2013

Trench 2 measured 10m in length by 2m in width, and was excavated to a maximum depth of 0.98m (see Figure 2 and Plates 2-3). The basal deposit was a compact industrial deposit (**2006**), composed of black-brown sandy clay, containing frequent slag, iron concretions and isolated mortar flecking, with a minimum depth of 0.06m. This was overlain by a loose industrial layer (**2005**), composed of a black silty clay and containing occasional angular and sub-angular stones (less than 0.06m in diameter), occasional iron slag and vitrified waste material fragments, isolated iron concretions, slate and glass fragments. The deposit had a depth of 0.32m. Overlying this was a levelling material (**2004**), composed of angular and sub-angular stones (less than 0.22m in diameter), machine-made brick, mortar and glass fragments, with a depth of 0.28m. Overlying **2004** was a layer of hardcore chippings (**2003**), and two layers of black tarmac (**2002** and **2001**).

Located at 169.37m OD were the remains of a wall (**2008**), although only a single course composed of two bricks survived, a third brick was present but not *in situ*. The foundations of the wall were formed of a mortar bed (**2009** and **2010**), which underlay a hardcore formed of an orange-brown clay (**2007**) containing frequent angular and sub-angular stones, slag and iron concretions. To the southwest of **2008**, underlying **2004**, was a deposit of demolition rubble (**2014**). The rubble effectively replaces **2005** within the interior of the **2008** building.

Three stone sleepers (**2013**) were contained by **2006**, and likely *in situ*. All were sub-rectangular in shape, with the northwestern sleeper measuring 0.46m by 0.3m by 0.12m; the southeastern sleeper measuring 0.4m by 0.34m by 0.12m, with the eastern stone measuring 0.32m by 0.26m by 0.1m. The iron fastening pins that would have secured the rails are still present in the northwestern and eastern stones, although only the retaining hole is present in the southeastern sleeper.

A service trench (**2011**) was also noted in Trench 2, aligned northeast-southwest and with a width of 0.36. The fill (**2012**) of the trench was composed of a fine grey sand which contained frequent angular stones (less than 0.01m in diameter).

A review of historic mapping (see Figure 3) suggests that wall **(2008)** and associated foundations, uncovered in Trench 2, are likely to be the remains of the eastern wall of one of the casting houses of the Ynys Fach Ironworks. The building was constructed in 1836 and is depicted on the Local Board of Health Plan (1852), 1st edition OS map (1876), 2nd edition OS map (1900) and 3rd edition OS map (1919). Rubble deposit **2014** is likely to be the remains of this structure, following its demolition in the mid 20th century. Similarly, the stone sleepers **(2013)** are the remains of the railway network utilised by the ironworks (see Figures 2 and 3). However, due to the relatively small scale of the evaluation, it was unclear whether **2013** was associated with the system that entered the casting house (Local Board of Health Plan and 1st edition OS), or the railway that ran parallel to, but outside the buildings (2nd and 3rd edition OS).

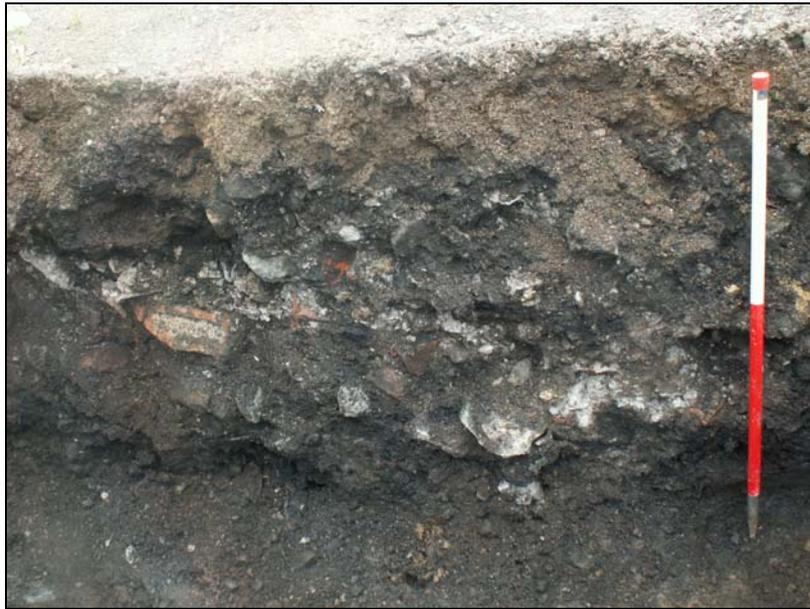
Trench 1 measured 5m in length by 2m in width, and was excavated to a maximum depth of 1.37m (see Plate 1). The basal context was a slag deposit (**1005**), composed of iron slag and vitrified waste material, with no bonding matrix and a minimum depth of 0.2m. This was overlain by an industrial layer (**1004**), composed of a black silty clay and containing occasional angular and sub-angular stones (less than 0.06m in diameter), isolated iron slag fragments, vitrified waste material, slate and mortar flecking. The deposit had a depth of 0.33m. Overlying this was a levelling material (**1003**), composed of angular and sub-angular stones (less than 0.21m in diameter), machine-made brick, iron, slate, wire and concrete fragments, with a depth of 0.62m. Overlying **1003** was a layer of black sandy clay (**1002**), which measured 0.13m in depth and contained occasional angular and sub-angular stones (less than 0.06m in diameter) and isolated mortar flecking. The uppermost deposit was a yellow-brown sand (**1001**), 0.09m in depth.

Plate 1: View to the southeast of Trench 1

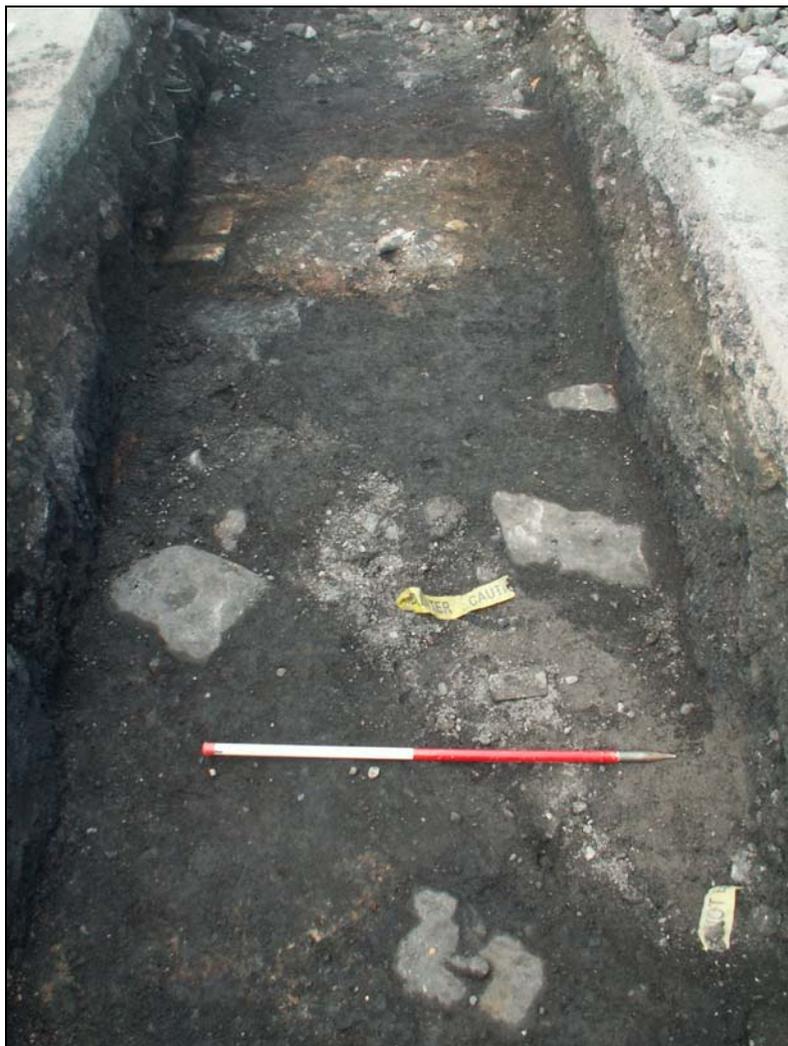
Plate 2: View to the northwest of Trench 2, showing wall 2008, associated foundations and stone sleepers 2013

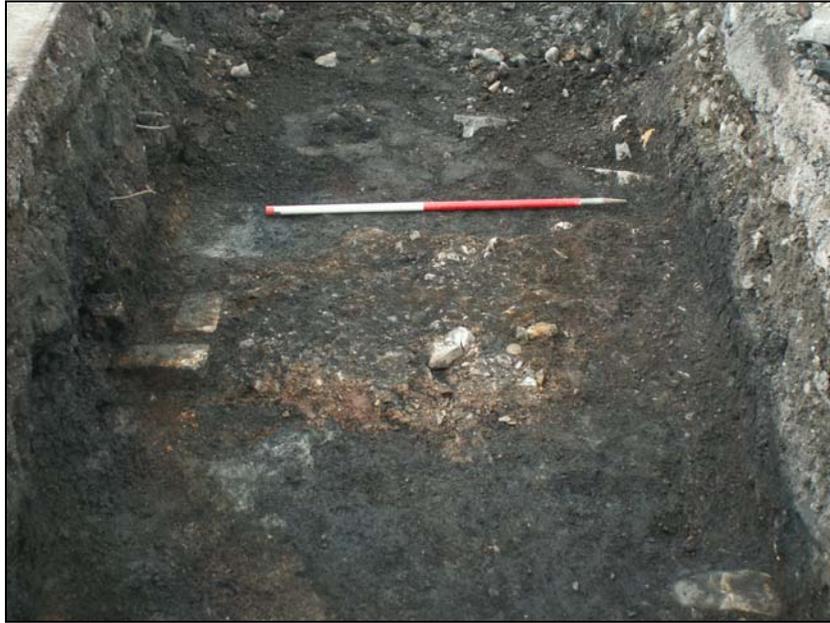
Plate 3: View to the southwest of Trench 2, showing wall 2008 and associated foundations

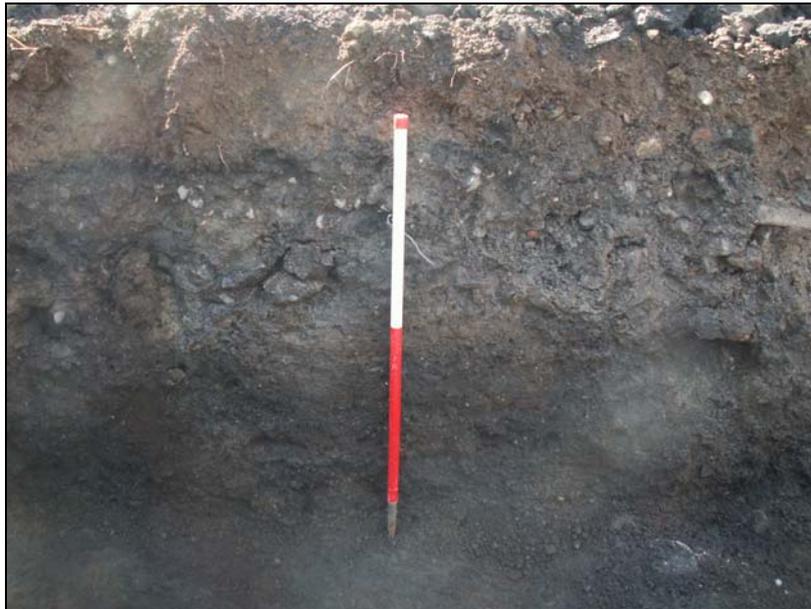
Trench 3 measured 10m in length by 2m in width, and was excavated to a maximum depth of 1.27m (see Plate 4). The basal deposit was a compact industrial deposit (**3006**), composed of black-brown sandy clay, containing frequent slag, iron concretions and isolated mortar flecking, with a minimum depth of 0.05m. This was overlain by a loose industrial layer (**3005**), composed of a black silty clay and containing occasional angular and sub-angular stones (less than 0.06m in diameter), occasional iron slag and vitrified waste material fragments, isolated iron concretions, slate and glass fragments. The deposit had a depth of 0.45m. This was overlain by a levelling deposit (**3004**), composed of a grey-black clay, containing angular and sub-angular stones (less than 0.16m in diameter), isolated machine-made brick, slate and iron concretions. Overlying this was a grey sandy clay (**3003**), containing frequent rounded and sub-rounded stones (less than 0.06m in diameter) isolated machine-made brick fragments, and with a depth of 0.16m. Overlying **3003** was a layer of black clay (**3002**), which measured 0.04m in depth and contained isolated angular stones (less than 0.01m in diameter) and frequent coke and slag fragments. The uppermost deposit was a light brown silty clay (**3001**), containing isolated rounded and sub-rounded stones (less than 0.06m in diameter), 0.26m in depth.

Plate 4: View of Trench 3, looking southeast

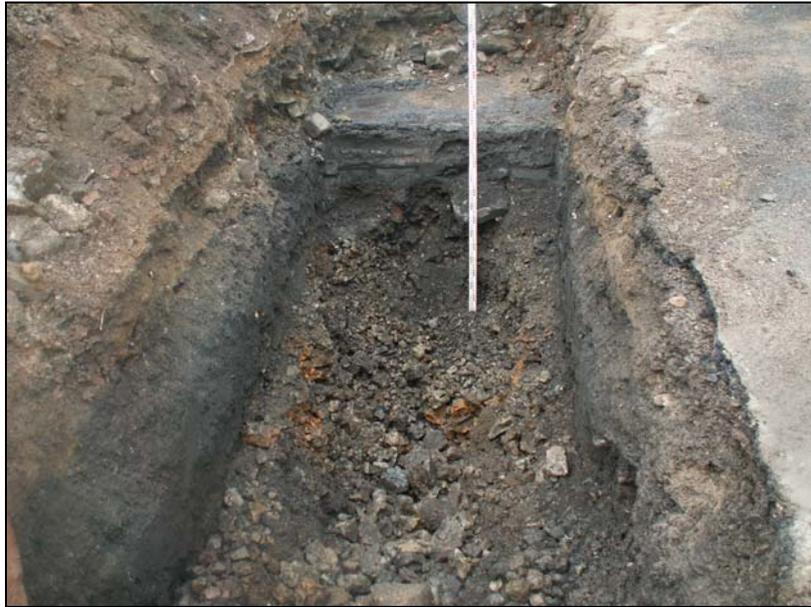
Trench 4 measured 10m in length by 2m in width, and was excavated to a maximum depth of 3.06m (see Plates 5-6). The basal context was a slag deposit (**4006**), composed of iron and vitrified waste material, with no bonding matrix and with a minimum depth of 1.7m. This was overlain by an industrial layer (**4005**), composed of a black silty clay and containing occasional angular and sub-angular stones (less than 0.06m in diameter), isolated iron slag and vitrified waste material fragments, iron concretions, slate, glass and mortar flecking. The deposit had a depth of 0.76m. This was overlain by a levelling deposit (**4004**), composed of angular and sub-angular stones (less than 0.24m in diameter), machine-made brick, mortar, wood and glass fragments. This deposit was only present in the southwest corner of the trench, and had a maximum depth of 0.35m. Overlying this were two layers of hardcore (**4003** and **4002**), with depths of 0.12m and 0.06m respectively. The uppermost deposit was composed of black tarmac (**4001**), 0.07m in depth.

Contained within deposit **4005** were a group of at least four stone flagstones (**4007**). They were aligned northwest-southeast, and while none survive intact, they measure 0.6m by 0.6m by 0.05m. Whilst no construction cut was apparent, they likely form a cover for ducting or services.

Plate 5: View of Trench 4, looking southwest

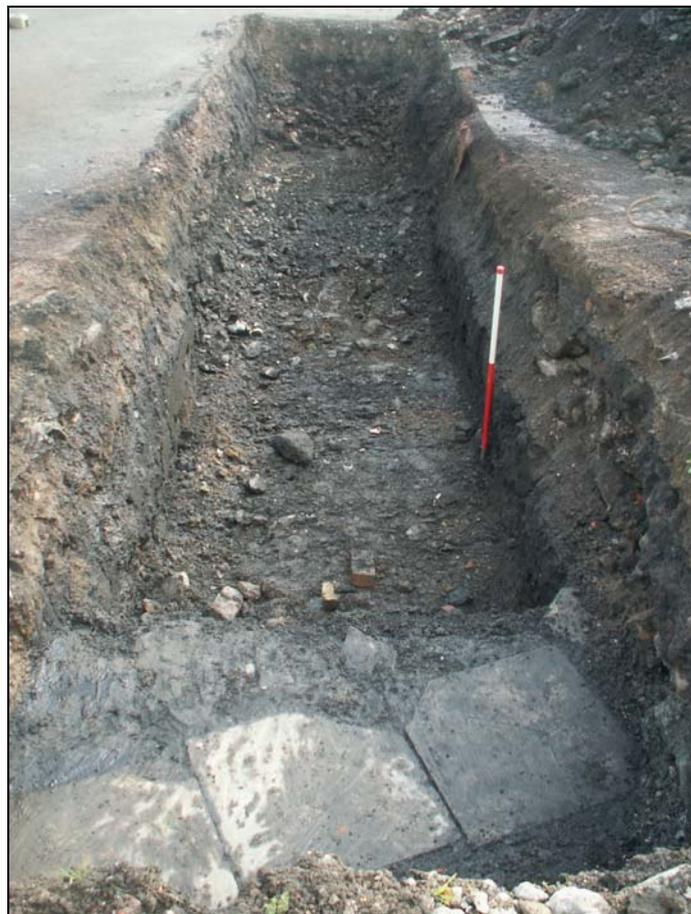
Plate 6: View of partially backfilled Trench 4, looking northeast
