Monastic Margam Community Survey Project

Report for Cadw
by Sam Pamment BA

GGAT report no. 2013/020
NGR: SS 8018 8626
Project no. GGAT 123

Summary

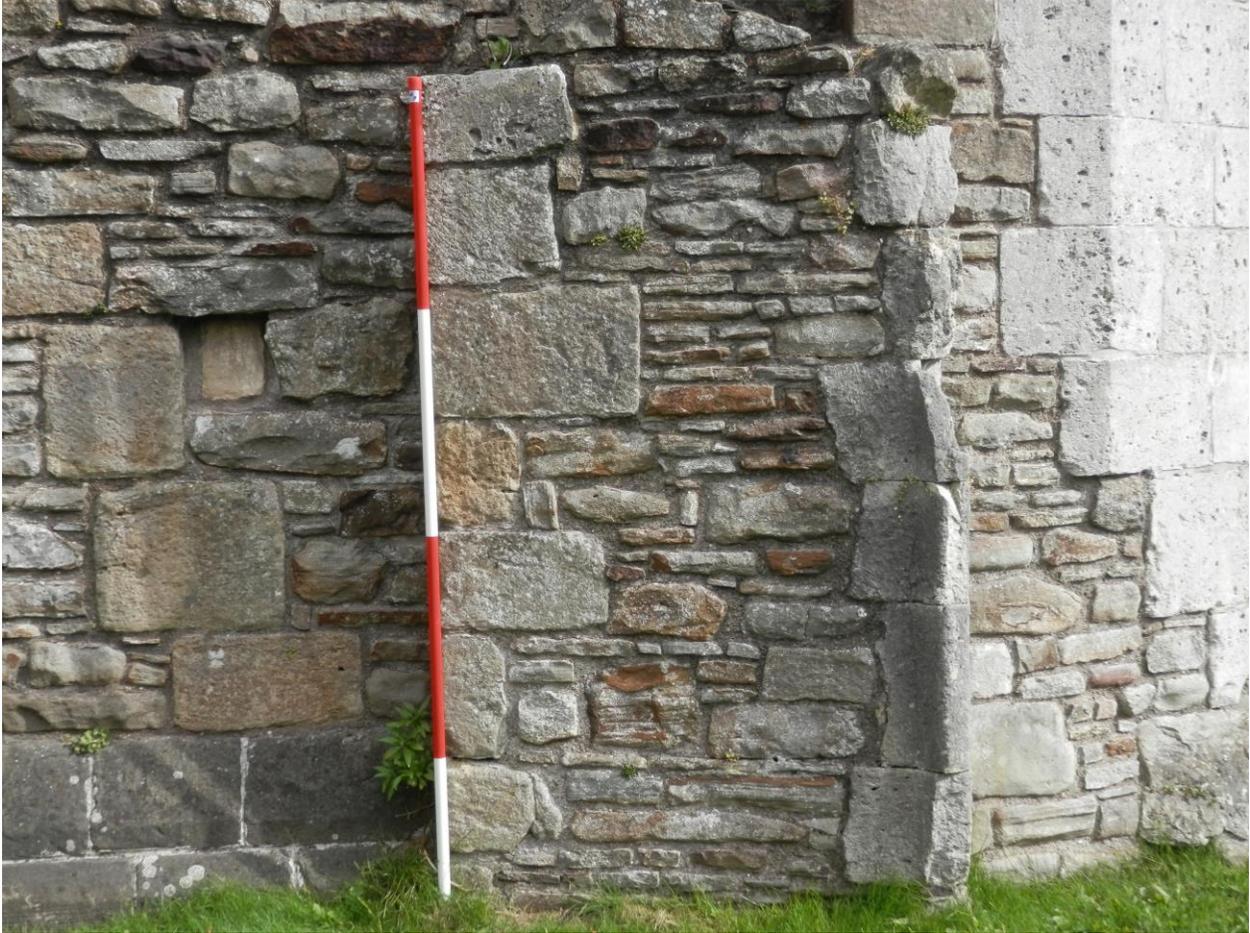
ID: 2 Site Number: 748 Site Name: Margam Monastic Ruins
Wall Number: 1 Photo Number: F1/2
Location: Chapter House Ext. right side section of stub wall .
Description: To right of photo 1 dressing of ashlar blocks of various sizes
Condition summary: A) Weathering on dressing. B) Weathering of stone.
C) Weathering of ashlar

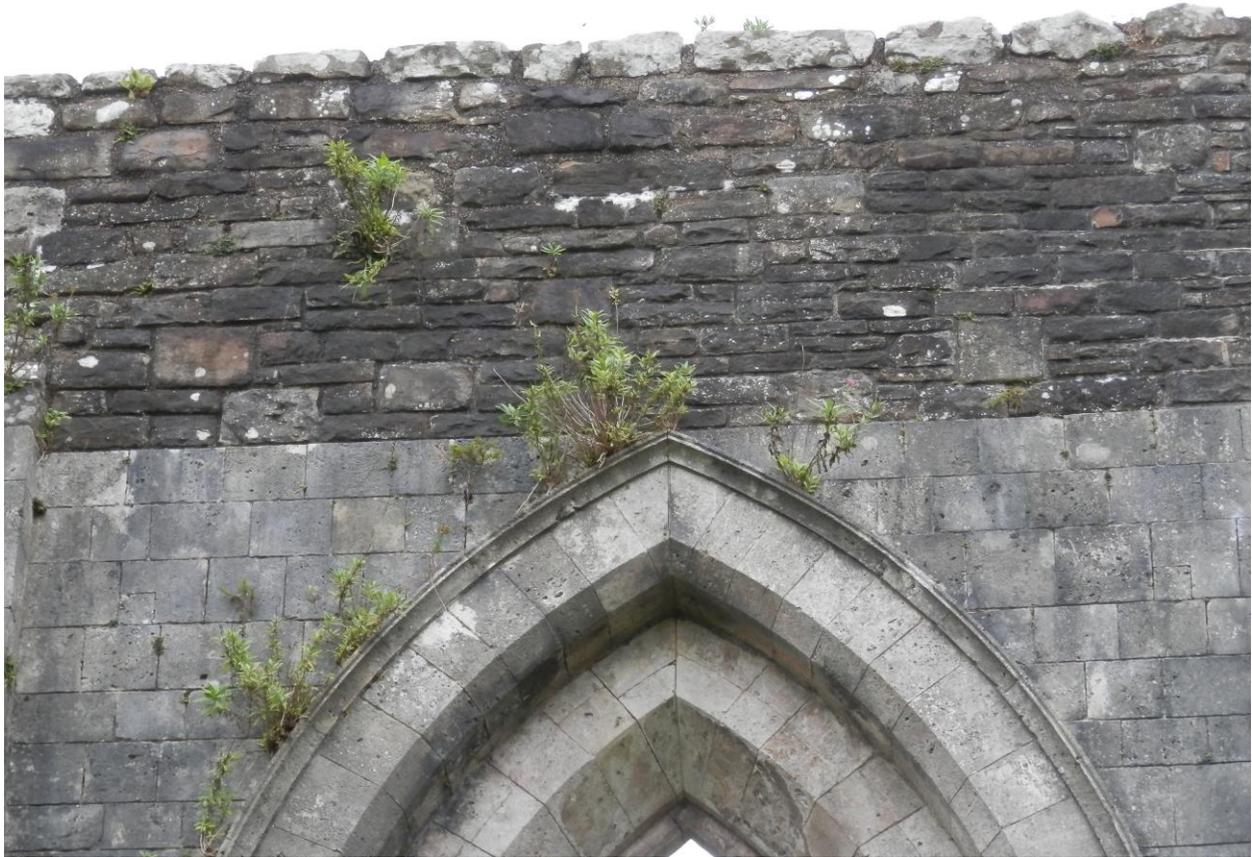
ID: 5 Site Number: 748 Site Name: Margam Monastic Ruins
Wall Number: 1 Photo Number: F1/6
Location: Chapter House Ext. top of wall
Description: Top section of chapter house ext. wall 1. Wall at top has hoodmould in ashlar; coursed rubble above
Condition summary: A) Vegetation, sprouting from top of building
Threats: Vegetation damage, weather erosion
Recorded by: Kay Thomas Date: 17/09/2012

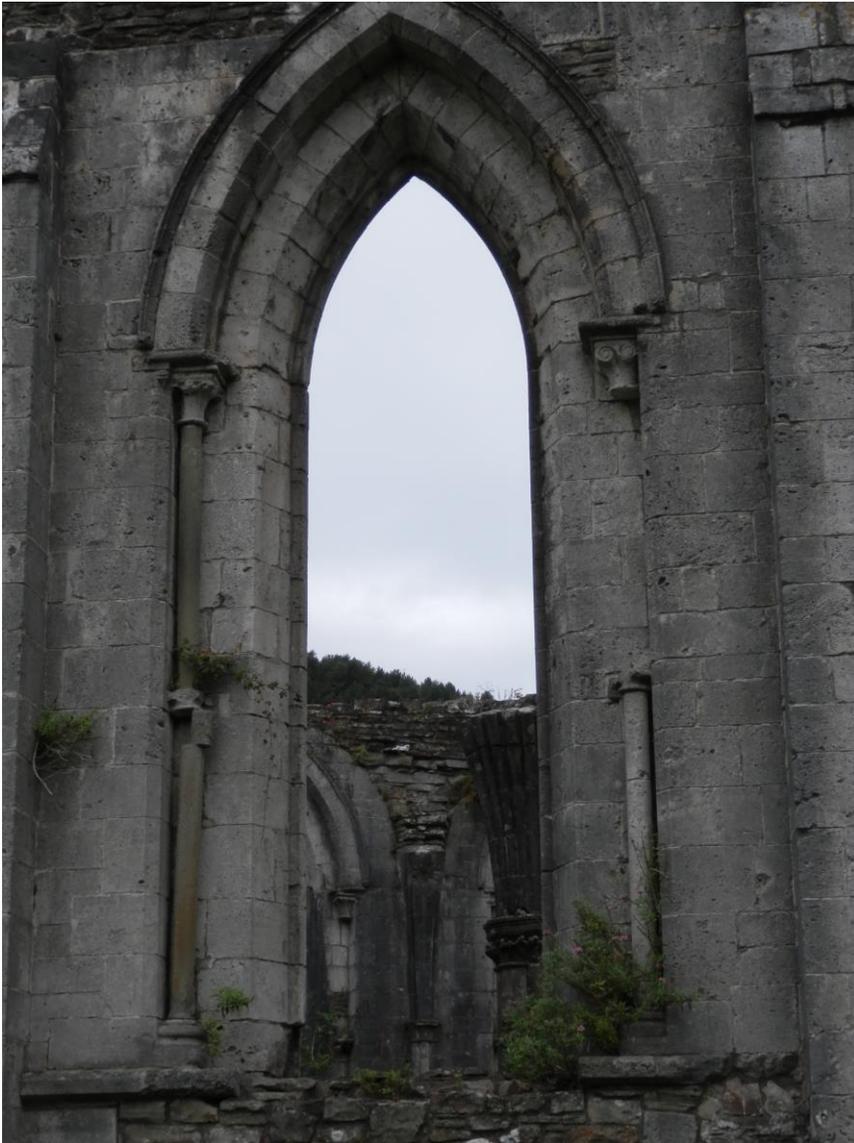
ID: 7 Site Number: 748 Site Name: Margam Monastic Ruins
Wall Number: 2 Photo Number: F1/8
Location: Chapter House Ext
Description: Window. All ashlar. One half of shaft missing. Piece of bottom left side shaft has come away and is on the point of falling out.
Condition summary: A) Broken shaft. B) Damage to shaft cap. C) Vegetation. D) Weathering to ashlar blocks .
Threats: Weathering, Vegetation
Recorded by: Ray Savage Date: 17/09/2012

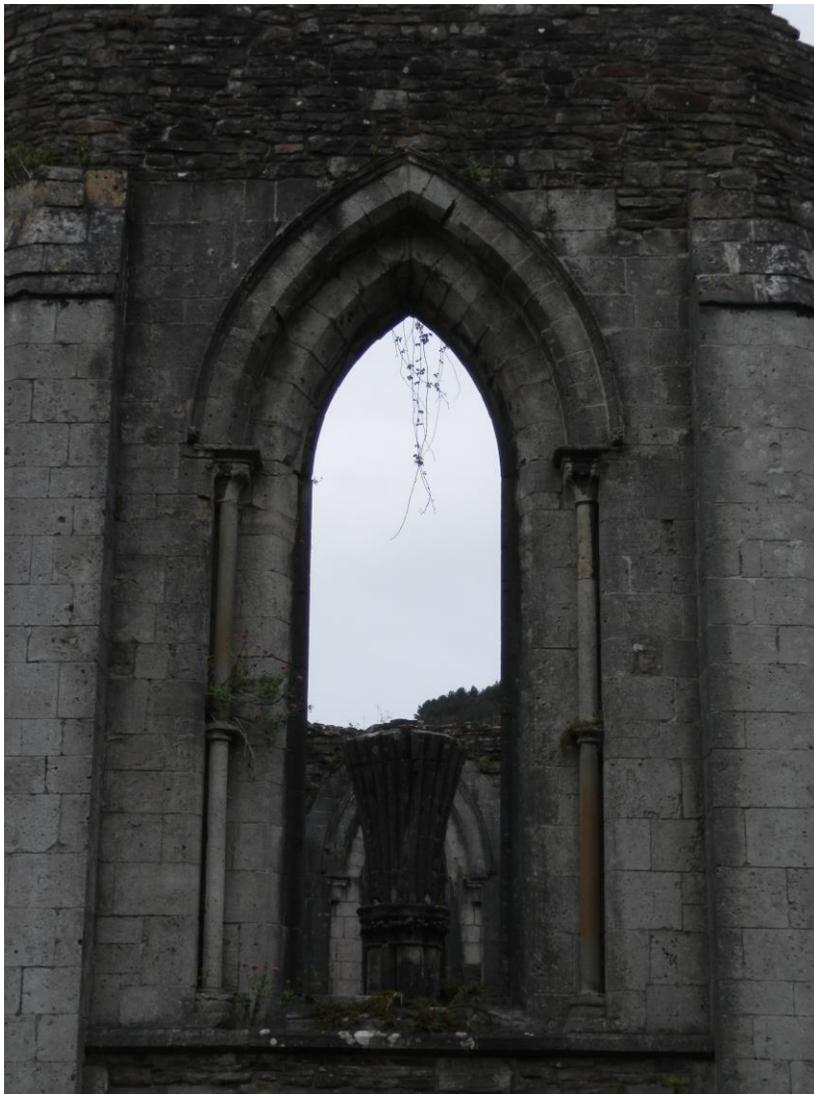
Condition summary: A) Right shaft (bottom section) erosion of bottom. B) Weathering at top of right hand shaft. C) Vegetation at bottom of arch window. D) Vegetation at centre of left hand shaft. E) Chip at top of arch on right hand side.

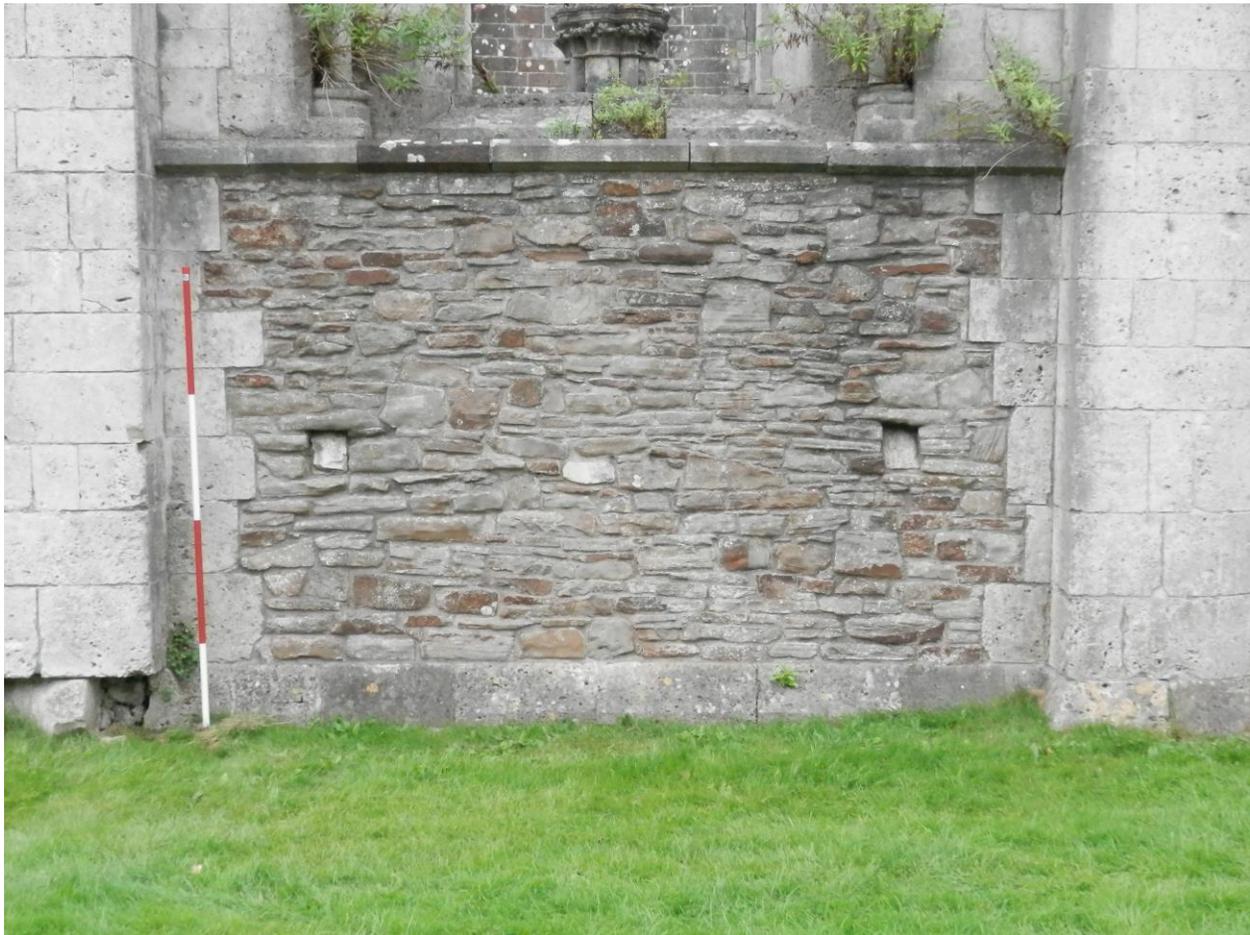
Condition summary: A) Weathering of some of the dressed sandstone work. B) Missing block from buttress to left. C) Large gap at base of ashlar to left.

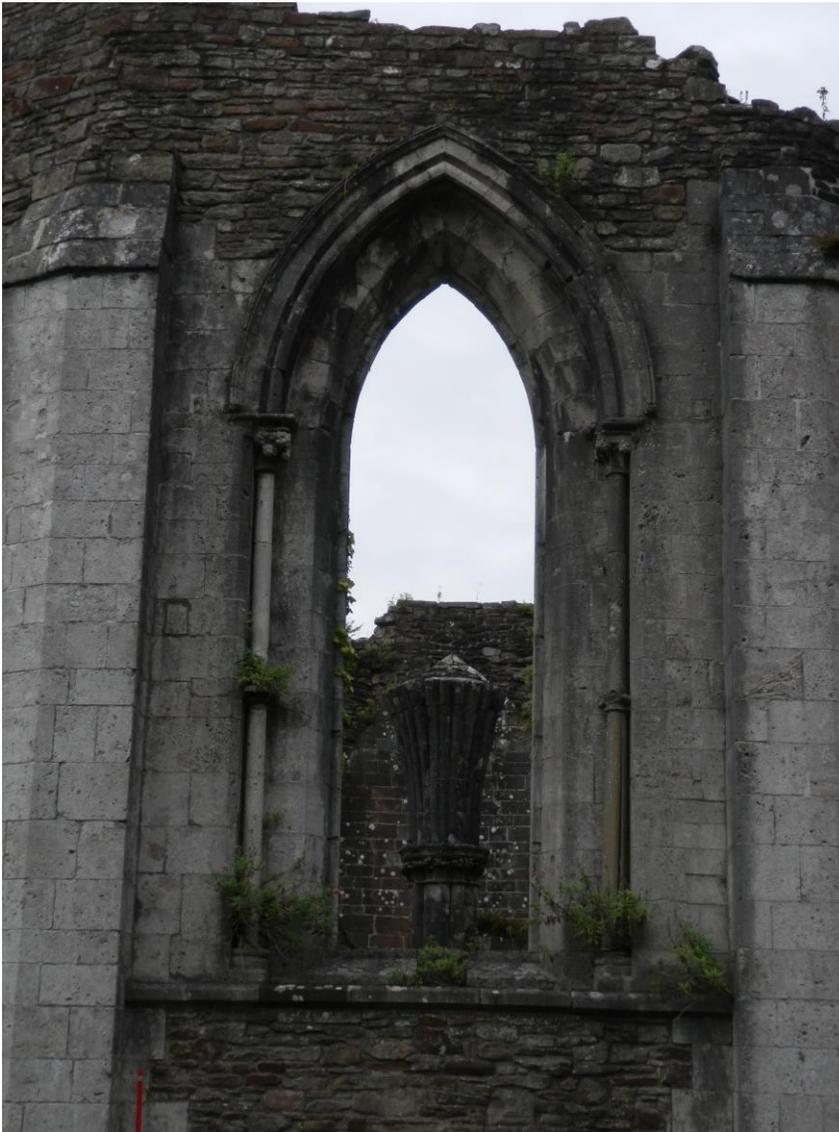
Condition summary: A) Right Hand shaft bottom section split from top to bottom.
B) Weathering of ashlar on shaft and surrounding stonework.
C) Excessive vegetation growing from window sections.

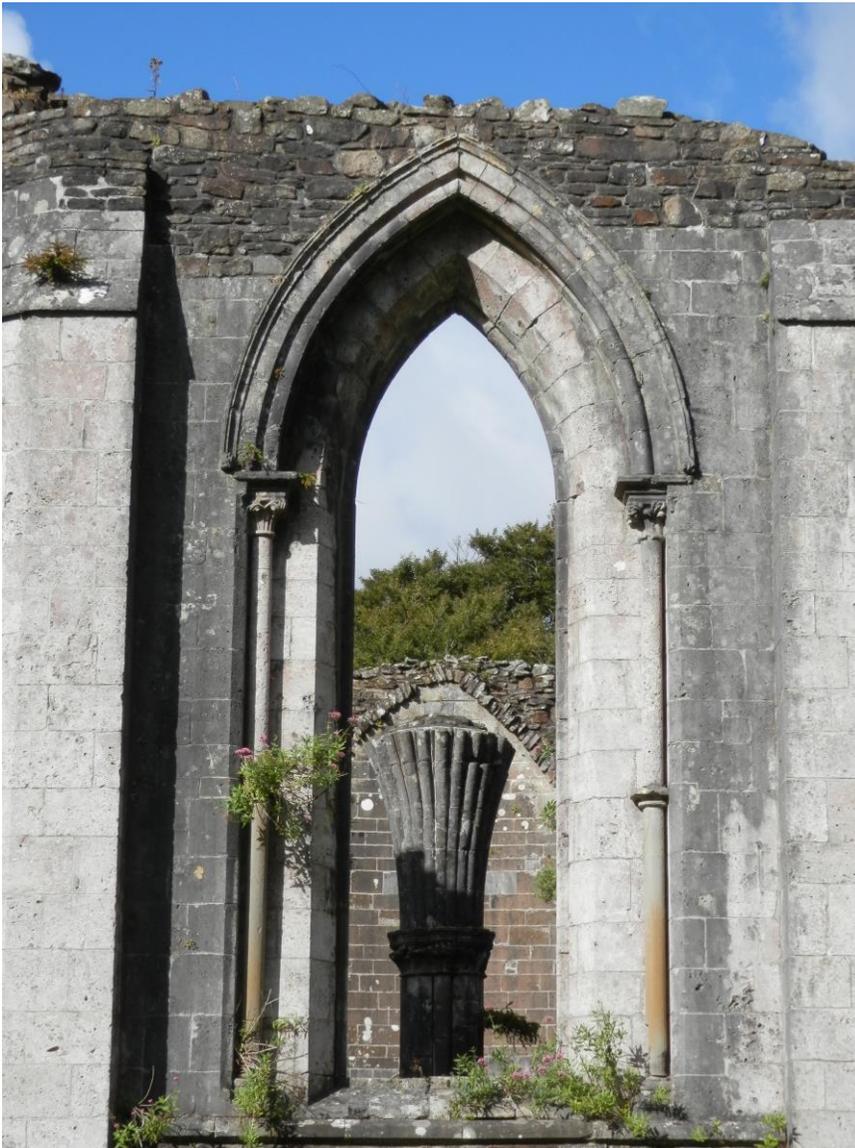
ID: 13 Site Number: 748 Site Name: Margam Monastic Ruins
Wall Number: 5 Photo Number: F1/14-15
Location: Chapter House Ext.
Description: Arched window in ashlar wall. 2 shafts, 1 each side of window frame. Bottom of each of these shaft are eroded. Part of the left-hand shaft is coming away from where it joins in the middle
Condition summary: A) Base of both shafts damaged. C) Left hand shaft coming away from the middle. D) Vegetation growing from cracks. E) Erosion on front of dressed stones.
Threats: Vegetation, column falling out, weathering
Recorded by: Ray Savage Date: 18/09/2012

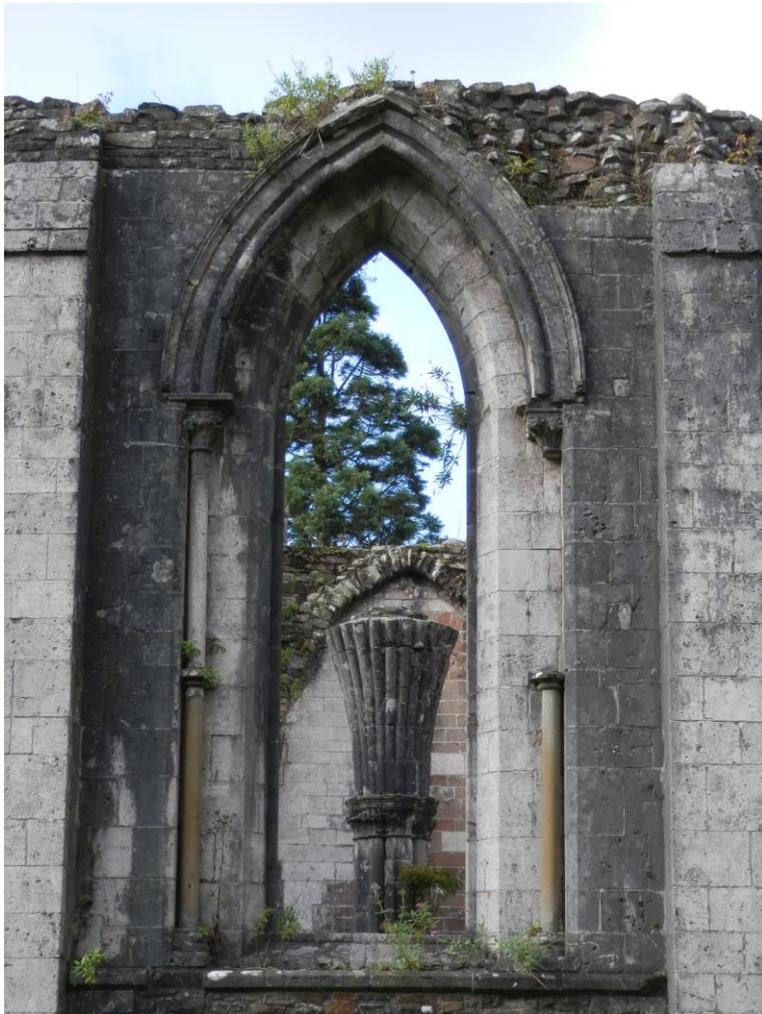
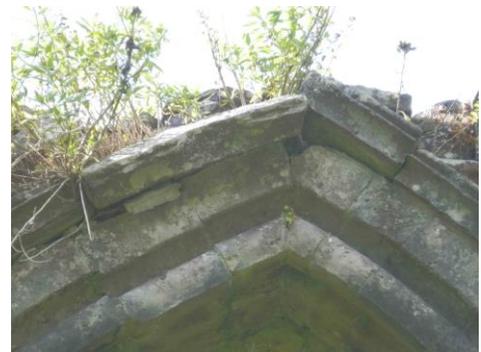
ID: 15 Site Number: 748 Site Name: Margam Monastic Ruins
Wall Number: 6 Photo Number:F1/18-19
Location: Chapter House
Description: Upper window section of chapter house consisting of ashlar 3/4 of arch then local sandstone. Central arched window. Left shaft intact, right shaft top section missing. Right shaft cap slightly chipped. Leaf motif at base of hood arch moulding.
Condition summary: A) Top of arch vegetation, loose mortar and bricks at top of arch. B) Chipped damaged shaft heads on right. C) Vegetation bottom of window ledge. D) Weathering of ashlar. E) Weathering to shaft bases. F) Weathering to shaft on left side.
Threats: Weathering. Vegetation
Recorded by: Maggie Cornelius Date: 18/09/2012

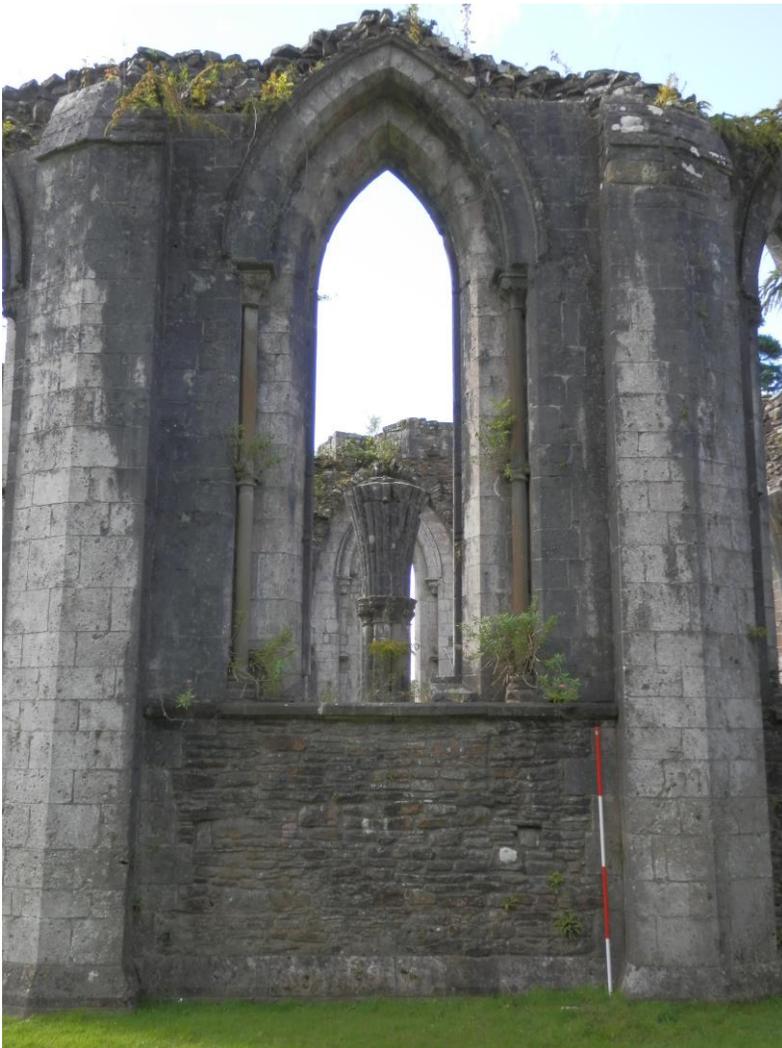
ID: 16 Site Number: 748 Site Name: Margam Monastic Ruins
Wall Number: 7 Photo Number: F1/21-22
Location: Chapter House Ext.
Description: Wall 7. Window is flanked by 2 shafts with decorated caps. Window narrows to a pointed arch with hood moulding surround. Window section mainly ashlar; very top, and wall below sill, constructed local sandstone rubble.
Condition summary: A) Hole right of right shaft base with vegetation growing out. B) Vegetation growing behind right and left shaft base. C) Ashlar at base of window missing. D) Vegetation growing behind middle of left and right central shafts. E) Vegetation growing at top of arch. F) Top left shaft has split. No obvious damage below sill.
Threats: Weathering, Vegetation
Recorded by: Sam Pamment Date: 18/09/2012

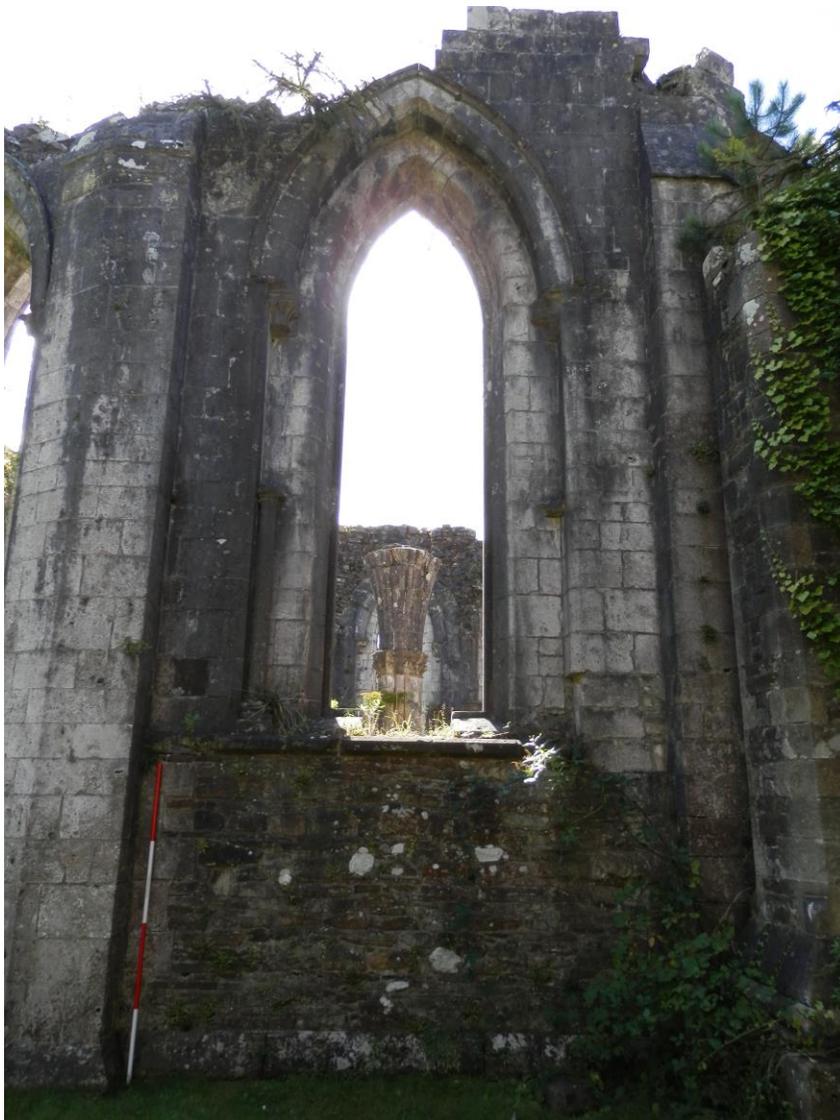
ID: 17 Site Number: 748 Site Name: Margam Monastic Ruins
Wall Number: 8 Photo Number: F1/23
Location: Chapter House Ext.
Description: Window section consisting of ashlar with some rubble above one side of hoodmould.
Condition summary: A) Top of Left hand shaft missing. B) Complete shaft missing on right. C) Shaft head badly damaged on right. D) Section of window sill missing on left and chunk missing from centre. E) Vegetation at top of arch and base of window. F) Base of right shaft missing. No obvious damage below sill.
Threats: Vegetation damage. Weathering of stone work
Recorded by: Jeff Jones Date: 18/09/2012

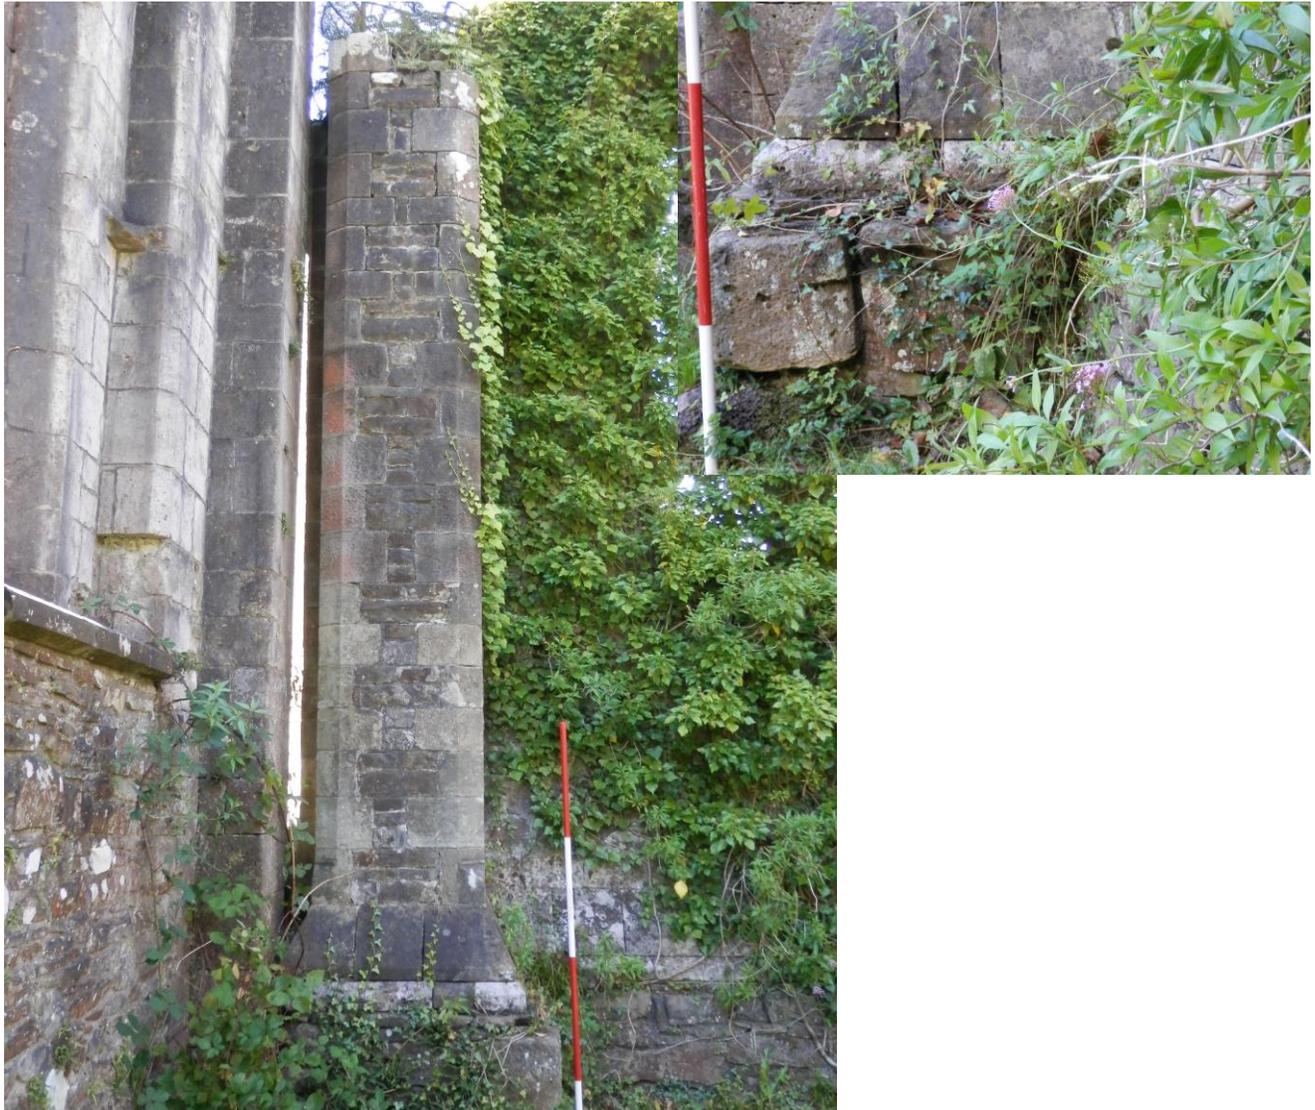
Description: Buttress rises 3/4 of height of transept wall, ashlar dressings to local sandstone rubble. Plinth at bottom. Top stones missing.

Condition summary: A) Mortar damage to base- loose, further erosion damage, collapsing with stones slipping out. B) Top similar to base mortar loose. C) tree growing from top.

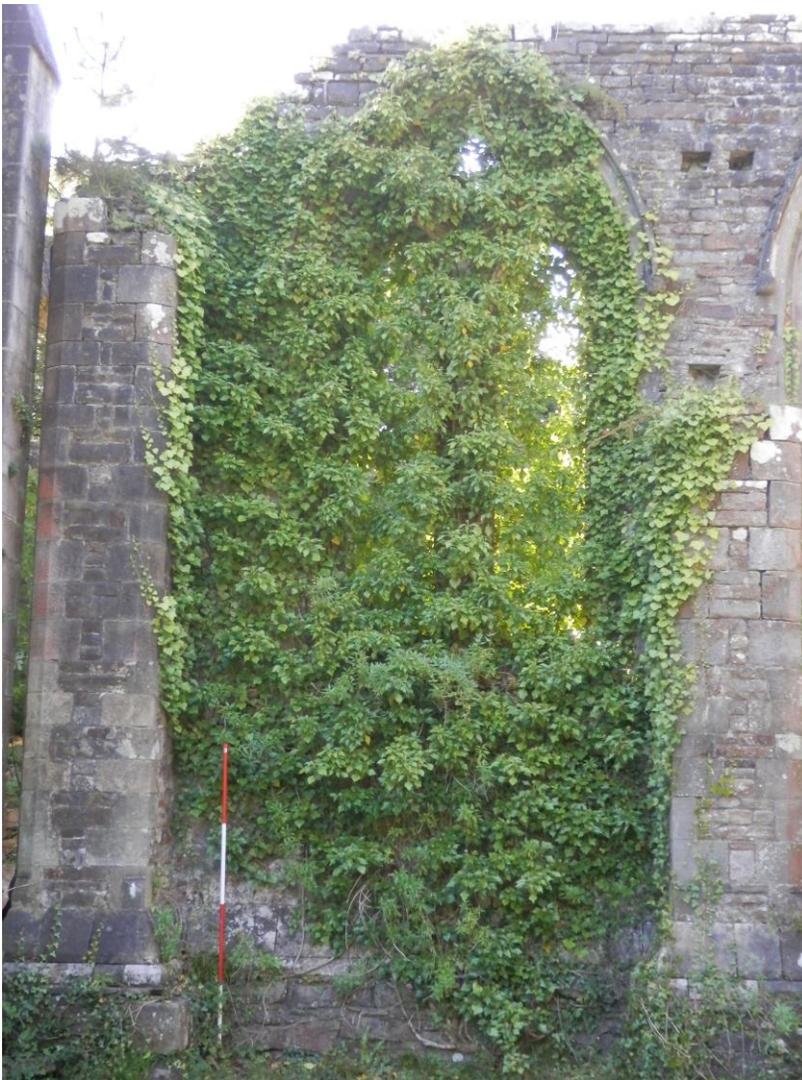
ID: 20 Site Number: 748 Site Name: Margam Monastic Ruins
Wall Number: 10 Photo Number: F1/29-34
Location: South Transept, East Wall Ext.
Description: Wall and window covered in ivy vegetation, stone work difficult to see. Some ashlar visible towards bottom of wall, below which is rubble. Ivy covers detail and damage to window. Stonework at top loose mortar eroded.
Condition summary: A) Ivy coverage over most of wall face obscuring features and damage. B) Top of wall, mortar has eroded, stone work loose, danger of falling stones.
Threats: Weathering Vegetation
Recorded by: Maggie Cornelius Date: 18/09/2012

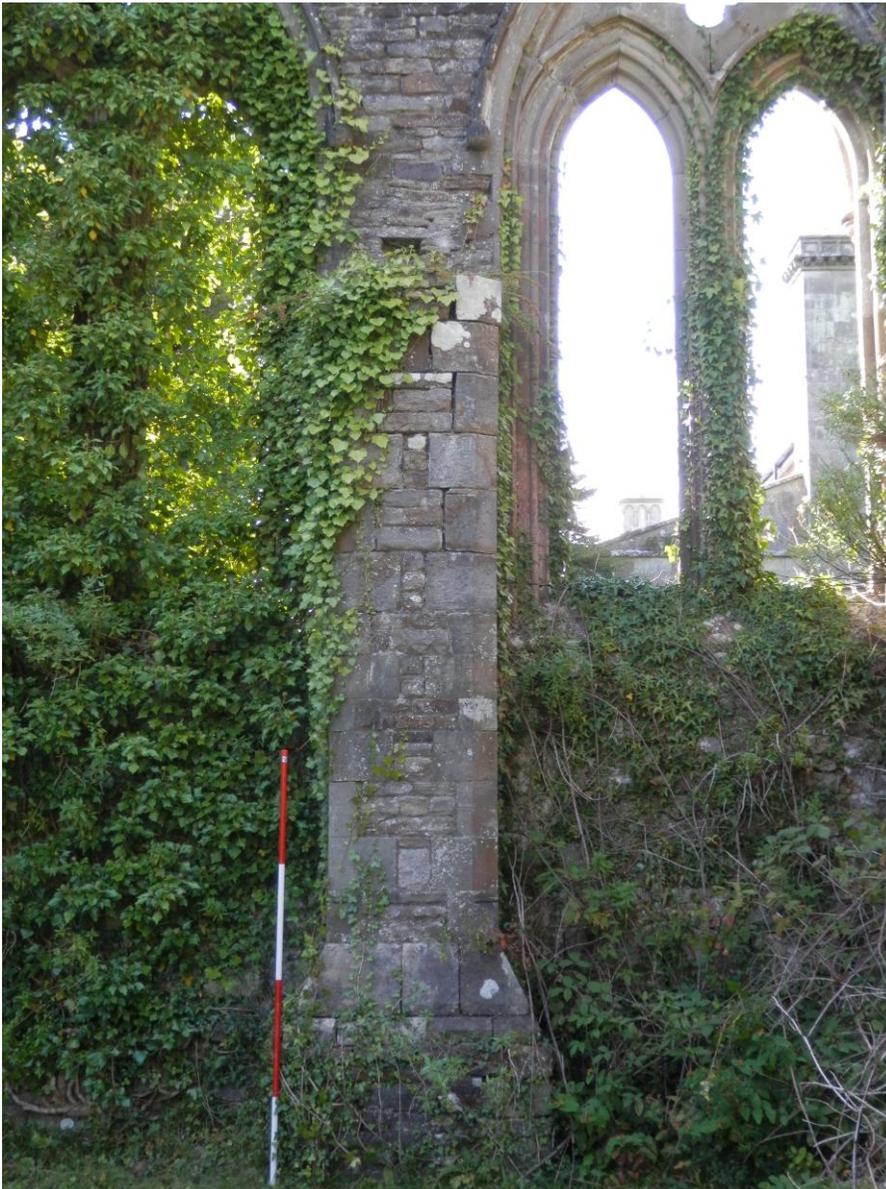
ID: 21 Site Number: 748 Site Name: Margam Monastic Ruins
Wall Number: 11 Photo Number: F1/32-34
Location: South Transept East Wall Ext. Buttress 2
Description: Buttress: both corners in ashlar, chamfered with rubblework in between.
Height: rises to 2/3 of the wall height. Plinth with batter to 2 upper courses
Base of plinth 1.20m wide, top of plinth 0.80m. Ivy covering top left corner.
Condition summary: A) Vegetation growing out of remains of column. B) Mortar erosion in
top 5 courses resulting in loose stonework needs to be repaired.
Threats: Weathering, Vegetation
Recorded by: Maggie Cornelius Date: 18/09/2012

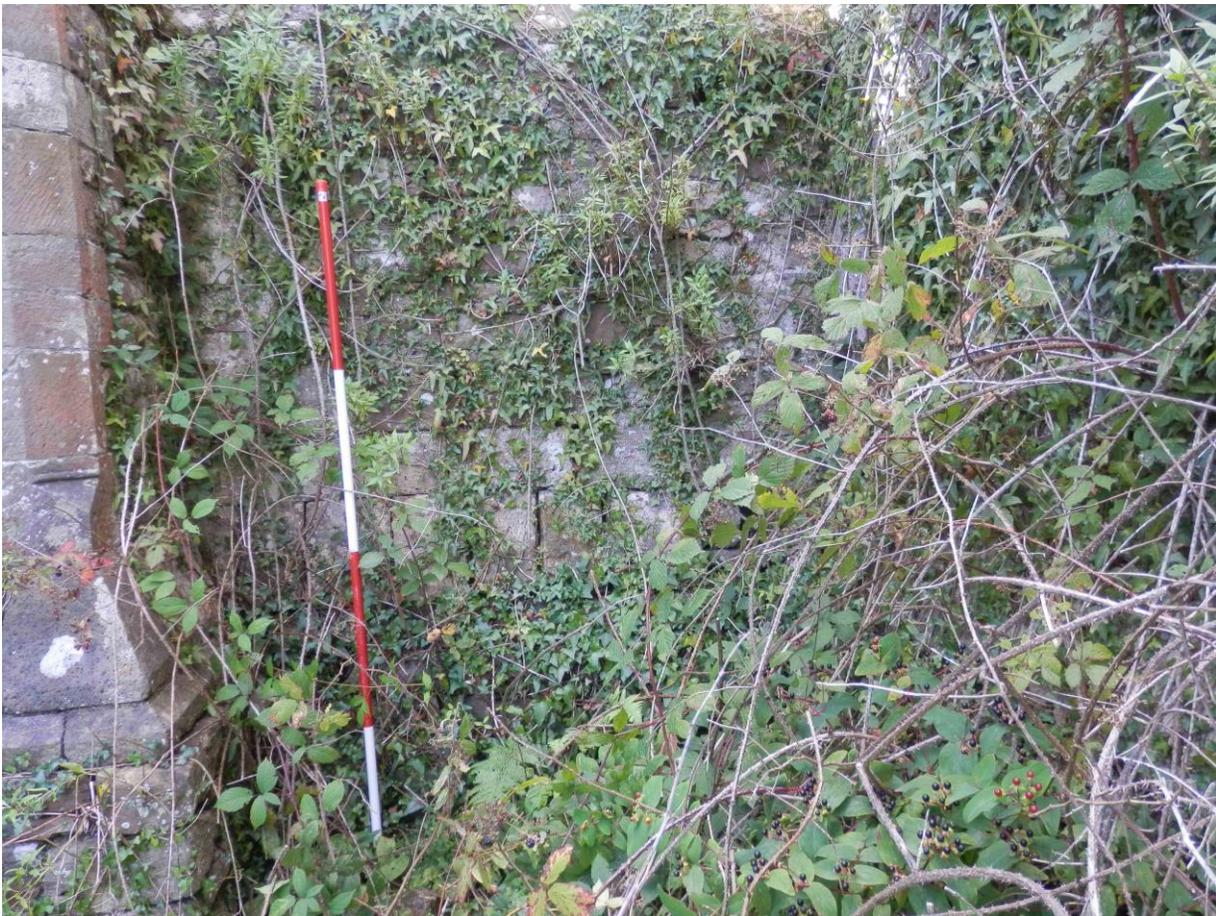
ID: 22 Site Number: 748 Site Name: Margam Monastic Ruins
Wall Number: 12 Photo Number: F1/35
Location: South Transept East Wall Ext.
Description: Lower half of wall (wall 12). Mainly local sandstone rubble; ashlar towards base mostly covered in ivy, bramble, vegetation. Mortar weathered out of most of stone work. Large hole, putlog hole. Plinth at base of wall has batter on top courses.
Condition summary: A) Vegetation, Ivy and bramble covers most of the wall difficult to spot damage. B) Mortar eroded and missing on the batter of the plinth. C) Weight of the wall keeping it together.
Threats: Vegetation, Weathering
Recorded by: Maggie Cornelius Date: 18/09/2012

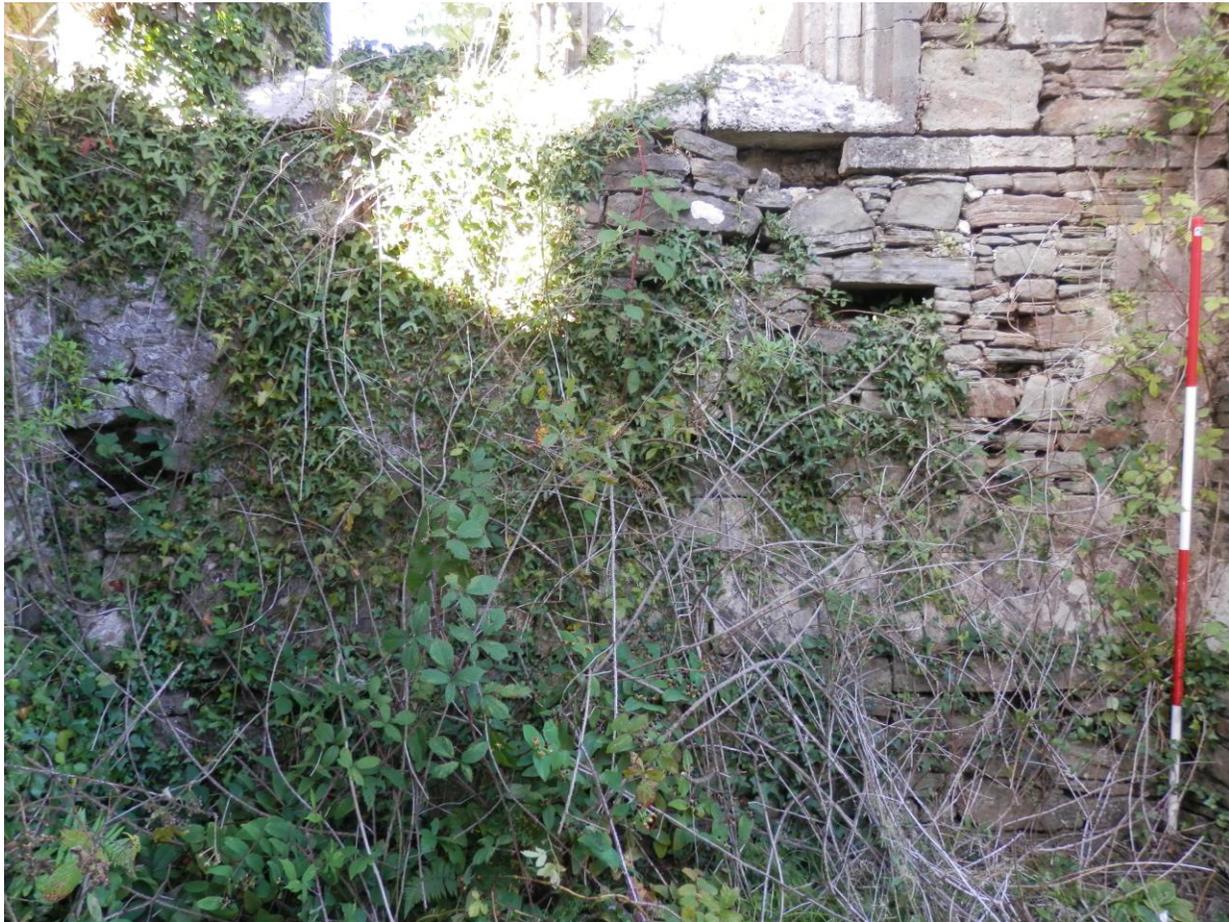
ID: 24 Site Number: 748 Site Name: Margam Monastic Ruins
Wall Number: 13 Photo Number: F1/36-37
Location: South Chancel Wall Ext.
Description: Lower wall is of local sandstone rubble with ashlar plinth (battered top)
Large amounts of vegetation - ivy and brambles
Condition summary: A) Large gaps where stone work has come away, mortar is eroding
out of the stone work weakening the structure. B) Ivy and brambles
are growing in between the gaps left by missing stones C) weathered
mortar
Threats: Vegetation! Weathering, Structural weakening
Recorded by: Maggie Cornelius Date: 19/09/2012

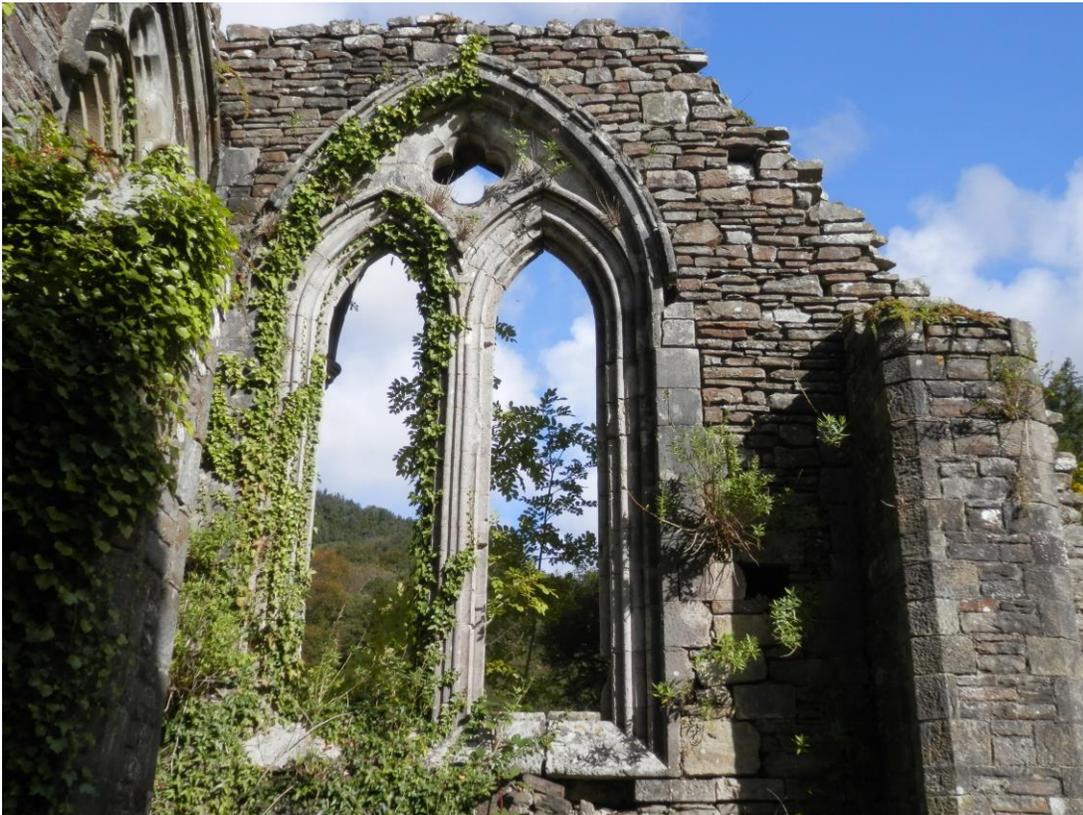
ID: 25 Site Number: 748 Site Name: Margam Monastic Ruins
Wall Number: 13 Photo Number: F1/36-37
Location: South Chancel Wall Ext.
Description: Some ashlar at base of window. Right side of window has a mixture of regular and irregular stones. Small stones fill gaps. Two putlog holes, one a 1/3 way up the window and second in line 1/2 way up arch. Window with two-centred head, two lights and quatrefoil above. Ashlar all carved and moulded. Hood mould to window arch. Extensively covered in ivy.
Condition summary: A) To right of window absence of mortar in ashlar and sandstone. B) In same area vegetation in lower half (bushy). C) No mortar in top of stonework. D) Vegetation growth on top. E) Dressed stone to left of window covered vegetation and ivy. F) Sill heavily covered in ivy and brambles. Missing mortar. G) Damage to internal moulding right of window, right hand edge. Evidence of missing moulding all away around window on both sides. H) Outer moulding of right hand arch missing above dressed stone plus damage to moulding generally. I) Left window heavily covered in ivy particularly at apex.

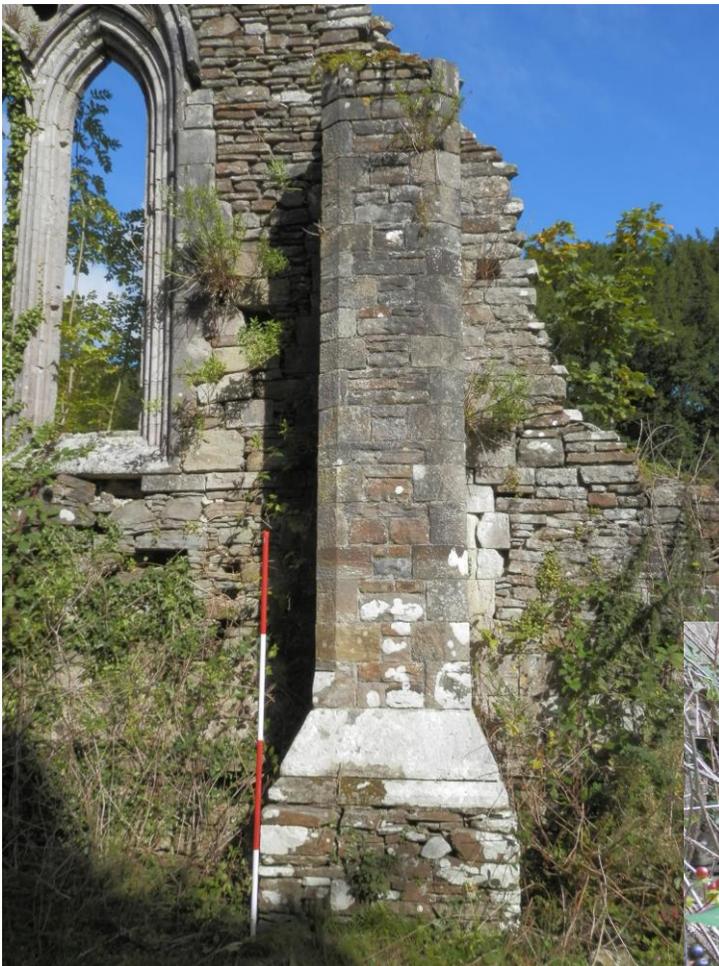
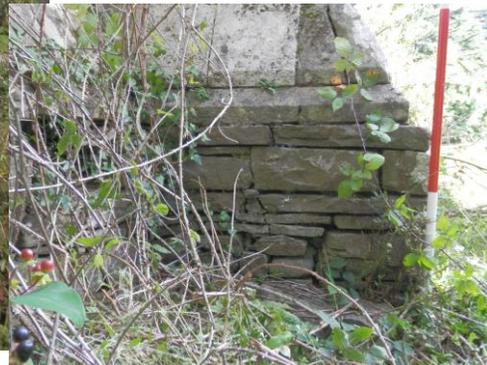
ID: 26 Site Number: 748 Site Name: Margam Monastic Ruins
Wall Number: 14 Photo Number: F1/43-48
Location: South Chancel Wall Ext. Buttress
Description: Buttress. Main body of buttress made of local sandstone rubble. Corners have chamfered quoins. Buttress widens at base with two battered courses of ashlar on top of rubble. Width at base 1.20m wide, height to batter 0.80m.
Condition summary: A) Base of buttress: mortar has weathered from between stones and on the south side some of the stones have collapsed. B) Vegetation growing in the gaps around the base. C) Stones on top of buttress look loose and mortar weathered. D) Vegetation growing around buttress.
Threats: Vegetation, Weathering
Recorded by: John Robertson Date: 19/09/2012

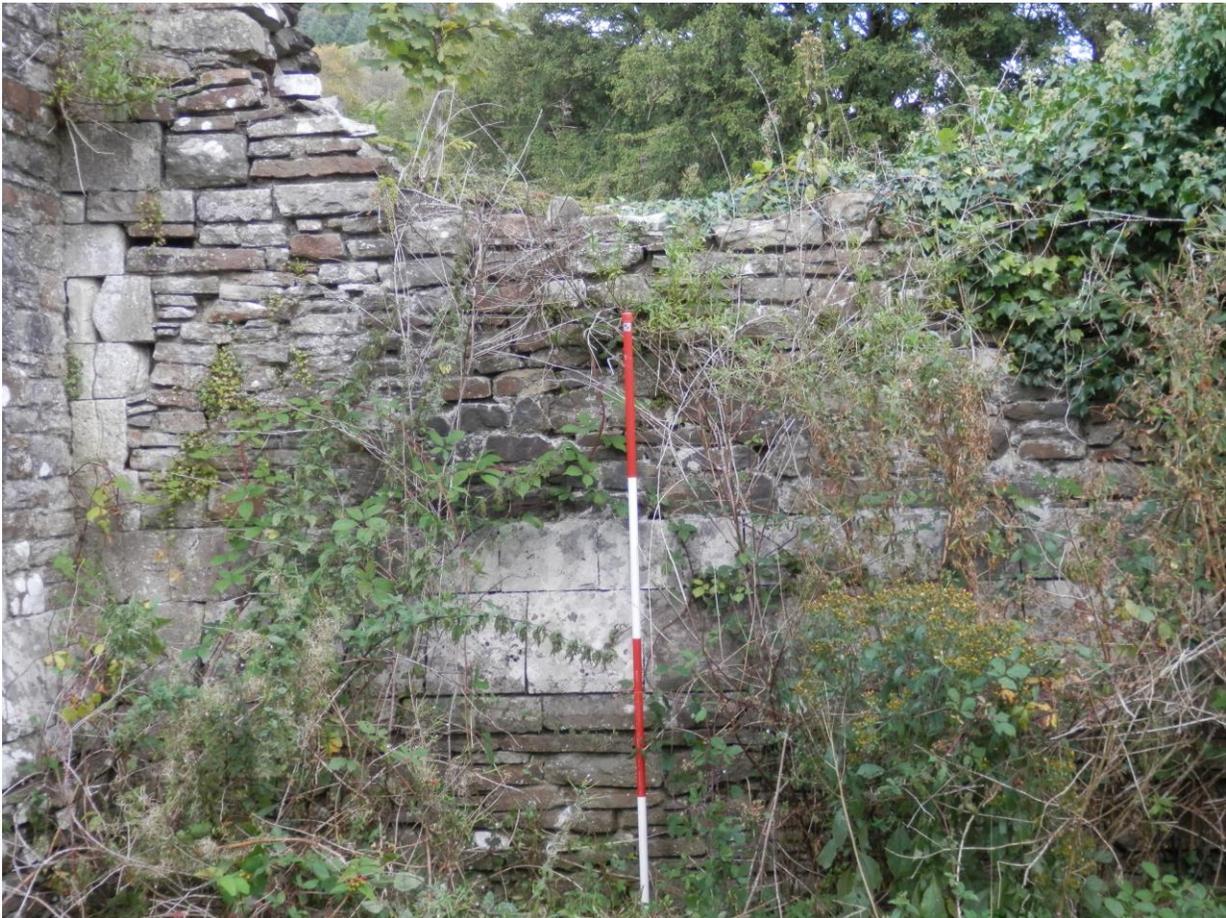
ID: 27 Site Number: 748 Site Name: Margam Monastic Ruins
Wall Number: 15 Photo Number: F1/49-53
Location: South Chancel Wall Ext.
Description: Remains of sandstone rubble wall, window section appears to have collapsed. Two courses of ashlar form batter on plinth, with rubble above and below. Ashlar blocks run up to sill height in corner next to buttress. One putlog hole with vegetation growing out of it.
Condition summary: A) Crack in ashlar and mortar. B) Missing stone in left-hand corner next to dressings at sill level. C) Mortar erosion in wall. D) Vegetation growing out of stonework where it abuts buttress. E) Brambles at base of wall. F) Ivy spreading from abbots door (wall 16)
Threats: Vegetation, weathering, mortar erosion
Recorded by: Fiona Richards Date: 19/09/2012

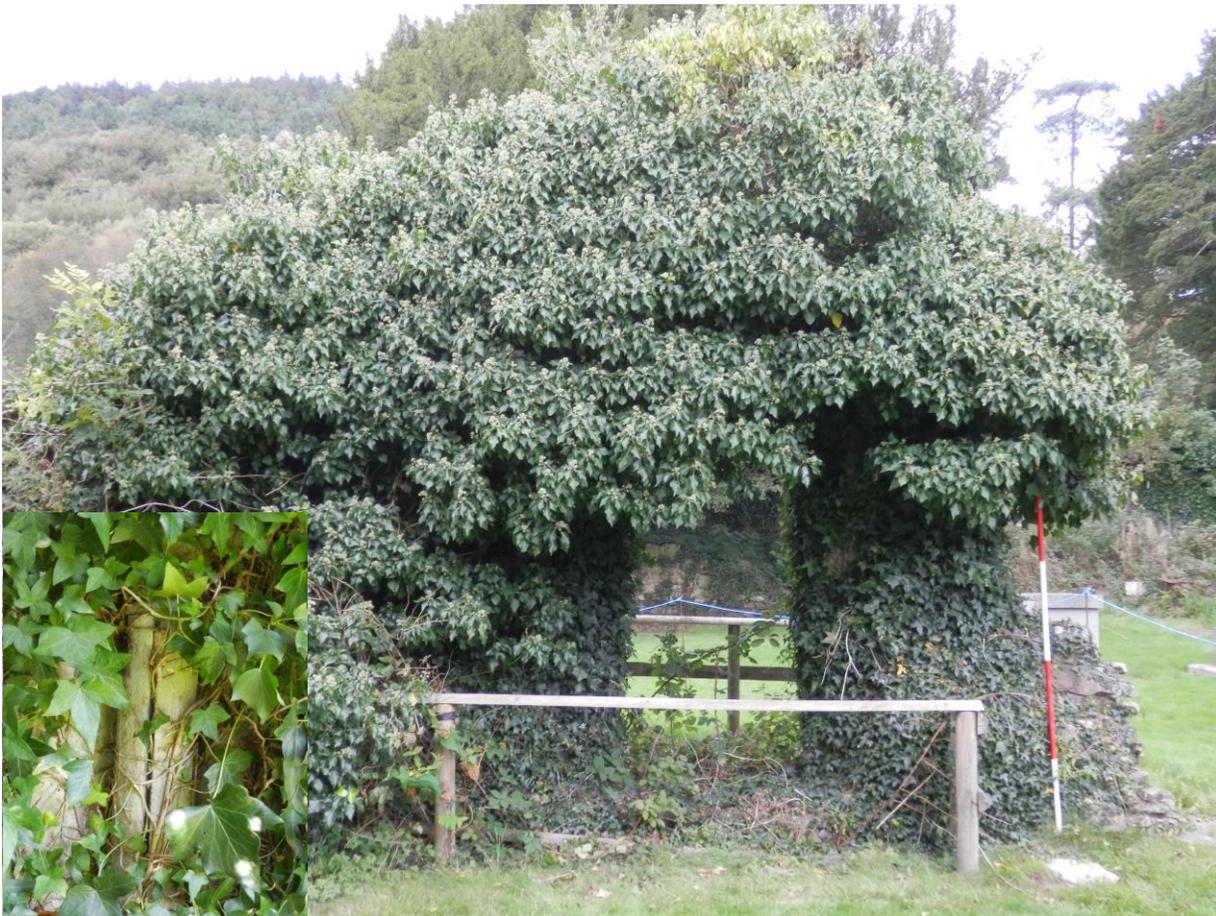
ID: 28 Site Number: 748 Site Name: Margam Monastic Ruins
Wall Number: 16 Photo Number: F1/54-56
Location: South Chancel Wall Ext. (Abbot's Door)
Description: Abbots door covered in Ivy very little of door visible, although one of shaft flanking door partly visible .There appears to be no stonework above the arch of the door. Fence surrounding the door for safety reasons.
Condition summary: A) Outer column l. side of door split by ivy. B) Whole door is in risk of collapse due to ivy.
Threats: Vegetation
Recorded by: John Robertson Date: 19/09/2012
