Monastic Margam Community Survey Project

Report for Cadw
by Sam Pamment BA

GGAT report no. 2013/020
NGR: SS 8018 8626
Project no. GGAT 123

Summary

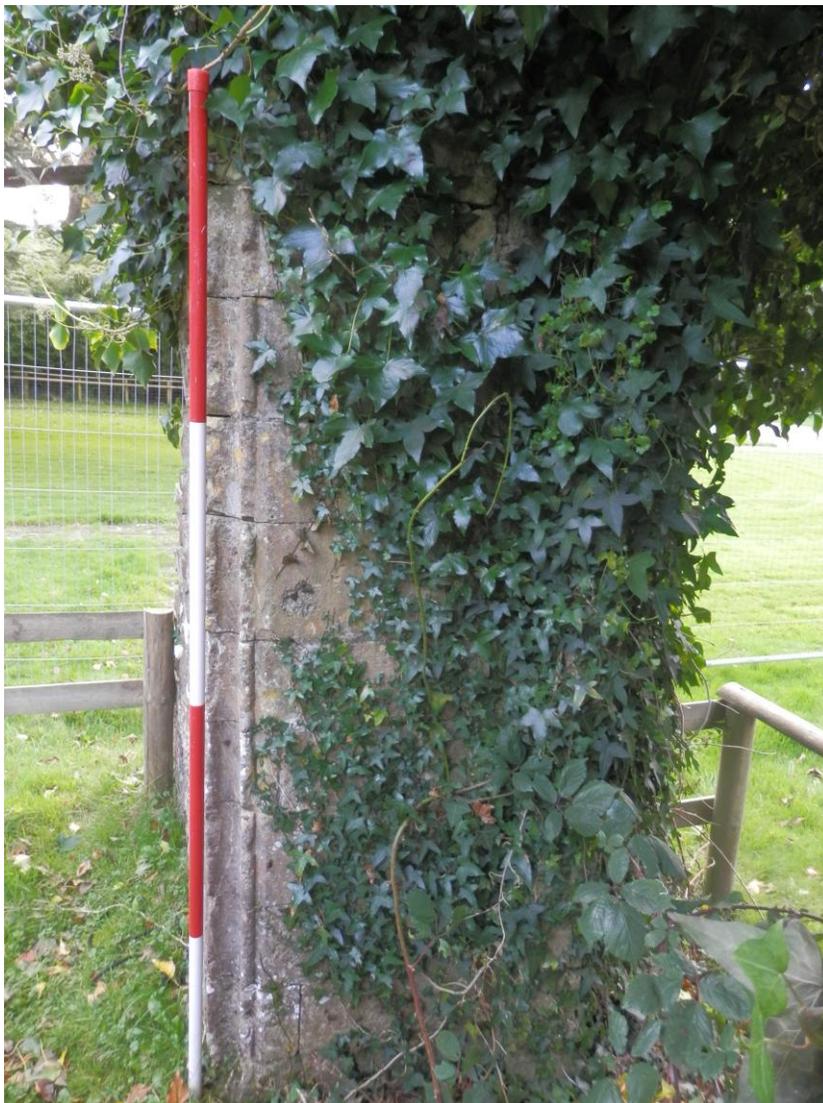
ID: 30 Site Number: 748 Site Name: Margam Monastic Ruins
Wall Number: 17.1 Photo Number: F3/1
Location: South Chancel Wall Int. (Abbot's Door)
Description: East inside face of abbot's door. Constructed of Sutton stone ashlar with moulded decoration on right side that forms door frame. The moulding rises to arch. Completely covered in ivy obscuring features and any damage.
Condition summary: A) Extensive ivy growth between stonework all the way down wall face. B) Gaps in stone work due to weathering of mortar.
Threats: Vegetation, Weathering
Recorded by: Sam Pamment Date: 28/09/2012

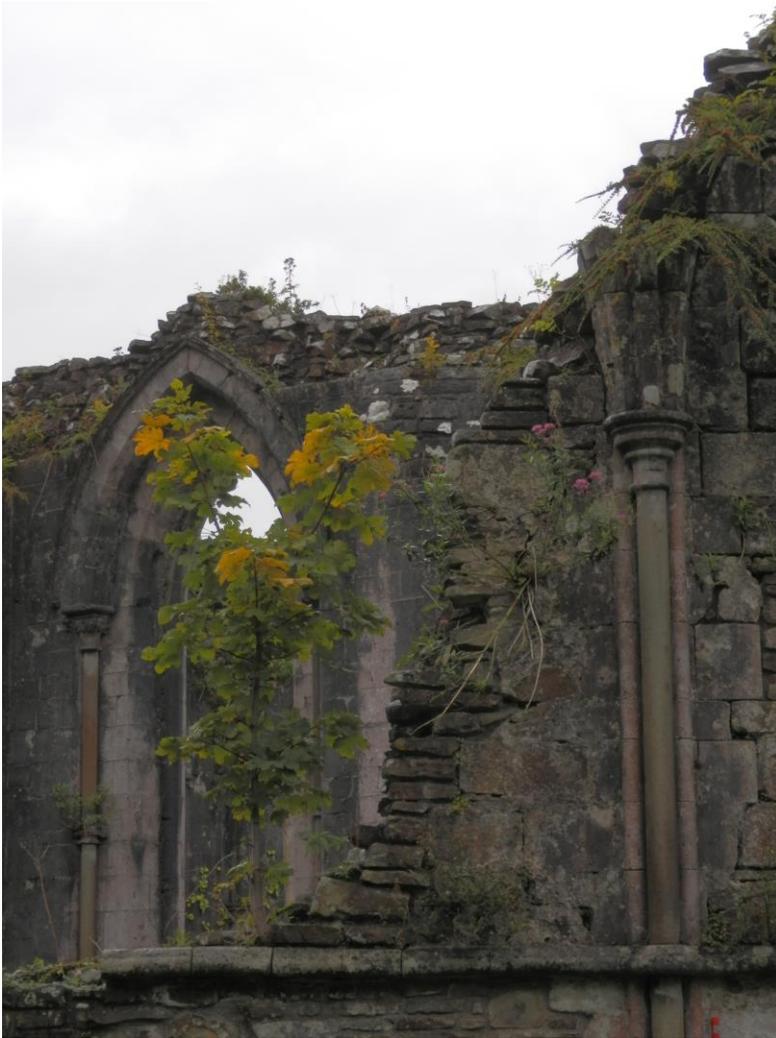
ID: 34 Site Number: 748 Site Name: Margam Monastic Ruins
Wall Number: 18 Photo Number: F1/60
Location: South Chancel Wall Int.
Description: Remains of surround of window of wall 18. Dressed Sutton stone for shaft and moulding. Moulding and shaft intact. Springing of vault at top of shaft, otherwise rubble at this height. Some plaster/lime rendering still remains
Condition summary: A) Vegetation at base of section and cracking in ashlarwork.
B) Vegetation growing in upper section of wall and cracks in stone work.
C) Mortar weathered at edge of rubble. D) Tree growing out of top of wall
E) Vegetation growing out of top of shaft.
Threats: Vegetation and Weathering.
Recorded by: Julian James Date: 20/09/2012

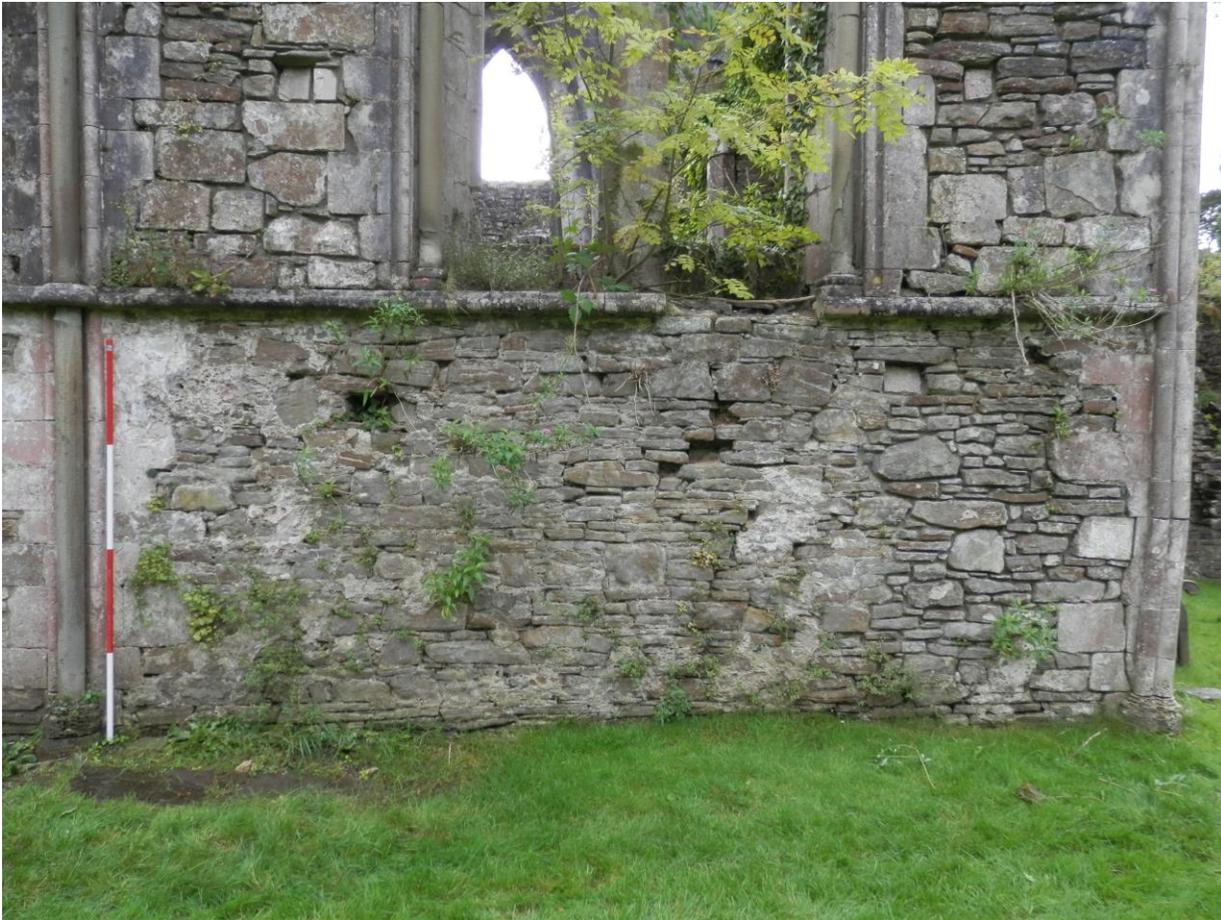
ID: 35 Site Number: 748 Site Name: Margam Monastic Ruins
Wall Number: 19 Photo Number: F1/61-63
Location: South Chancel Wall Int.
Description: Lower section. Quoins in Sutton stone, otherwise local sandstone rubble
Sutton stone molded shaft to west corner. Moulded sill: 2 sections in
centre missing. Some rendering on wall.
Condition summary: A) Damage to wall missing stones. B) Vegetation growing along base
and on left side. C) West shaft above 5th course broken bowing out.
D) Shaft base weather damaged. E) Sill missing 2/3 blocks. F) Crack
from ground up ashlar by right shaft. G) Vegetation growing
through mortar.
Threats: Vegetation, weathering.
Recorded by: Maggie Cornelius Date: 20/09/2012

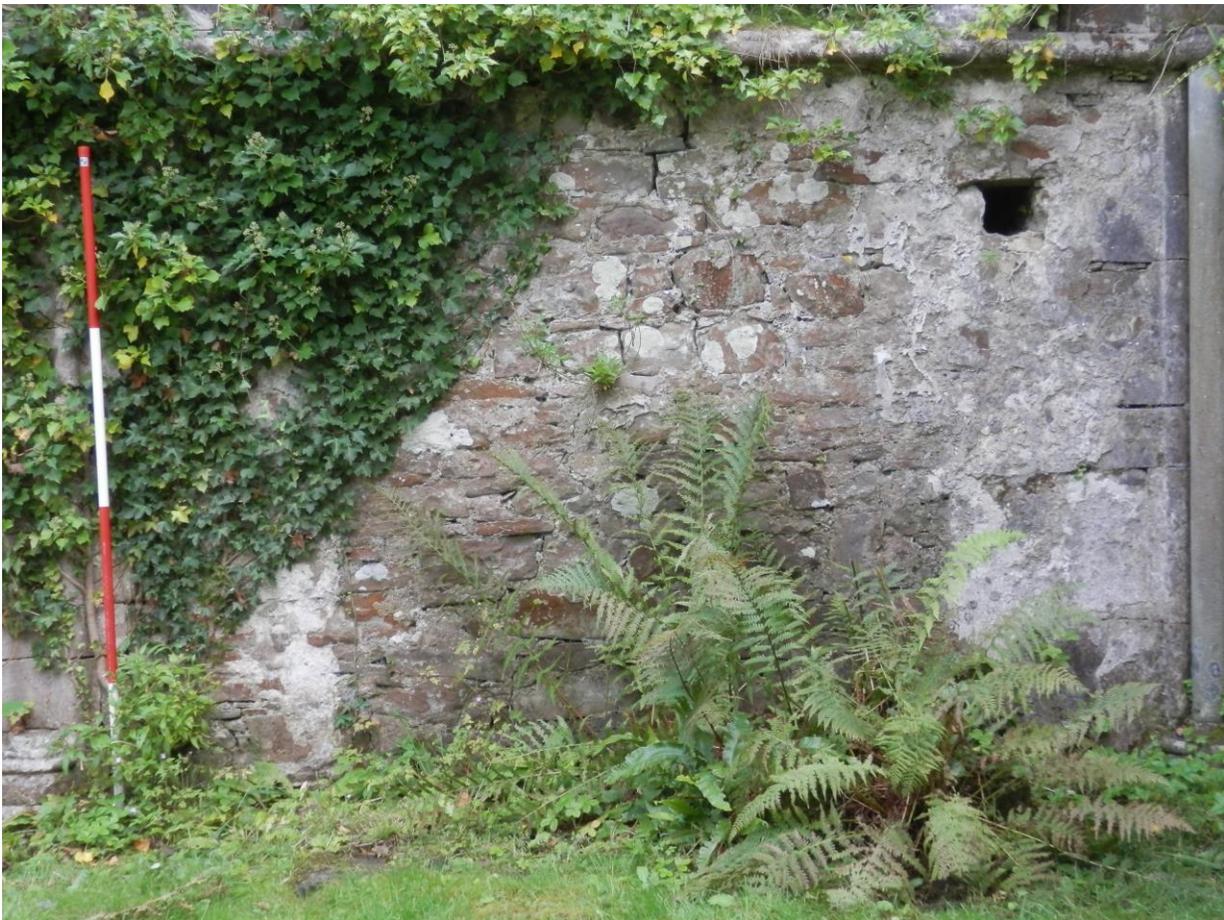
ID: 39 Site Number: 748 Site Name: Margam Monastic Ruins
Wall Number: 21 Photo Number: F1/77-79
Location: South Transept East Wall Int.
Description: Lower Wall. Ashlar on left and right. Shaft in right corner next to south wall of transept. Moulded sill running along the top. Mason mark on 5th stone up from bottom on right side. Wall in good condition, centre of wall sandstone rubble. Ivy growth.
Condition summary: A) Crack running down wall from sill half way down wall. B) Crack in moulded shaft. C) Some weathering to wall but in fairly good condition. D) Ivy and vegetation growth on wall.
Threats: Vegetation, Weathering
Recorded by: John Robertson Date: 21/09/2012

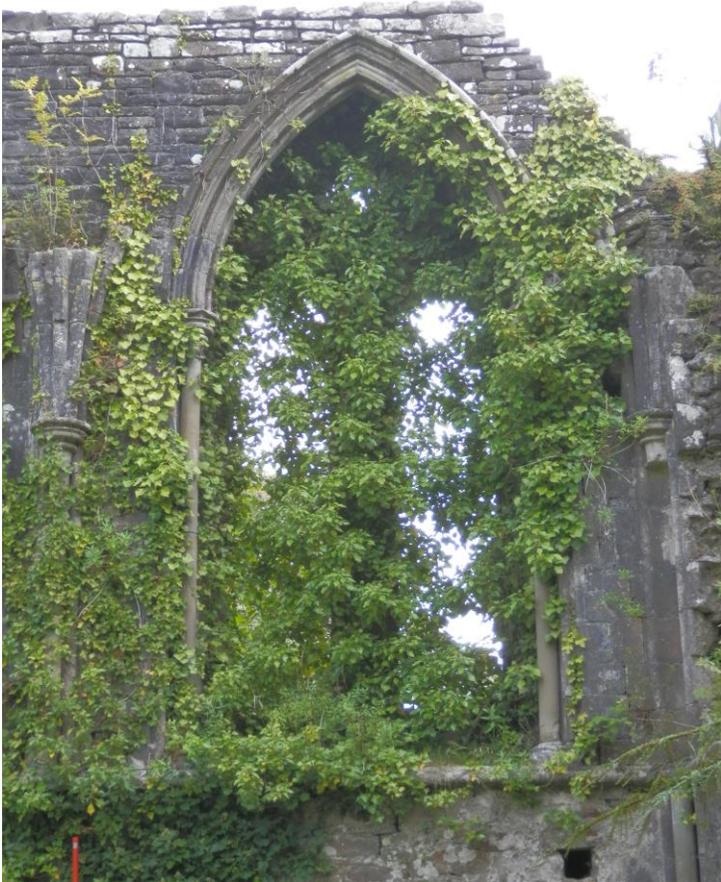
ID: 40 Site Number: 748 Site Name: Margam Monastic Ruins
Wall Number: 21 Photo Number: F1/78-79
Location: South Transept East Wall Int.
Description: Upper Wall right hand side. Majority covered in ivy. Wall double light window set within a single arch with quatrefoil above. Hoodmould. Window constructed out of ashlar. Shaft for vault support at right hand side of bay is missing, but springing of vault survives at both sides. Upper third of wall is of local sandstone rubble.
Condition summary: A) Ashlar shaft missing corner of wall 21&22. B) Cracking in ashlar up to shaft cap between left hand side window. C) Local sandstone loose above window hood moulding. D) Hood moulding damage-cracks & small pieces missing on left hand side. E) Arch moulding missing bottom right of window.
Threats: Vegetation, Weathering
Recorded by: Paul Minton Date: 21/09/2012

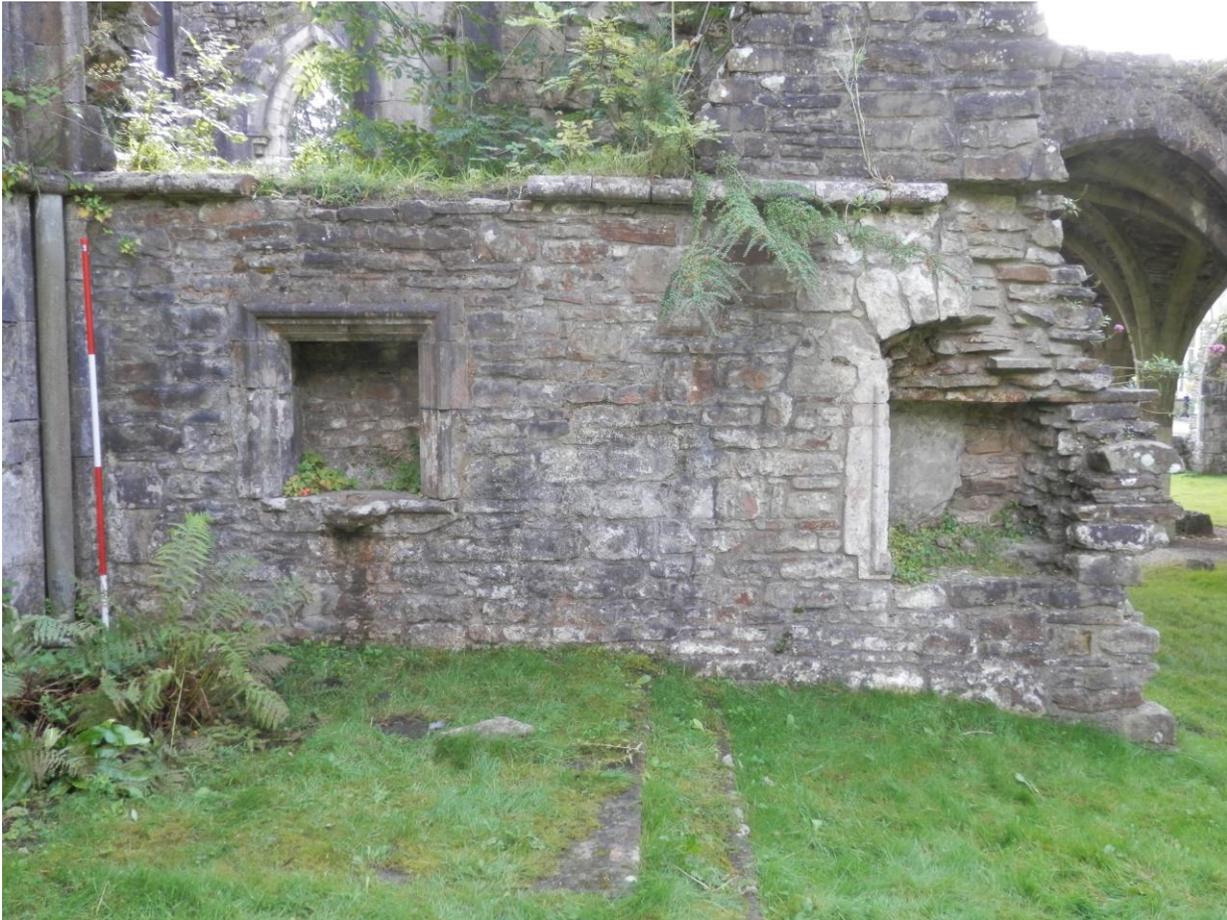
(See figure 2, figure 7 elevation 22)

ID: 41 Site Number: 748 Site Name: Margam Monastic Ruins
Wall Number: 22 Photo Number: F1/80-83
Location: South Transept South Wall Int.
Description: Lower Wall. Dressed stone components of the wall consist of a shaft in the left corner, moulded sill. On the left a piscina made of Sutton stone, nearly complete some damage. On the right the remains of a sedilia or aumbrey constructed out of Sutton stone and sandstone; although badly damaged the shape is still there. Rest of wall consists of sandstone rubble.
Condition summary: A) Middle section of dressed sill stone missing. B) Piscina has vegetation damage to ashlar and basin has been broken with 1/4 on floor exposing metal work (?former repair). C) Sedilia or aumbrey - most of dressings missing, shape apparent, vegetation and weather damage present.
Threats: Vegetation, Weathering
Recorded by: John Robertson Date: 21/09/2012

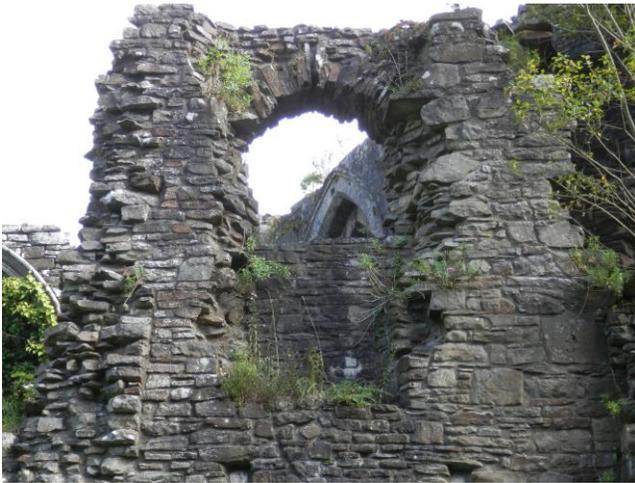
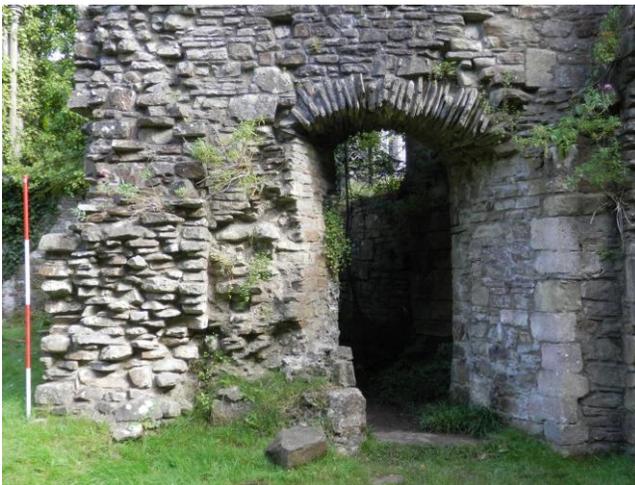
(See figure 2, figure 7 elevation 23)

ID: 43 Site Number: 748 Site Name: Margam Monastic Ruins
Wall Number: 23 Photo Number: F1/85
Location: East Cloister Wall East Wall Int.
Description: Part of sacristy. Constructed from local sandstone rubble.
Upper floor has doorway, arched head constructed from local sandstone;
lower half opening blocked up. Ground floor doorway, ashlar dressing on
corner of door, both sides. Reused grave slab as threshold.
Condition summary: A) Left hand side ground door some of dressings missing; modern mortar
used in places. B) Right hand side ground door arch stones potential to
come loose. C) Top floor arch, stone work loose fallen away from
walls, vegetation damage. D) Right hand side of ground door cracking
and loose mortar in dressed blocks.
Threats: Vegetation, Weathering
Recorded by: Paul Minton Date: 21/09/2012

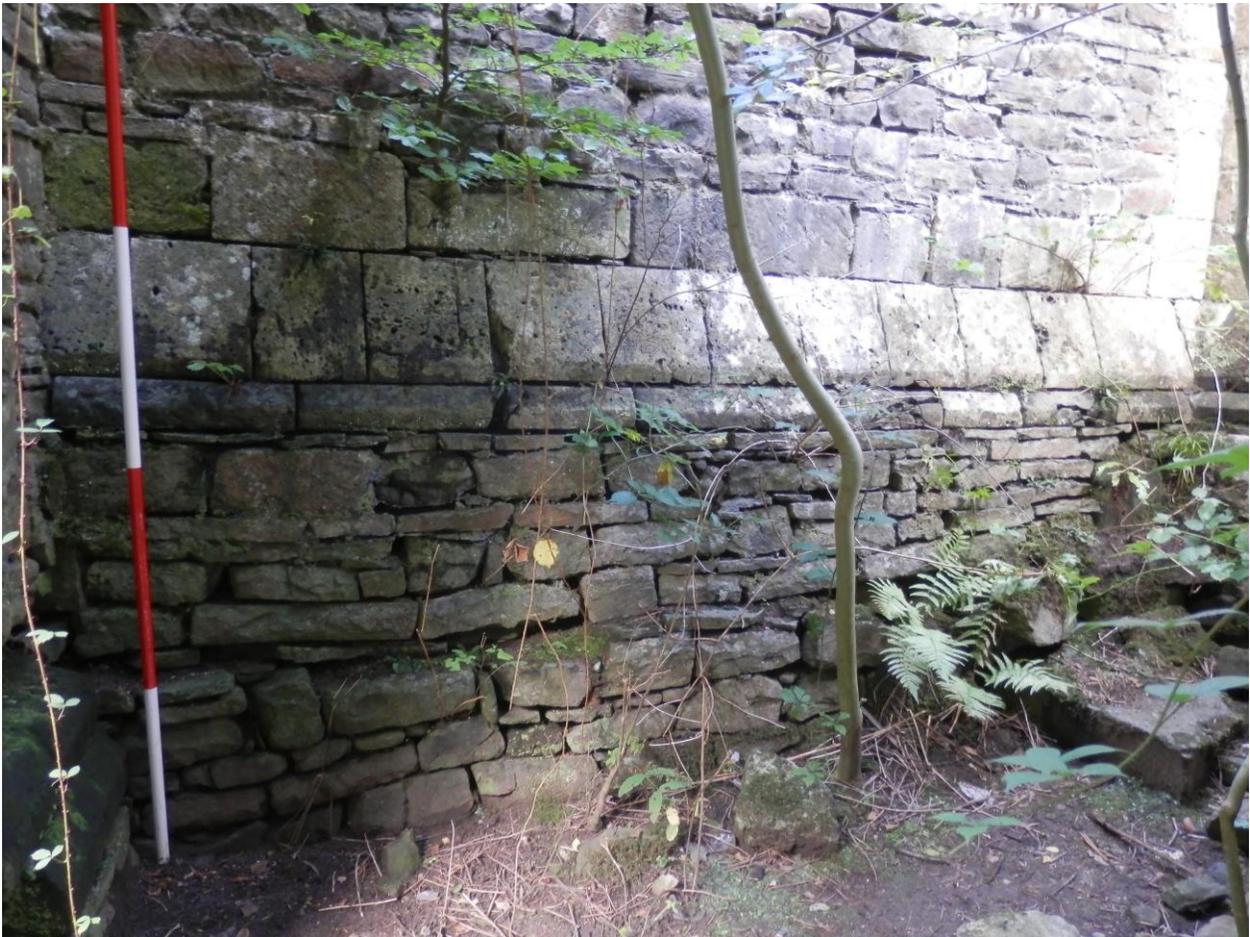
(See figure 2)

Condition summary: A) Vegetation in general and along the top of standing remains of wall. B) Trees growing out from wall. C) Three saplings on top of the wall with other vegetation. D) Sapling growing on floor and will possible undermine wall in future.

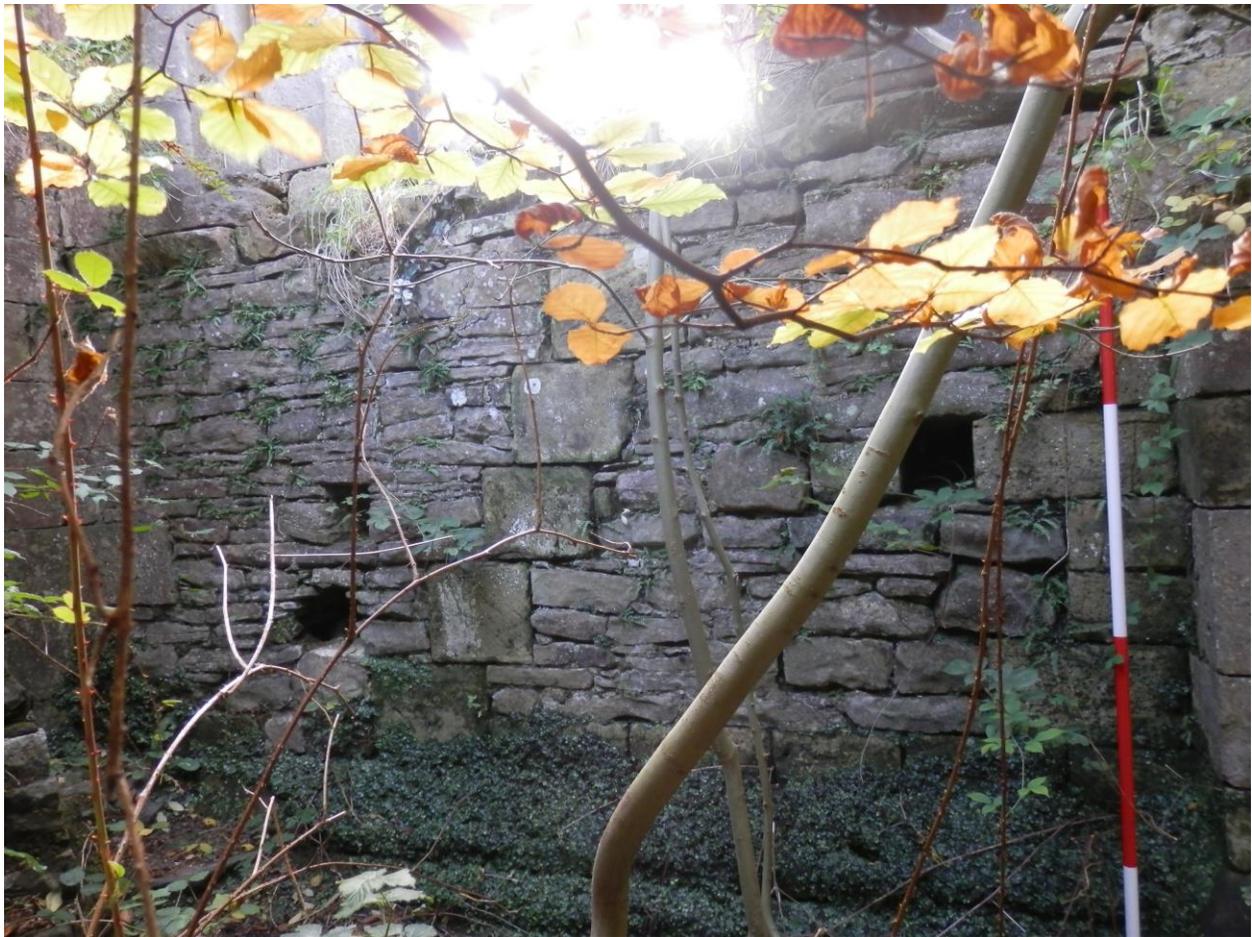
(See figure 2)

Condition summary: A) Hole below putlog on left hand side . B) Fractured blocks on window sill. C) Loose missing mortar & vegetation growing from it including right-hand-side putlog. D) Sapling at base of wall.

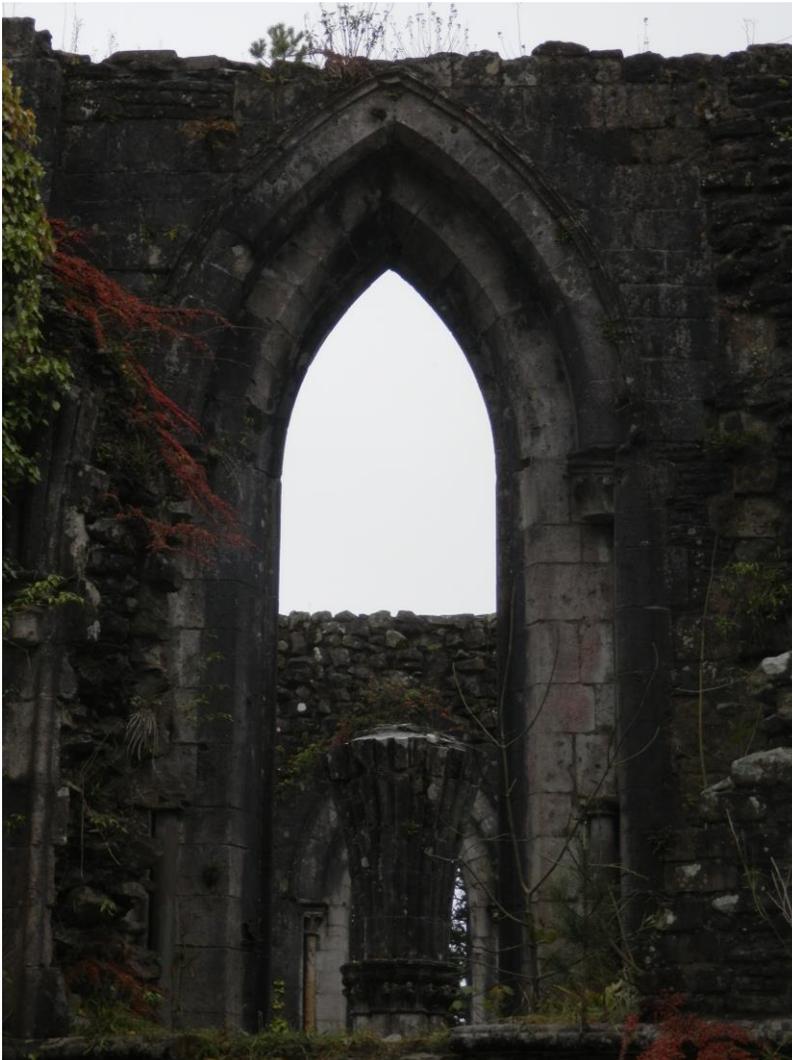
(See figure 2, figure 7 elevation 20)

ID: 46 Site Number: 748 Site Name: Margam Monastic Ruins
Wall Number: 25 Photo Number: F3/32
Location: Chapter House Wall Ext.
Description: Upper Wall. Ashlar wall with lancet with hood and decorative moulding.
Condition summary: A) Dressed blocks missing in left buttress. B) Top of shaft, left hand side & right hand side missing. C) blocks missing between left hand side buttress and window. D) Base of left shaft weathered. E) Window arch chip in blocks F) Ashlar right hand side window missing mortar. G) Vegetation right side of window crack.
Threats: Vegetation, Weathering
Recorded by: Paul Minton Date: 21/09/2012

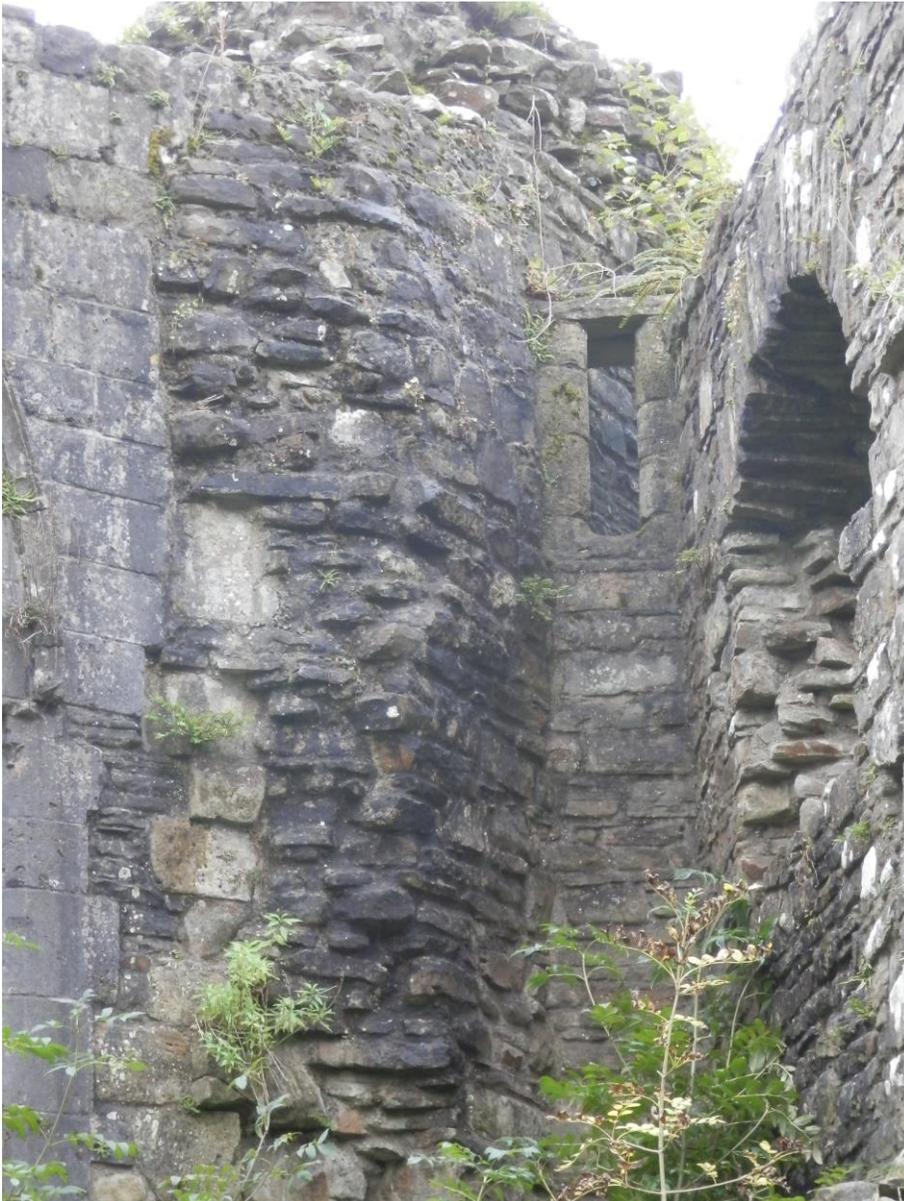
(See figure 2)

ID: 48 Site Number: 748 Site Name: Margam Monastic Ruins
Wall Number: 26 Photo Number: F2/284
Location: Chapter House Ext.
Description: Upper Wall. Dressed stone on bottom left hand side wall and to right of Arch, 2 blocks wide. All other is rough sandstone rubble. Top of middle section is possible window opening. Earlier chapter house/later chapter house wall joining up.
Condition summary: A) Weathering. B) Some vegetation lower section mainly.
Threats: Vegetation, Weathering
Recorded by: Bob Hardwick Date: 05/10/2012

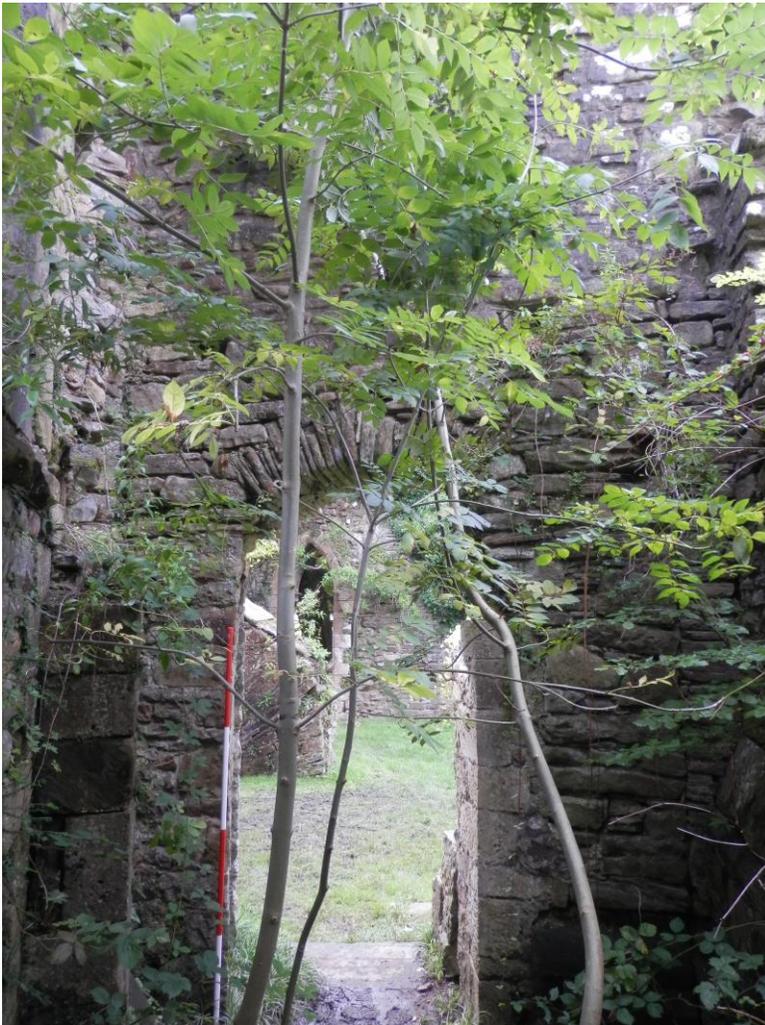
(See figure 2)

Description: Wall constructed of sandstone rubble; left corner has 4 blocks of dressed stone. Right corner has 3 blocks of dressed stone. Putlogs above left hand arch of door. Window at the top of wall. Stones missing in window. Putlog left hand side center of window.

Condition summary: A) Missing large amount of mortar all over wall. B) Vegetation growing on main wall. C) Vegetation growing on top of wall. D) Number of stones in main wall missing. E) Arch door missing mortar. F) Arch of window missing mortar. G) Stones missing above right hand door support.

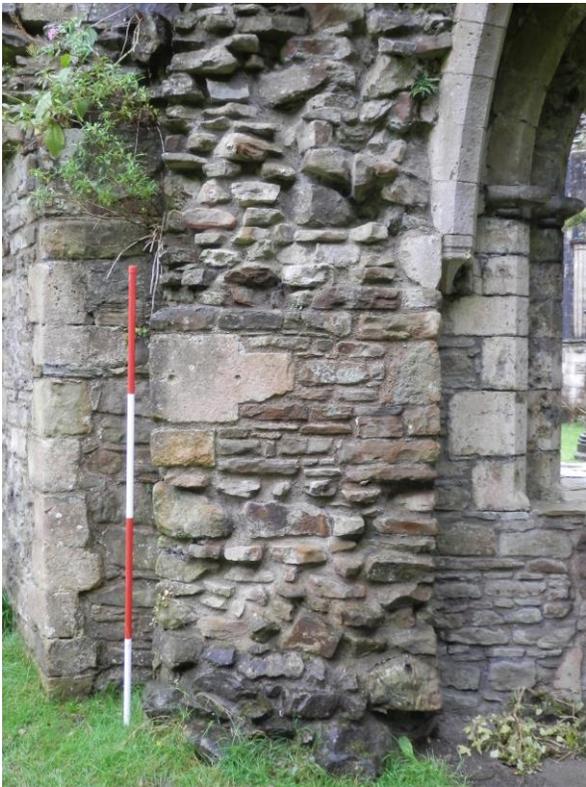
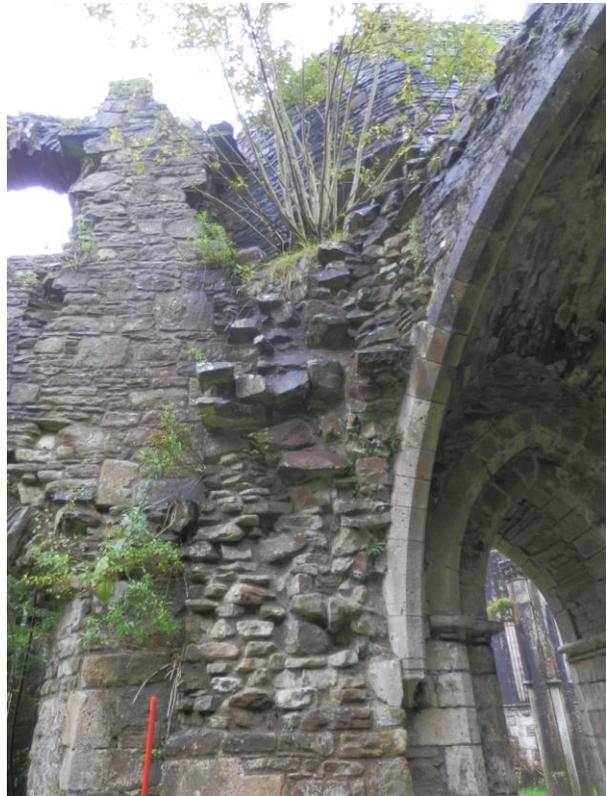
(See figure 2, figure 7 elevation 28)

ID: 50 Site Number: 748 Site Name: Margam Monastic Ruins
Wall Number: 28 Photo Number: F2/1-2
Location: East Cloister East Wall Int. Sacristy (remains of) Wall
Description: Remains of south wall of sacristy. Wall in section showing rubble.
Approximately 1m from base wall appears to have been reconsolidated
and tidied up. At 4m up wall, large stones overhanging, possible danger of
falling. Large tree/bush on top of wall.
Condition summary: A) Large sapling at top of wall. B) Large branches. C) Many overhanging
stones, with potential to fall. D) Vegetation growing on wall in corner
between wall 29 and 23
Threats: Vegetation, Weathering
Recorded by: Sally Jones & Marie Evans Date: 24/09/2012

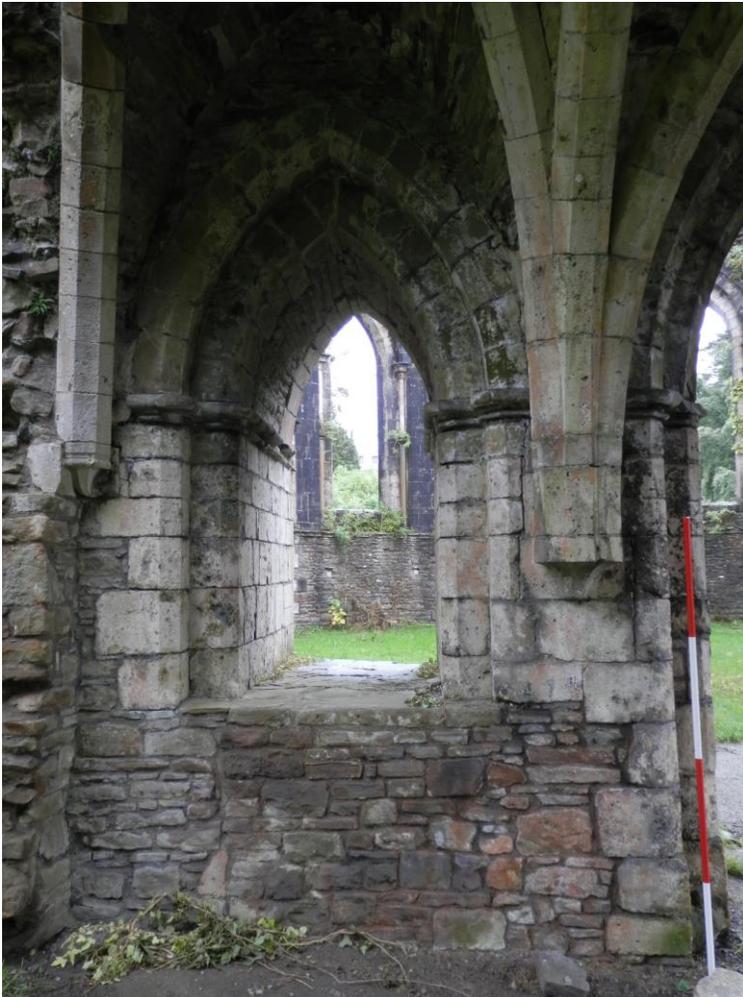
(See figure 2, figure 7 elevation 29)

ID: 51 Site Number:748Site
Name: Margam Monastic Ruins
Wall Number: 29 Photo Number: F2/3
Location: East Cloister Int./Chapter House Wall Ext.
Description: External wall of Chapter House, with a pointed window in centre. Ribs of vault to the left and right of window. Base of wall in good condition, with ashlar on the right hand side extending to whole window arch. Deep breadth at base of window, 1m long.
Condition summary: A) Weathering on ashlar throughout. B) Loss of mortar around vault and window. C) Dressed stone moulding on left hand side of window recess eroding away. D) Damage to ribs on left hand side.
Threats: Vegetation, Weathering
Recorded by: Sally Jones & Marie Evans Date: 24/09/2012

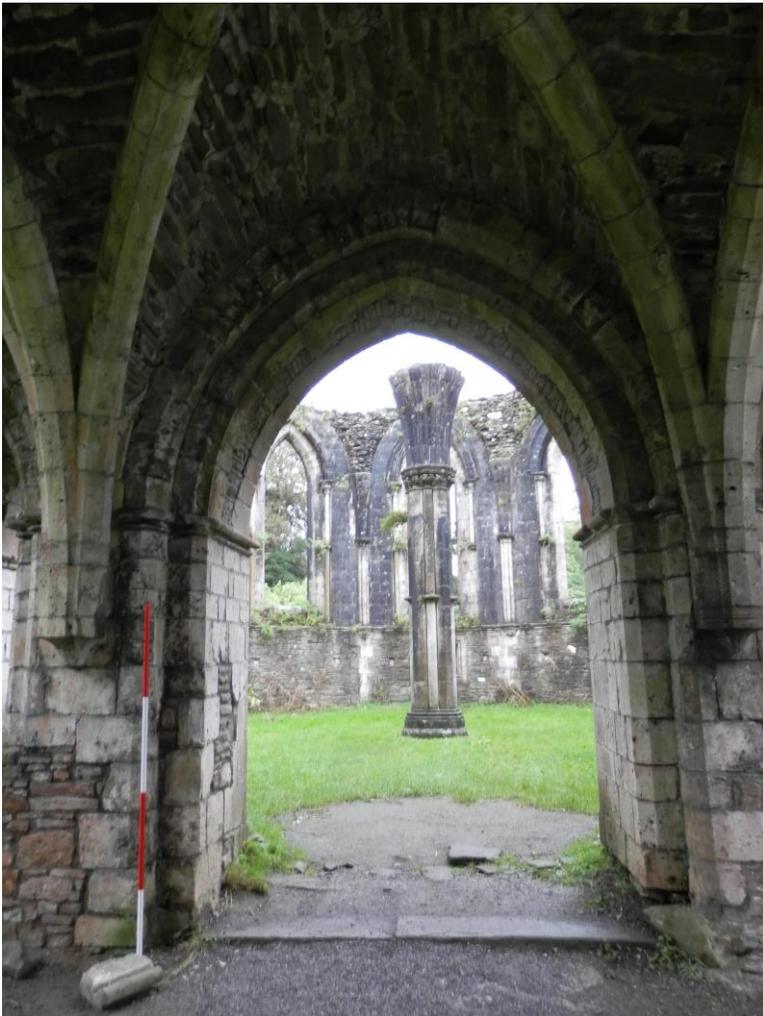
(See figure 2, figure 7 elevation 30)

ID: 52 Site Number: 748 Site Name: Margam Monastic Ruins
Wall Number: 30 Photo Number: F2/7
Location: East Cloister East Wall Int./Chapter House Wall Ext. Doorway.
Description: Large Arched doorway reaching an apex. Ashlar discolored black, Missing mortar replaced with cement like as part of a restoration. Attached wall columns on either side of door in fairly good condition.
Condition summary: A) Base stones of right side of doorway missing, stones overhanging. B) Broken base stone on left of doorway. C) Some mortar missing especially to left of doorway. D) Moulding broken in places around middle of doorway. E) Weathering to 1st, 2nd and 5th corner stones at doorway base.
Threats: Weathering
Recorded by: Sarah Baker Date: 24/09/2012

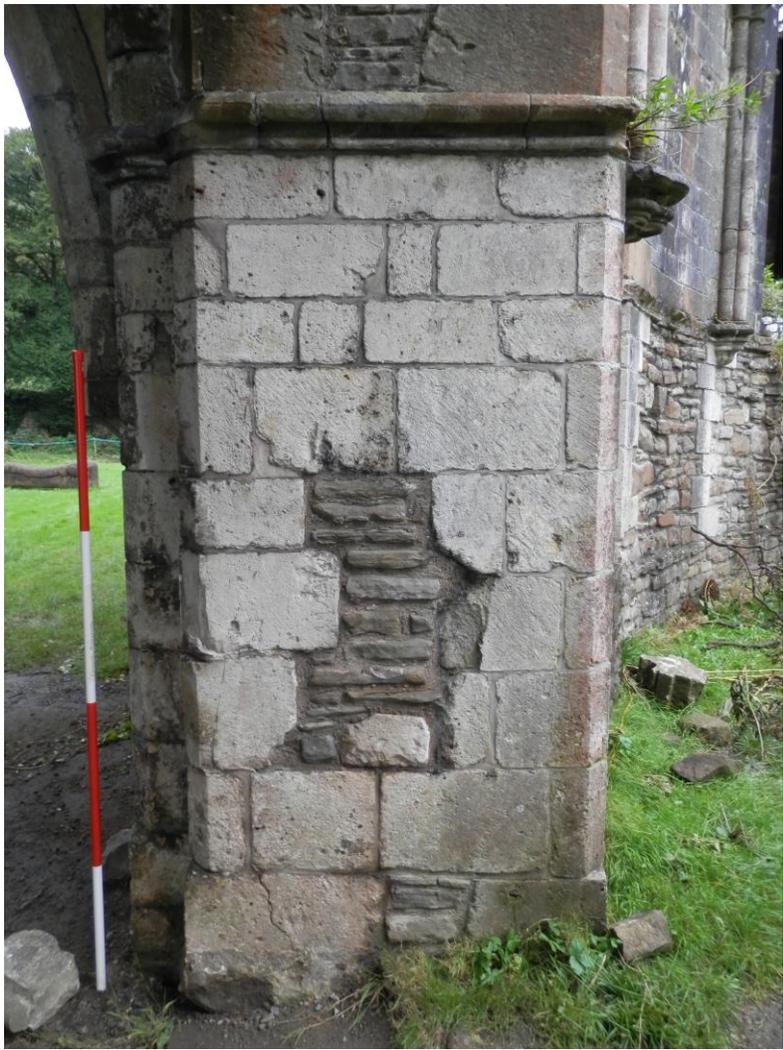
(See figure 2)

ID: 53 Site Number: 748 Site Name: Margam Monastic Ruins
Wall Number: 31.1 Photo Number: F2/9
Location: Chapter House Wall arch doorway (wall 30) north face.
Description: Mostly Ashlar, small central core of rough sandstone rubble, probably repair work. Mortar has been repaired with concrete! Arch dressings in ashlar blocks, with sandstone rubble between.

Condition summary: A) 3rd dressed stone on left hand side, crack. B) 4th dressed stone weather damage (Left side). C) 1st dressed stone large crack (Left side).
D) Damage to moulding on left side. E) 4th dressed stone up crack in left side.

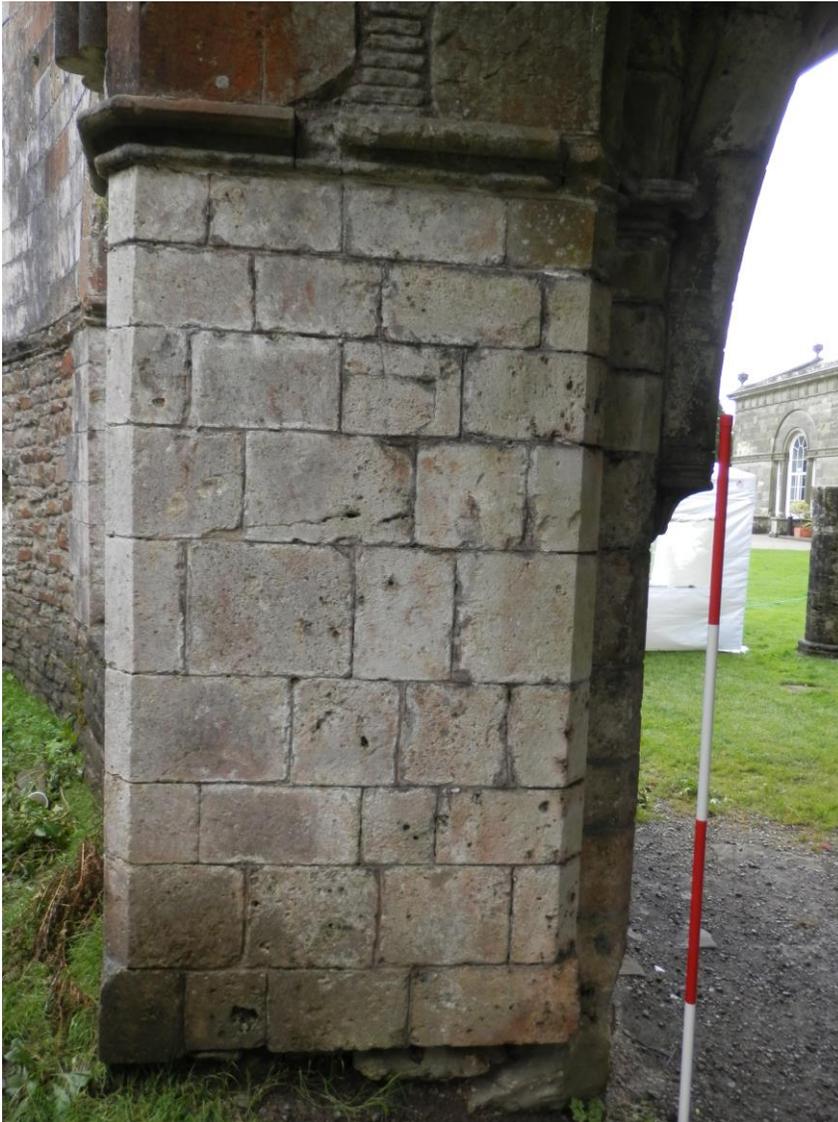
(See figure 2)

Condition summary: A) Bottom Row of dressed stone missing. B) Row above overhanging!
C) Crack on 6th dressed stone (central), weathering. D) Crack on 7th dressed stone (central). E) Part of moulding missing/weathering.

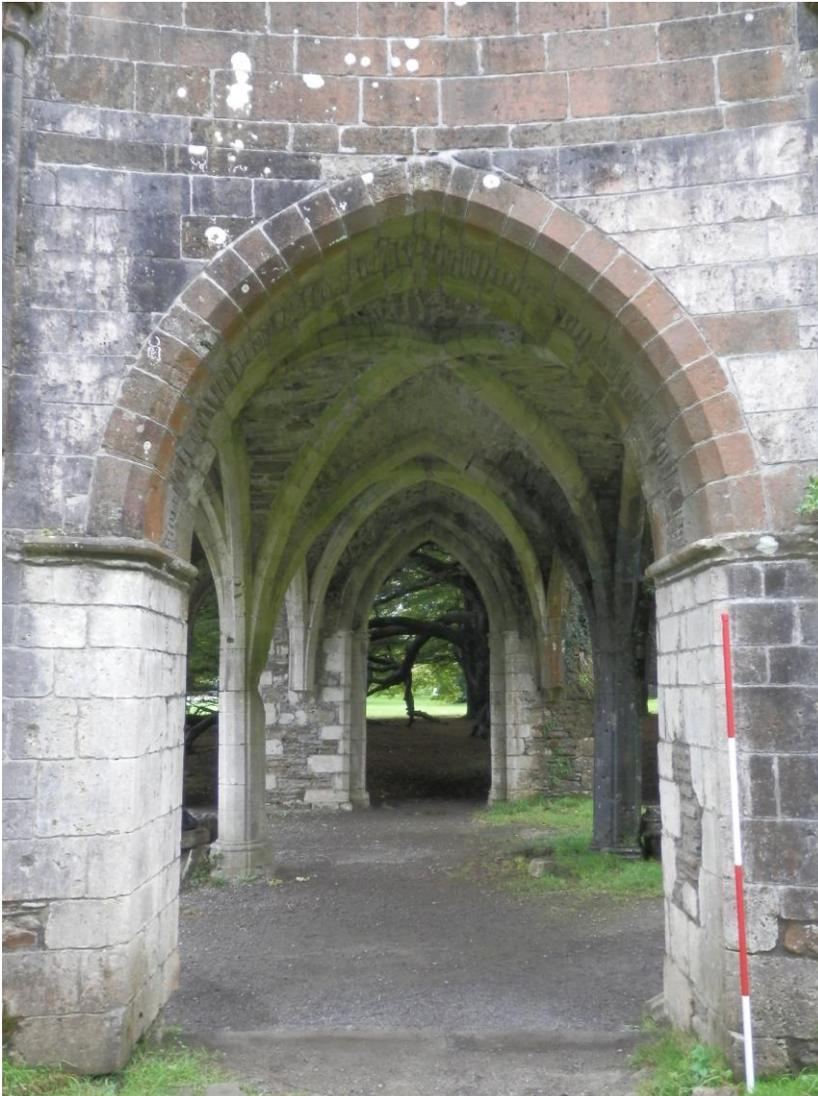
(See figure 2, figure 8 elevation 32)

ID: 55 Site Number: 748 Site Name: Margam Monastic Ruins
Wall Number: 32 Photo Number: F2/11-12
Location: Chapter House Wall Int.
Description: Internal wall of chapter house doorway, lower section. Lichen on apex of arch. Ashlar. Group of three shafts either side, starting c.2m up. Moulded column base on left missing some rougher sandstone rubble to left and right of base.
Condition summary: A) Vegetation at base of right and left column. B) Moulding weathered. C) Cement on lower left-hand side of right side of door. D) Crack 5 courses up (from moulding) on left side of door. E) Moulding weathered. F) Weathering on 5th dressed stone on left of arch.
Threats: Weathering
Recorded by: (not filled in) Date: 24/09/2012

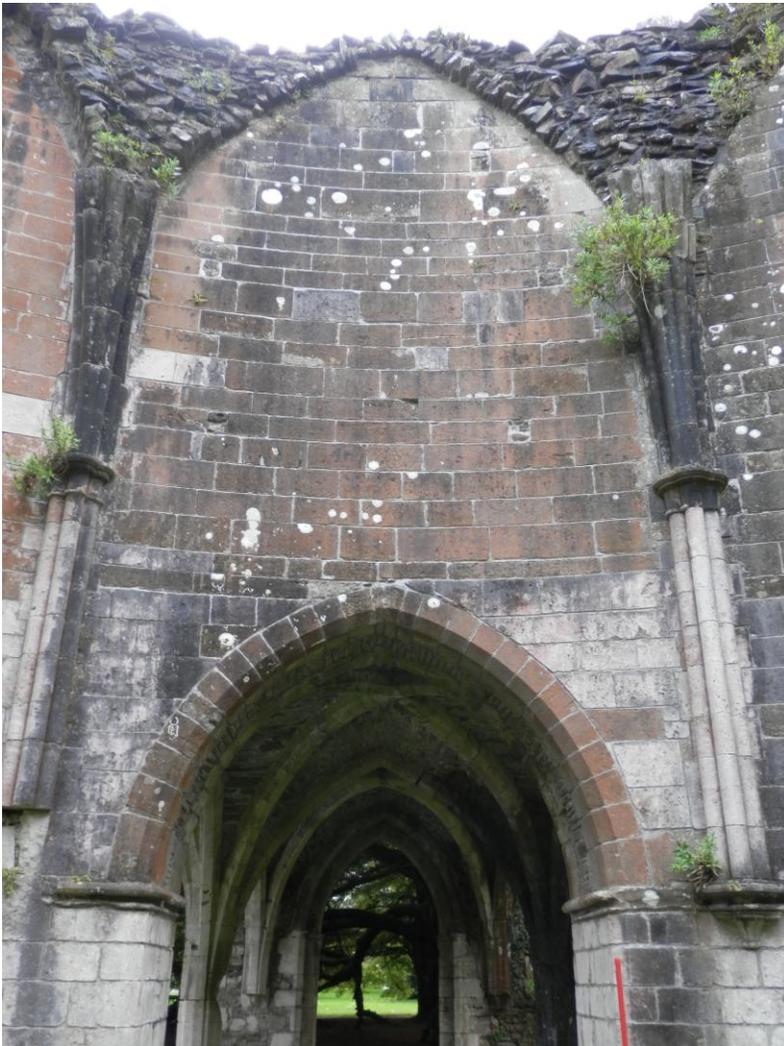
(See figure 2, figure 8 elevation 32)

ID: 56 Site Number: 748 Site Name: Margam Monastic Ruins
Wall Number: 32 Photo Number: F2/13
Location: Chapter House Wall Int.
Description: Upper section. Possibly not contemporary with abbey, maybe due to renovations, due to presence of cement between the stones. Ashlar. Putlog holes up on left and right and near the top of arch.
Condition summary: A) Severe weathering to central stonework. B) Vault support on right side - vegetation has displaced the blocks in springing of the vault, so they overhang dangerously. C) Vault springing on the left has vegetation growing from it but no obvious displacement. D) Missing bottom section of column on left side.
Threats: Vegetation, Weathering, possible collapse of vault support on right
Recorded by: Sally Jones & Marie Richards Date: 24/09/2012

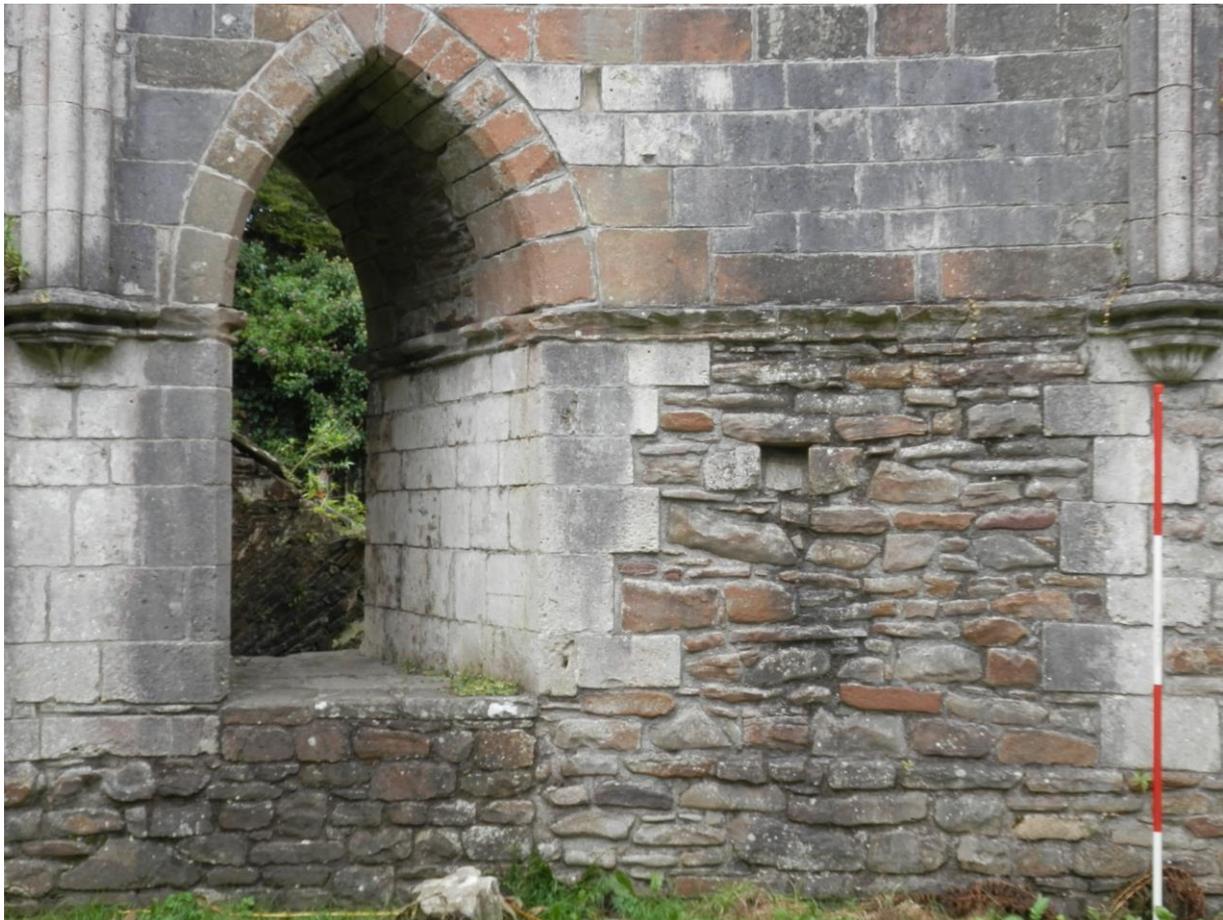
(See figure 2, figure 8 elevation 33)

Description: Lower section. Ashlar in reasonable condition. Little vegetation. Cement filling in areas of missing mortar from previous repair. Different stone above moulding. Putlog hole to right of window. Straight joint continues line of right-hand side of window downwards, with noticeably different construction in the rubble at either side. Ashlar around window, with a different stone used for the arch different material. Triple shafts support vaulting.

Condition summary: A) Cracks in stonework around window. B) Weathering on moulding, and crack. C) Mortar missing between voussoirs of window.

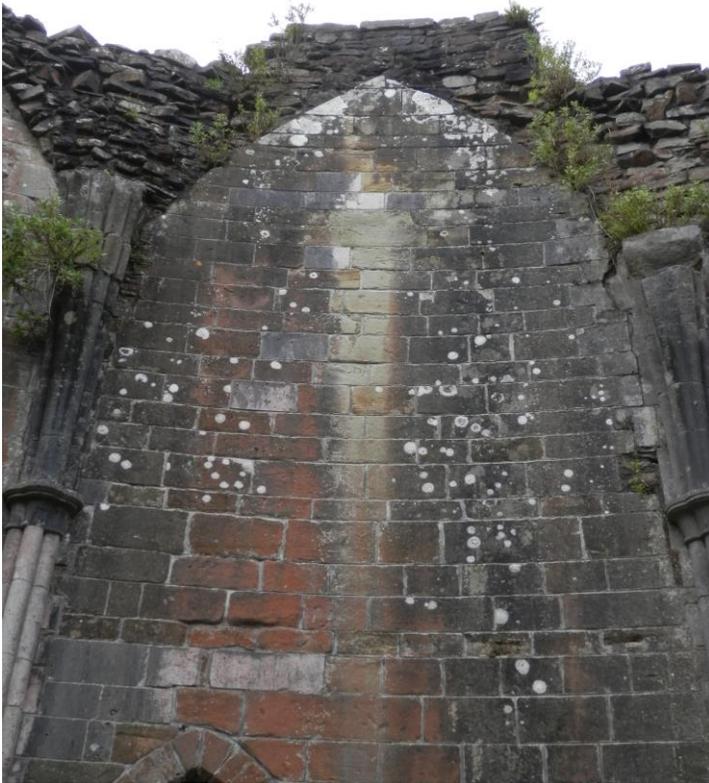
(See figure 2, figure 8 elevation 33)

ID: 58 Site Number: 748 Site Name: Margam Monastic Ruins
Wall Number: 33 Photo Number: F2/15
Location: Chapter House Wall Int.
Description: Upper section. Modern cement indicates wall has been repaired. Considerable discoloration. Upper part of vaulting missing. Weathered stone at very top of arch. Ashlar facing top right missing, lots of vegetation on both sides of arch. Springing of vault on the right has weathered away at the top. Third course of stones from the top of the window have weathered. Sandstone rubble used as filler on right hand side, vegetation growing out of it.
Condition summary: A) Weathered row of stone, third course from window arch. B) Top of left hand column very loose, vegetation growing out of it. C) Top of right hand column weathered and missing, fourth and fifth block. D) Vegetation at top of stones also in between stones. E) Very top of dressed stones becoming loose.
