Monastic Margam Community Survey Project

Report for Cadw
by Sam Pamment BA

GGAT report no. 2013/020
NGR: SS 8018 8626
Project no. GGAT 123

Summary

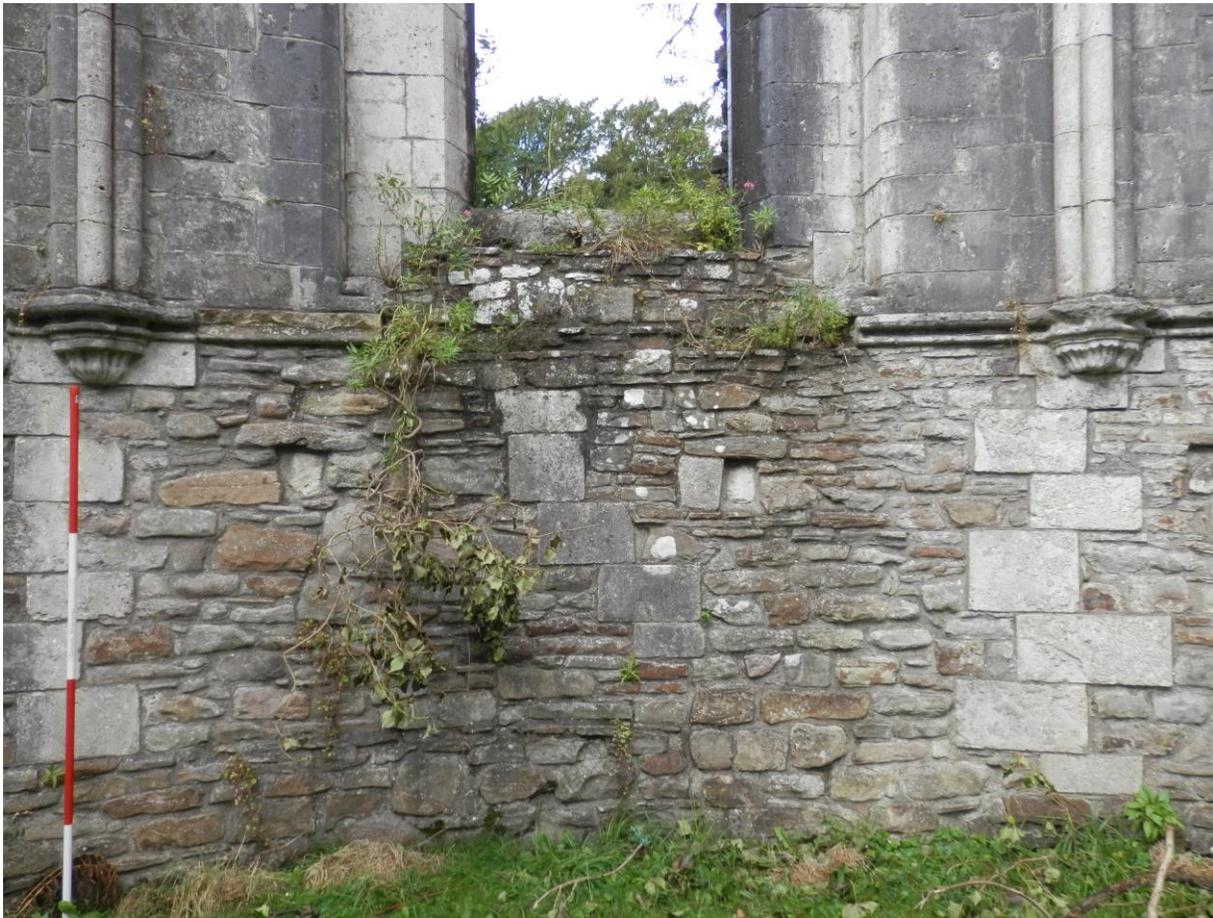
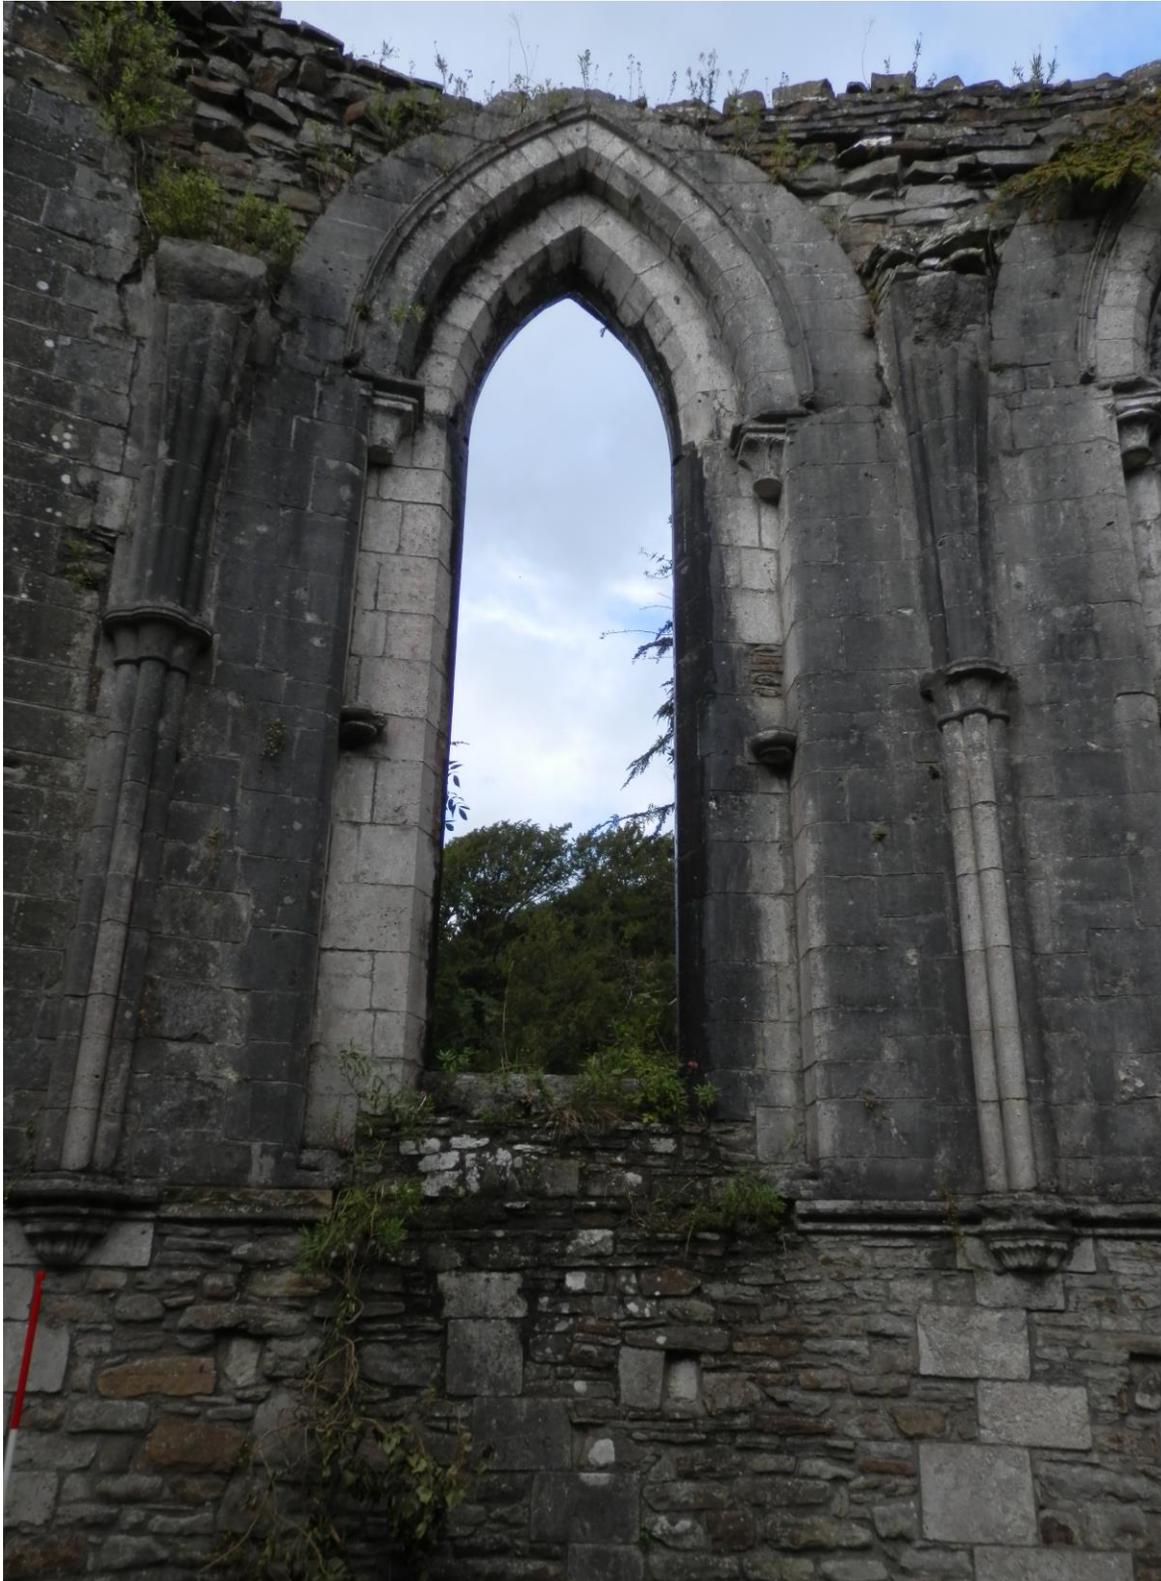
(See figure 2, figure 8 elevation 34)

ID: 59 Site Number: 748 Site Name: Margam Monastic Ruins
Wall Number: 34 Photo Number: F2/16-17
Location: Chapter House Wall Int.
Description: Lower section below window constructed from sandstone rubble, and contains 2 putlog holes. There are ashlar blocks set diagonally up the wall as far as the moulding below the window. Masons mark on one of these blocks, and possible original rendering. Upper section around window made of ashlar, with shafts either side of the opening. Triple shafts either side of the bay, supporting the vaulting. Very top of wall mostly rubble.
Condition summary: A) Vegetation on window sill & under window sill. B) Moulding sill missing under window. C) Window column bases and caps weathered. D) Bottom of triple shaft group on right side weathered. E) Weathering to Vaulting ribs. F) A lot of vegetation to the apex of arch. G) Severe weathering at 4th course stone up from moulding left hand side.

Threats: Vegetation, Severe weathering to top of vault supports.
Recorded by: Sally Jones & Marie Richards Date: 24/09/2012

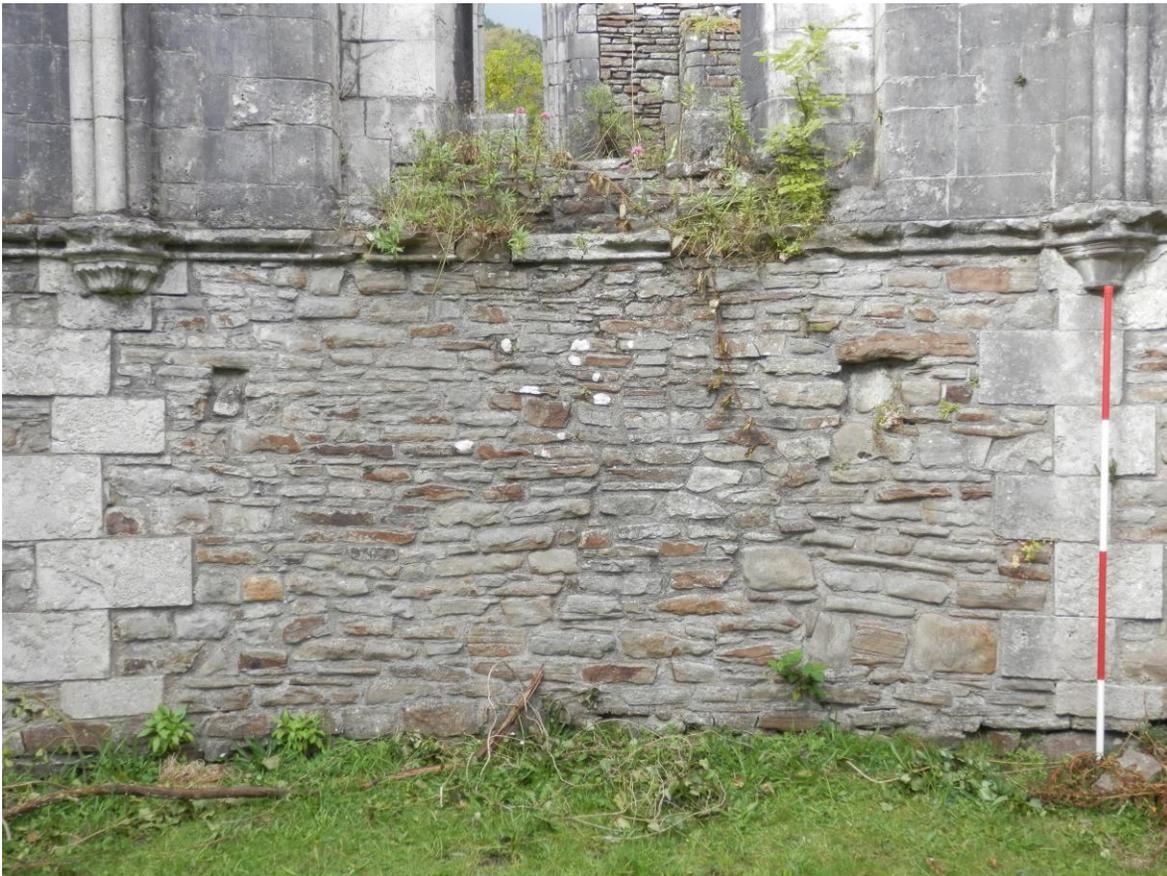
(See figure 2, figure 9 elevation 35)

Description: Lower section of chapter house wall, generally in good condition. Most of bottom of wall sandstone rubble, but reinforced by ashlar under the groups triple shafts that support the vaulting. Two putlog holes. Upper part of wall in ashlar; bases to groups of shafts are to different designs. On right side ashlar 3 mason's marks on top 3 blocks. Possible limewash/mortar/plaster on ashlar blocks.

Condition summary: A) Vegetation growth in stone work at base of wall. B) Vegetation growing out of stonework next to putlog hole on left. C) Weathering to moulding at top of section. D) Vegetation growth at top of section below window. E) Weathering to left column base. F) Weathering to right column base.

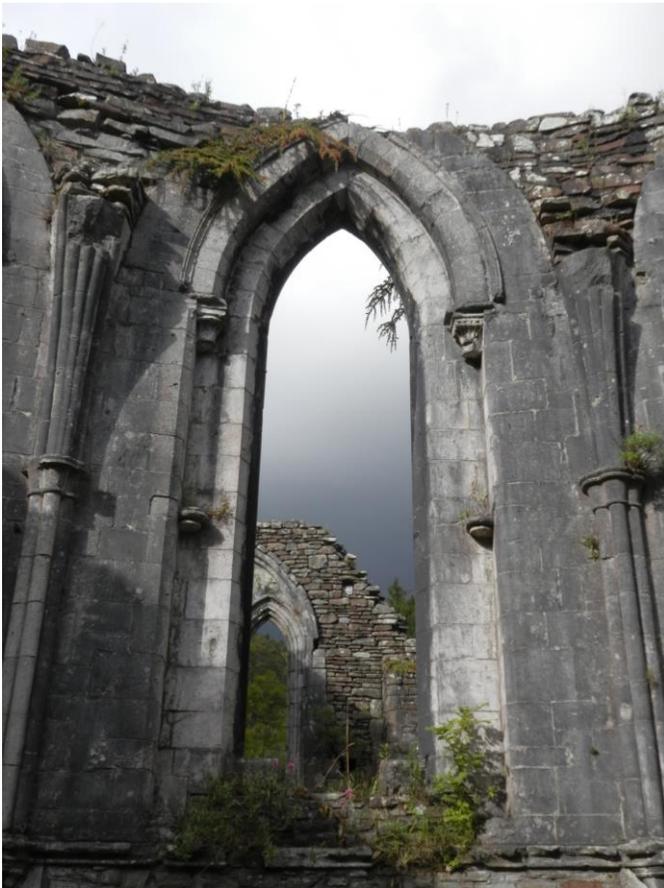
(See figure 2, figure 9 elevation 35)

ID: 61 Site Number: 748 Site Name: Margam Monastic Ruins
Wall Number: 35 Photo Number: F2/19
Location: Chapter House Wall Int.
Description: Upper section of chapter house wall. Shafts missing either side of window; however shaft base, caps and middle moulding remain. Mainly ashlar, but with rubble at bottom of window and around window head. Triple shafts left and right of window with to support spring of vault.
Condition summary: A) Loose stones at top of wall section. B) Vegetation growing at top of arch. C) Loose ashlar corner of window edge, halfway up window. D) Vegetation growing behind moulding of missing shaft on left. E) Vegetation growing behind moulding of missing shaft on right. F) Weathering of column base left. Weathering of shaft base right. G) Vegetation growing at base of window. H) Moulding missing at arch apex.
Threats: Weathering, Vegetation.
Recorded by: Sam Pamment Date: 24/09/2012

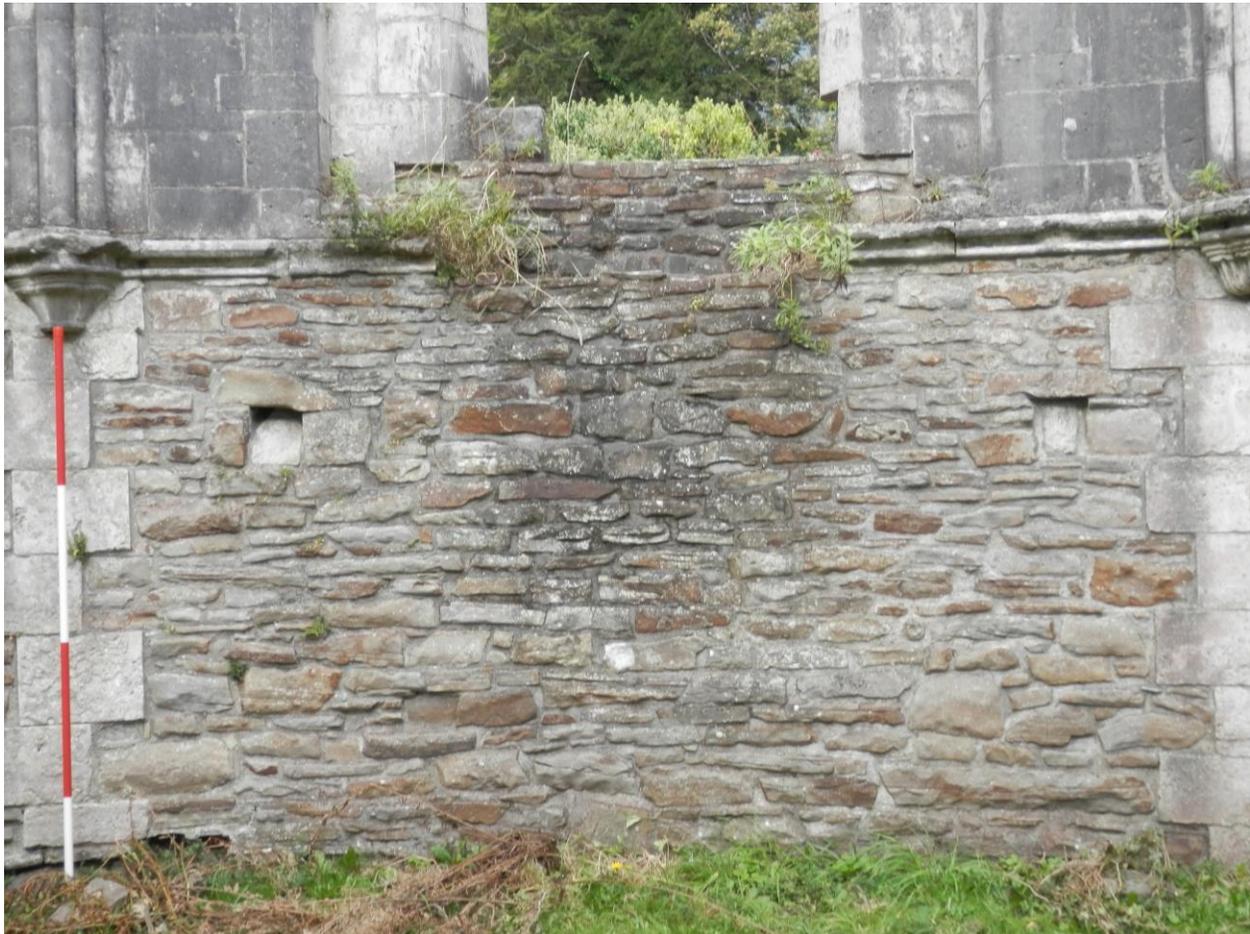
(See figure 2, figure 9 elevation 36)

Description: Lower section. Modern cement used on top of mortar during restoration to secure stones. Main part sandstone rubble, but with ashlar blocks below triple shafts. Two putlogs holes. Base of groups of shafts different from each other. Wall in fairly good condition with very little vegetation to left of wall section.

Condition summary: A) Sill missing middle stones, weathering. B) Vegetation growing into stones on top of sill and into wall column base. C) Hole in mortar of putlog, Stones missing in left of base.

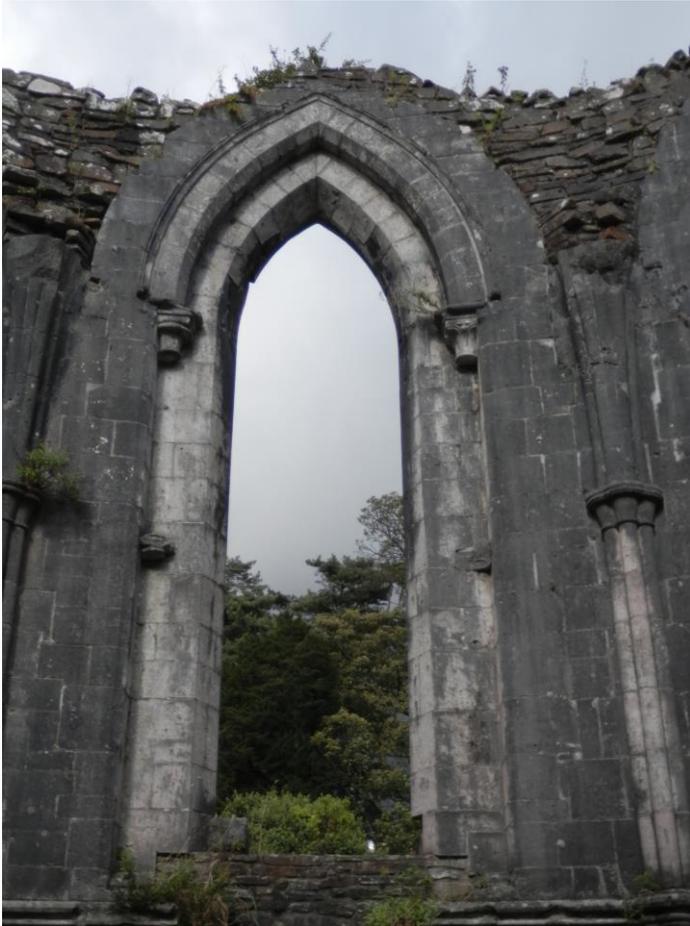
(See figure 2, figure 9 elevation 36)

ID: 63 Site Number: 748 Site Name: Margam Monastic Ruins
Wall Number: 36 Photo Number: F2/21
Location: Chapter House Wall Int.
Description: Upper section. Shaft bases eroded with weathering. Shafts flanking window missing both sides, but rest of dressings intact. Little vegetation growing out of window. Stone of archway moving, signs of water erosion due to cracks in the stone. Vegetation growing out of the stones at the top of the arch. Tops of column starting to fall off, moulding on archway weathered and pieces missing.
Condition summary: A) Base of window missing, stones gone. B) Columns missing and moulding damaged. C) Water damage on inside of arch. D) Top of arch way missing. E) Archway moulding damaged/weathered. F) Vegetation at top possible stone erosion.
Threats: Vegetation, Weathering
Recorded by: Gloria Rowles Date: 24/09/2012

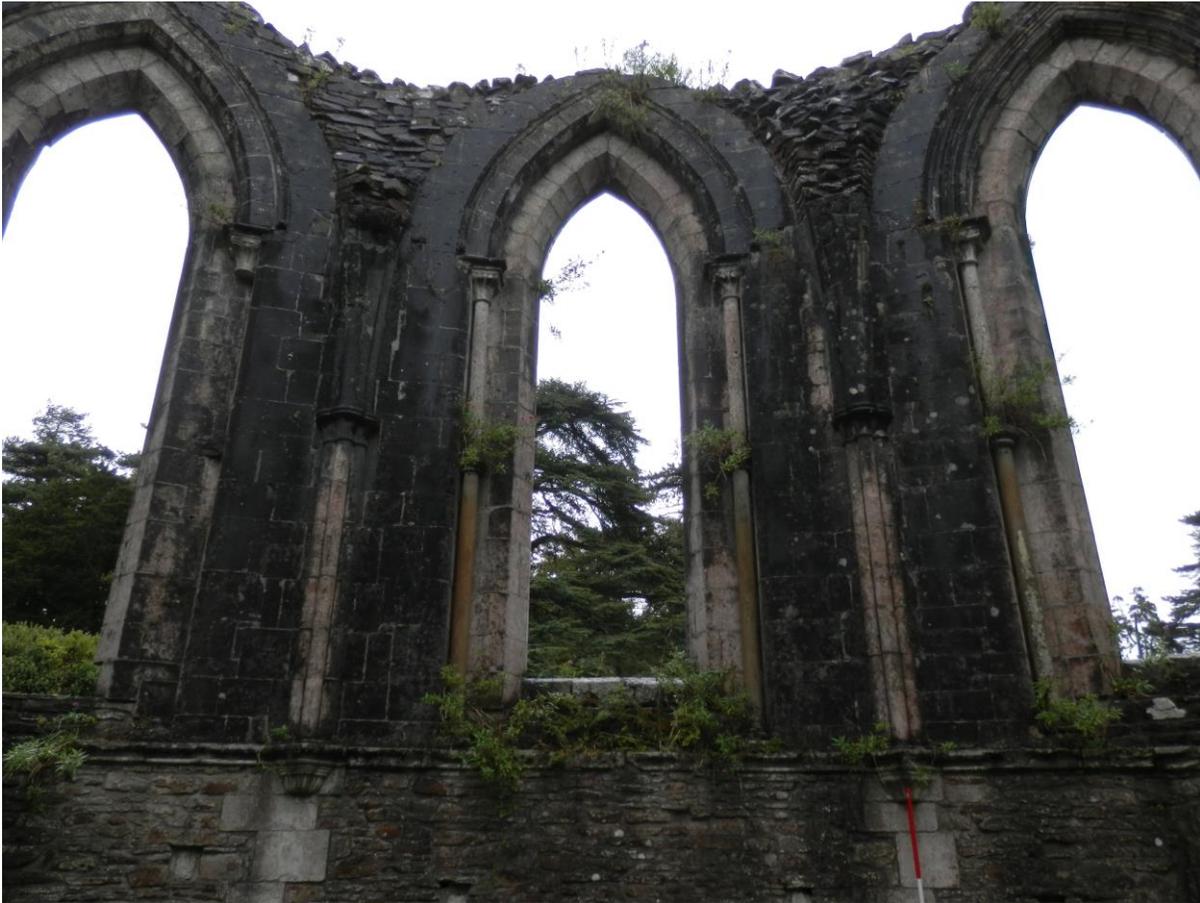
(See figure 2, figure 9 elevation 37)

ID: 65 Site Number: 748 Site Name: Margam Monastic Ruins
Wall Number: 37 Photo Number: F2/23-24
Location: Chapter House Wall Int.
Description: Upper section. Vaulted window edged with dressed sandstone flanked by shafts with decorated caps. Bay flanked by triple shafts to support vault. Sill to base all in good state of repair.
Condition summary: A) Vegetation, particularly at base of window and around sill. B) Also halfway up window columns and at apex of window. C) Shaft bases reveal weather erosion and some base missing to right hand base. D) Right hand shaft at base evidence of outer surface peeling off, loose. E) Weathering to upper half of both shafts - pitted. F) Stone above columns requires inspection particularly as there is a small stone on grass below.
Threats: Vegetation, Weathering
Recorded by: Fiona Richards Date: 25/09/2012

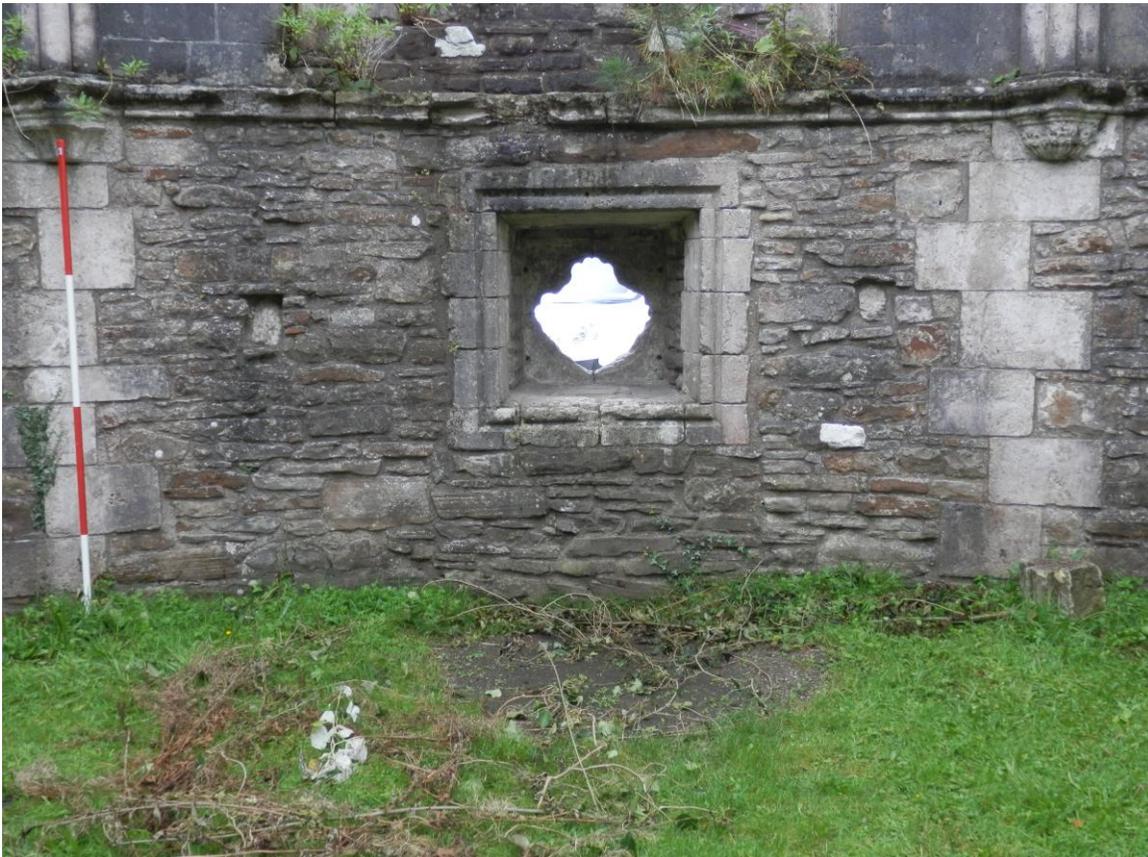
(See figure 2, figure 10 elevation 38)

ID: 66 Site Number: 748 Site Name: Margam Monastic Ruins
Wall Number: 38 Photo Number: F2/26-27 & 30-31
Location: Chapter House Wall Int.
Description: Lower section. Sandstone rubble wall flanked by ashlar blocks, two putlog holes present. Quatrefoil inset, ashlar frame, rubble internally; slightly off centre. four ?bolt holes present in each corner. Fleur-de-lys moulding as base to right-hand side triple shaft group. Mason's marks on ashlar. Fragment of moulding on ground suspected to have come from corner shafts. Moulding separates upper and lower sections of wall. Mortar generally in good condition.
Condition summary: A) Sill badly damaged, pieces missing. B) Weathering to frame of quatrefoil inset and also to hole, hole possible rubbed smooth by human hand. C) Moulding at bottom of right-hand side vaulting column eroded. D) Vegetation to top of sill
Threats: Vegetation, Weathering
Recorded by: Jeff Jones Date: 25/09/2012

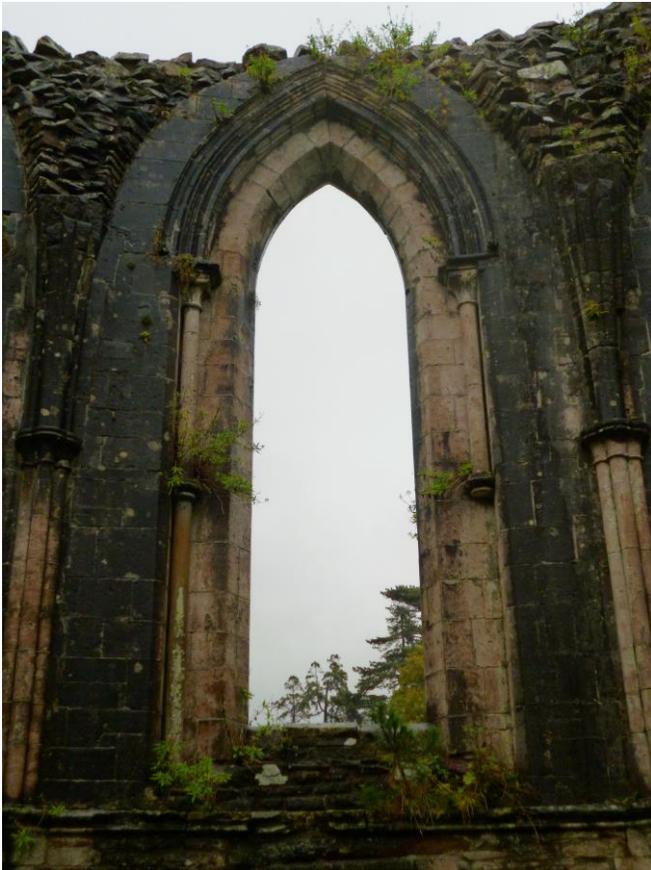
(See figure 2, figure 10 elevation 38)

Condition summary: A) Vegetation at base of sill; young tree here of particular concern. B) Vegetation halfway up the window column and at the top of column. C) Weather erosion and damage to bases of shafts flanking window. D) Lower half of right hand window column is missing, no evidence of it within chapter house. E) Fragments of moulding on the ground look as though they have fallen from vaulting above. F) Stonework above vaulted column has vegetation growing from it and could be unstable.

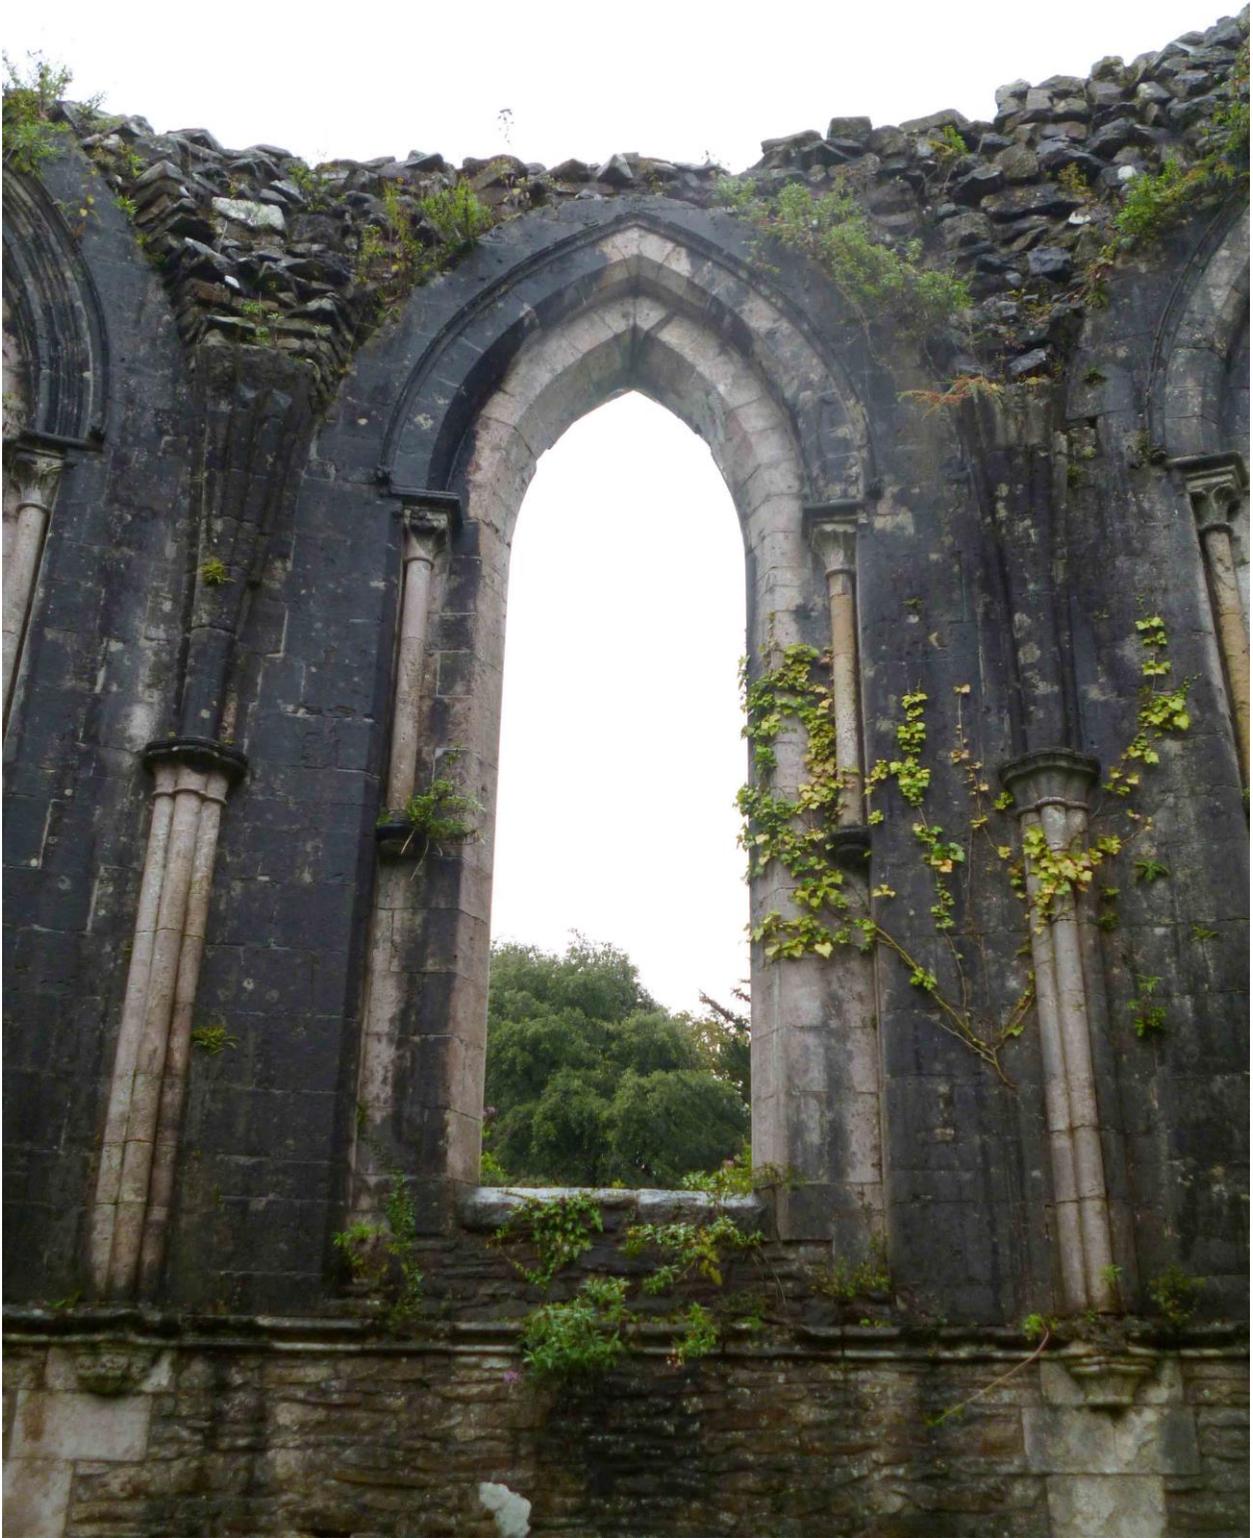
(See figure 2, figure 10 elevation 39)

ID: 69 Site Number: 748 Site Name: Margam Monastic Ruins
Wall Number: 39 Photo Number: F2/29
Location: Chapter House wall int.
Description: Window. Possible damage to apex of window dressings. Lots of vegetation on top. Ashlar surround to window in reasonable condition. The upper parts the shafts flanking the window still intact, with caps in good condition.
Condition summary: A) Base of column weathered B) Vegetation growing out of mid-shaft moulding on left. C) Ivy growing over right hand side of window. D) Ivy growing over base of window and stones beginning to crumble. E) Chunks of stone missing on inside of window allowing damp and water to get in. F) Top arch of window moldings weathered G) Vegetation growing out of top of arch on stones and top of vault Springing on right, H) Loose stones on very top of wall. I) Mortar starting to come away from window dressings and shafts.
Threats: Vegetation, Weathering

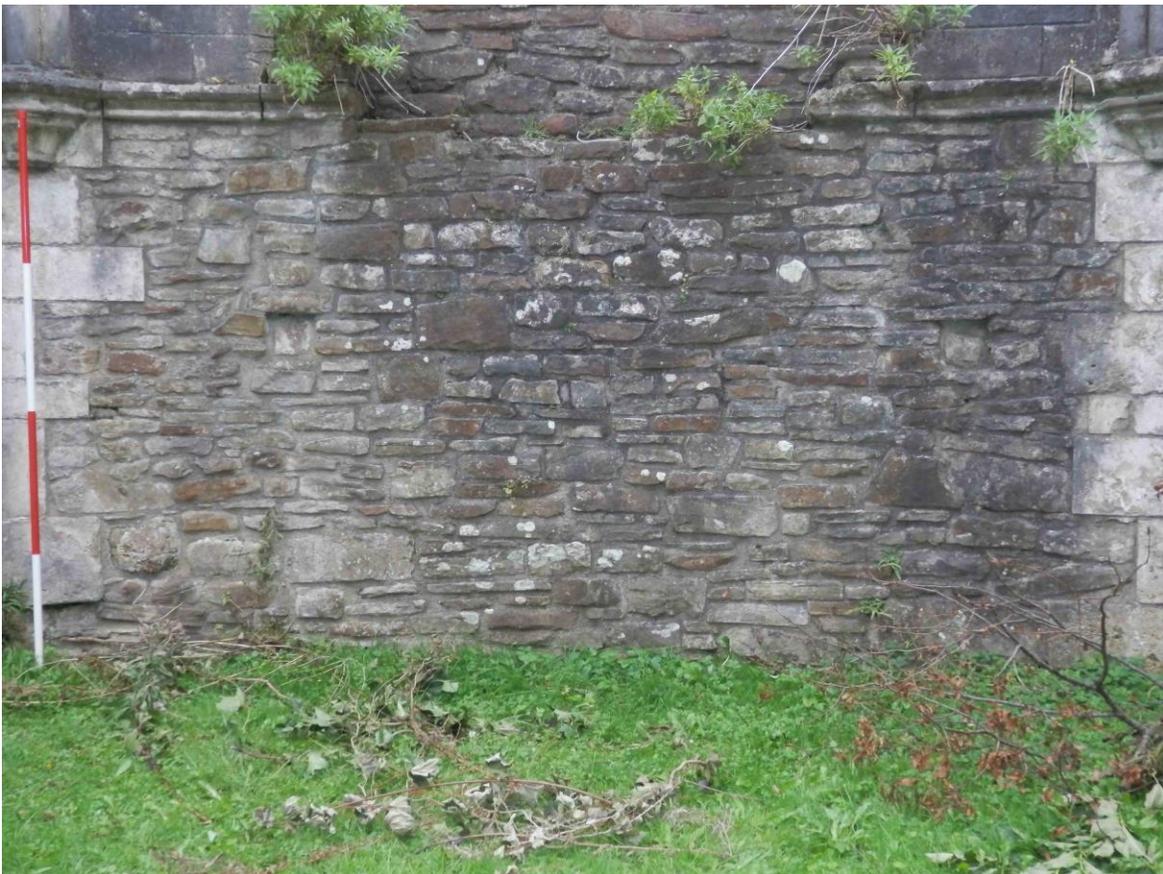
(See figure 2, figure 11 elevation 41)

Description: Lower wall. Original mortar seems to be intact. Wall in very good condition local stone rubble. Ashlar blocks underneath groups of triple shafts with mortar replaced in between with cement (restoration). One mason's mark on fourth ashlar block from base on right. One mason's mark on fourth ashlar from base on left. Two putlog holes. Almost no vegetation on wall. Broken ashlar has been patched up with cement. Some water discoloration on right. Column bases intact. Second dressed stone from base on left is hanging in mid-air. Lowest ashlar block on the left has crumbled away exposing rubble core. Cement seems to hold stones together.

Condition summary: A) Sill stones missing and due to weakness, stones below have come away. B) Vegetation growing in gap in sill and between joins. C) Sill mouldings weathered. D) Mortar missing between sill stones. E) Lowest ashlar block on right is weathered.

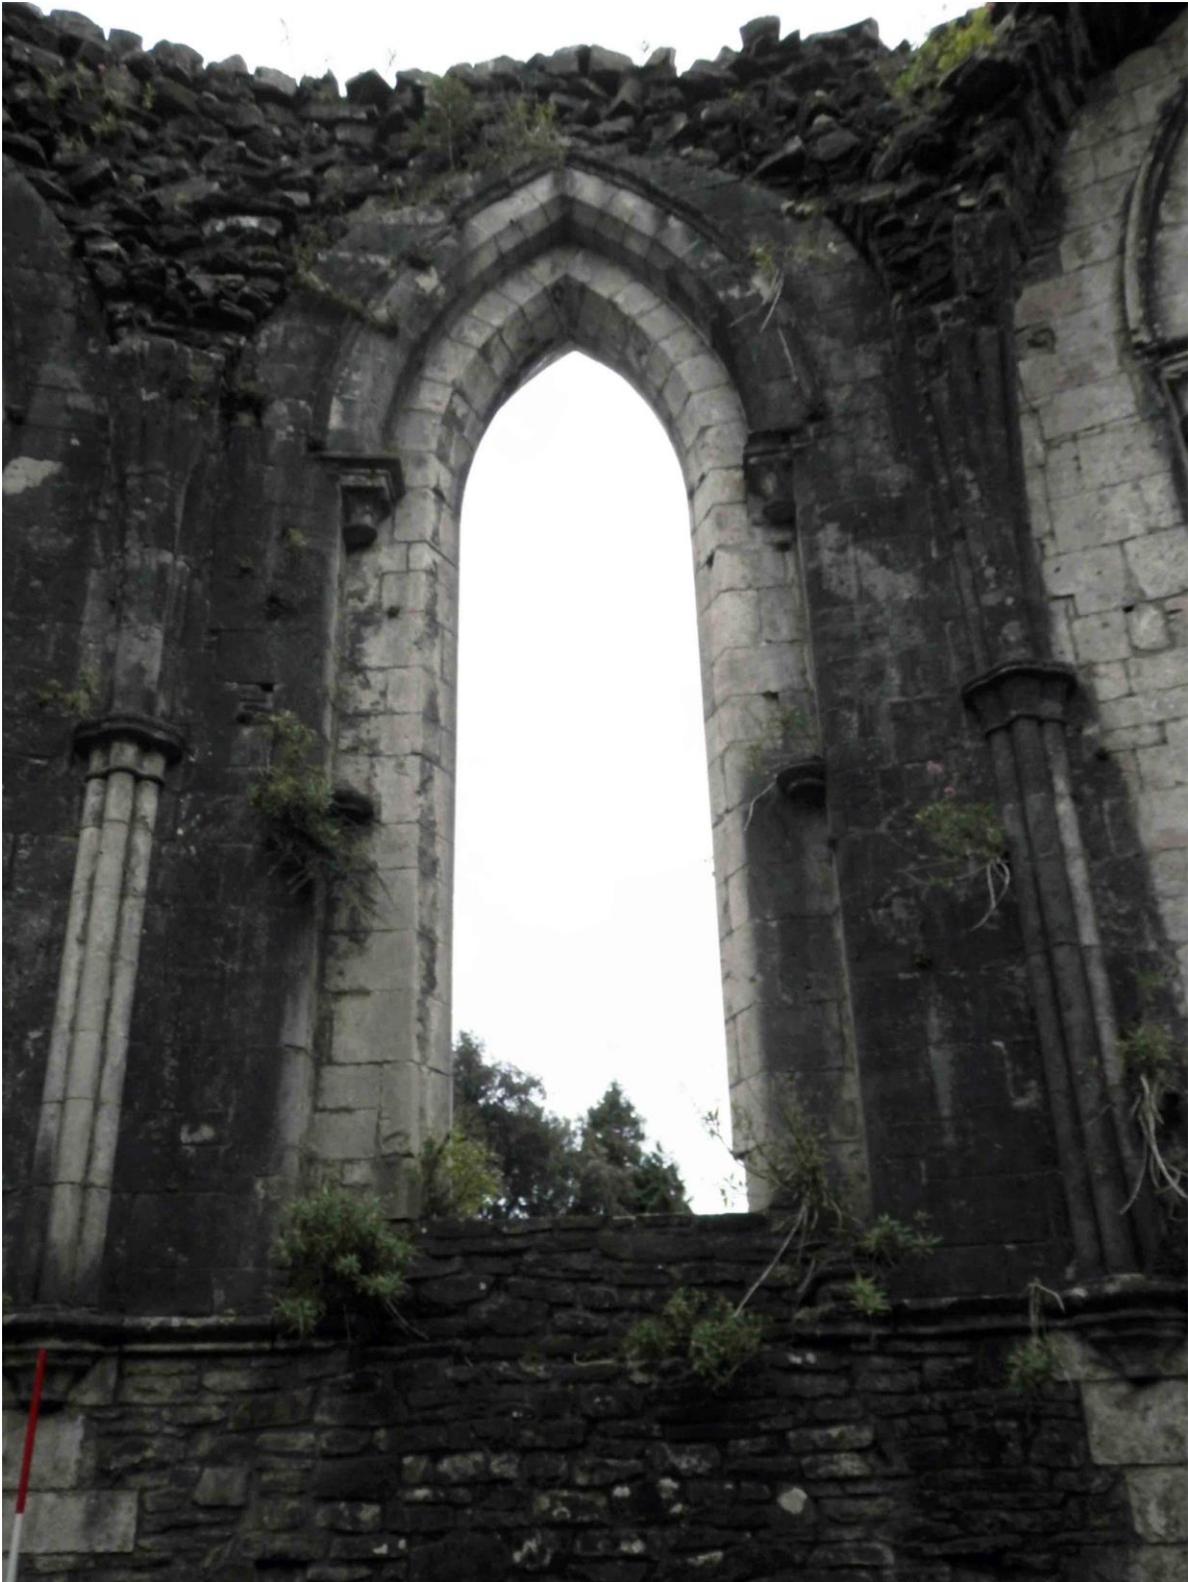
(See figure 2, figure 11 elevation 41)

ID: 73 Site Number: 748 Site Name: Margam Monastic Ruins
Wall Number: 41 Photo Number:F2/35,
Location: Chapter House wall int.
Description: South window. Most of ashlar intact. Discoloration from water damage. Top of lancet is weathering and crumbling. Molding around window weathered. Shafts flanking windows have disappeared but mouldings survive. Ashlar block is hanging from right at window where loose stones are missing.
Condition summary: A) Vegetation on base of window sill. B) Stones missing on base of window. C) Chunks out of dressed stone windows/weathering. D) Mold of archway coming away. E) Loose stones on very top. F) Discoloration on inside of window due to water leaks - possible future erosion. G) Vegetation coming out of wall columns. H) Vegetation coming out of column bases. I) Vegetation coming out of wall to the left of window. J) Vegetation coming out of top arch.
Threats: Vegetation, Weathering

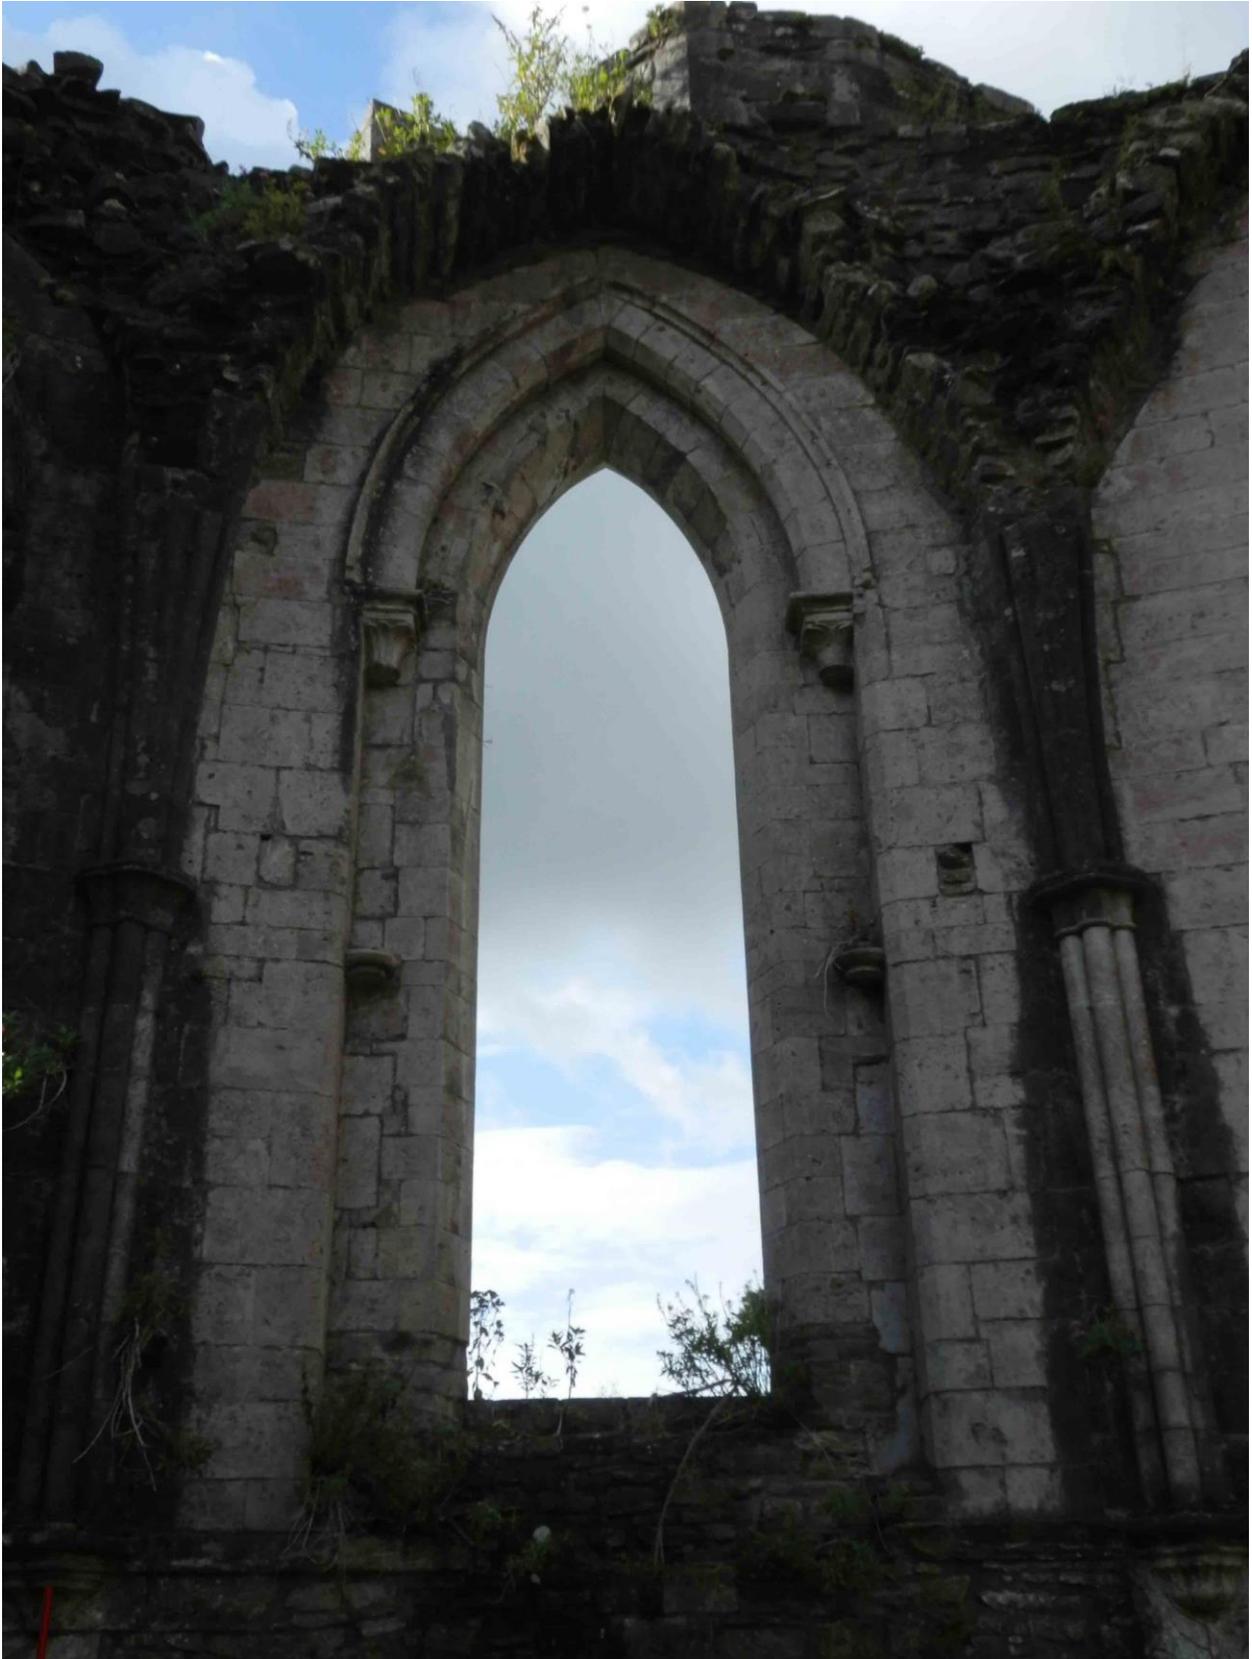
(See figure 2, figure 11 elevation 42)

ID: 75 Site Number: 748 Site Name: Margam Monastic Ruins
Wall Number: 42 Photo Number:F2/45
Location: Chapter House wall int.
Description: Pointed lancet with ashlar dressings. Part of the sandstone rubble vaulting survives, projecting over window. Above the vault is a piece of sandstone rubble walling with ashlar quoin, possibly from earlier chapter house or upper floor of monastery. Shafts flanking windows on both sides are missing, but middle moldings intact. Base mouldings to triple groups of shaft supporting vault. Local sandstone rubble at base of window. Putlog either side of window, one with ?original plug. Vegetation in base of window, sill and vault?
Condition summary: A) Base left and right hand side columns missing. B) Left hand side vault 2-3 ashlar blocks look loose and could fall . C) Overhanging danger-loose stones. D)Vegetation top on overhanging vault. E) Shafts weathered.
Threats: Vegetation, Weathering

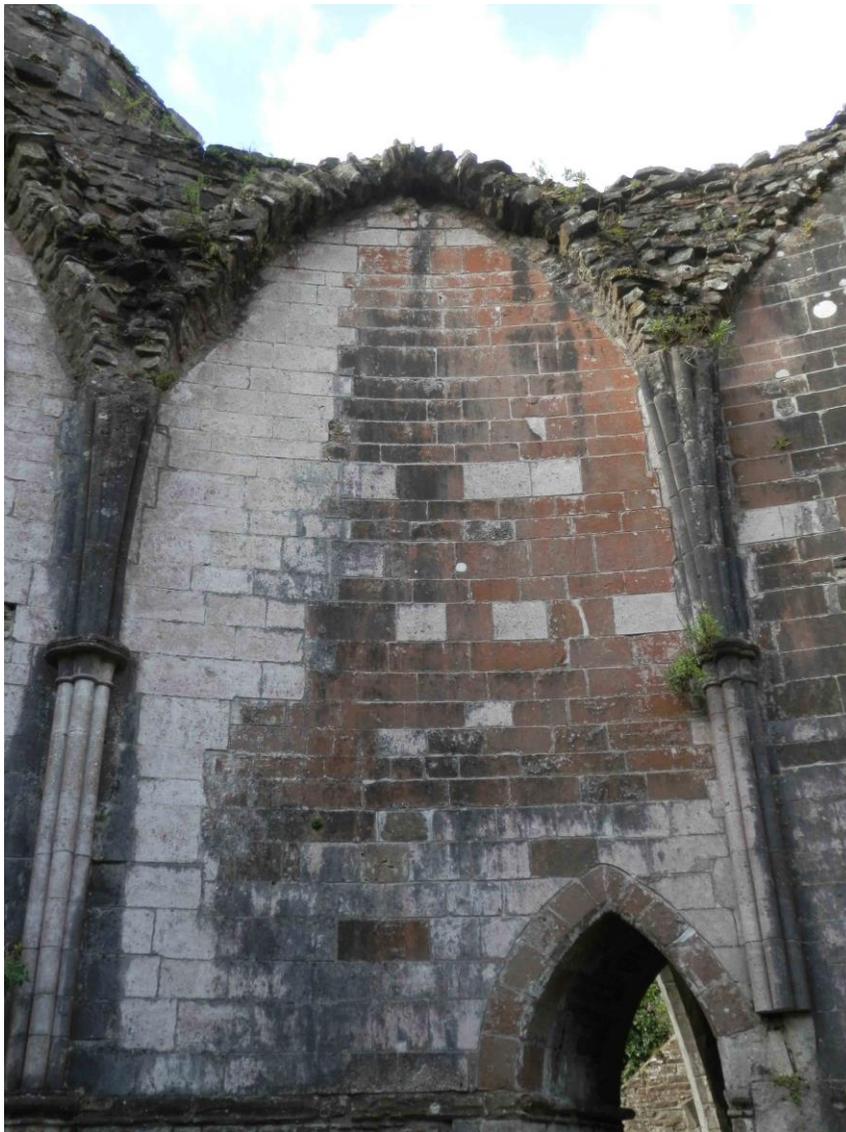
(See figure 2, figure 11 elevation 43)

ID: 76 Site Number: 748 Site Name: Margam Monastic Ruins
Wall Number: 43 Photo Number: F2/47
Location: Chapter House wall int.
Description: Upper Section of wall, to the left of the entrance. Fragment of stone vault overhanging wall face. Vegetation coming out of right-hand shaft. Ashlar discoloured and starting to weather. Vegetation coming out of right shaft. Vegetation started to grow on top of vault. Possible loose stones on very top. ?New cement filled between stones replacing mortar.
Condition summary: A) Weathering to dressed stones. B) Weathering to top of columns. C) Vegetation on right columns.
Threats: Weathering, Vegetation
Recorded by: Ruth Hopkins Date: 26/09/2012

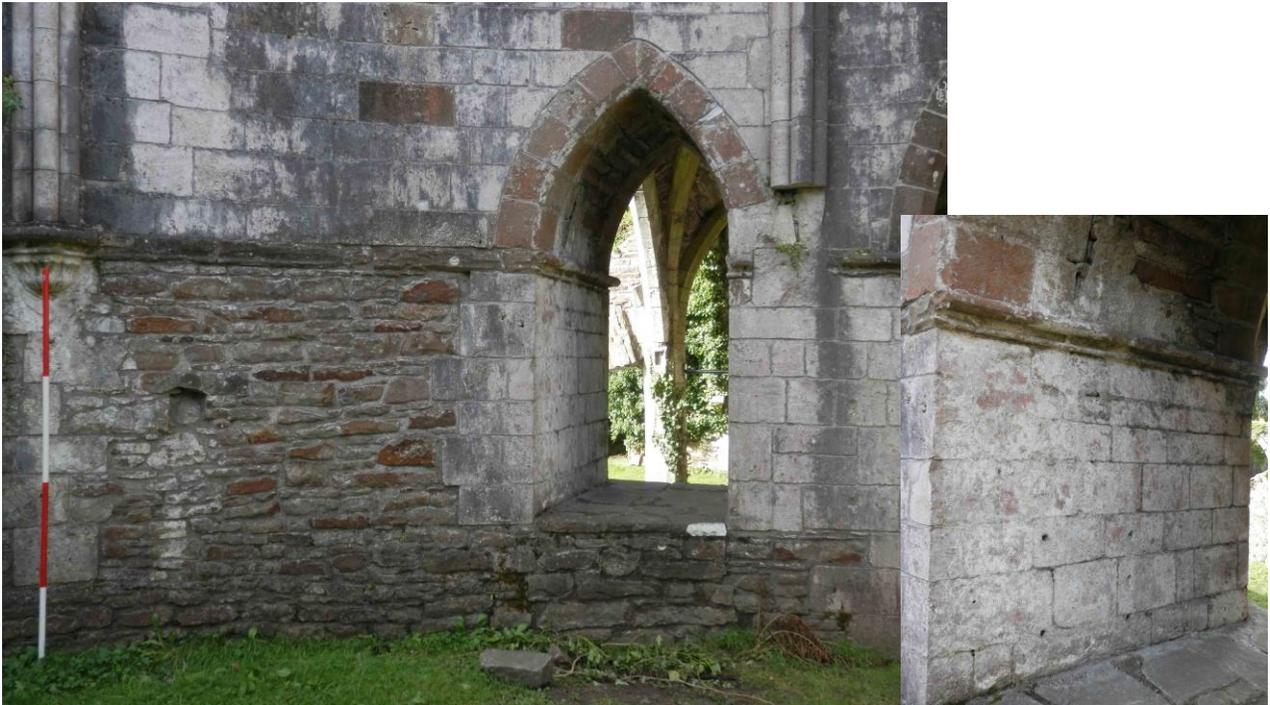
(See figure 2, figure 11 elevation 43)

ID: 77 Site Number: 748 Site Name: Margam Monastic Ruins
Wall Number: 43 Photo Number: F2/46, 48-50
Location: Chapter House wall int.
Description: Small lancet to left of entrance, with ashlar dressings. Local sandstone rubble underneath and to left as far as the ashlar blocks that run vertically below the triple group of shafts on left. Molding running across from base of these shafts across window and then to doorway. This molding separates the rubble below from the ashlar above. One putlog hole. Local sandstone windowsill. Cement mortar. Wall in good condition. Little vegetation other than moss and fern towards bottom. Four drill holes in left side of wall of arch window - fitting/fixture? Two holes on wall to left of entrance - weathering?

Condition summary: A) Most of molding on wall missing - weathered. B) Missing shaft base on right of window (where base should be there is a crack in the stone). C) Small amount of vegetation coming out of molding and column base. D) Crack in bottom dressed stone on bottom right of arch window. E) Small piece of dressed stone come away from weathering.
