Monastic Margam Community Survey Project

Report for Cadw
by Sam Pamment BA

GGAT report no. 2013/020
NGR: SS 8018 8626
Project no. GGAT 123

Summary

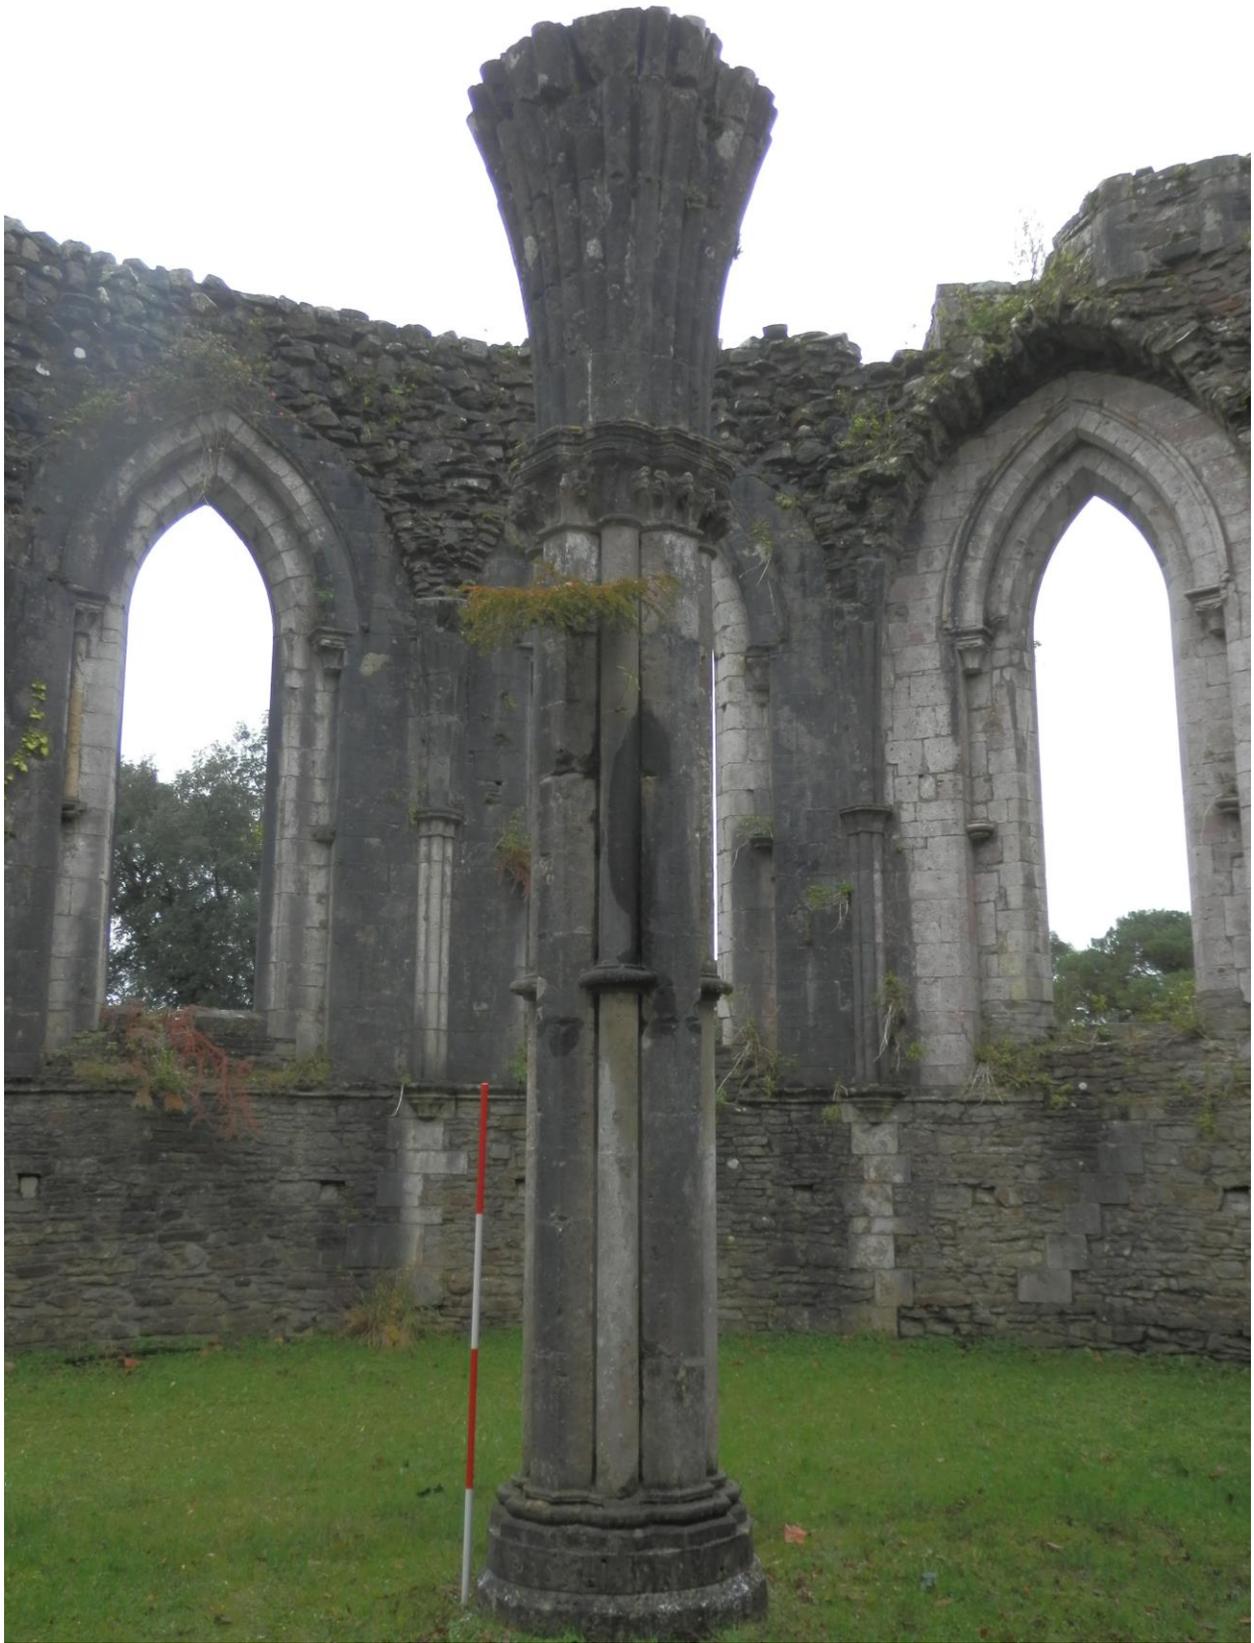
(See figure 2)

ID: 78 Site Number: 748 Site Name: Margam Monastic Ruins
Wall Number: 44 Photo Number: F3/22-25
Location: Chapter House wall int.
Description: Main central pillar. Large central pillar in middle of chapter house, as support for vaulted ceiling. Mainly ashlar, with some cement infill. Roughly 12-14 meters height. It is made up of Four larger shafts at the corner, with four smaller shafts between each pair; these smaller shafts each have a central moulding. The base has a series of mouldings above a low polygonal plinth. The caps are decorated, with motifs including fleurs-de-lis. The springing of the vault survives at the top of the pillar.
Condition summary: A) Vegetation is coming out at one side. B) Ornate carving is weathered. C) Some vegetation growing out of top (northwest side). D) Some holes in stone in various places round columns. E) Vaulting weathered with some large pieces missing.

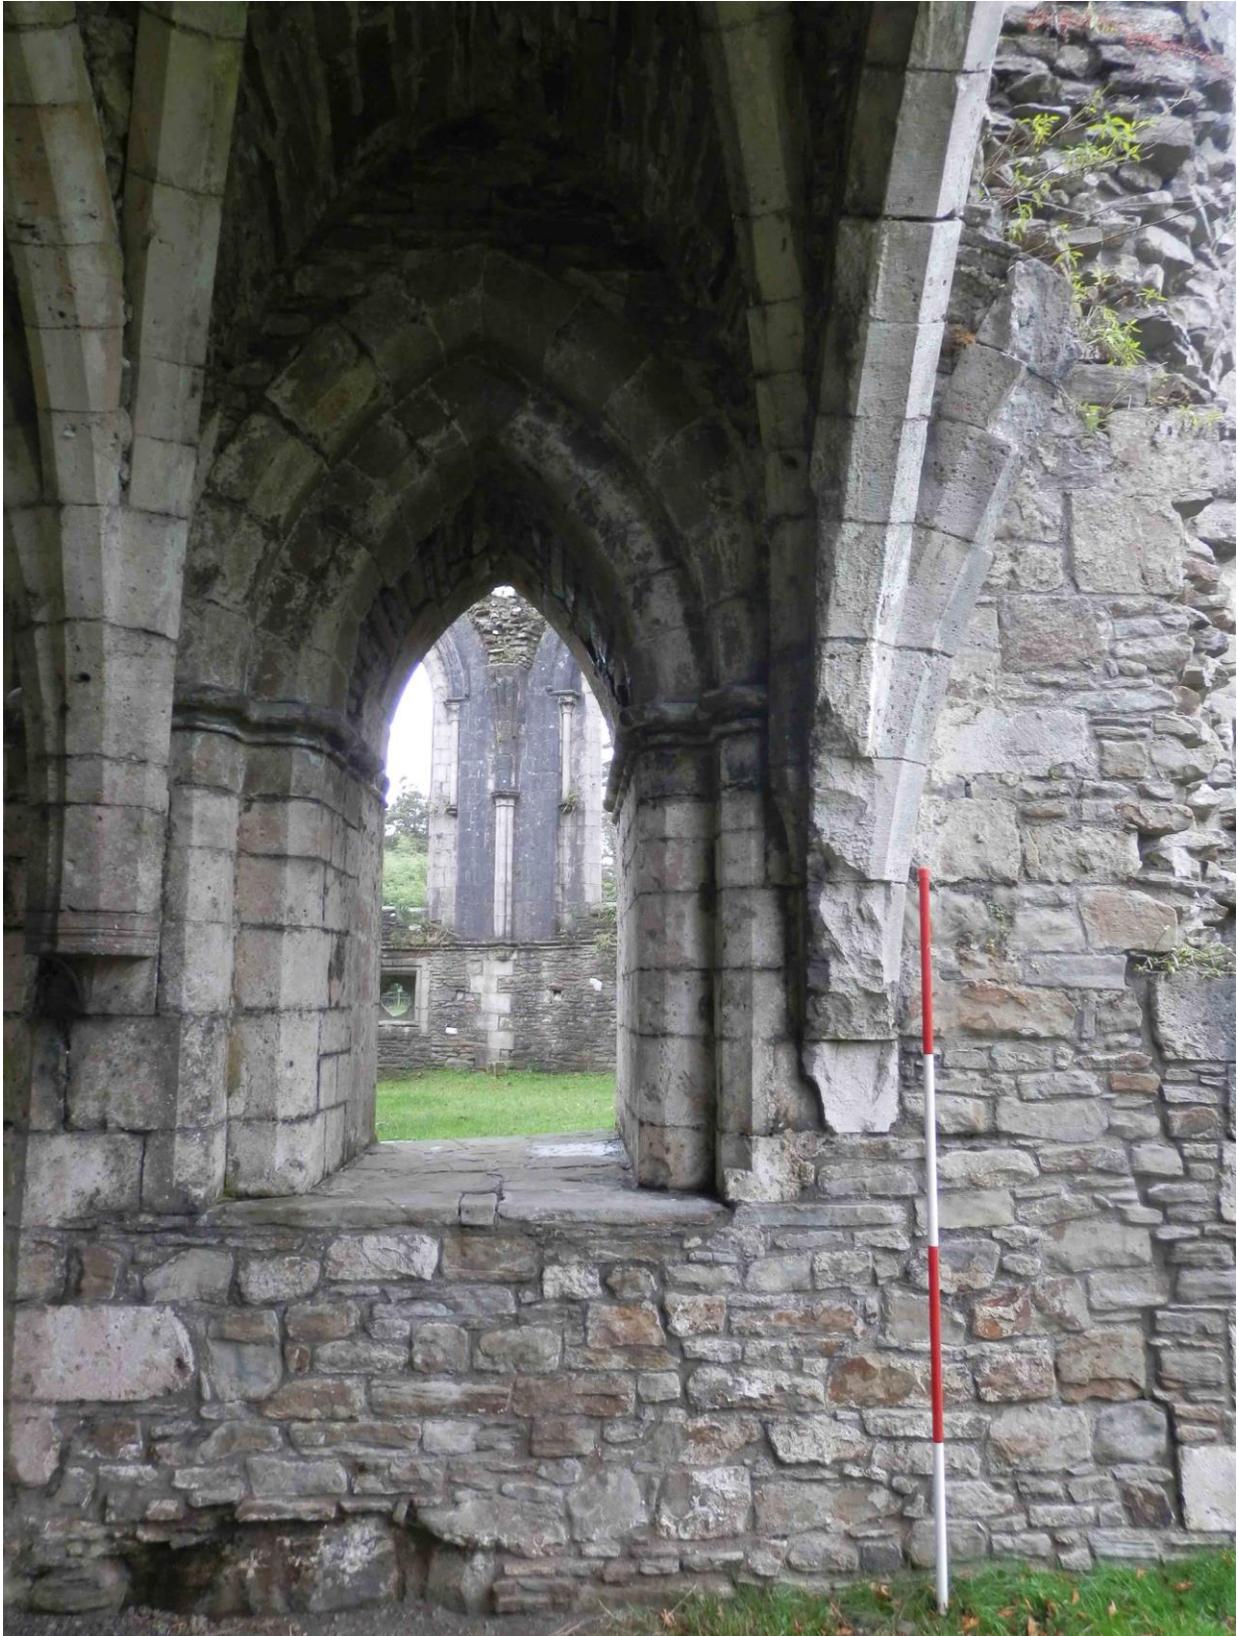
(See figure 2, figure 7 elevation 45)

ID: 79 Site Number: 748 Site Name: Margam Monastic Ruins
Wall Number: 45 Photo Number: F3/26-27
Location: Chapter House wall Ext.
Description: Small lancet with mouldings at the springing of the arch. Ashlar dressings. Base has sandstone sill; below this the wall facing is in a different style of coursed rubble from that used elsewhere in the building, and large irregular blocks can be seen in the core. This facing extends to the right-hand corner of the wall, whereas on the left there is an ashlar quoin. Similar rubble, but with neater blocks, is visible above the window. Large crack which has been consolidated. [This note appears to refer to the straight joint on the right-hand side of the photograph.] Ribs of vaulting extend down either side of window; these survive to a height of c 3.5m, above which the rubble core is visible.
Condition summary: A) Vertical crack [straight joint] with mortar to consolidates. B) Right hand side bottom of vault ribs cracked and eroded. C) Base wall below sill slight overhang and patching. D) Vegetation on vaulted section right hand side. E) Vegetation right hand side corner of wall. F) Right hand side doorway bottom stone missing.

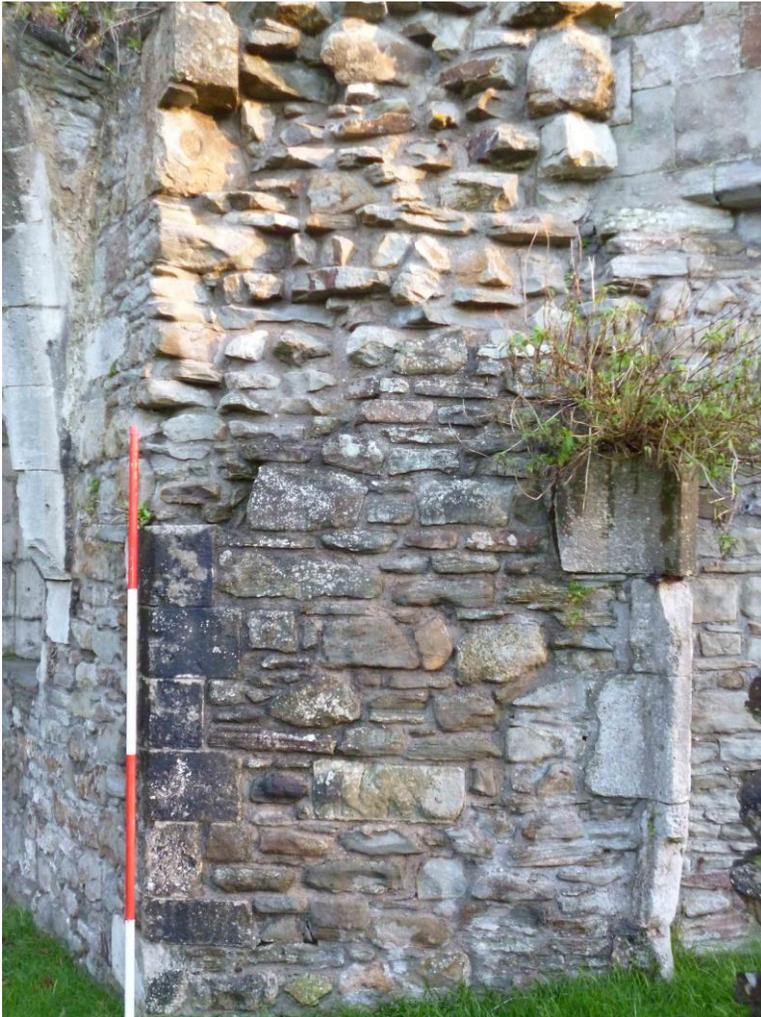
ID: 80 Site Number: 748 Site Name: Margam Monastic Ruins
Wall Number: 46 Photo Number: F3/59
Location: Chapter House wall Ext.
Description: East wall end, lower. Left hand side ashlar quoin (but probably Reconsolidated) 1.8meters length. Right hand side ashlar with metal hinge support at 1.2m. Vegetation above this - top loose - crack/gap in mortar. Mortar eroded in places. Face of wall in local sandstone rubble to a height of 2.5 meters. Unfaced above.
Condition summary: A) Loose stone block. B) Lose of facing stonework (rubble-like) possibility of loose stones with further weathering.
C) Damaged/broken ashlar. D) Weathered mortar.
Threats: Weathering, Vegetation
Recorded by: Paul Minton Date: 26/09/12

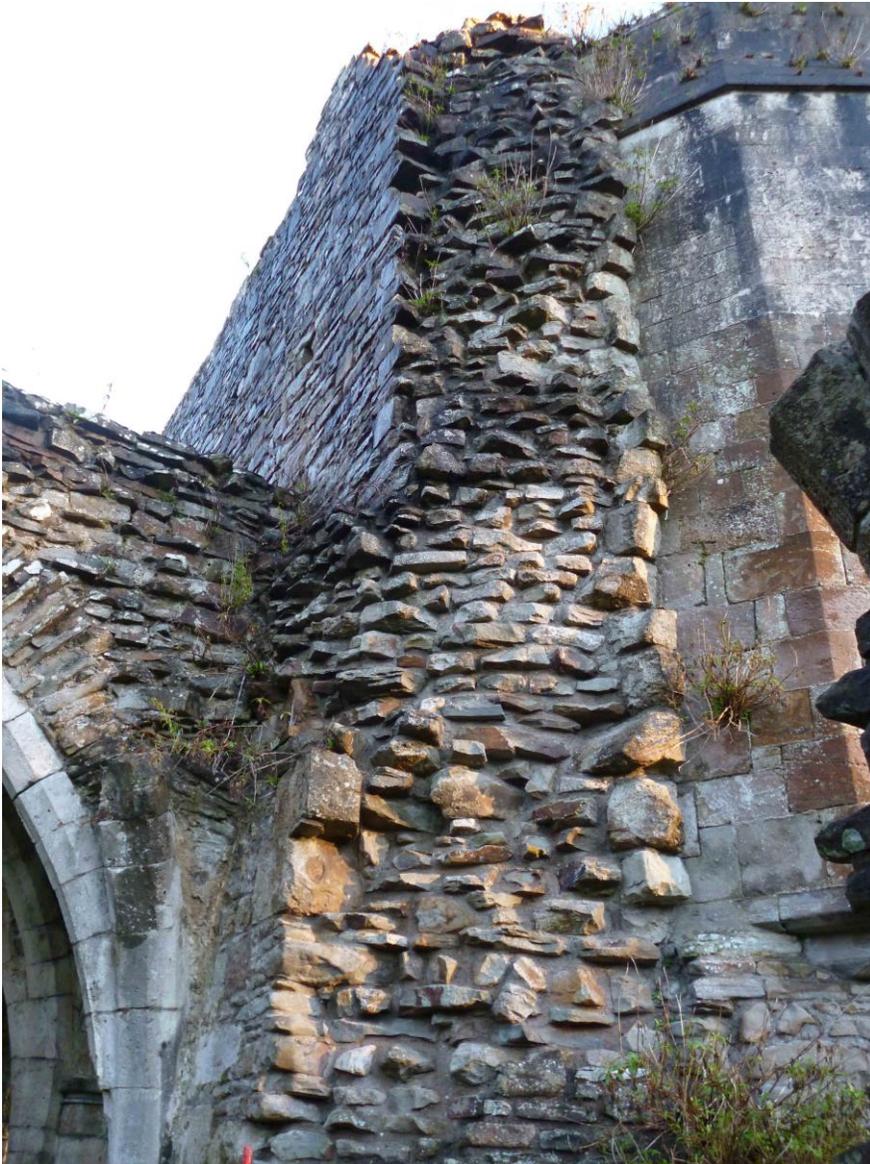
ID: 81 Site Number: 748 Site Name: Margam Monastic Ruins
Wall Number: 46 Photo Number: F3/60
Location: Chapter House east wall end
Description: Upper section of wall face exposed rubble core with some ashlar blocks on the right hand side of the wall Vegetation top third.
Condition summary: A) Weathering to stones B) Vegetation. C) Mortar weathering.
Threats: Weathering, Vegetation
Recorded by: (not filled in) Date: 26/09/12

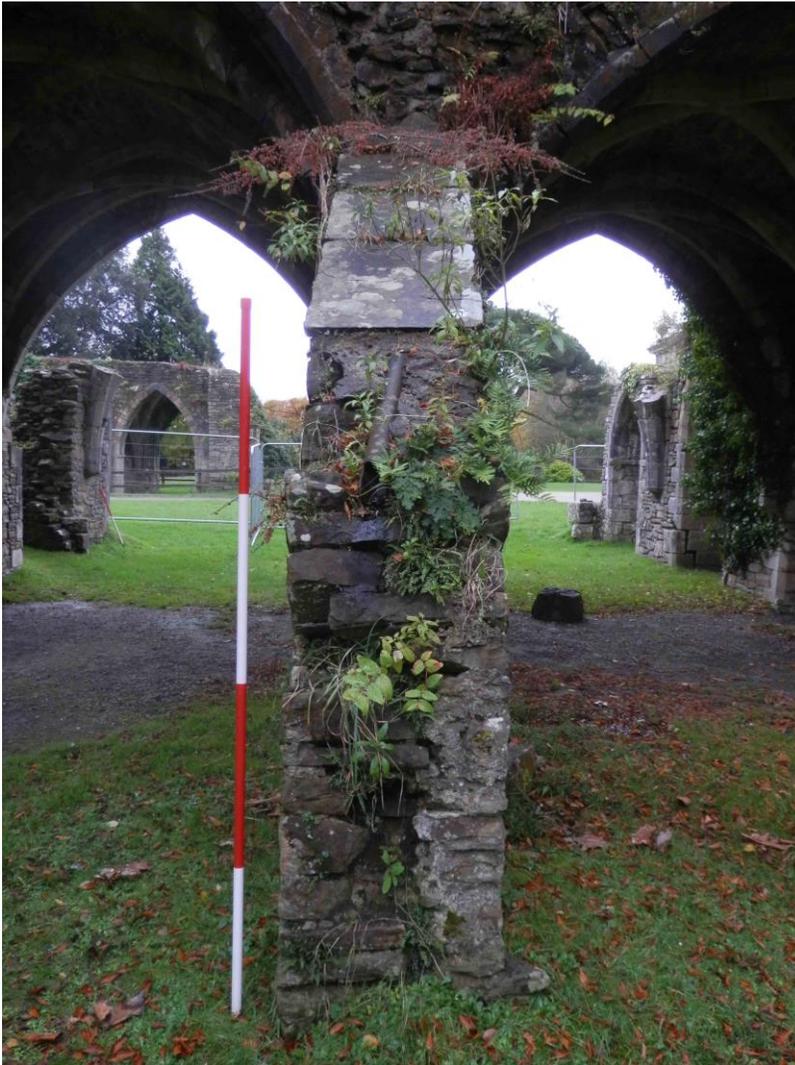
ID: 83 Site Number: 748 Site Name: Margam Monastic Ruins
Wall Number: 48 Photo Number: F3/45
Location: Buttress (not part of original abbey fabric) – east cloister, north end on.
Description: Same as 47, but end of buttress facing south. three slabs covering iron pipes and sandstone blocks on dip in down into buttress. Cracks.
Condition summary: A) Same as 47, but end of buttress facing south. Slabs missing.
B) Mortar missing from where slabs damaged. C) End stone worn with end stone missing. D) Vegetation
Threats: Weathering, Vegetation, drainage from pipe.
Recorded by: (not filled in) Date: 26/09/12

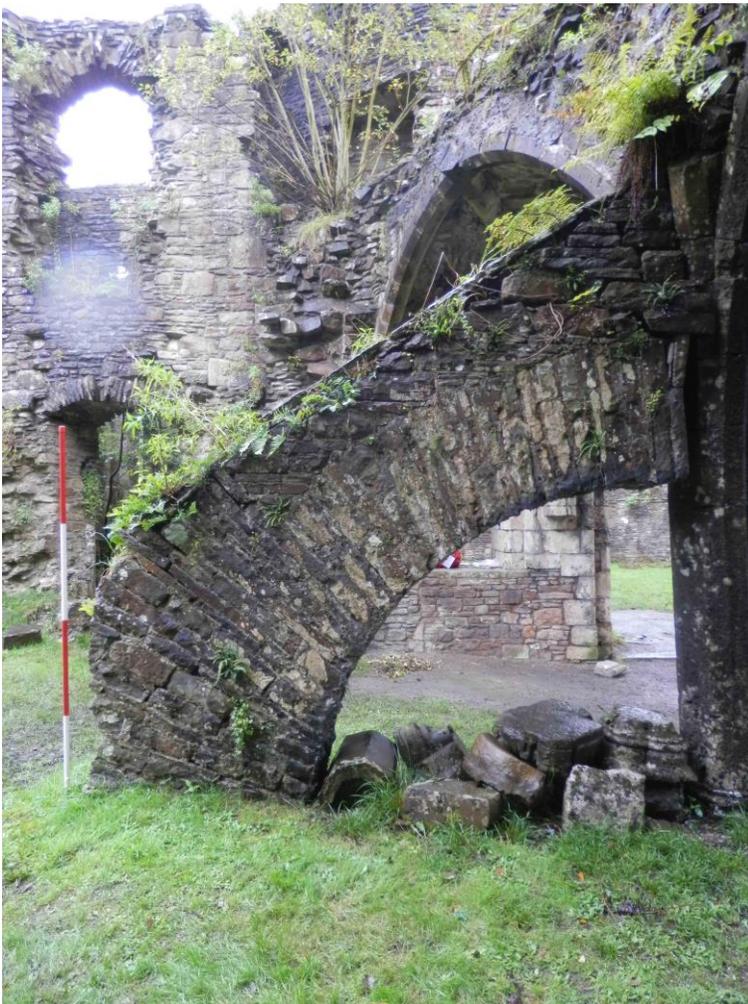
ID: 84 Site Number: 748 Site Name: Margam Monastic Ruins
Wall Number: 49 Photo Number: F2/41
Location: North Buttress (not part of original abbey fabric) east cloister, west face.
Description: Same as 47, but northwest face. Inner arch stones set vertically, outer horizontal. Capped by sandstone slab. Left-hand side - some missing. Right-hand side horizontal stone abutting pillar. Gaps where the mortar is missing and the stones look loose. Middle of wall above arch, some horizontal stones loose, missing no mortar. Left-hand side includes stones, cracks, gaps, loose stone.

Condition summary: A) Same as 47, but northwest face left-hand side includes stones, gaps, cracks. B) Middle above arch: cracks, gaps, loose stones. C) Right hand side there are loose stones, cracks, gaps. D) Vegetation mainly along top of wall

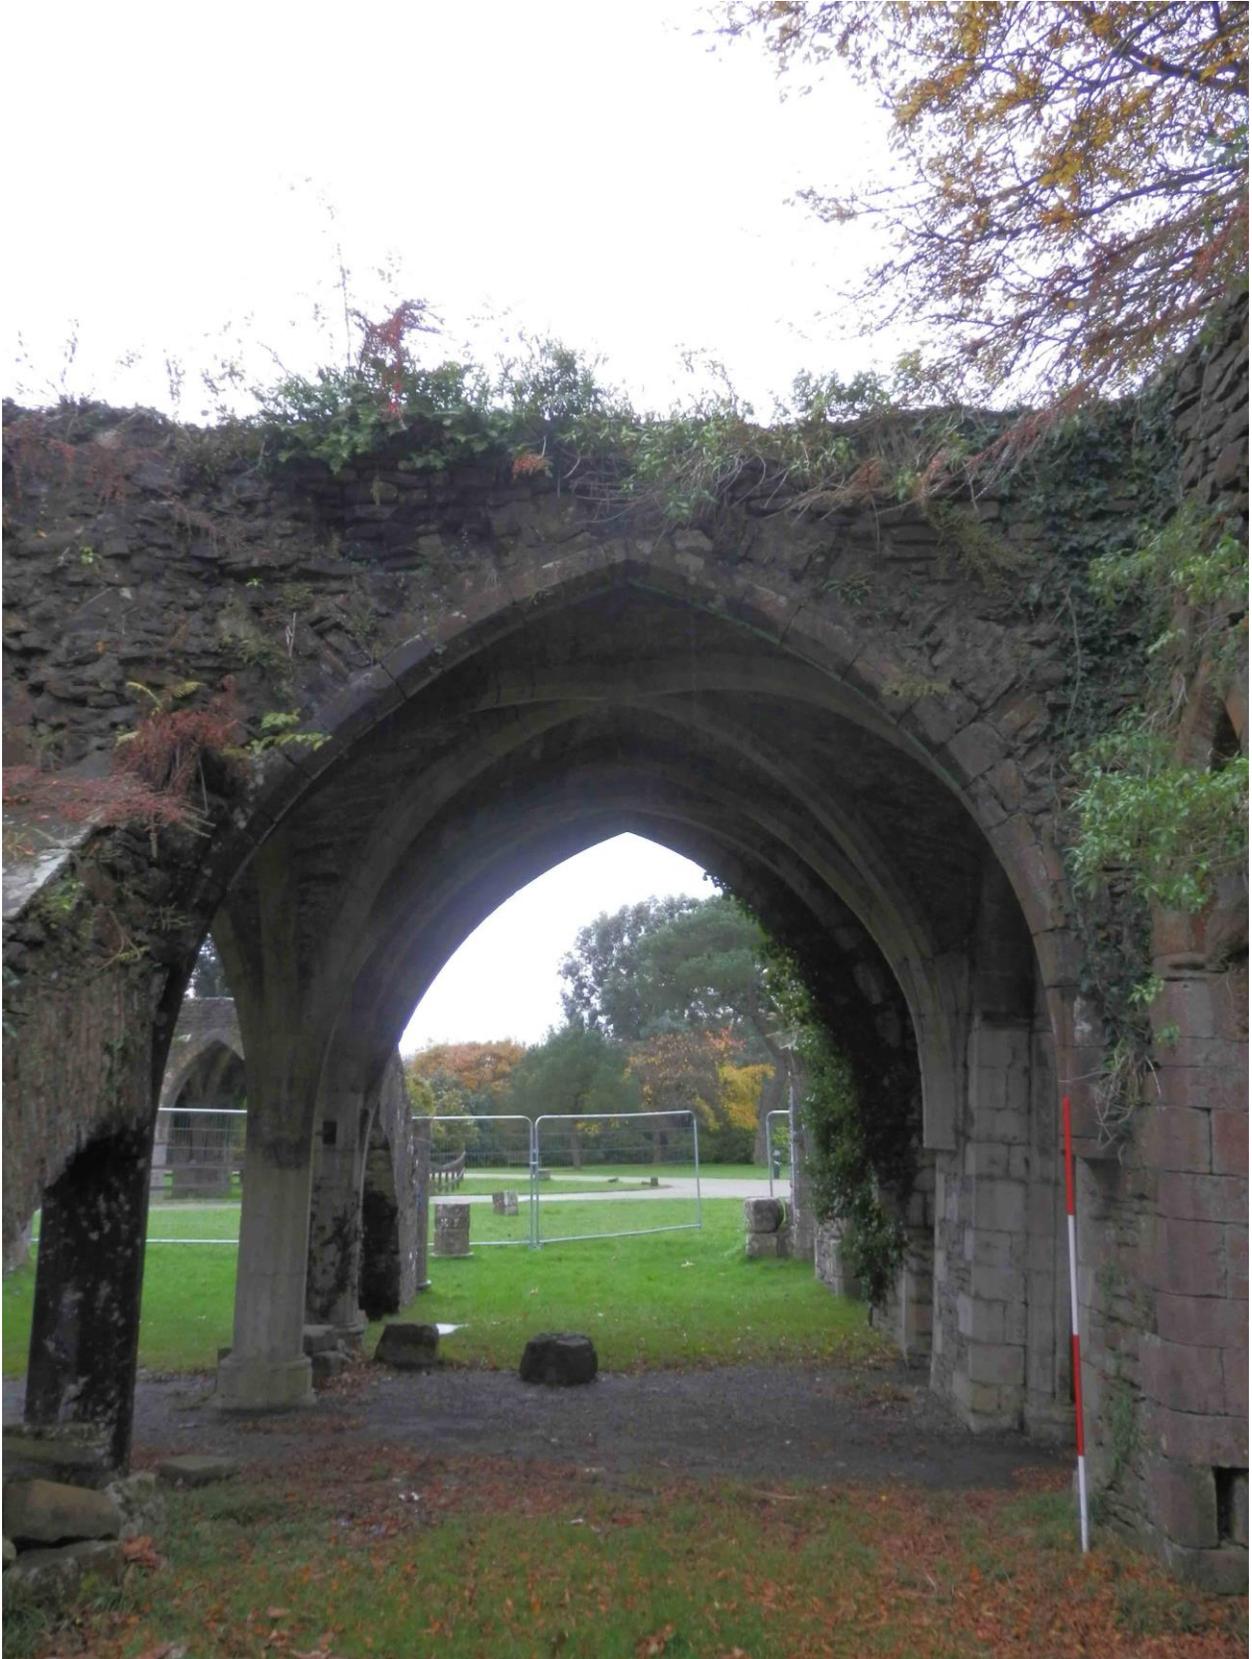
ID: 85 Site Number: 748 Site Name: Margam Monastic Ruins
Wall Number: 50 Photo Number: F2/36-39
Location: Vaulted arch east cloister, north side right-hand side
Description: Vaulted arch in ashlar, local sandstone rubble above. Top of wall obscured by vegetation. Some cracks right-hand side of arch, loose stone, with no mortar near the remains of the vaulting. Above this on wall more cracks and missing mortar. Vaulting rib is cracked along length. Gaps between stone work weathered. Seepage.
Condition summary: A) Loose and mortar free stone. B) Ashlar in arch crack right-hand side C) Vegetation on top. D) Loose stone work on top. E) Weathering on ashlar. F) Seepage left-hand side.
Threats: Weathering, Vegetation, seepage
Recorded by: Paul Minton Date: 26/09/12

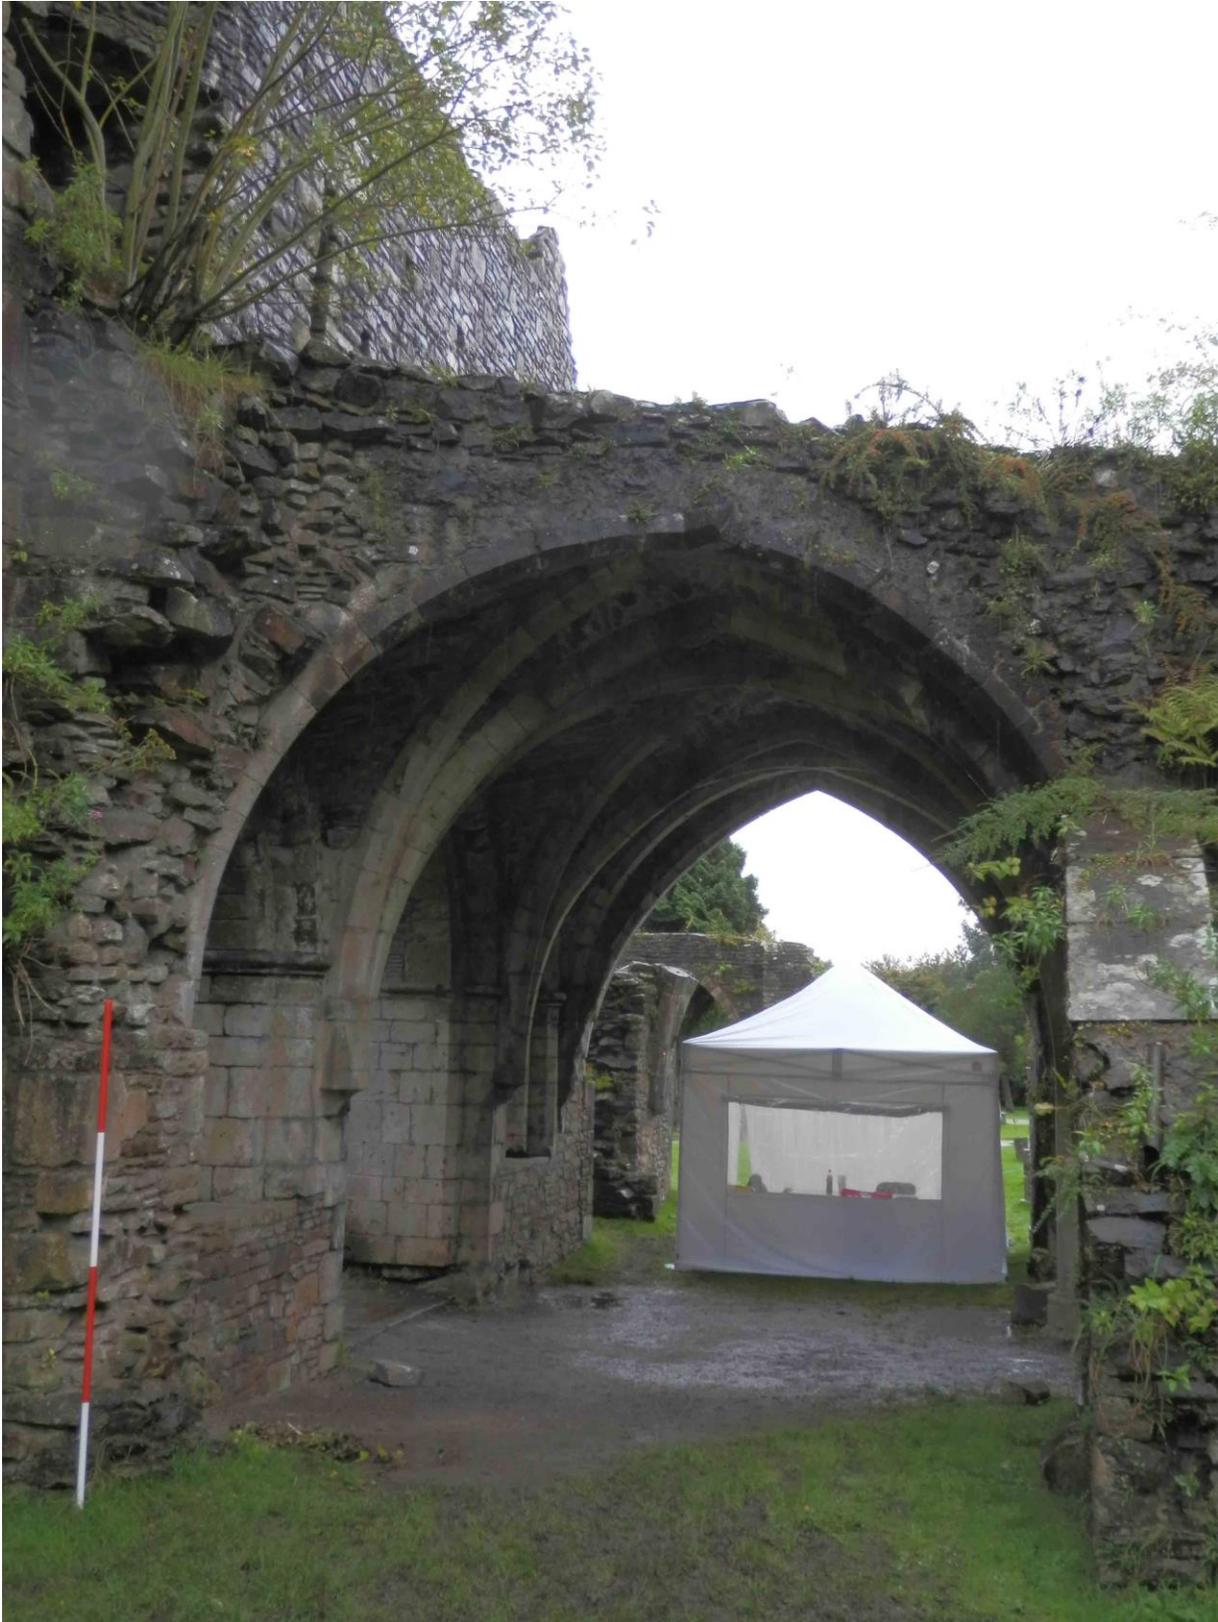
ID: 86 Site Number: 748 Site Name: Margam Monastic Ruins
Wall Number: 50 Photo Number: F3/28-31
Location: Vaulted arch east cloister, north side left hand side
Description: Vault arch in ashlar. The longitudinal rib of the vault projects slightly, indicating where there would originally have been another bay; some of the rubbles of haunches of this survives to project from the face of the standing bay. Right-hand side is supported by buttress (wall no.49). Right-hand side heavy water seepage.
Condition summary: A) Left-hand side arch; lower 1/2 some stones missing mortar. B) Left-hand side arch; protruding stone potential to weather, loose - danger to visitors. C) Loose stone on top. D) Vegetation. E) Seepage
Threats: Weathering, Vegetation, seepage
Recorded by: Paul Minton Date:26/09/12

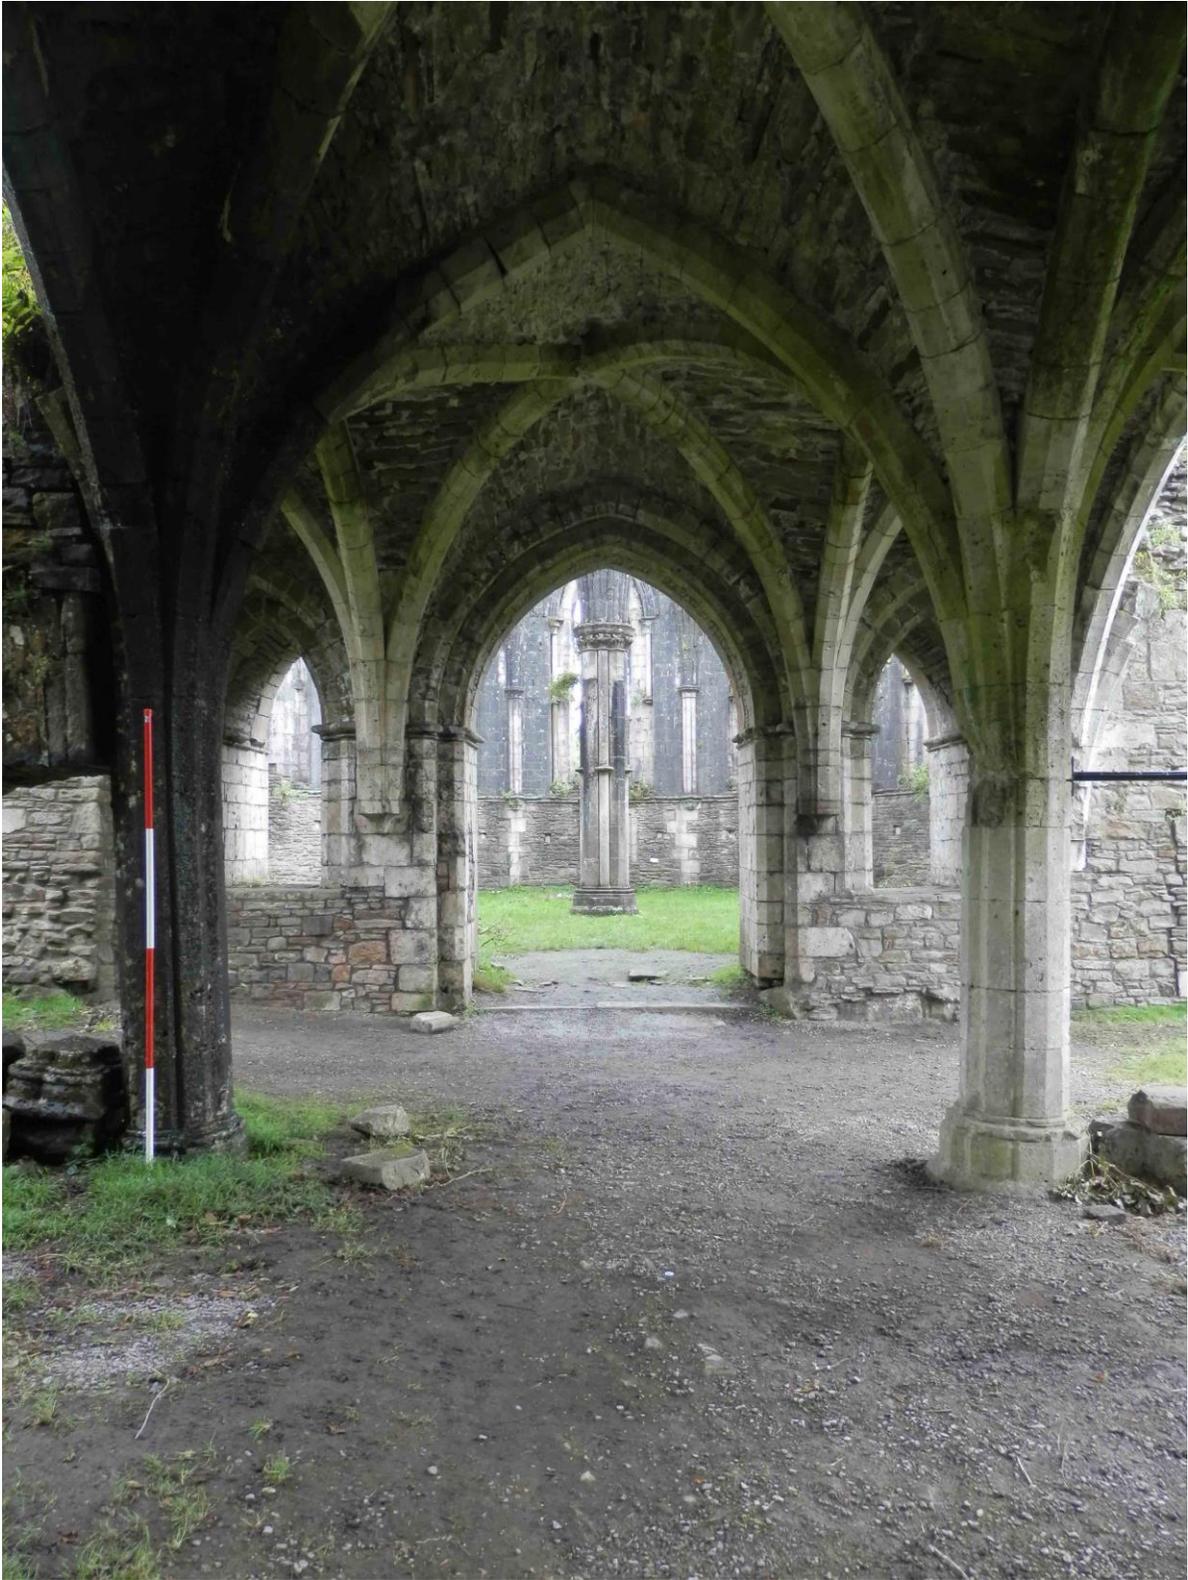
ID: 87 Site Number: 748 Site Name: Margam Monastic Ruins
Wall Number: 51 Photo Number: F2/56-57
Location: Central bay of east cloister, (west face)
Description: Ashlar columns and archway. Right side of arch and right pillar turning green with moss. Carved pillar bases. Large dent in right pillar. Serious leaking on left column - can turn black during rain. Drips leaking all the way down from chips in ashlar. Left base seems to be sinking into the ground - lower than right base. Local rubble forms vault.
Condition summary: A) Dent on right column where stone has come away - weak point. B) Water leaking and dripping down left column. Constant rain and time can cause collapse on left side. C) Parts of stone has come away on left side of arch and column allowing leaks. D) Crack in stone on vaulting on right of arch. E) Mortar missing between stones -weak-may fall - stone wedged in place to secure. F) Some weathering of base of columns

Threats: Weathering, Vegetation, damp, water erosion
Recorded by: Sarah Baker Date: 26/09/2012

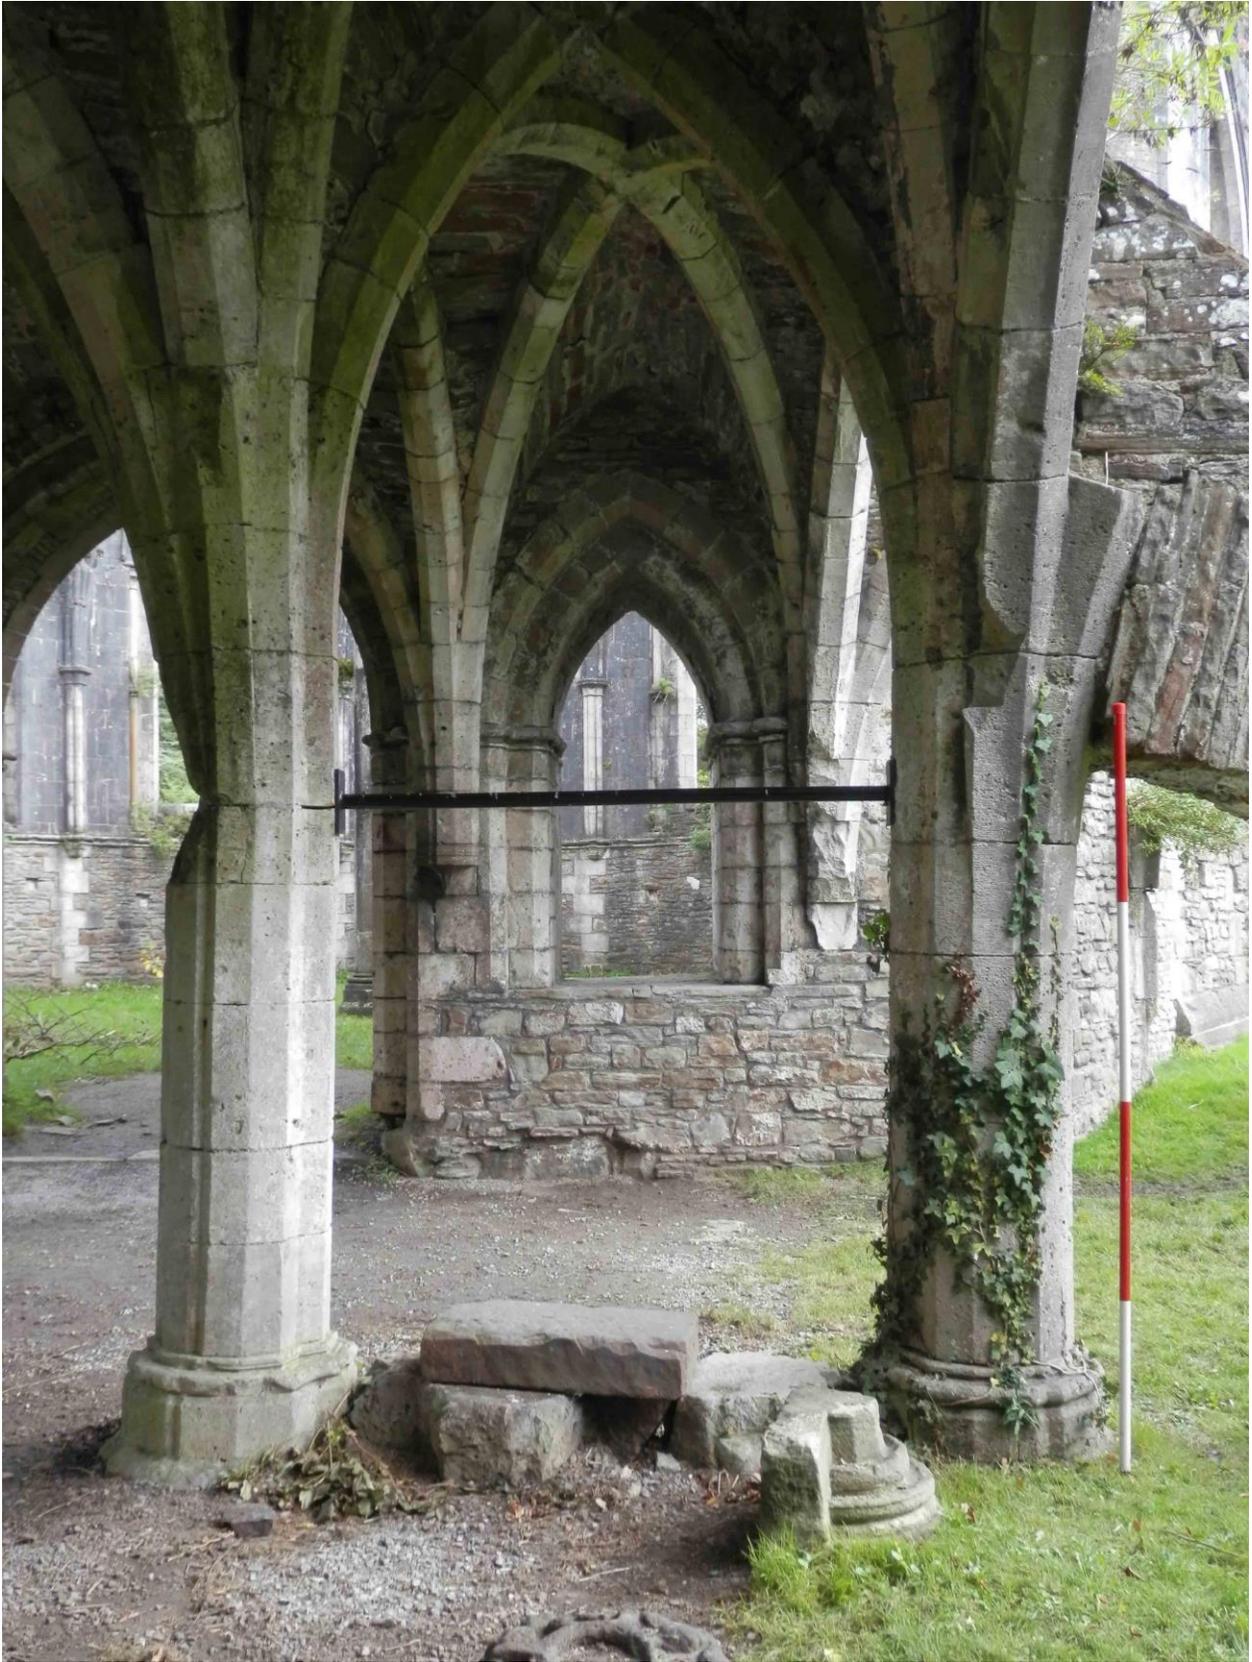
ID: 88 Site Number:748Site
Name: Margam Monastic Ruins
Wall Number: 52 Photo Number:F2/58
Location: East cloister south surviving bay (west face)
Description: Vault ribs and pillars ashlar. Metal bracing bar horizontal at height of 1.5m from ground. Left-hand side pillar - joint at bracing bar has sprung slightly. Pillars - roughly hexagonal shape, moulded bases. Arch mirrors shape of exterior chapter house window. Loose stone on ground between pillars, includes 1/2 of a moulded column base. Right-hand side pillar still supports ribs for two complete arches and part of another. Left-hand side pillar has ribs for three complete arches, and one damaged.
Condition summary: A) Right-hand side pillar 5th and 6th blocks damaged. B) Damage to right-hand pillar. C) Left-hand pillar leans slight, with sprung joint next to bracing bar. D) Right-hand pillar vegetation. E) Damage to masonry left side of left-hand side pillar. F) Gaps in vaulting ribs.

Threats: Weathering, Vegetation, Structure movement
Recorded by: Paul Minton Date: 26/09/12

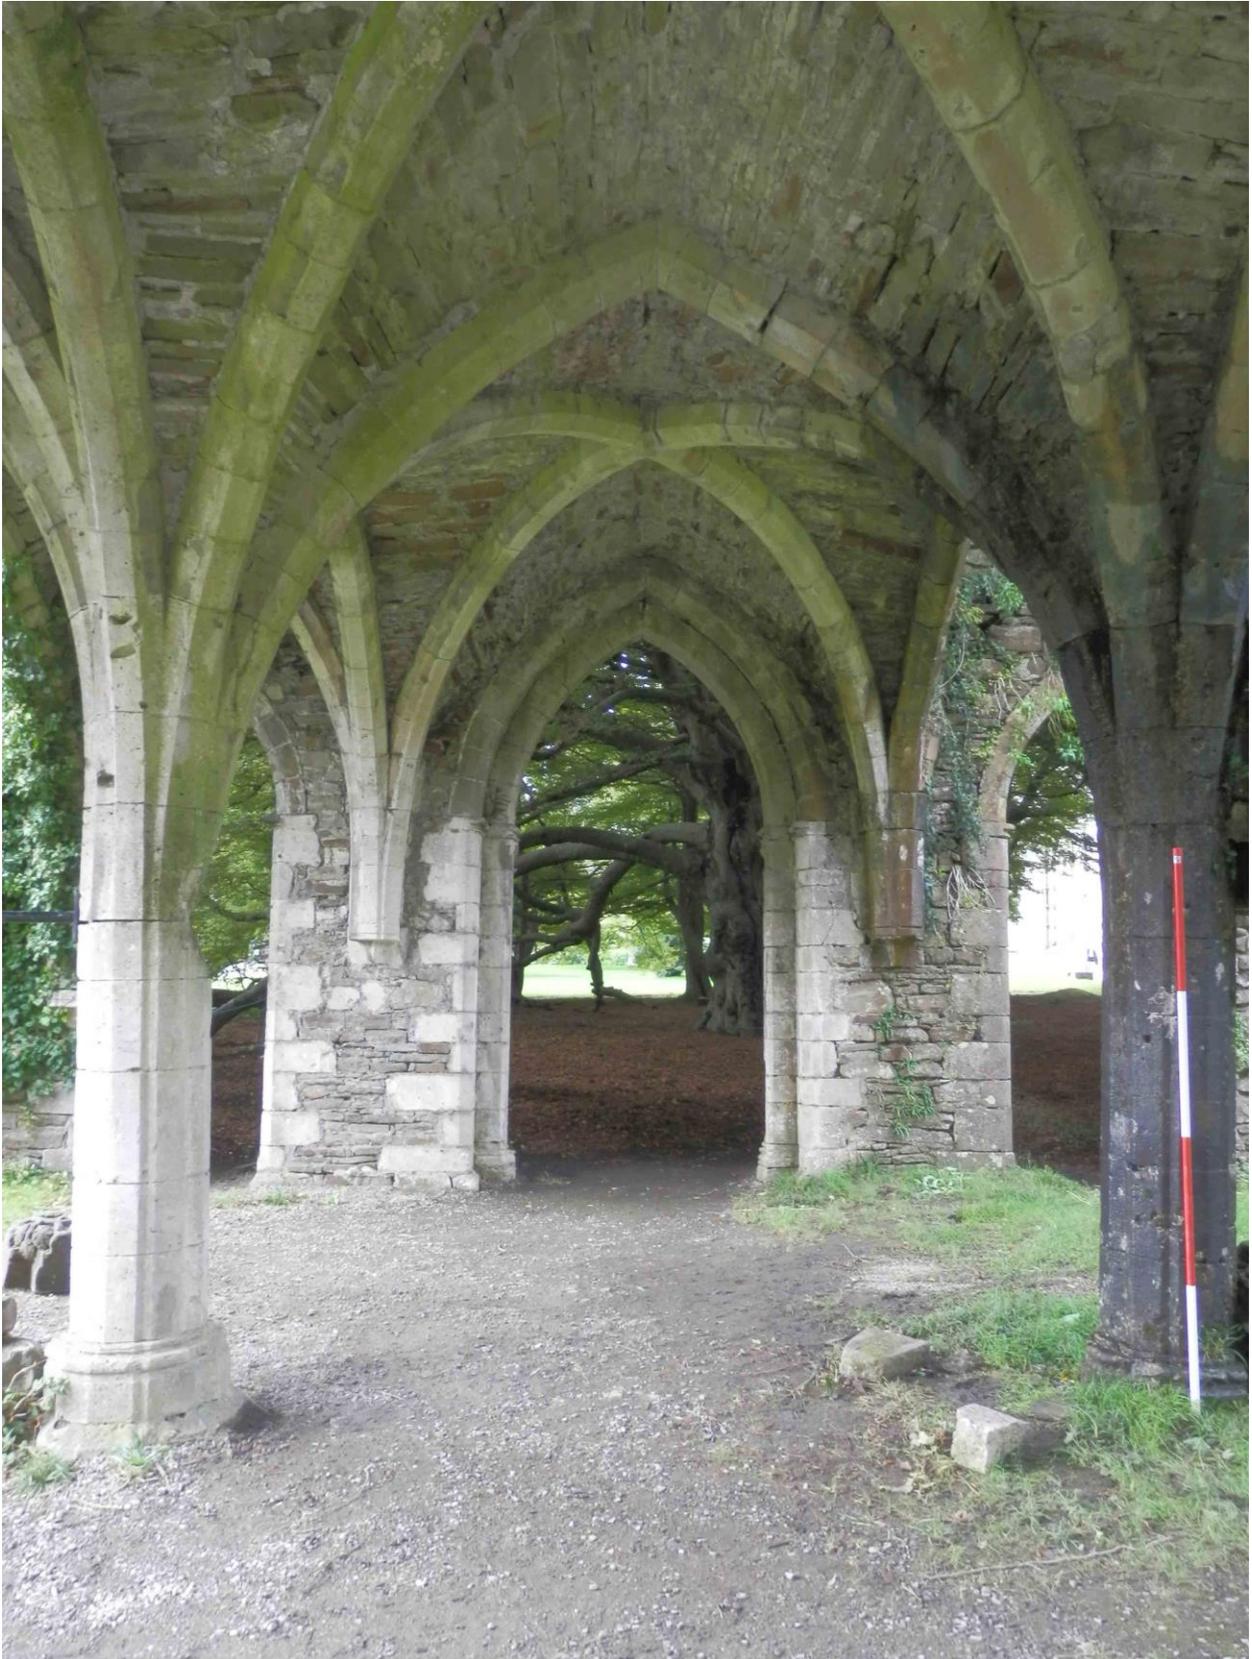
ID: 90 Site Number: 748 Site Name: Margam Monastic Ruins
Wall Number: 54 Photo Number: F2/52-55
Location: Central bay of east cloister, (east face).
Description: Two ashlar pillars facing west to support arch and a vaulted ceiling. Right side is supported by modern buttress. Vault is comprised of Sandstone rubble, which appears to be stabilized lately.
Condition summary: A) Right-hand pillar - water damage due to blocked drainage in buttress. B) Right-hand pillar has damage to 7th and 8th stones. C) Right-hand side of arch has section of mortar missing at the 2nd stones from apex. D) Arch has generally mortar missing. E) Left-hand side of arch has crack on the 2nd block from to springing of arch. F) Right hand side of pillar has a number of small areas of damage due to weather and water. G) Base of left-hand pillar has a number of small areas of damage due to weather. H) Right-hand side of vault 1/2 way up - water damage causing loss of mortar. I) Left hand side of vault 1/2 way up - weather damage + loss of mortar. J) Top section of arch has been re-pointed roughly with some mortar damage.

Threats: Weathering, Vegetation, Water, people
Recorded by: John Robertson Date: 27/09/2012

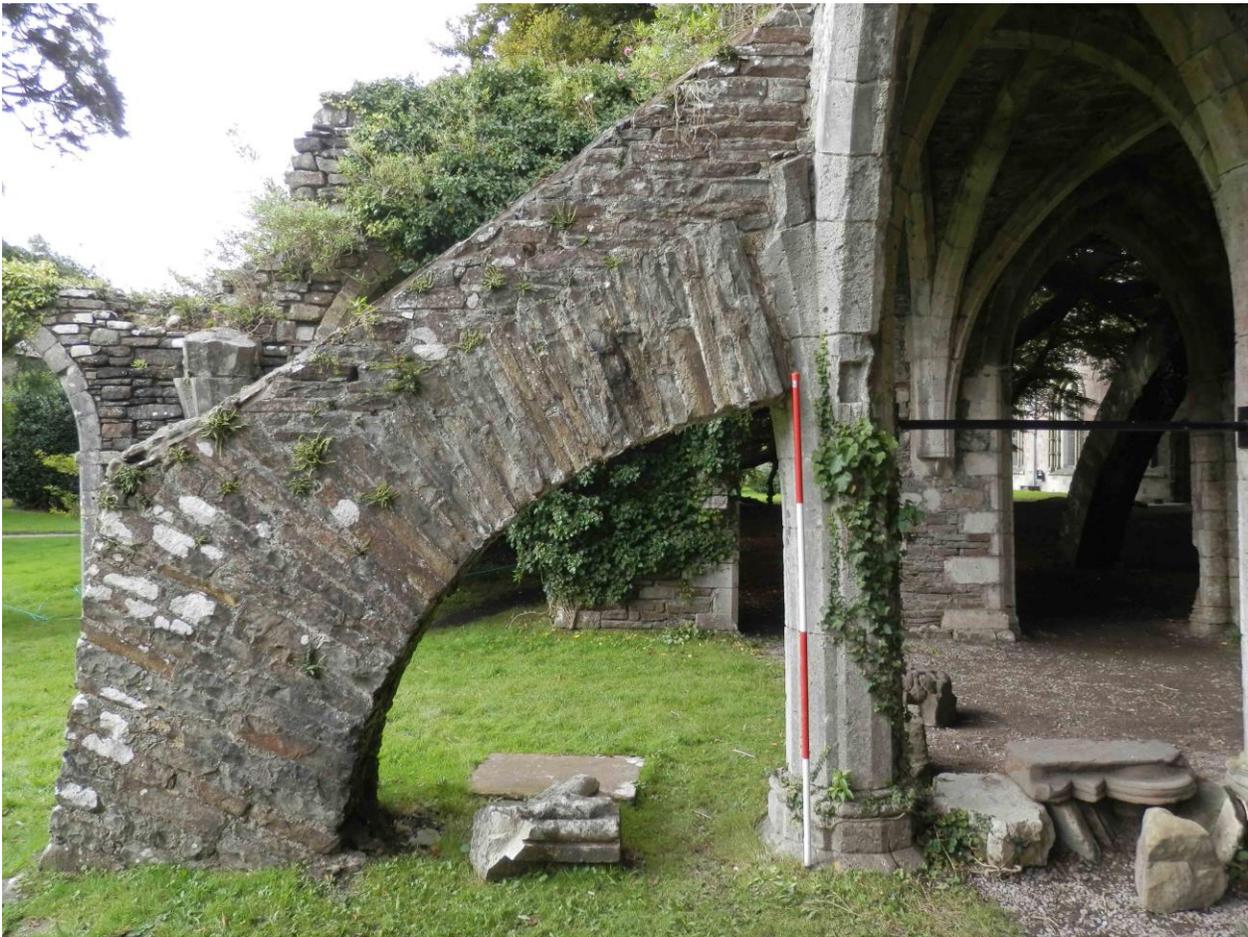
ID: 91 Site Number: 748 Site Name: Margam Monastic Ruins
Wall Number: 55 Photo Number: F2/59
Location: South Buttress, east cloister (not part of original abbey fabric), east face
Description: Buttress supports south pillar of remaining section of cloister. Underlying arch of cloister has lime residue deposits. Buttress made of local sandstone (mostly made of small pieces at arched area stones are laid following the arch. The buttress is not contemporary with the abbey. Small amount of vegetation to side. On the top of the buttress slab capping no longer in place - cement/mortar only. In the rest of the wall mortar is in reasonable condition.
Condition summary: A) Underneath of arch has lime residue building up. B) Small amount of vegetation to the side. C) Slab capstones on top of buttress no longer in place, cement only remains. D) No serious cracking to wall, mortar in reasonable condition

Threats: Weathering, Vegetation, water damage
Recorded by: Julian T. James Date: 27/09/2012

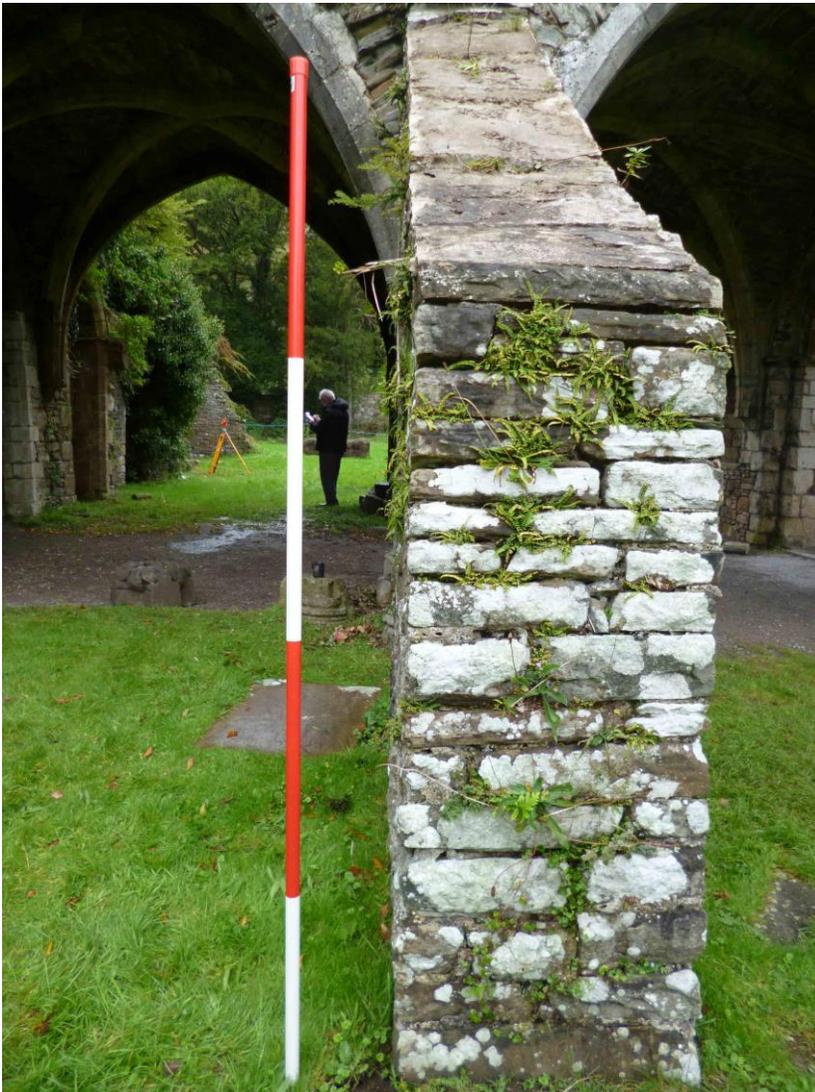
ID: 92 Site Number: 748 Site Name: Margam Monastic Ruins
Wall Number: 56 Photo Number: F2/60
Location: South Buttress, east cloister (not part of original abbey fabric) end on
Description: Buttress consists of local sandstone coursed rubble. The buttress was capped with slabs which are now removed. Base of buttress built on top of another slab, but not certain if this underlies the whole of the bottom section. Buttress runs up at an angle to support south outer wall of cloister walk (against the pillar).
Condition summary: A) Slabs missing from top of buttress. B) erosion of mortar from between stonework. C) Vegetation growing between joints, (fern, etc.). D) Courses at the bottom off horizontal ?possibly sinking
Threats: Weathering, Vegetation, mortar washed out of joints
Recorded by: Jeff Jones Date: 27/09/2012
