Monastic Margam Community Survey Project

Report for Cadw
by Sam Pamment BA

GGAT report no. 2013/020
NGR: SS 8018 8626
Project no. GGAT 123

Summary

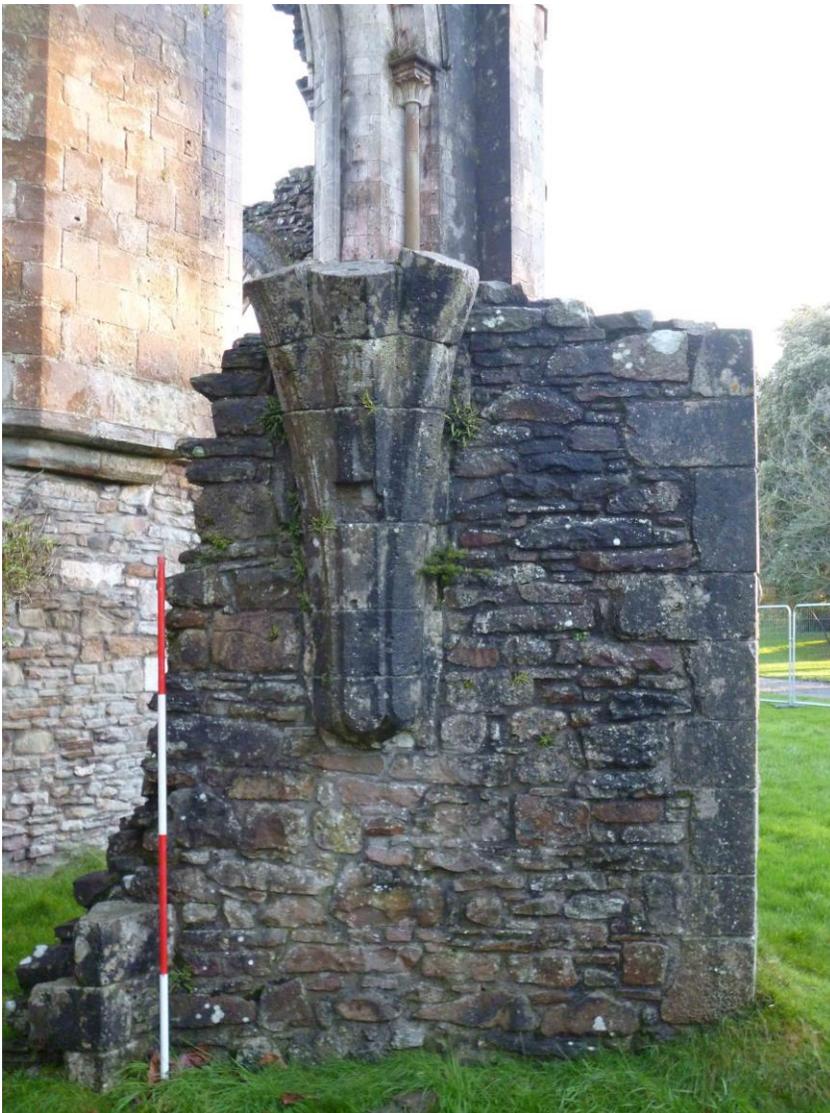
ID: 94 Site Number: 748 Site Name: Margam Monastic Ruins
Wall Number: 58 Photo Number: F2/62
Location: East cloister east wall, internal (plus small section of return at west side)
Description: Local sandstone rubble wall quoined with ashlar blocks right-hand side
Return on the right hand side of wall has same quoins. There is a the
springing of a vault with a square socket in the centre, possibly cut
to support a beam. Mortar inside seems to be in good condition.
Condition summary: A) Vegetation growing out of parts of wall (sapling growing out of joint
Between wall and ribs for vault). B) General weathering of quoin (bottom
right). C) Some slight weathering of vaulting ribs.
Threats: Weathering, Vegetation
Recorded by: Jeff Jones Date: 27/09/2012

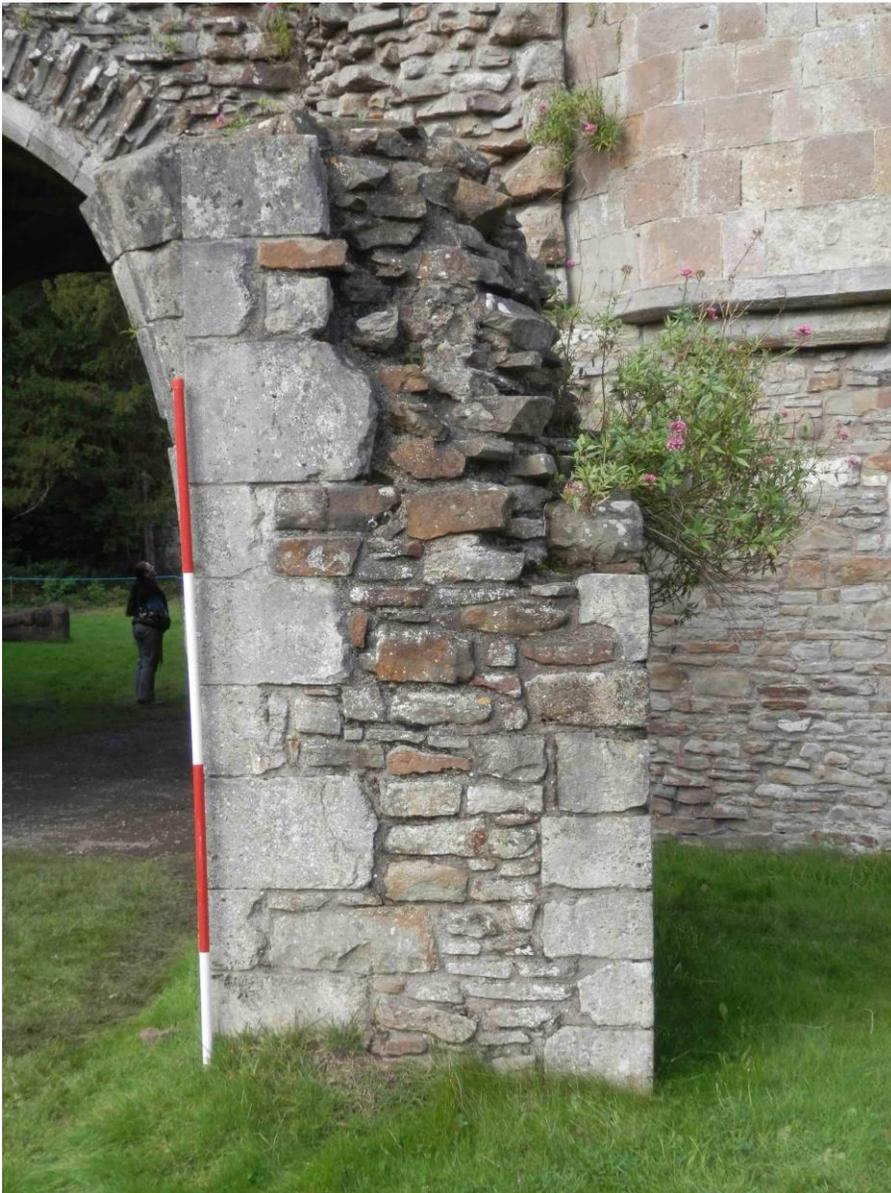
ID: 95 Site Number: 748 Site Name: Margam Monastic Ruins
Wall Number: 59 Photo Number: F2/68
Location: East cloister west wall. South end
Description: South end of east cloister, west wall. Coursed sandstone rubble quoined with ashlar blocks. Face of wall rises for about 1.62m, above which only the core survives. Quoin on the left corner rises to the full height of the standing remains
Condition summary: A) No visible damage, no work needed on this wall face
Threats: Weathering, Vegetation
Recorded by: Ruth Hopkins Date: 28/09/2012

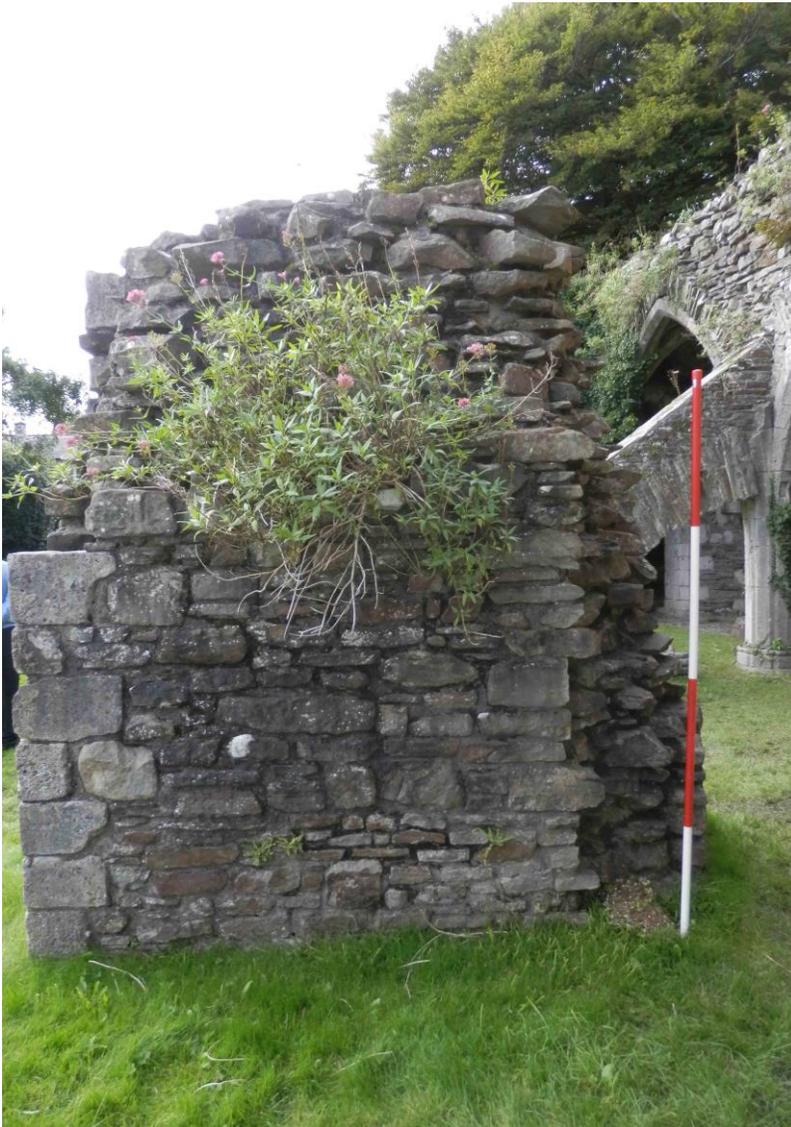
ID: 96 Site Number: 748 Site Name: Margam Monastic Ruins
Wall Number: 60 Photo Number: F2/69
Location: East cloister east wall – Ext.
Description: Wall has coursed rubble face to a height of 1.70m, and then continues to top as unfaced core . The left hand side of the wall has an ashlar quoin. The mortar joints are in good condition
Condition summary: A) Weathering of quoin. B) Vegetation present in centre of wall (valerian), with some ferns growing at the bottom. C) Water running down the face of wall after heavy rainfall.
Threats: Weathering, Vegetation
Recorded by: Jeff Jones Date: 28/09/2012

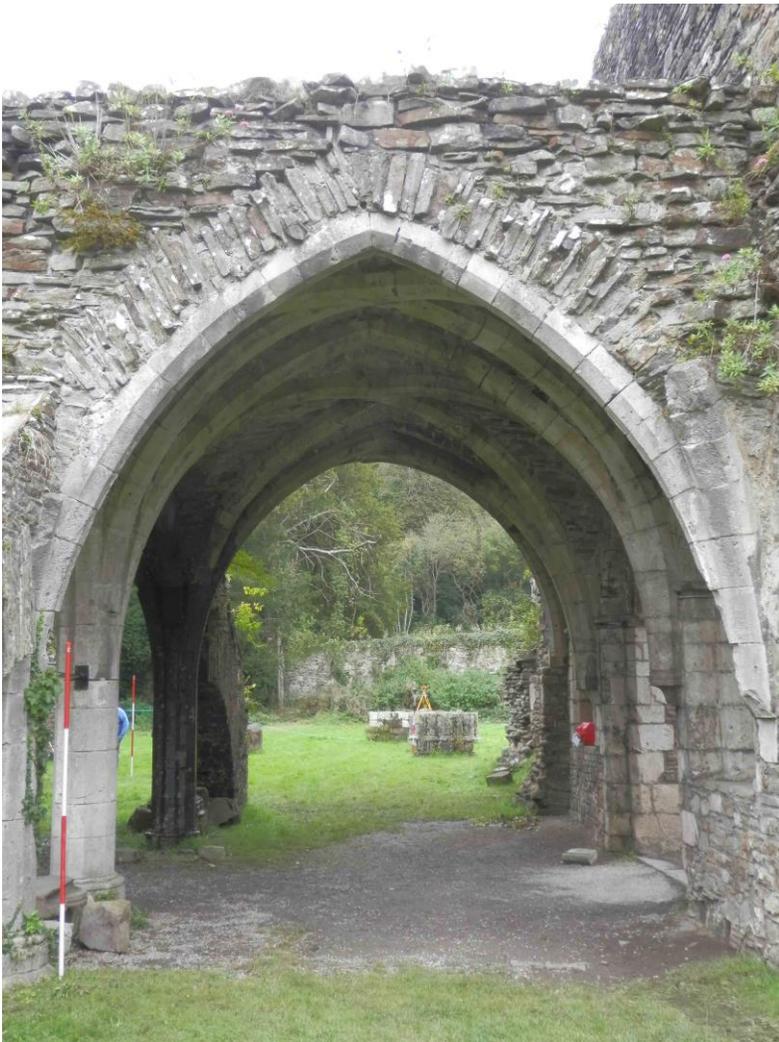
ID: 98 Site Number: 748 Site Name: Margam Monastic Ruins
Wall Number: 62 Photo Number: F2/73-74
Location: Vaulted arch east cloister south end east arch.
Description: Large archway supports a vaulted roof. Arch way of dressed stone with a rubble relieving arch and coursed rubble above. Left pillar is intact, right side of arch support by bracket built in external face of the chapter house wall. Shored up by a buttress (wall no.55)
Condition summary: A) Loose stones on top. B) Vegetation is growing on top of wall. C) Pillars and arch have some broken stones. D) Bracket on right pillar damaged. E) Vegetation growing on the right side about vaulting pushing some stones out. F) Weathering on stones above archway.
Threats: Weathering, Vegetation, loose stones on top. Vegetation is pushing some stones out.
Recorded by: Ruth Hopkins Date: 29/09/2012

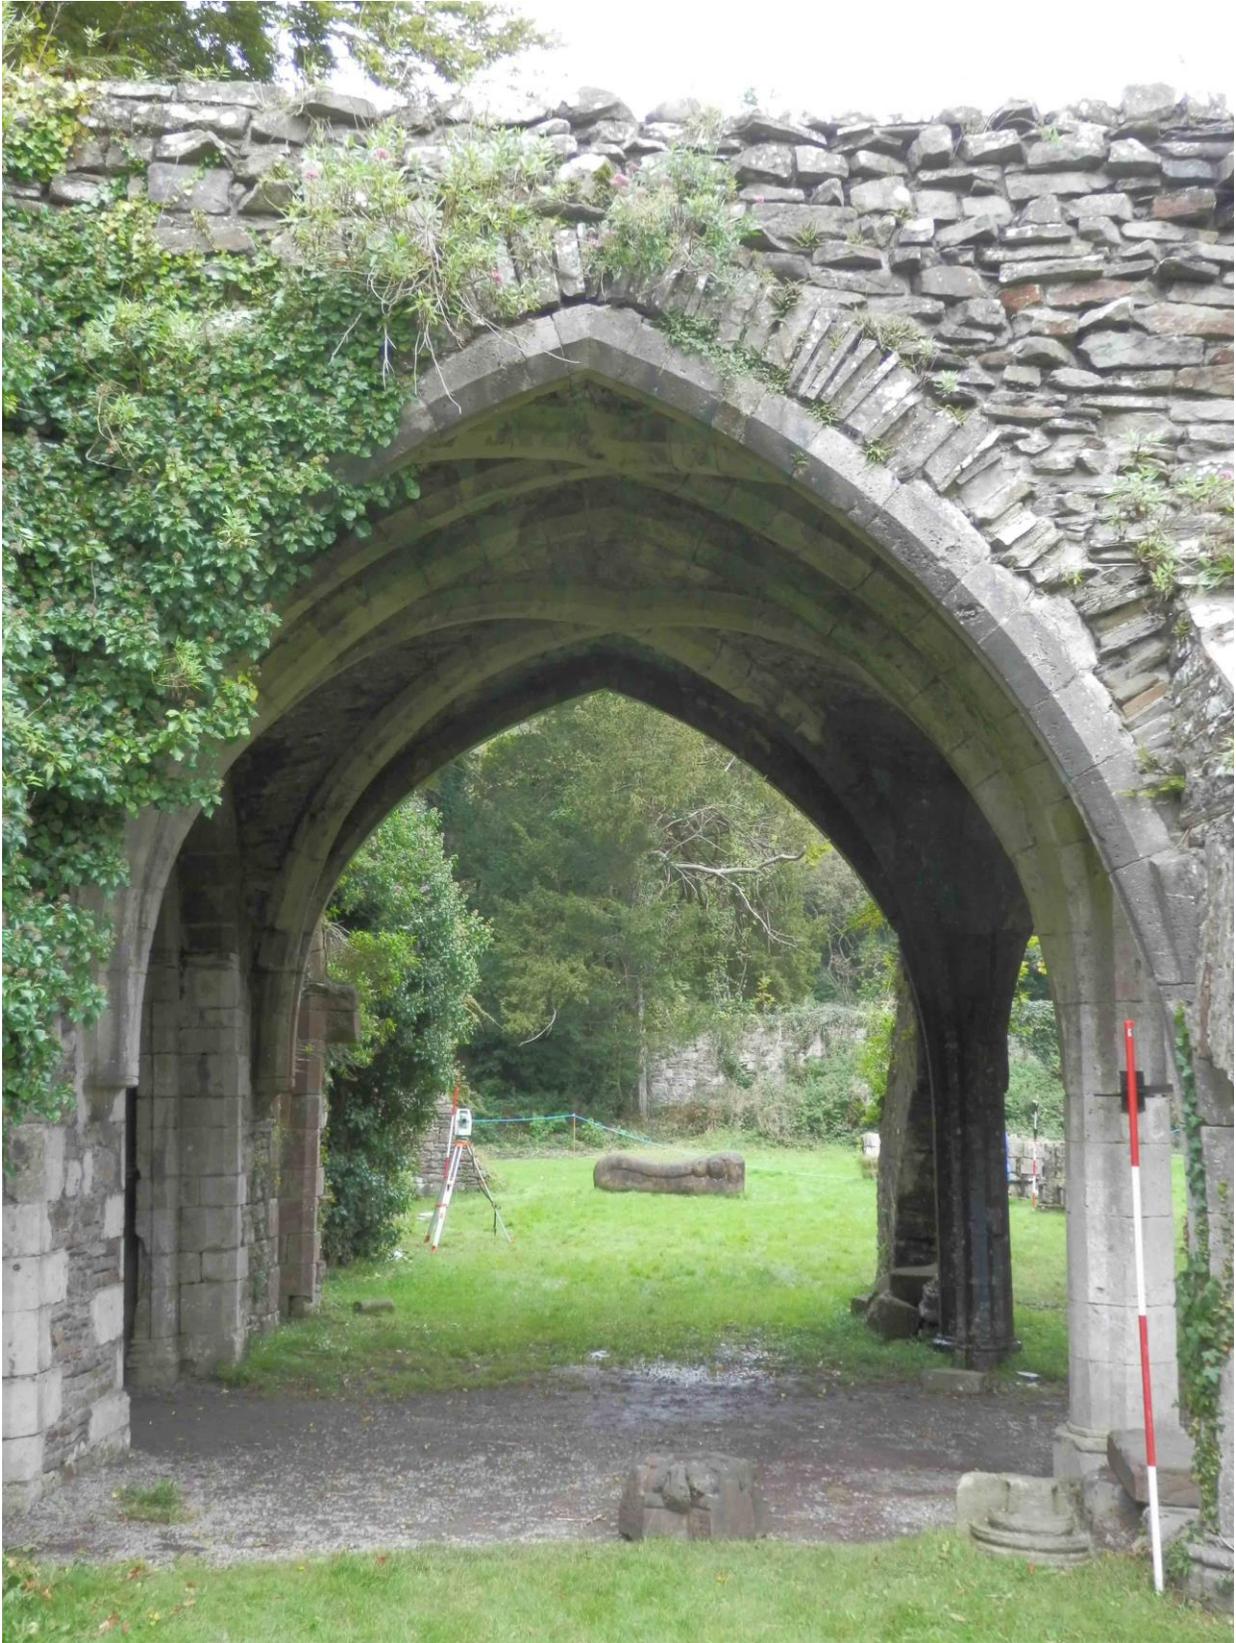
ID: 99 Site Number: 748 Site Name: Margam Monastic Ruins
Wall Number: 63 Photo Number: F2/75-76
Location: Vaulted arch east cloister south end west arch. Ext.
Description: Arch consists of ashlar block chamfered at corners. The arch is supported on the left hand side by a bracket built into the wall, while on the right hand side the arch is supported by an ashlar pillar from ground level. There is a rubble relieving arch over the ashlar. Above is local sand stone rubble of which the top section needs to be checked for any which are loose. The mortar infill at the bottom ends looks to be ok, but the top end requires inspection.
Condition summary: A) Excessive vegetation on west side of arch (ivy) with same running up the line of arch, also growth of same at top of arch, also ivy climbing up right hand support pillar. B) Pointing of stonework at top of arch badly eroded. C) Weathering of ashlar on east side of arch. D) Section of wall between the west/east arch being supported by buttress. E) Left hand support bracket starting to split away from bottom end of arch. F) Split in pillar base.

Threats: Weathering, Vegetation,
Recorded by: Jeff Jones Date: 29/09/2012

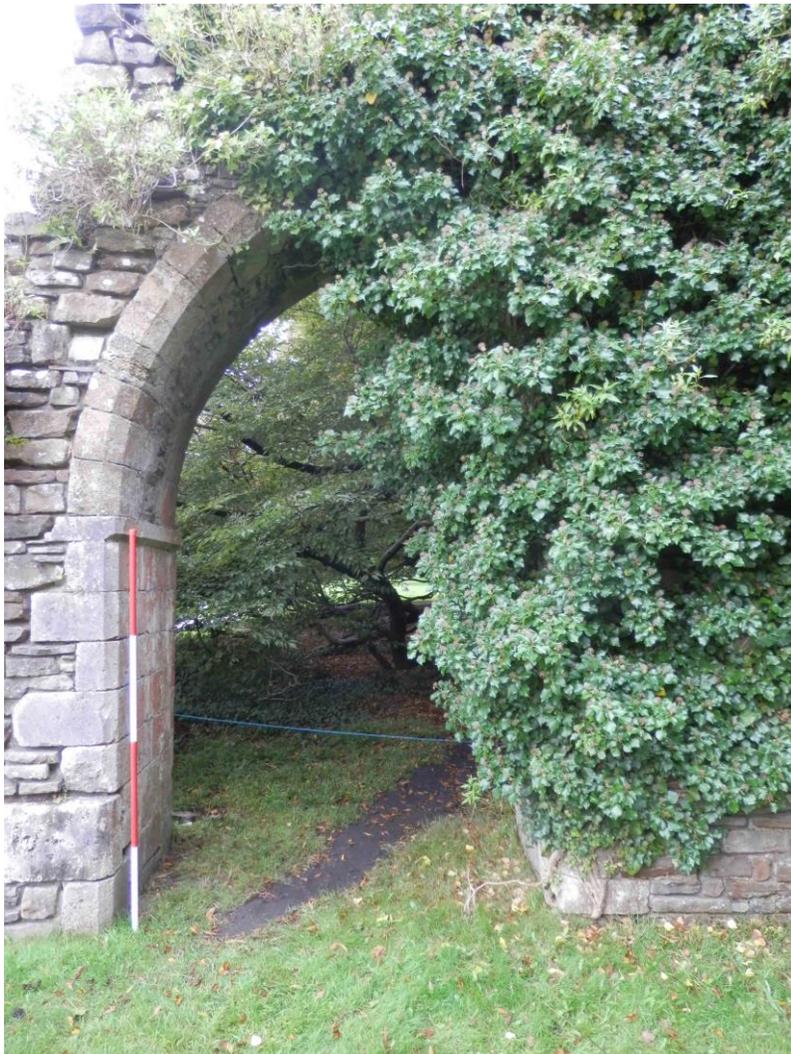
Description: Arch window/door west wall. Ashlar facings for archway. Wall in sandstone rubble. Archway complete, with right hand side covered in ivy (dense) obscuring any detail and damage. Approx 1.2m of sandstone wall above arch. Putlog hole on left hand side of arch. Vegetation to and right hand side of arch.

Condition Summary: A) Weathered corner bottom stones left hand side of arch. B) Mortar missing on sandstone rubble left hand side of arch. C) Above left hand side arch, vegetation growing out of stone. D) Above arch and down right hand side ivy completely covering.

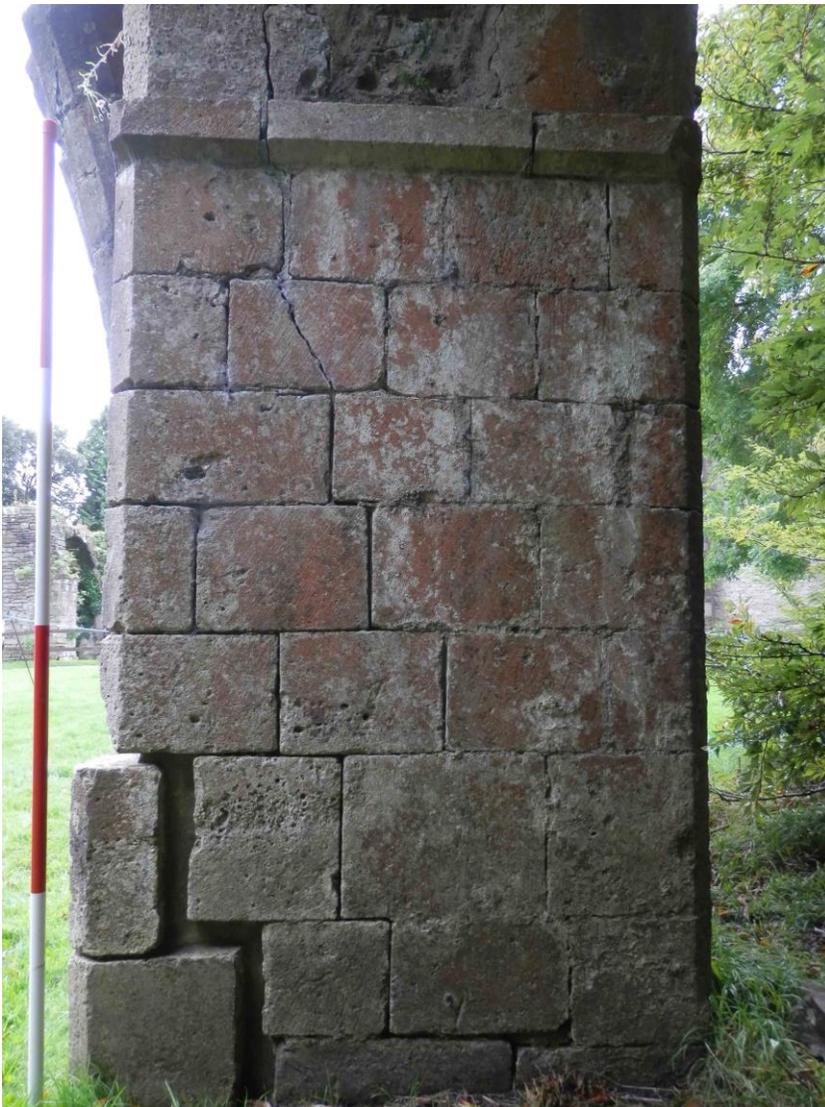
ID: 107 Site Number: 748 Site Name: Margam Monastic Ruins
Wall Number: 71.1 Photo Number: F2/81
Location: East cloister west wall inside arch (wall 70) south face
Description: Lower half ashlar with string course at height of 2m. Above string course, ashlar quoins on both outer edges with core of sandstone rubble- this has been cemented in the past.
Condition Summary: A) Crack starting from 6th course continues vertically up through arch. B) Lower left hand side 2 stones are misplaced; the gap has been filled with concrete. C) The core which has been cemented and may crack in future.
Threats: Vegetation, Erosion, structural weakening
Recorded by: Roy Thomas Date: 01/10/2012

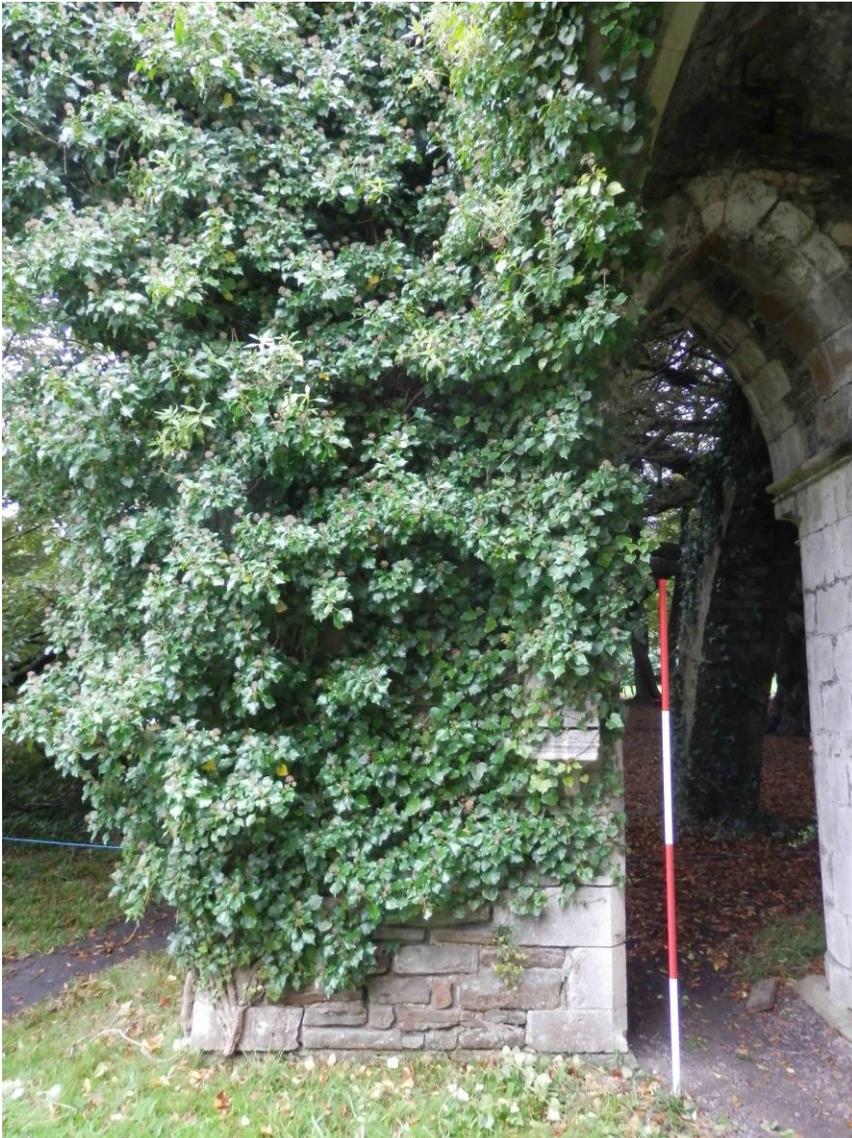
ID: 109 Site Number: 748 Site Name: Margam Monastic Ruins
Wall Number: 72 Photo Number: F2/85
Location: East cloister west wall Int.
Description: Wall 98% covered in ivy, some weather damage to bottom right-hand corner (mortar). Ashlar quoins on each corner, rubble in centre. On the right-hand side there is a bracket to support the vault.
Condition Summary: A) Extensive Ivy coverage. B) Mortar damage. Weathering
Threats: Vegetation (ivy) weathering mortar)
Recorded by: Bob Hardwick Date: 01/10/2012

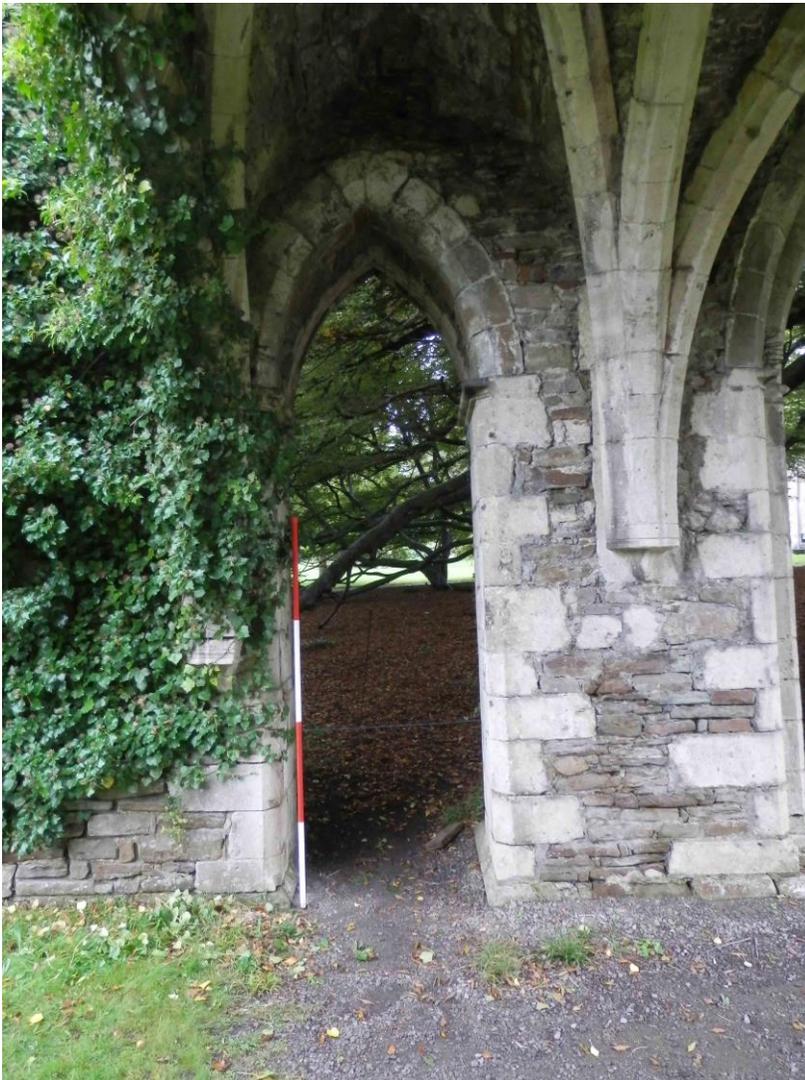
ID: 110 Site Number: 748 Site Name: Margam Monastic Ruins
Wall Number: 73 Photo Number: F2/84
Location: East cloister west wall Int.
Description: Archway between two brackets supporting the vaulting. Archway is off-centre - tight against left-hand bracket, but with c0.6m space to right-hand bracket - archway has ashlar dressings to the height of c2.4m foot where there is a string course; ashlar blocks continue above to form arch. Rest of wall in sandstone rubble. Left-hand side has ivy coverage.
Condition Summary: A) Pointing in wall has weathered away - leaving right-hand edge of arch with gaps from wall. B) Base of left-hand vaulting bracket has a gap where 2 pieces are separating.
Threats: Vegetation, Weathering
Recorded by: Roy Thomas Date: 01/10/2012

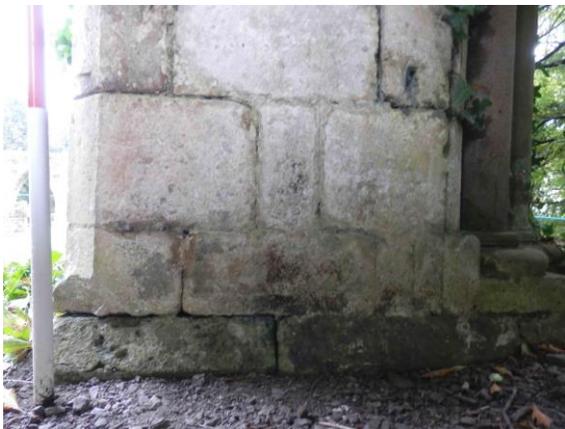
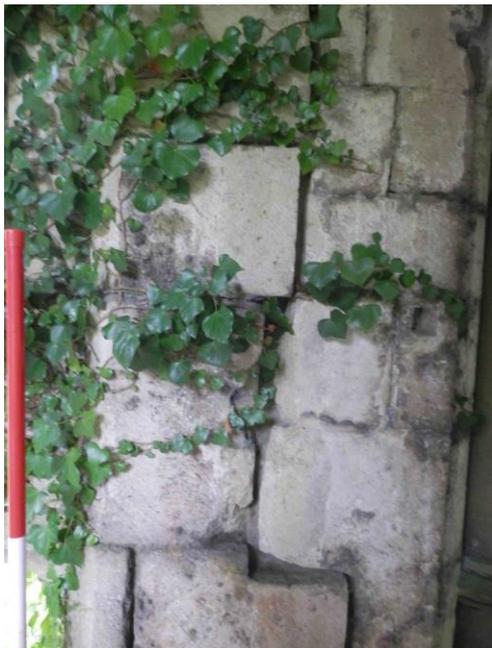
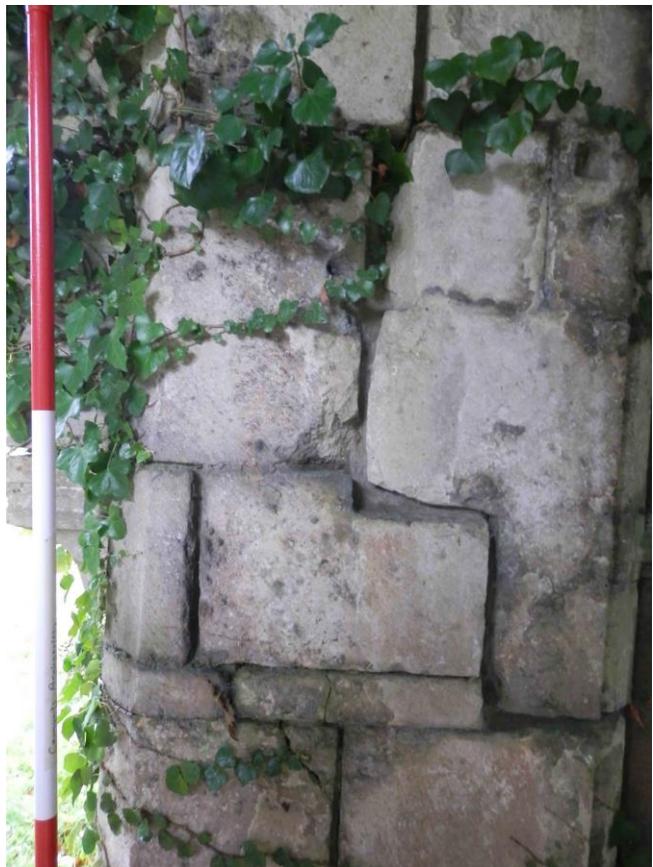
ID: 111 Site Number: 748 Site Name: Margam Monastic Ruins
Wall Number: 74.1 Photo Number: F2/87-88-89-
Location: East cloister west wall inside face south (wall 73)
Description: All ashlar. Inside archway (south face of 73) 2 holes for fittings right-hand side String course at springing of arch head, then dressed stone of outside of arch and sandstone rubble on inside. Right-hand side (exterior centre face) fissured, and repaired with cement.
Condition Summary: A) From moulding down - fissure has been cemented (will cause future damage). B) Some minor ivy growth in and around the fissure. C) Moulding damage (weathering)
Threats: Vegetation, Weathering
Recorded by: Bob Hardwick Date: 01/10/2012

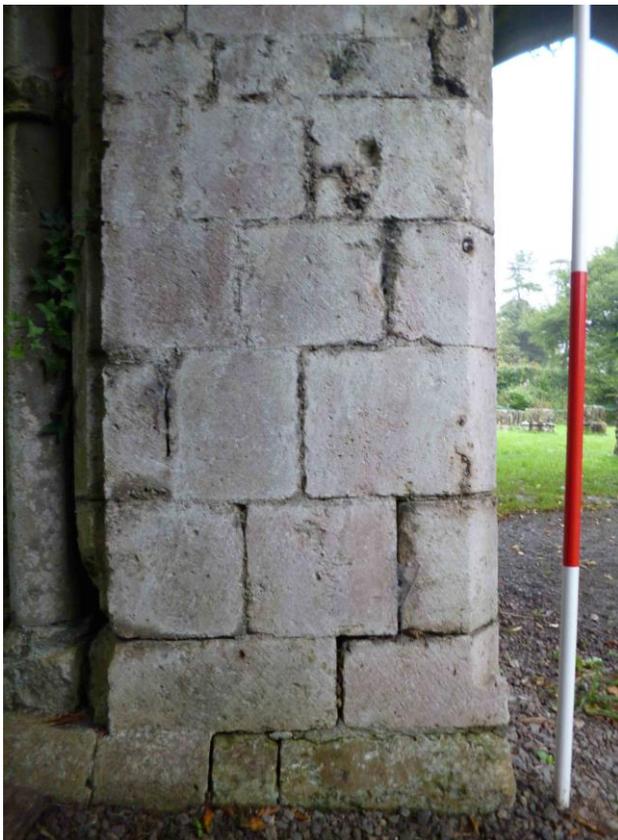
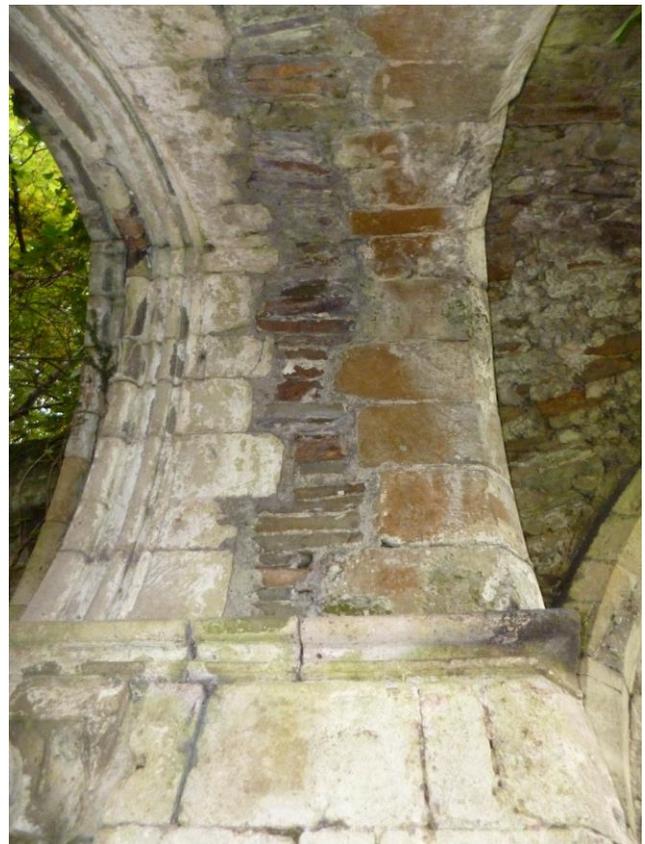
ID: 112 Site Number: 748 Site Name: Margam Monastic Ruins
Wall Number: 74.2 Photo Number: F2/92-94
Location: East cloister west wall inside face north (wall 73)
Description: Ashlar blocks of up to height of c2.4m foot, string course, arch springs from there with ashlar both sides but with a sandstone rubble core. Left hand side of arch has a shaft in the angle, up to the string course, with mouldings on the external face of the arch.
Condition Summary: A) The arch is leaning out to the west. B) A crack starting one course below string course runs through right-hand string course up the arch following the dressings.
Threats: Weathering, Vegetation
Recorded by: Roy Thomas Date: 01/10/2012

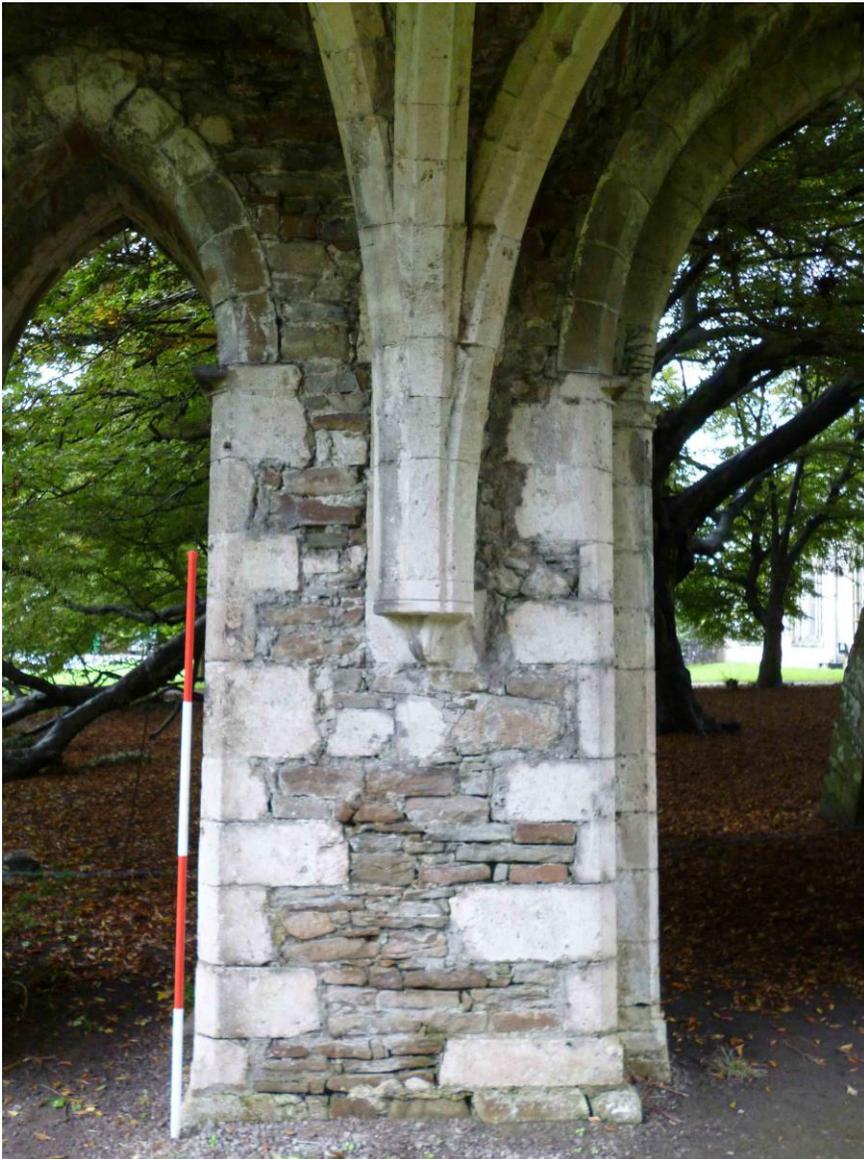
ID: 113 Site Number: 748 Site Name: Margam Monastic Ruins
Wall Number: 75 Photo Number: F2/113
Location: East cloister west wall Int.
Description: Wall of sandstone rubble quoined with ashlar blocks at the archways.
In centre of wall (approx. 1.5m from floor) a bracket supports the ribs for the vault.
Condition Summary: A) Weather damage to sandstone rubble (gaps in many areas) - missing mortar (parts re-pointed - not well done) mostly now missing, cement used. B) Weathering on brackets.
Threats: Weathering, Vegetation
Recorded by: Bob Hardwick Date: 01/10/2012

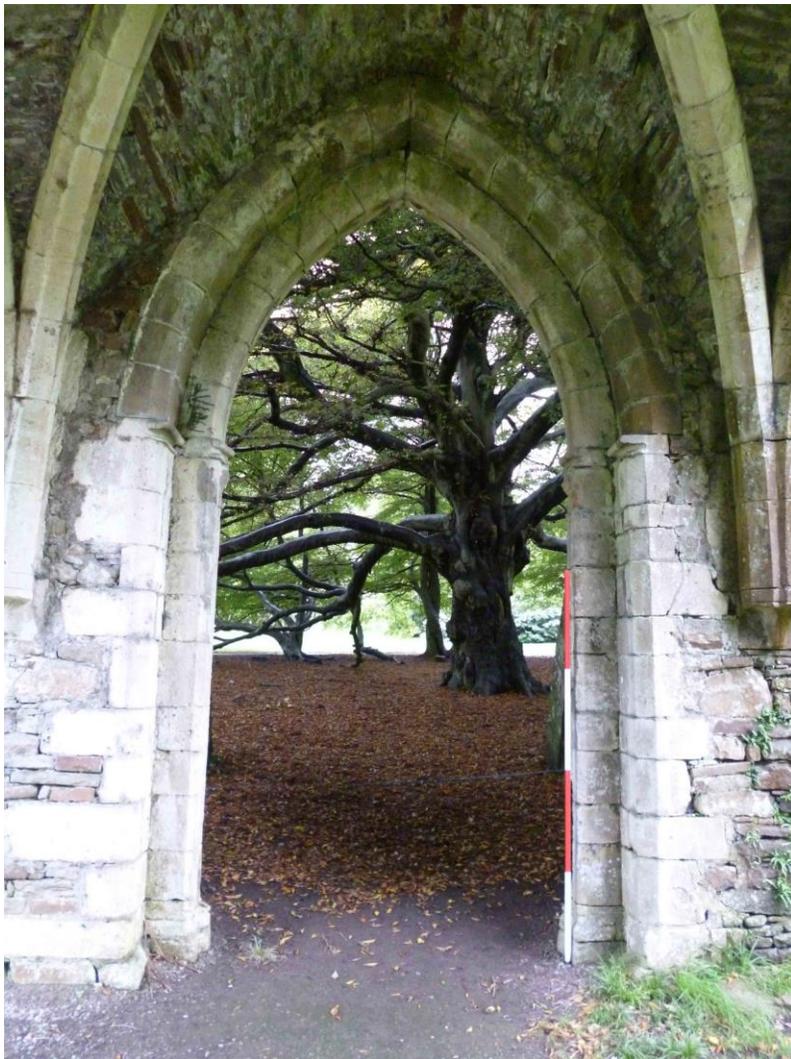
ID: 114 Site Number: 748 Site Name: Margam Monastic Ruins
Wall Number: 76 Photo Number: F2/114
Location: East cloister west wall Int. Central doorway.
Description: Ashlar to archway; vaulted above. String course at springing of arch.
Archway flanked on either side by two brackets built into wall to support vaulted ceiling. Repair work to ashlar (cement)
Condition Summary: A) Cracks on right hand side, wall repaired with cement now disintegrating. B) Vegetation on left hand side of door.
C) Gaps in ashlar both sides of archway. D) General weathering stonework. E) Vegetation - mortar missing in rubble.
Threats: Weathering, Vegetation
Recorded by: Bob Hardwick Date: 01/10/2012

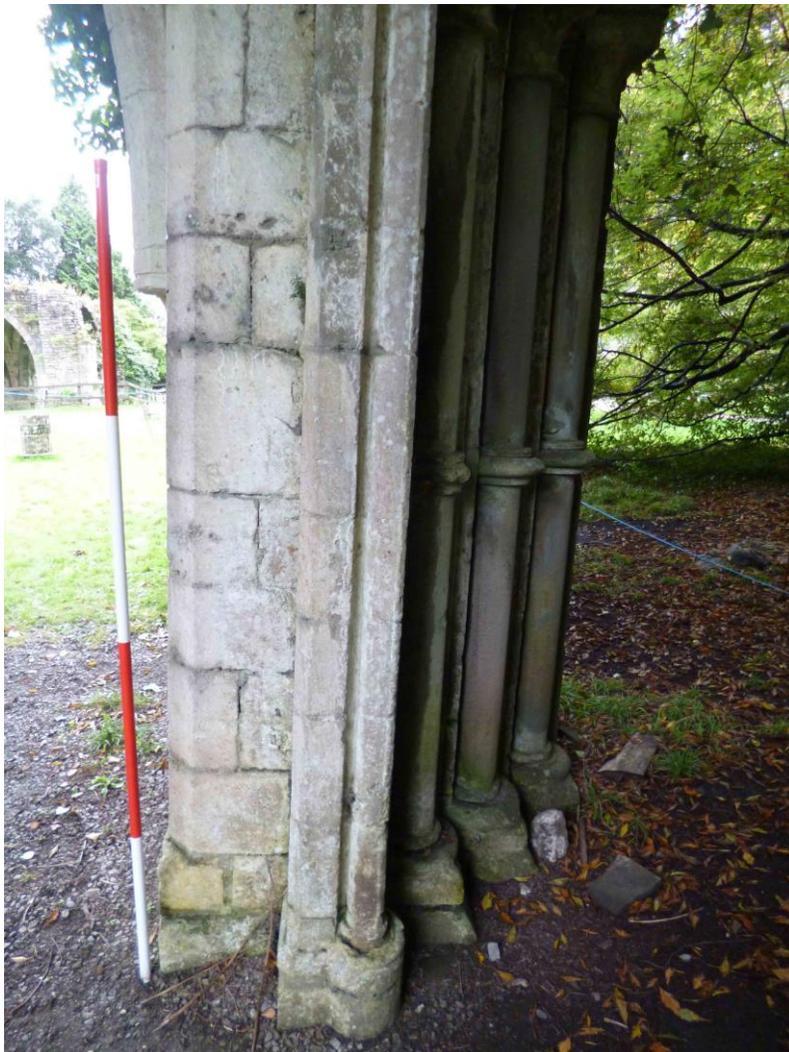
ID: 115 Site Number: 748 Site Name: Margam Monastic Ruins
Wall Number: 77.1 Photo Number: F2/117-118-1
Location: East cloister west wall arch doorway (south side of wall 76)
Description: South side of arch internal. On left-hand side, ashlar up to c2.4m where there is a string course. There is a bracket for the springing of the arch lower than this, (on 6th course from ground). Right-hand side has a cluster of shafts to jamb of the door, with mouldings around the head.
Condition Summary: A) The whole arch is leaning badly to the west. B) There are gaps in the arch stones. C) Weathering damage to decoration on cap moulding. D) Vegetation growing at string course level.
Threats: Weathering, Vegetation
Recorded by: Roy Thomas Date: 01/10/2012

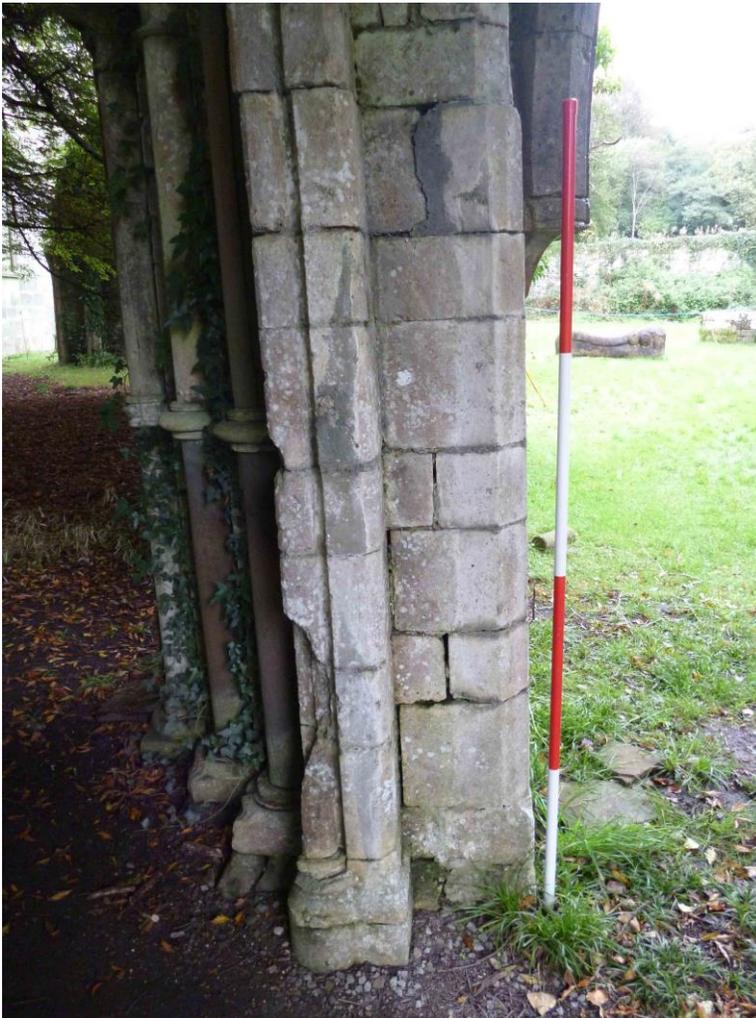
ID: 116 Site Number: 748 Site Name: Margam Monastic Ruins
Wall Number: 77.2 Photo Number: F2/120-121-1
Location: East cloister west wall arch doorway (north side of wall 76)
Description: North side of arch internal. On right-hand side, ashlar up to c2.4m where there is a string course. There is a bracket for the springing of the arch lower than this, (on 6th course from ground). Left-hand side has a cluster of shafts to jamb of the door (discoloration at string-course level), with mouldings around the head (cracked).
Condition Summary: A) The whole arch is leaning badly to the west. B) Gapping on block work - cement filled which is now separating. C) Weathering or impact damage on door moulding ivy growing up between shafts. D) shafts showing splitting.
Threats: Weathering, Vegetation
Recorded by: Roy Thomas Date: 01/10/2012

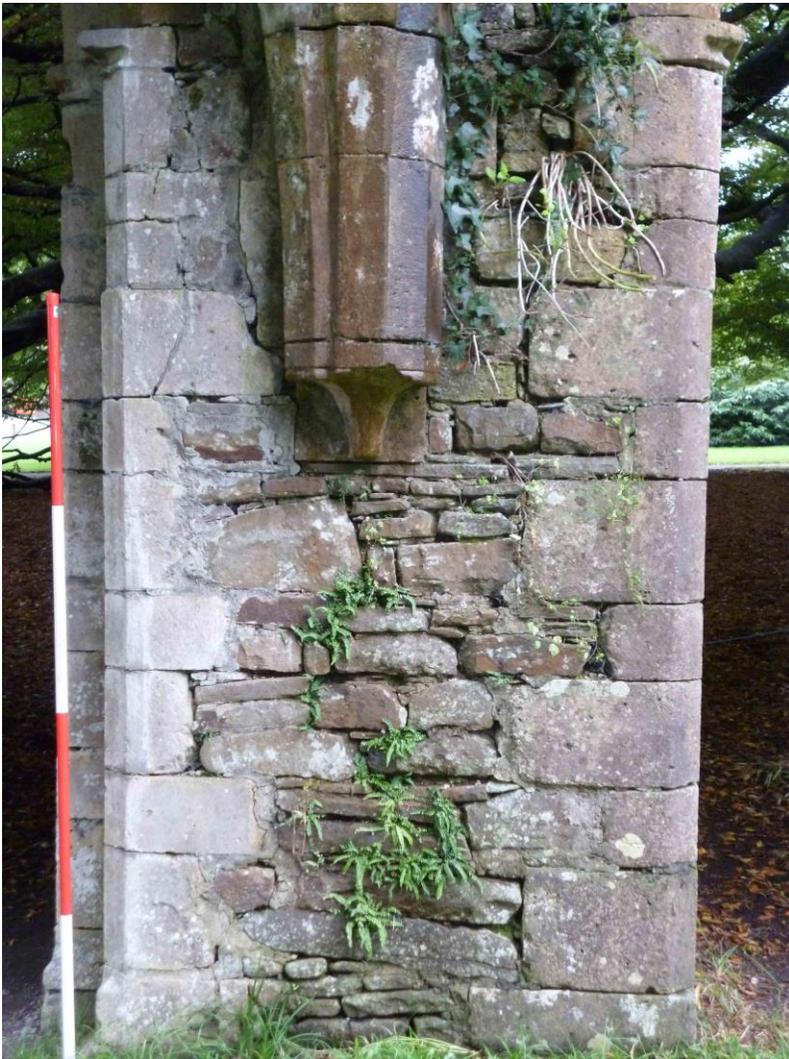
Condition Summary: A) Cracks left-hand side of central vaulted point. B) Gaps between stone face central bracket. C) Crack through upper part to right of bracket. D) Masonry gaps to right-hand side of bracket. E) Gaps in dressed smaller stone of north end arch. F) Mortar gaps and vegetation in centre below central bracket

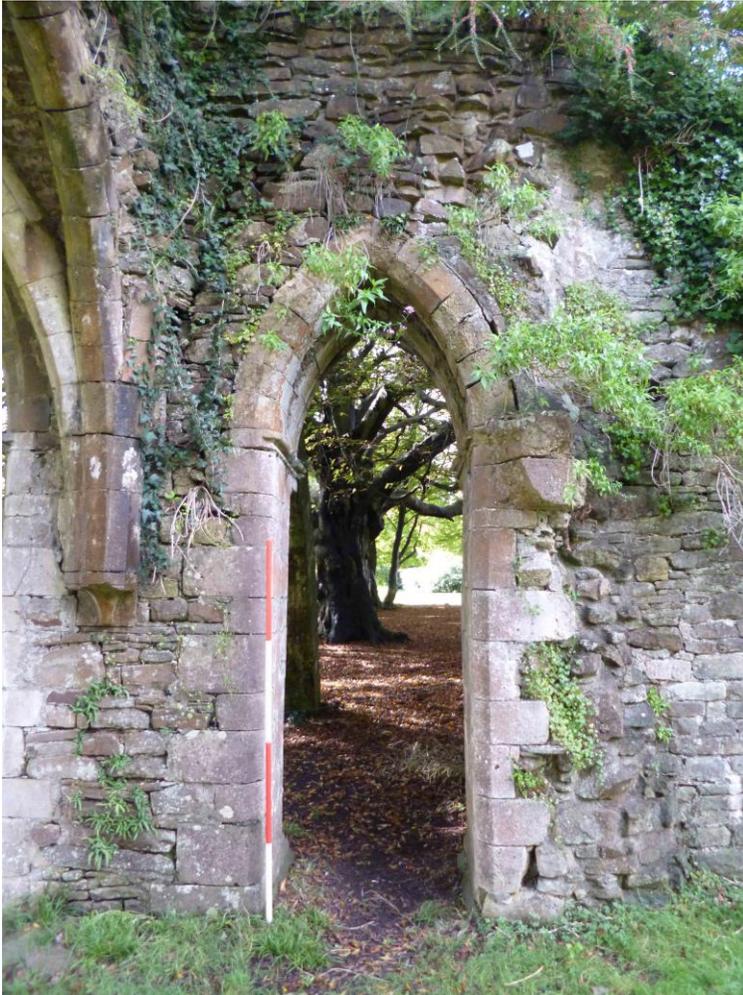
ID: 118 Site Number: 748 Site Name: Margam Monastic Ruins
Wall Number: 79 Photo Number: F2/134
Location: East cloister west wall interior (archway)
Description: Narrow archway to right of central doorway. Dressings in ashlar; rest of wall in sandstone rubble. Restoration at top of arch and to its right, including what may be the remains of the vault. Restoration of extremely poor standard.. To right of archway possible remains of wall extending east to west
Condition Summary: A) Several gaps and damage to left-hand side archway (to right of bracket). B) Separation of stonework in arch. C) Displace stonework, bottom right-hand archway. D) Vegetation. E) Some cemented areas haphazard (including placement of facing stones above and to the right of the arch); gaps in masonry
Threats: Weathering, Vegetation
Recorded by: (not filled in) Date: 01/10/2012

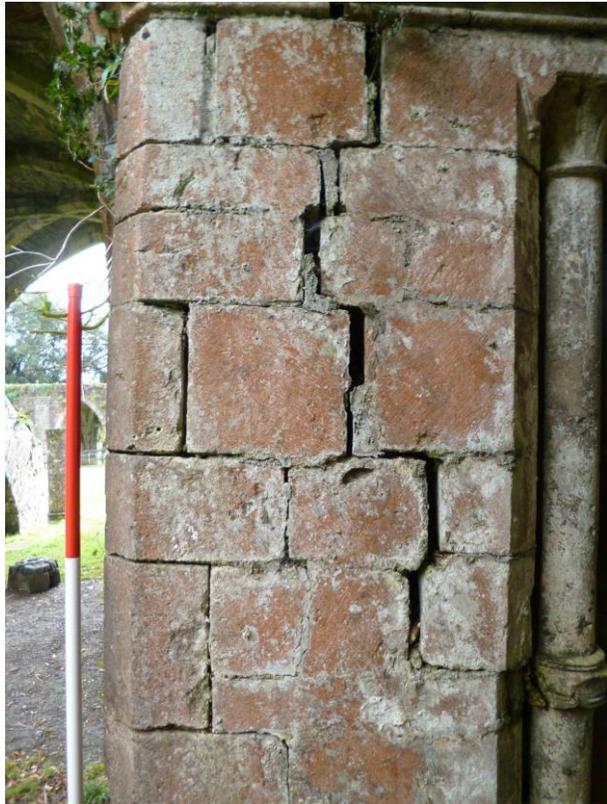
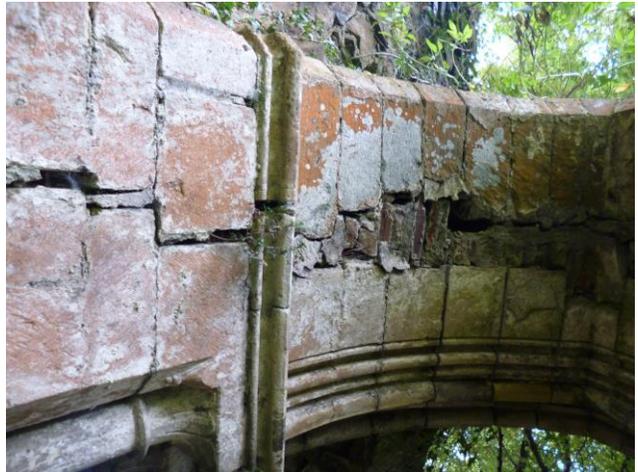
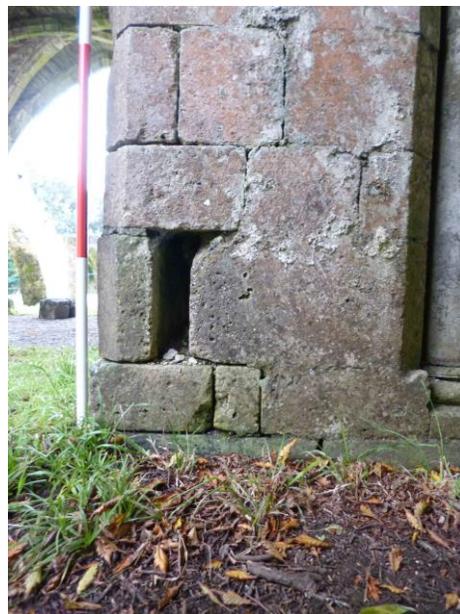
ID: 119 Site Number: 748 Site Name: Margam Monastic Ruins
Wall Number: 80.1 Photo Number: F2/126-127-1
Location: East cloister west wall (south side of wall 79).
Description: Internal arch has ashlar to c2.4m foot; string course at .
springing of arch. Two shafts to the west. Above string course arch in
with ashlar dressings flanking a narrow band of sandstone rubble core.
Mouldings around the head of the arch
Condition Summary: A) Bad crack starts at level of 5th course, runs up to top of arch and back
down north side of arch- west side blocks moving away. B) Block
missing in 2nd layer. C) Much mortar missing in rubble.
D) Weathering on shafts and mouldings. E) Wall leans to west
Threats: Weathering, Vegetation
Recorded by: Roy Thomas Date: 01/10/2012

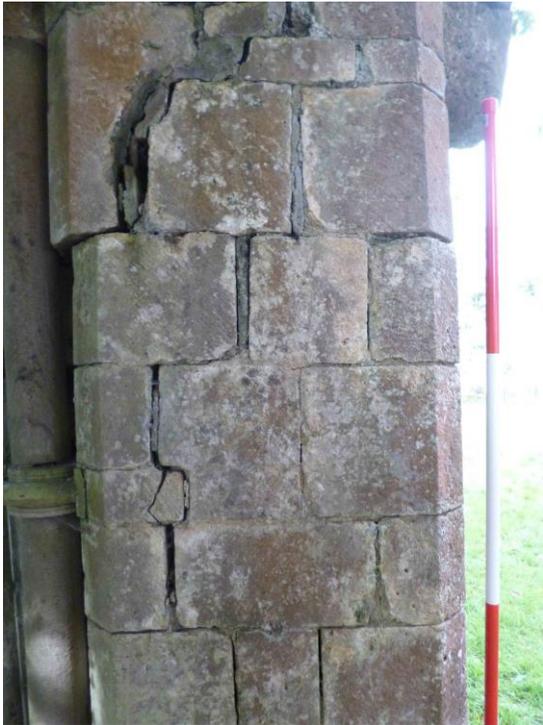
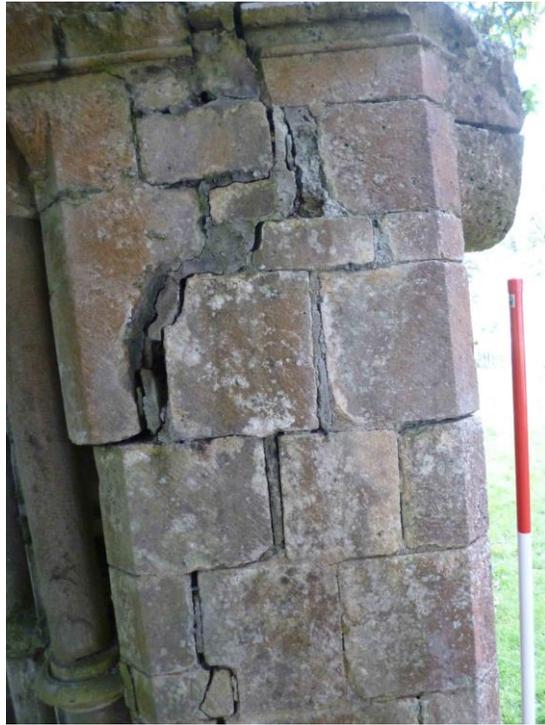
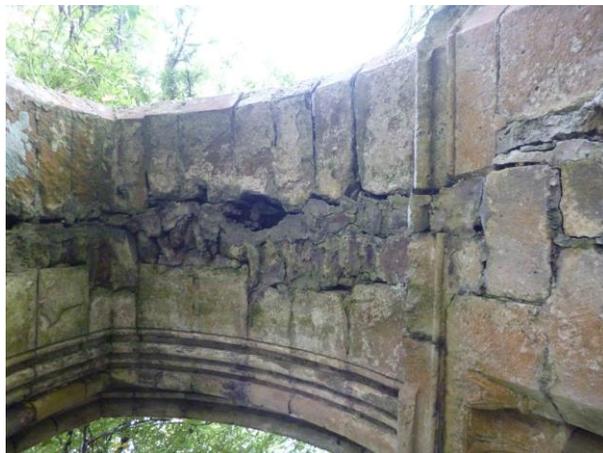
ID: 120 Site Number: 748 Site Name: Margam Monastic Ruins
Wall Number: 80.2 Photo Number: F2/126-127-1
Location: East cloister west wall (north side of wall 79).
Description: Opposite side of wall from 80.1. Description as 80.1
Condition Summary: A) Wall leans to west. B) Crack runs down from top of arch to 2nd stone. C) Gap filled with cement where ashlar has moved. D) Bottom stone missing. E)String course weathered. F) Shaft twisted
Threats: Weathering, Vegetation
Recorded by: Roy Thomas Date: 01/10/2012
