Monastic Margam Community Survey Project

Report for Cadw
by Sam Pamment BA

GGAT report no. 2013/020
NGR: SS 8018 8626
Project no. GGAT 123

Summary

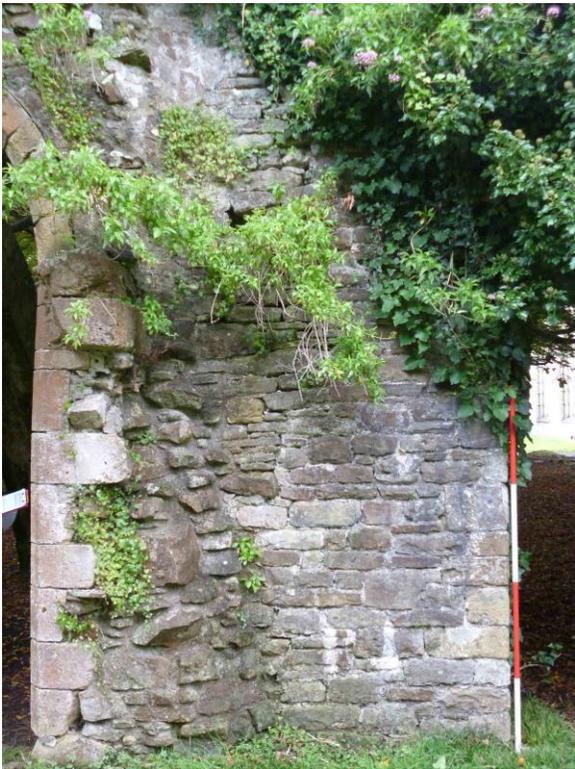
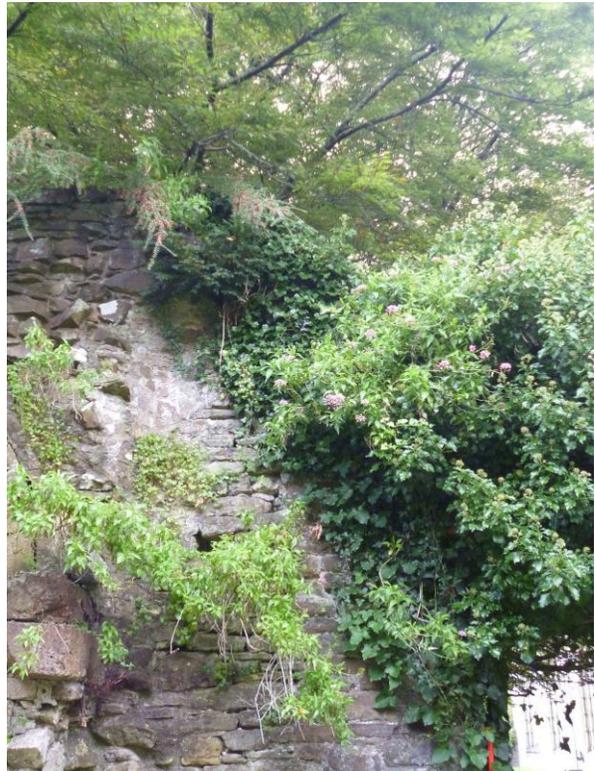
(See figure 2, figure 13 elevation 81)

ID: 121 Site Number: 748 Site Name: Margam Monastic Ruins
Wall Number: 81 Photo Number: F2/135-136
Location: East cloister west wall interior
Description: Wall to right of archway constructed of sandstone rubble. Right-hand quoins have been replaced at some time with less carefully cut blocks of various sizes and shapes. Vegetation causing gaps in stonework . Mortar replacement necessary. Putlog hole to right of arch c2.4m feet above ground.
Condition Summary: A) Rubble has gaps in mortar across whole area. Cracks in many areas.
B) Extensive growth of vegetation. C) Erosion
Threats: Weathering, Vegetation
Recorded by: Bob Hardwick Date: 01/10/2012

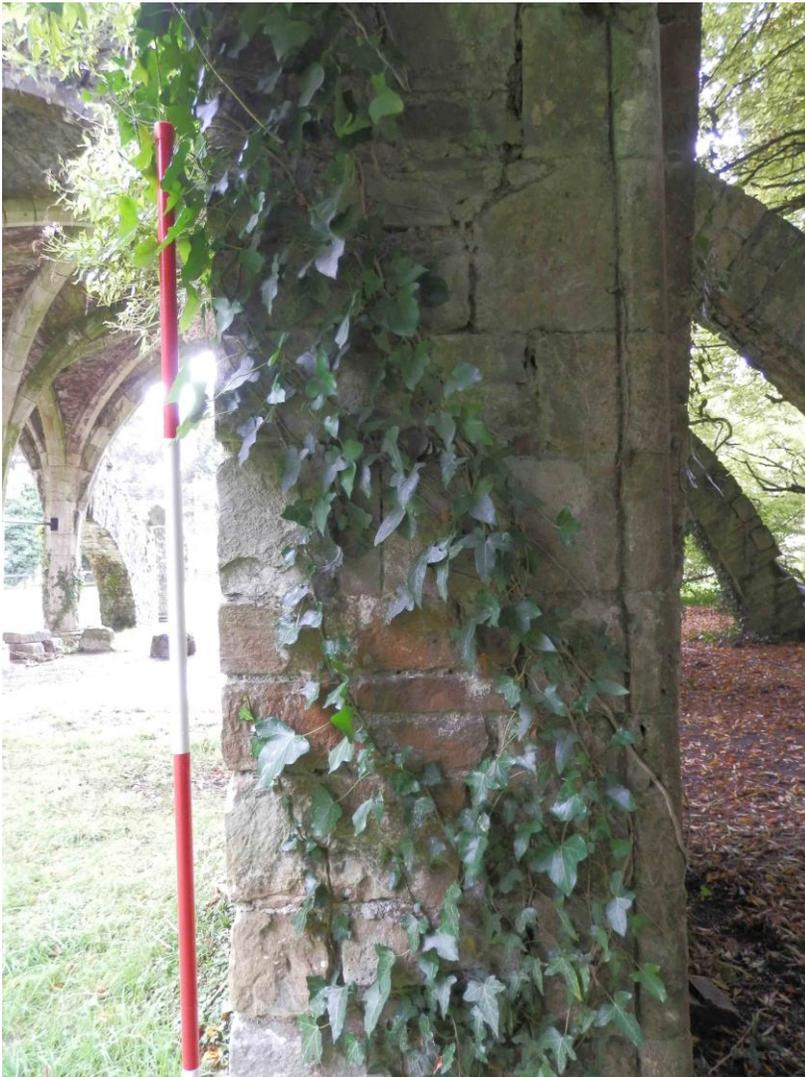
ID: 123 Site Number: 748 Site Name: Margam Monastic Ruins
Wall Number: 83.1 Photo Number: F2/139-140
Location: East cloister west wall, square arch (south inside face of wall 82)
Description: Ashlar pier with moulding on west edge. Square head to opening.
East edge rebuilt, incorporating brick Ivy vegetation growing from bottom
Condition Summary: A) Huge crack starts top middle of archway running to 1/3 of wall.
B) Eroded mortar. C) Vegetation - ivy growing from base to top.
Threats: Weathering, Vegetation
Recorded by: Maggie Cornelius Date: 02/10/2012

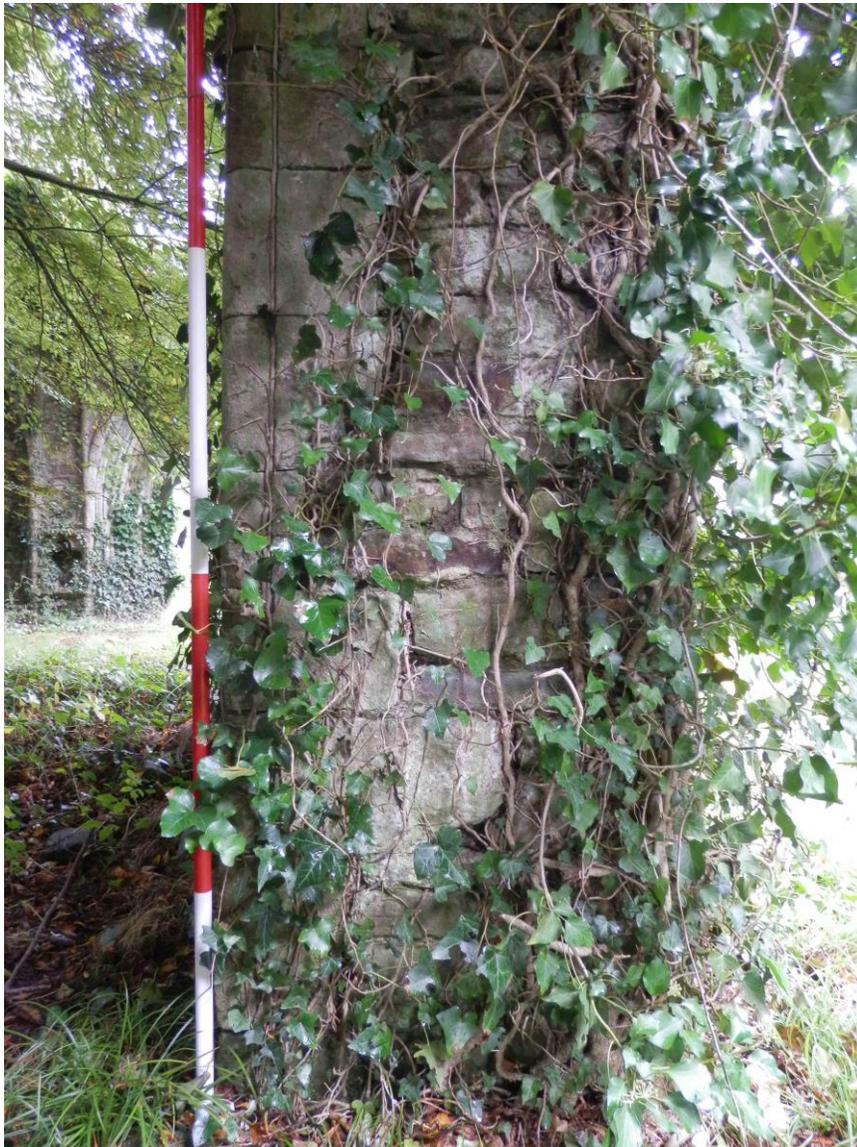
ID: 124 Site Number: 748 Site Name: Margam Monastic Ruins
Wall Number: 83.2 Photo Number: F2/141-142
Location: East cloister west wall, square arch (north inside face of wall 82)
Description: Pier with moulding on west edge; this face largely of rubble construction. Square head to opening. Mortar in poor state - eroded or missing, ivy vegetation covering most of wall
Condition Summary: A) Large crack running from top to bottom of wall through the arch on to the wall 83.1. B) Small stone missing. C) Vegetation- root damage. D) Mortar missing/weathered
Threats: Weathering, Vegetation, crack
Recorded by: Maggie Cornelius Date: 02/10/2012

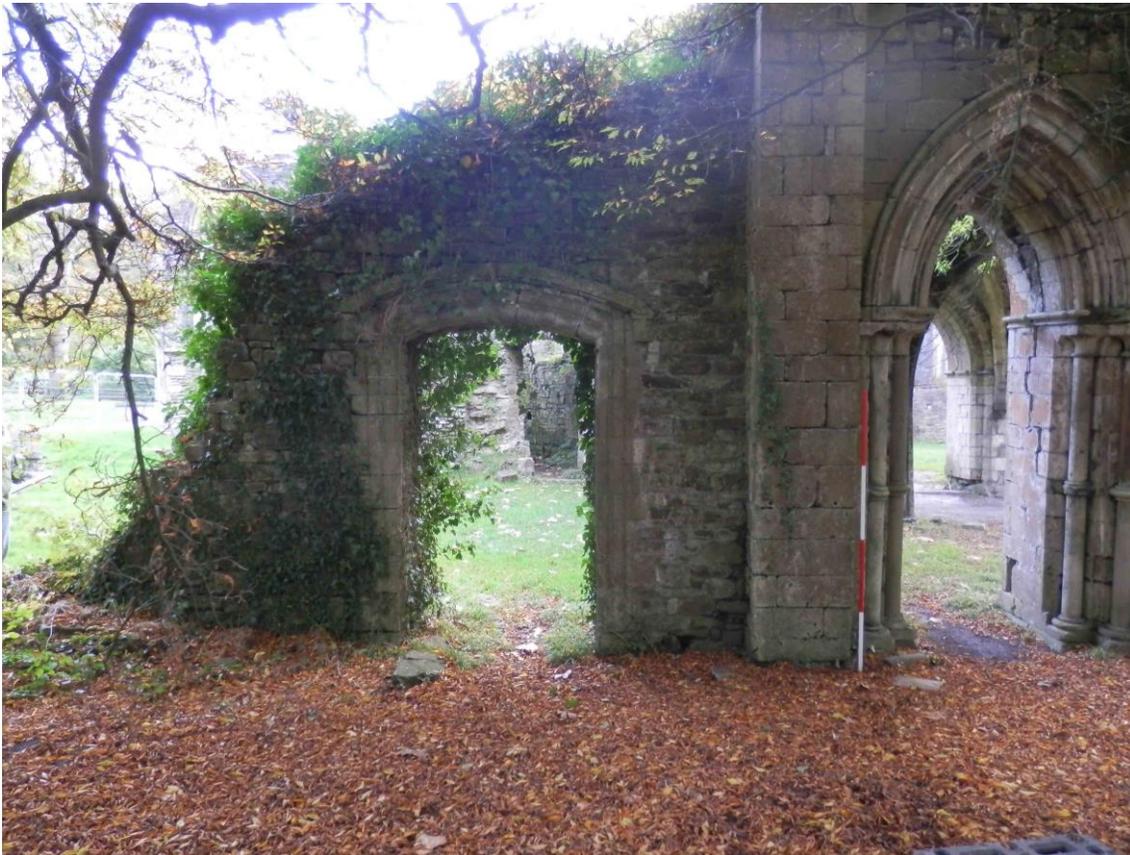
(See figure 2, figure 13 elevation 84)

ID: 125 Site Number: 748 Site Name: Margam Monastic Ruins
Wall Number: 84 Photo Number: F3/6-9
Location: East cloister west wall Ext.
Description: Part of west wall containing two doorways, separated by a buttress. The left-hand (north) doorway has a segmental arched head; possibly some decoration on triangular stone at bottom of arch. Wall rubble. To the north of the door, the remainder of the wall has fallen away. Considerable amount of loose mortar. Vegetation covering most of the left hand side of wall. Moulding above arch intact but outside left wall has lots of missing stones, some fallen at bottom of arch. Top of wall missing. Between this section of wall and buttress there are three stones at top of wall sticking out over a very loose stone. Missing stone bottom right hand side. Loose stones also there. Crack in top of right-hand jamb. (Right-hand door described as wall no. 85.)
Condition Summary: A) Missing north end. B) Missing top. C) Mortar damage .

D) Crack right hand top of arch. E) Missing stones at bottom right hand. F) Crack adjoining buttress. G) vegetation
Threats: Weathering, Vegetation, North end vulnerable to children climbing
Recorded by: Gloria Rowles Date: 02/10/2012

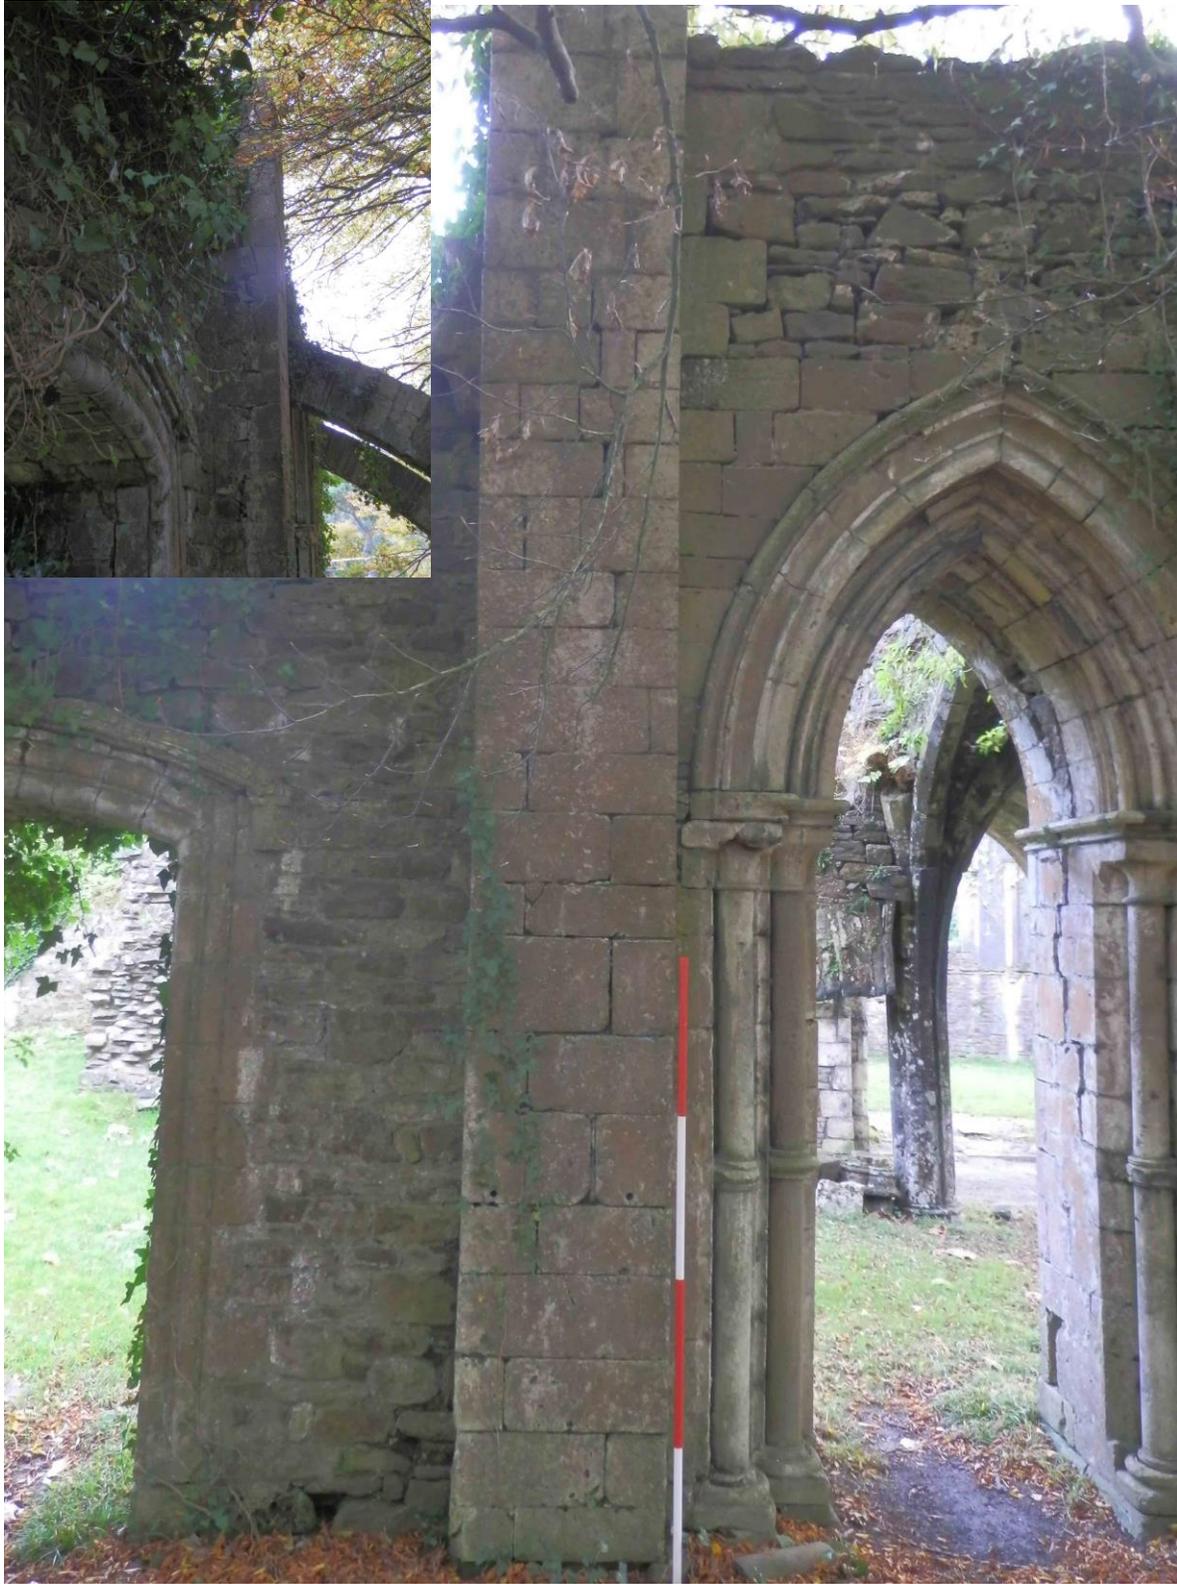
(See figure 2, figure 13 elevation 85)

ID: 126 Site Number: 748 Site Name: Margam Monastic Ruins
Wall Number: 85 Photo Number: F2/149-150
Location: East cloister west wall (continuation of wall no.84 -buttress and 2nd arch)
Description: Buttress in ashlar. Missing stones, loose stones and missing mortar. Loose small stones infill missing mortar. Cracked stones. No vegetation. Sixth row up two drilled holes on separate stones. South side of buttress - chunks missing on six stones, stones crumbling where mortar has come away. Hole halfway down similar to front holes. Possible socket for beam on right side wall of arch. Loose local sandstone rubble on top of wall above arch - mortar missing. Arch in ashlar; flanked by two columns either side. Mouldings around head. Wall supported by inserted flying buttress (wall no.86). Wall is leaning to the west and the west face is breaking away from the core. All shafts are intact, although their bases are weathered. Caps are carved with identical patterns, and there are carved decorations between shafts and jambs. Ashlar face on inner south side of arch has come away from wall and is pushing shaft out of alignment so that it leans. In corner behind shaft, cement is coming away and it is very loose.

Condition Summary: A) On left buttress there is a crack in the 7th stone from top. B) Mortar missing in buttress. C) Stones beginning to crumble due to missing mortar on buttress. D) Ivy growing into cracks in buttress. E) Loose stones on top above archway. F) Stone on left side of archway has come away from wall. G) Weathering to column base stops. H) Weathering to arch mouldings. I) Mortar missing between archway blocks. J) Wall leaning away to west leaving a crack in the wall separating east and west side.

Threats: Weathering, Vegetation, wall leaning
Recorded by: Gloria Rowles & Sarah Baker Date: 02/10/2012

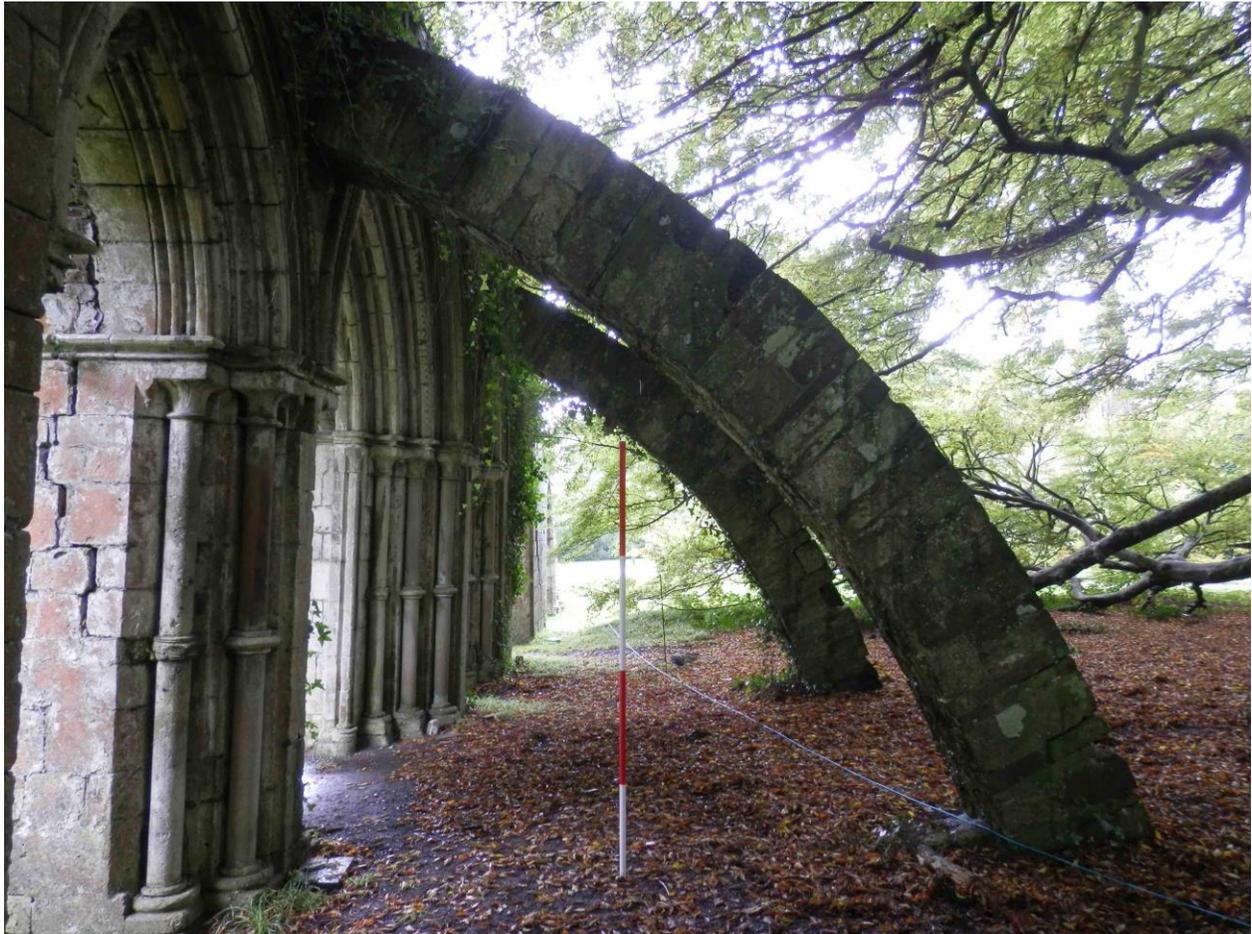
(See figure 2, figure 13 elevation 87)

ID: 127 Site Number: 748 Site Name: Margam Monastic Ruins
Wall Number: 86 Photo Number: F2/143
Location: East cloister west wall exterior, flying buttress 1 north face
Description: Half of an arch supporting the outside east cloister west wall. Made out of large sand stone blocks laid vertically. Cement mortar. Stalactites formed underneath The buttress is not contemporary with the abbey.
Condition Summary: A) Stone missing from the bottom. B) Little vegetation. C) Possible loose mortar. D) Water damage. E) Cement, mortar weakness
Threats: Weathering, Vegetation, human impact
Recorded by: Ruth Hopkins Date: 02/10/2012

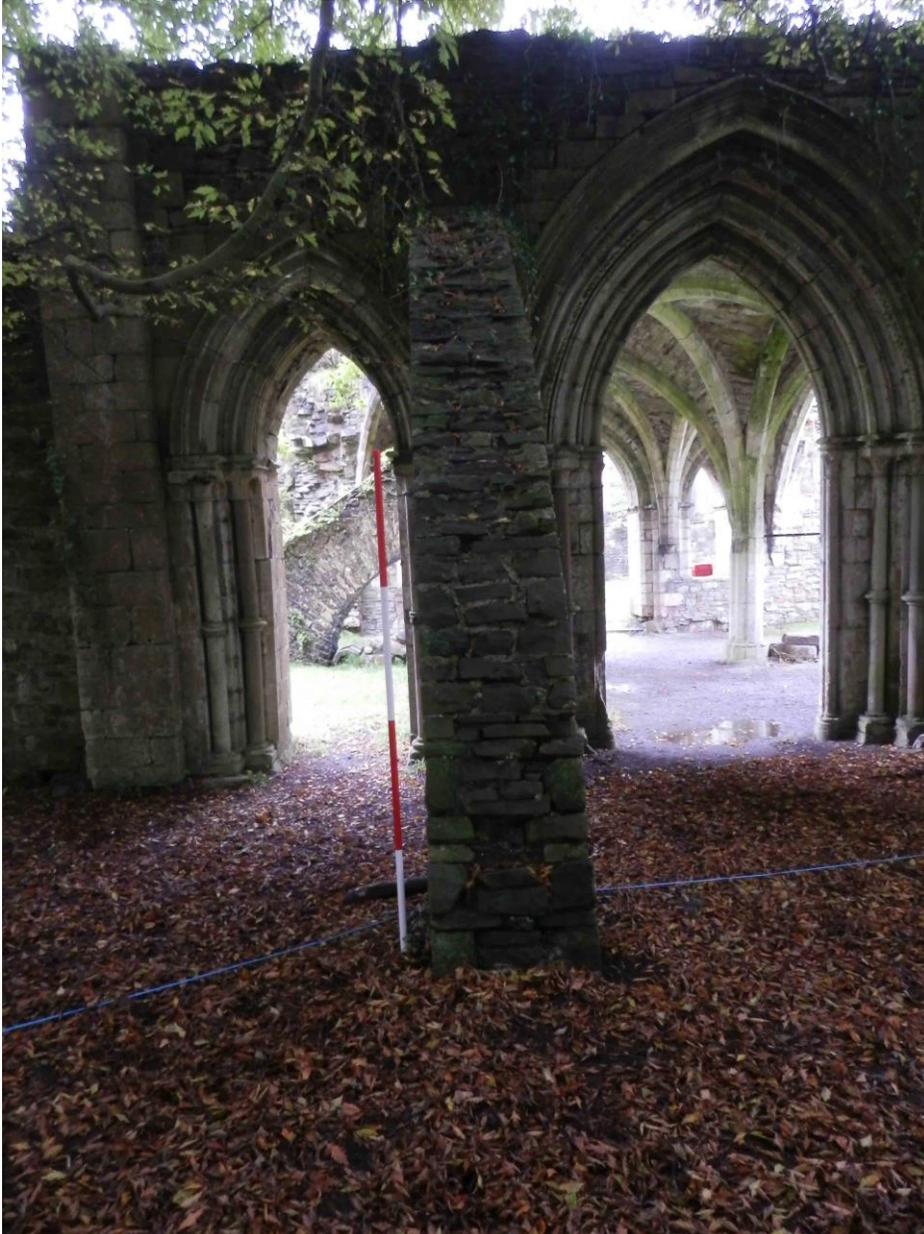
(See figure 2, figure 13 elevation 87)

ID: 128 Site Number: 748 Site Name: Margam Monastic Ruins
Wall Number: 87 Photo Number: F2/144
Location: East cloister west wall, flying buttress 1 end face
Description: Same as 86, but end face, smaller sandstones in middle, mortar
Condition Summary: A) Stones missing. B) Vegetation at the top. C) Loose stones
D) Missing/loose mortar
Threats: Weathering, Vegetation, human interaction
Recorded by: Ruth Hopkins Date: 02/10/2012

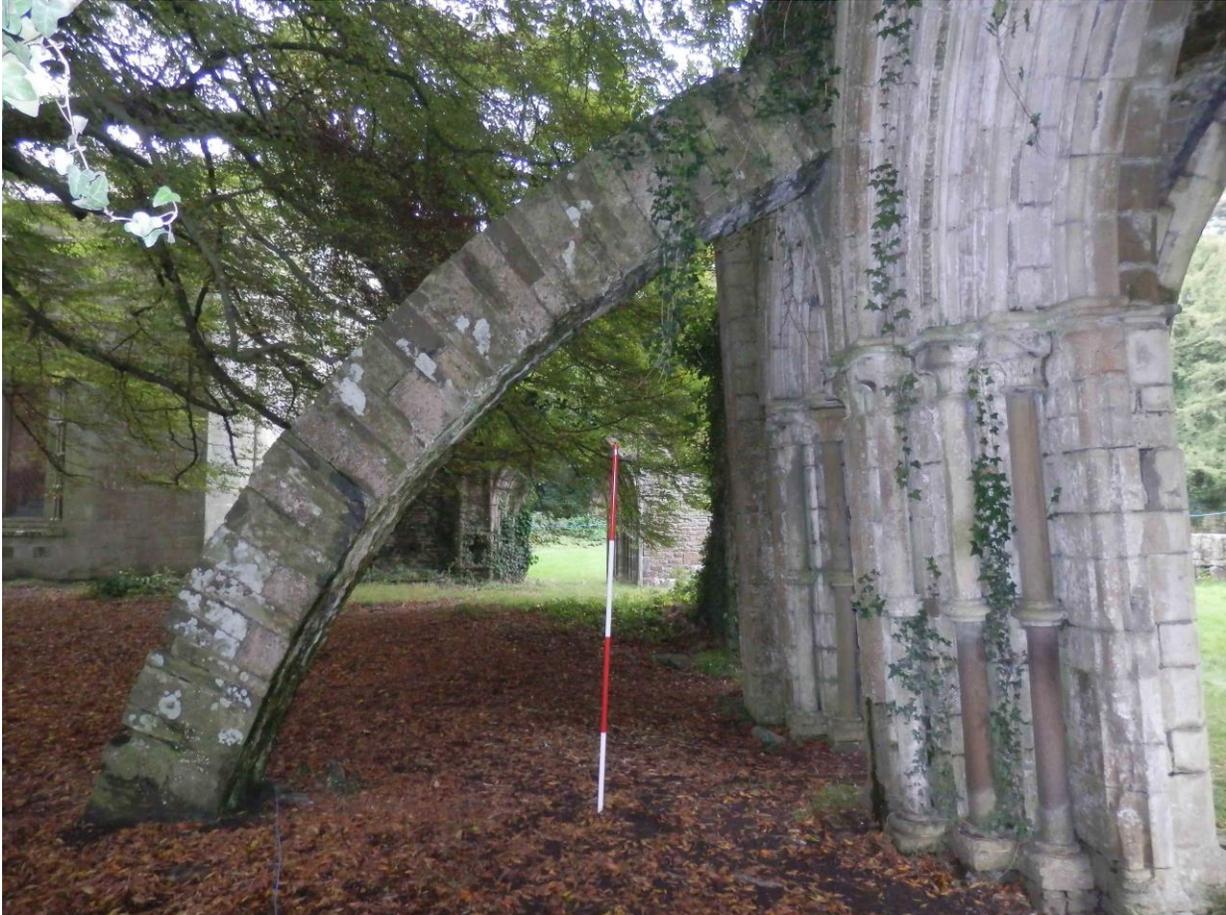
(See figure 2, figure 13 elevation 87)

ID: 129 Site Number: 748 Site Name: Margam Monastic Ruins
Wall Number: 88 Photo Number: F2/159
Location: East cloister west wall flying buttress 1, south face.
Description: Same as 86, but south face, stones follow curve of arch
Condition Summary: A) Stones missing at the bottom. B) Mortar missing. C) Vegetation at top end (ivy).D) Cement mortar
Threats: Weathering, Vegetation, Human Interaction
Recorded by: Ruth Hopkins Date: 02/10/2012

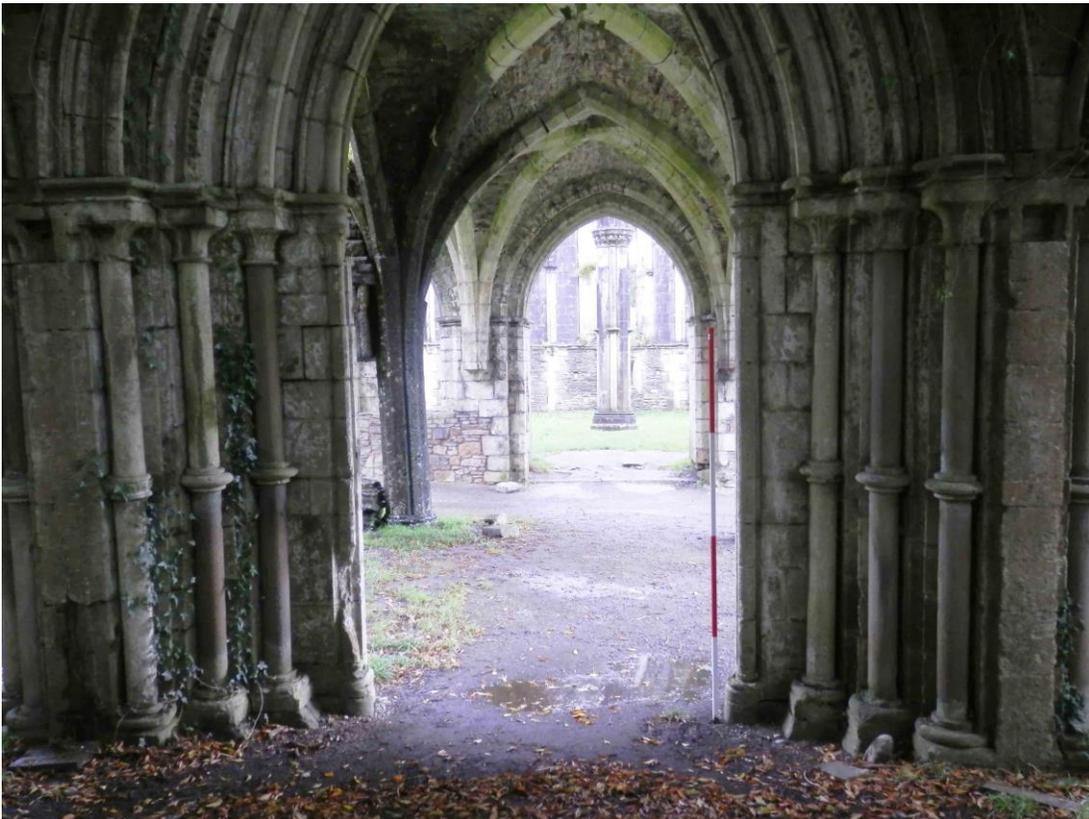
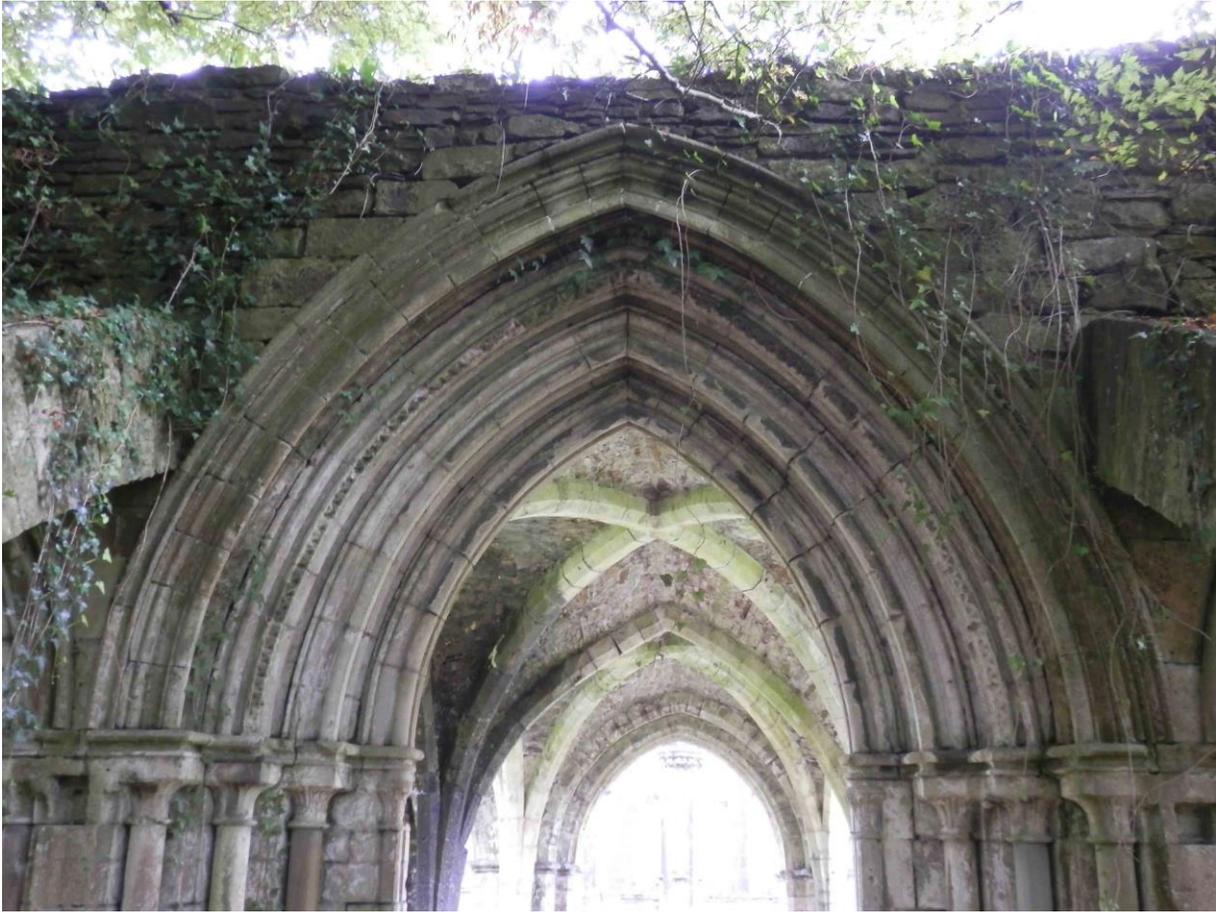
(See figure 2, figure 13 elevation 89)

ID: 130 Site Number: 748 Site Name: Margam Monastic Ruins
Wall Number: 89 Photo Number: F2/145-146-1
Location: East cloister west wall external
Description: Central archway leading from cloister into east cloister walk, archway in ashlar with a group of three shafts on both the north and south side of the archway. From these shafts spring the mouldings around the head of the arch, some enriched by carved decoration. The shafts have carved bases and caps and a central moulding. The west side of the arch is leaning badly to the west and is supported by two large buttresses (walls no.86 and 90), each which look as though they are constructed of blocks from the abbey ruins.
Condition Summary: A) Edge of arch at the bottom, large chunk of stonework missing (north side). B) Wall being supported by two buttresses on each side of archway (see above). C) Wall leaning to the left. D) Vegetation growing to the top of wall and archway (ivy), starting to penetrate pointing. D) Branches of tree growing in cloister area starting to grow up against wall. E) Supporting buttresses have some large stones missing from bottom, and also the pointing is being washed out. F) Erosion of pointing between blocks at bottom of arch and also stonework to bottom of wall.

Threats: Weathering, Vegetation, weakness in buttress that hold up wall
Recorded by: Jeff Jones Date: 02/10/2012

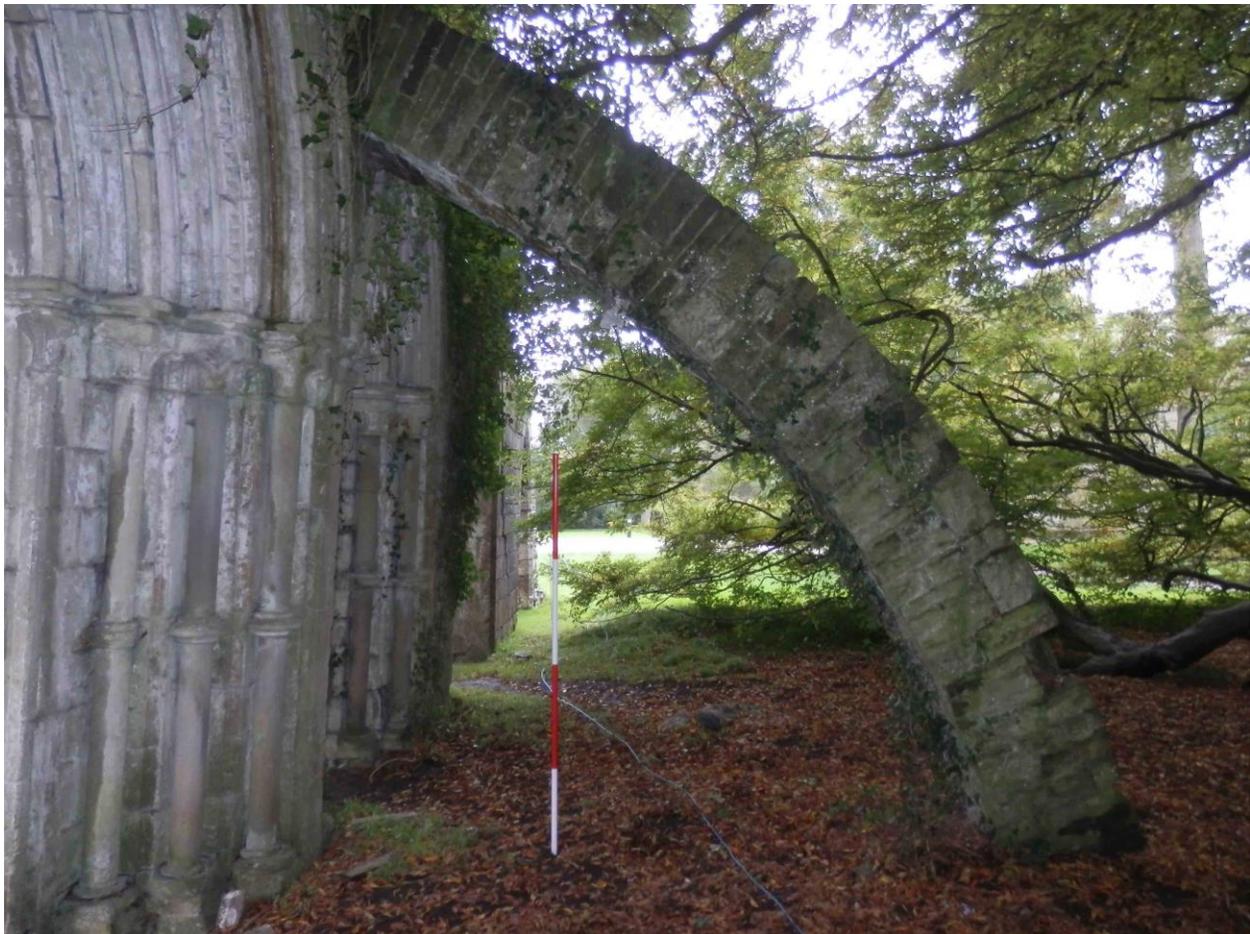
(See figure 2, figure 13 elevation 91)

ID: 131 Site Number: 748 Site Name: Margam Monastic Ruins
Wall Number: 90 Photo Number: F2/158
Location: East cloister west wall external flying buttress 2 north
Description: Buttress built from uniform stonework with also some dressed blocks derived possibly from other parts of ruins. One of buttresses supporting east cloister wall. Pointing at top looks sound but needs inspecting
Condition Summary: A) Pointing missing or washed out in a number of places. B) Some large sections of stonework missing from bottom end. C) Vegetation starting to penetrate through joints in stonework (ivy). D) Some stonework loose at bottom.
Threats: Weathering, Vegetation, missing stone at base,
Recorded by: Jeff Jones Date: 02/10/2012

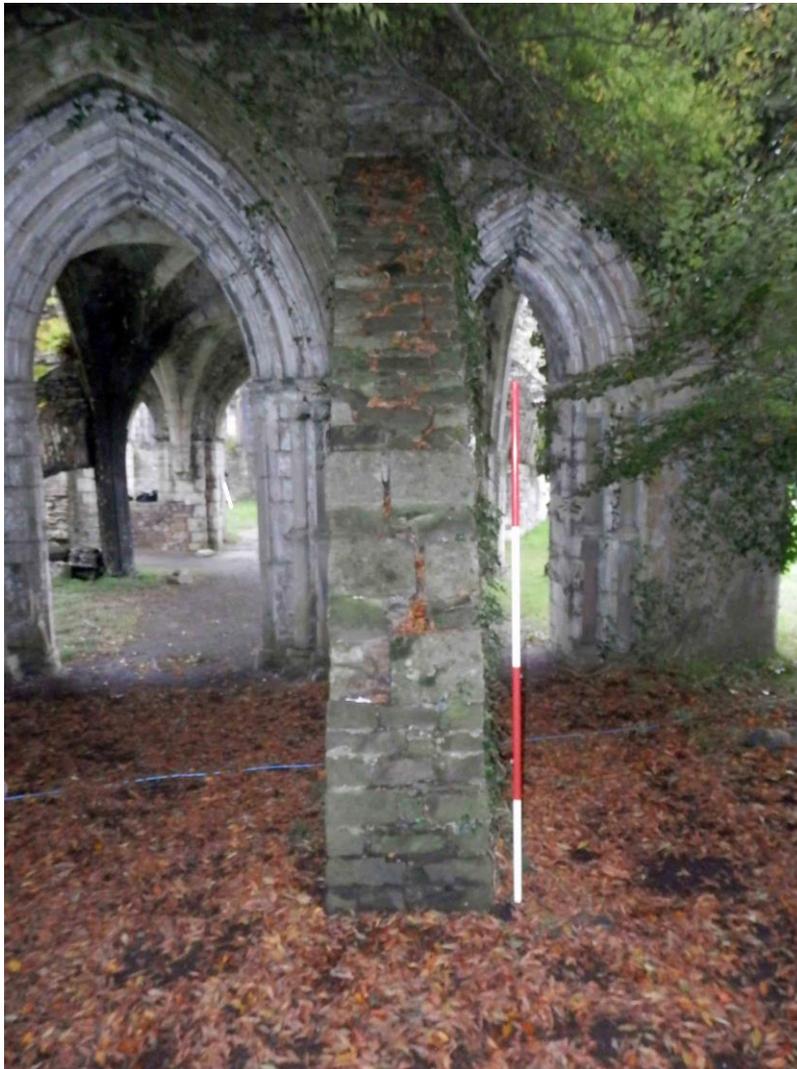
(See figure 2, figure 13 elevation 91)

ID: 132 Site Number: 748 Site Name: Margam Monastic Ruins
Wall Number: 91 Photo Number: F2/165
Location: East cloister west wall external flying buttress 2 west
Description: Buttress built from uniform stonework with also some dressed blocks derived possibly from other parts of ruins. One of buttresses supporting east cloister wall. Pointing between stone work in very poor
Condition Summary: A) Pointing between stonework very poor, with large gaps between stonework. B) Large pieces of stonework missing from bottom end of buttress which could be weakening the effectiveness of the structure. C) Vegetation started to grow within the joints of the stonework.
Threats: Weathering, Vegetation, Stonework missing
Recorded by: Jeff Jones Date: 02/10/2012

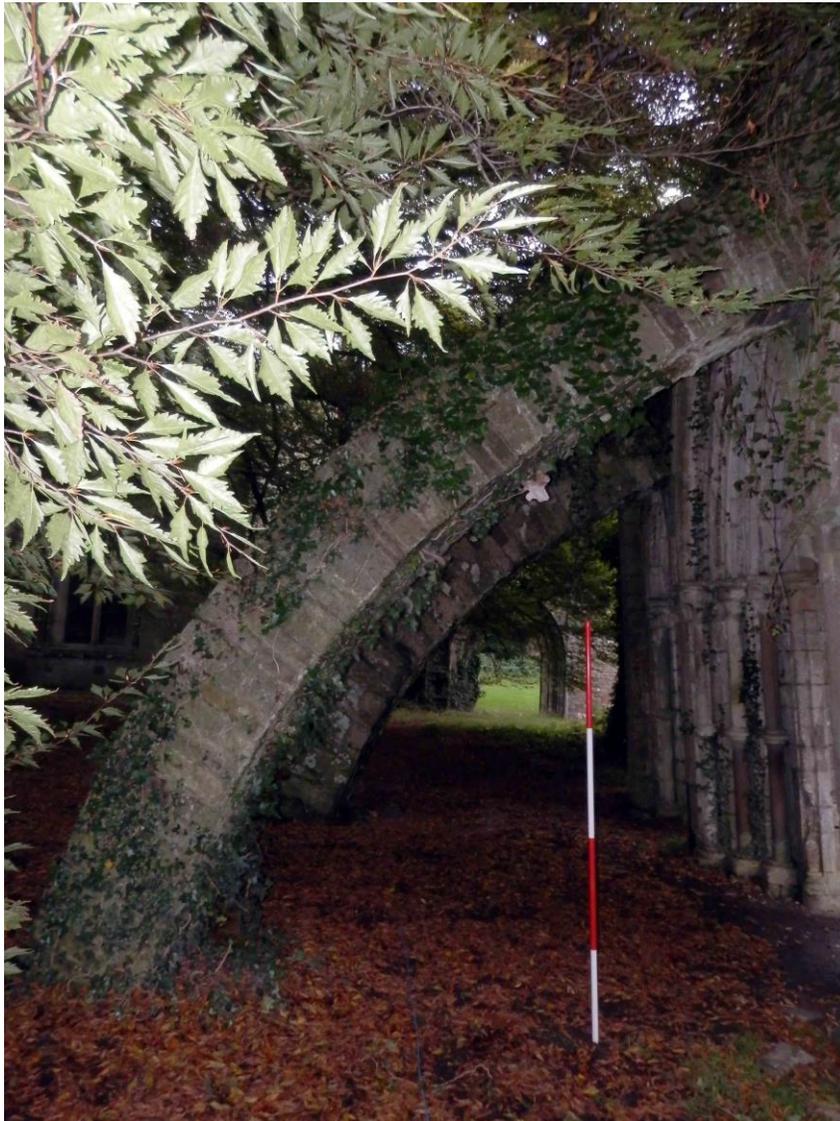
(See figure 2, figure 13 elevation 91)

ID: 133 Site Number: 748 Site Name: Margam Monastic Ruins
Wall Number: 92 Photo Number:F2/166
Location: East cloister west wall, external flying buttress south
Description: Buttress built from uniform stonework with also some dressed blocks derived possibly from other parts of ruins. One of buttresses supporting east cloister wall. Pointing on this side looks sound, but some gaps present. Vegetation starting to grow in gaps in stonework.
Condition Summary: A) Some gaps in pointing at top edge. B) Vegetation starting to grow in gaps(ivy)
Threats: Weathering, Vegetation, gaps in pointing, ivy
Recorded by: Jeff Jones Date: 02/10/2012

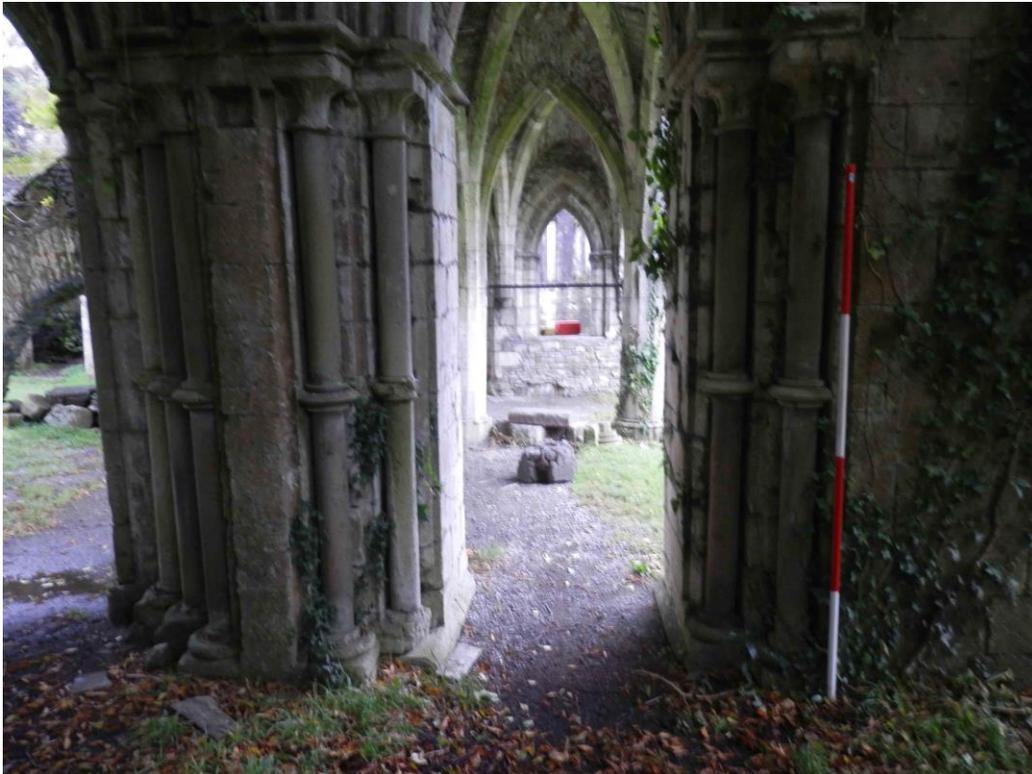
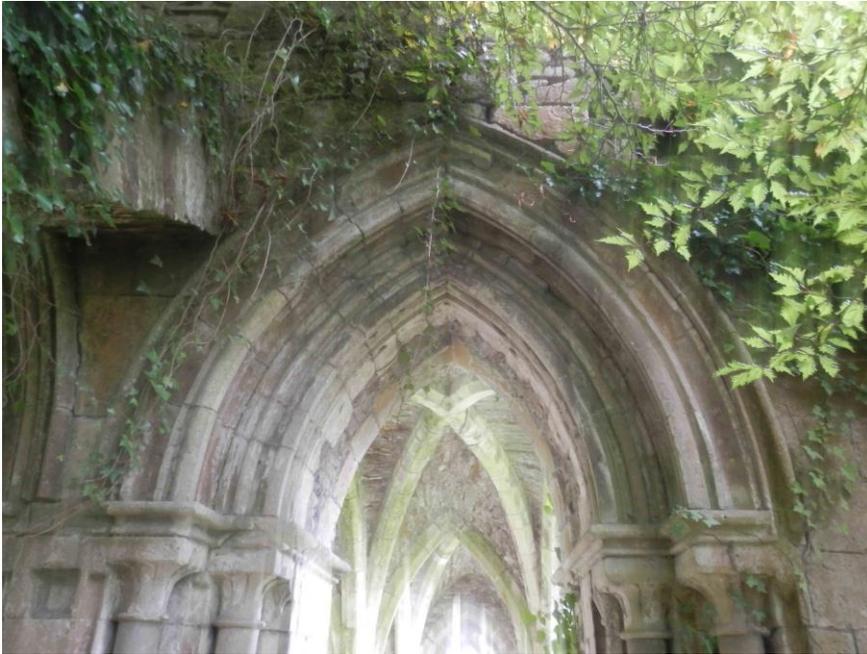
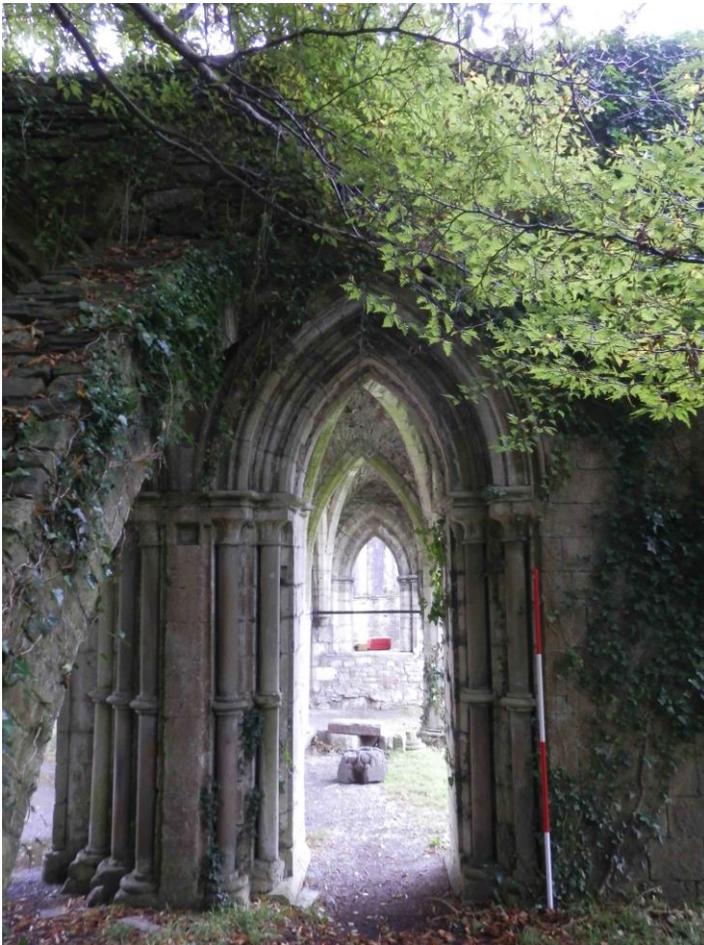
(See figure 2, figure 13 elevation 93)

ID: 134 Site Number: 748 Site Name: Margam Monastic Ruins
Wall Number: 93 Photo Number: F2/153-154-1
Location: East cloister west wall Ext. right-hand arch
Description: Same design as arch on wall 85, which flanks the main archway wall 89 on the other side. Ashlar. Top of wall above arch made from local sandstone rubble. Possible beam socket on left side wall of arch. Caps of shafts in good Condition Summary - design still clear although some weathering especially on middle mouldings and bases. Molding of archway in fairly good Condition Summary, with weathering only on three stones. These include apex on interior moldings and on some outer moldings. Flanking shafts still in position, although some weathering. Corners carved. Putlog hole to right of arch. Large amount of vegetation/ivy climbing up right side of arch and above arch. Some ivy climbing up left shaft of archway. Wall leaning to west, starting to split

Condition Summary: A) Weathered archway moldings. B) Mortar missing. C) 1/2 Stone section missing on left hand side of archway, 9 stones from bottom. D) Middle pillar base/joint + base of pillar on interior left shaft weathered away. E) Missing half of stone behind base of left shaft base. F) Corner of top left shaft has come away/weathered. G) Outer right-hand bottom shaft weathered and flaking. H) Vegetation
Threats: Weathering, Vegetation,
Recorded by: Sarah Baker Date: 02/10/2012

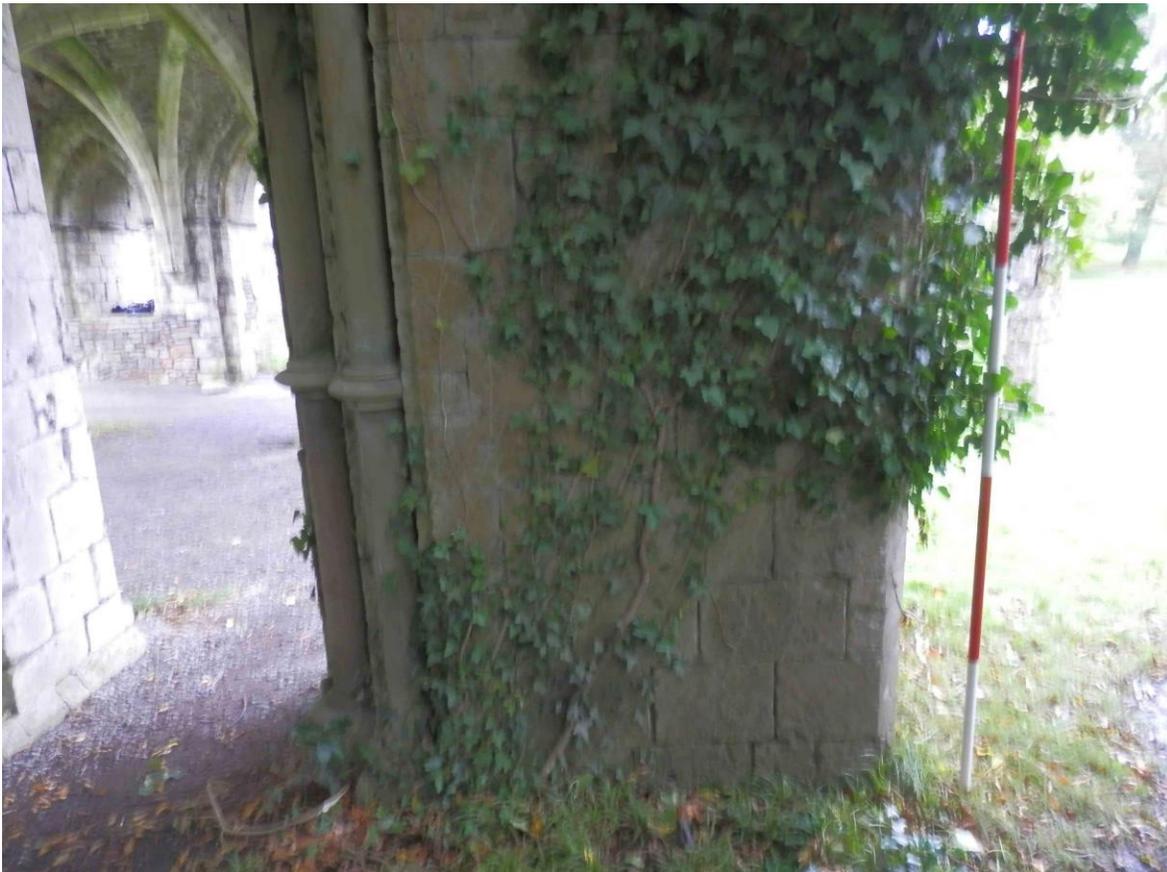
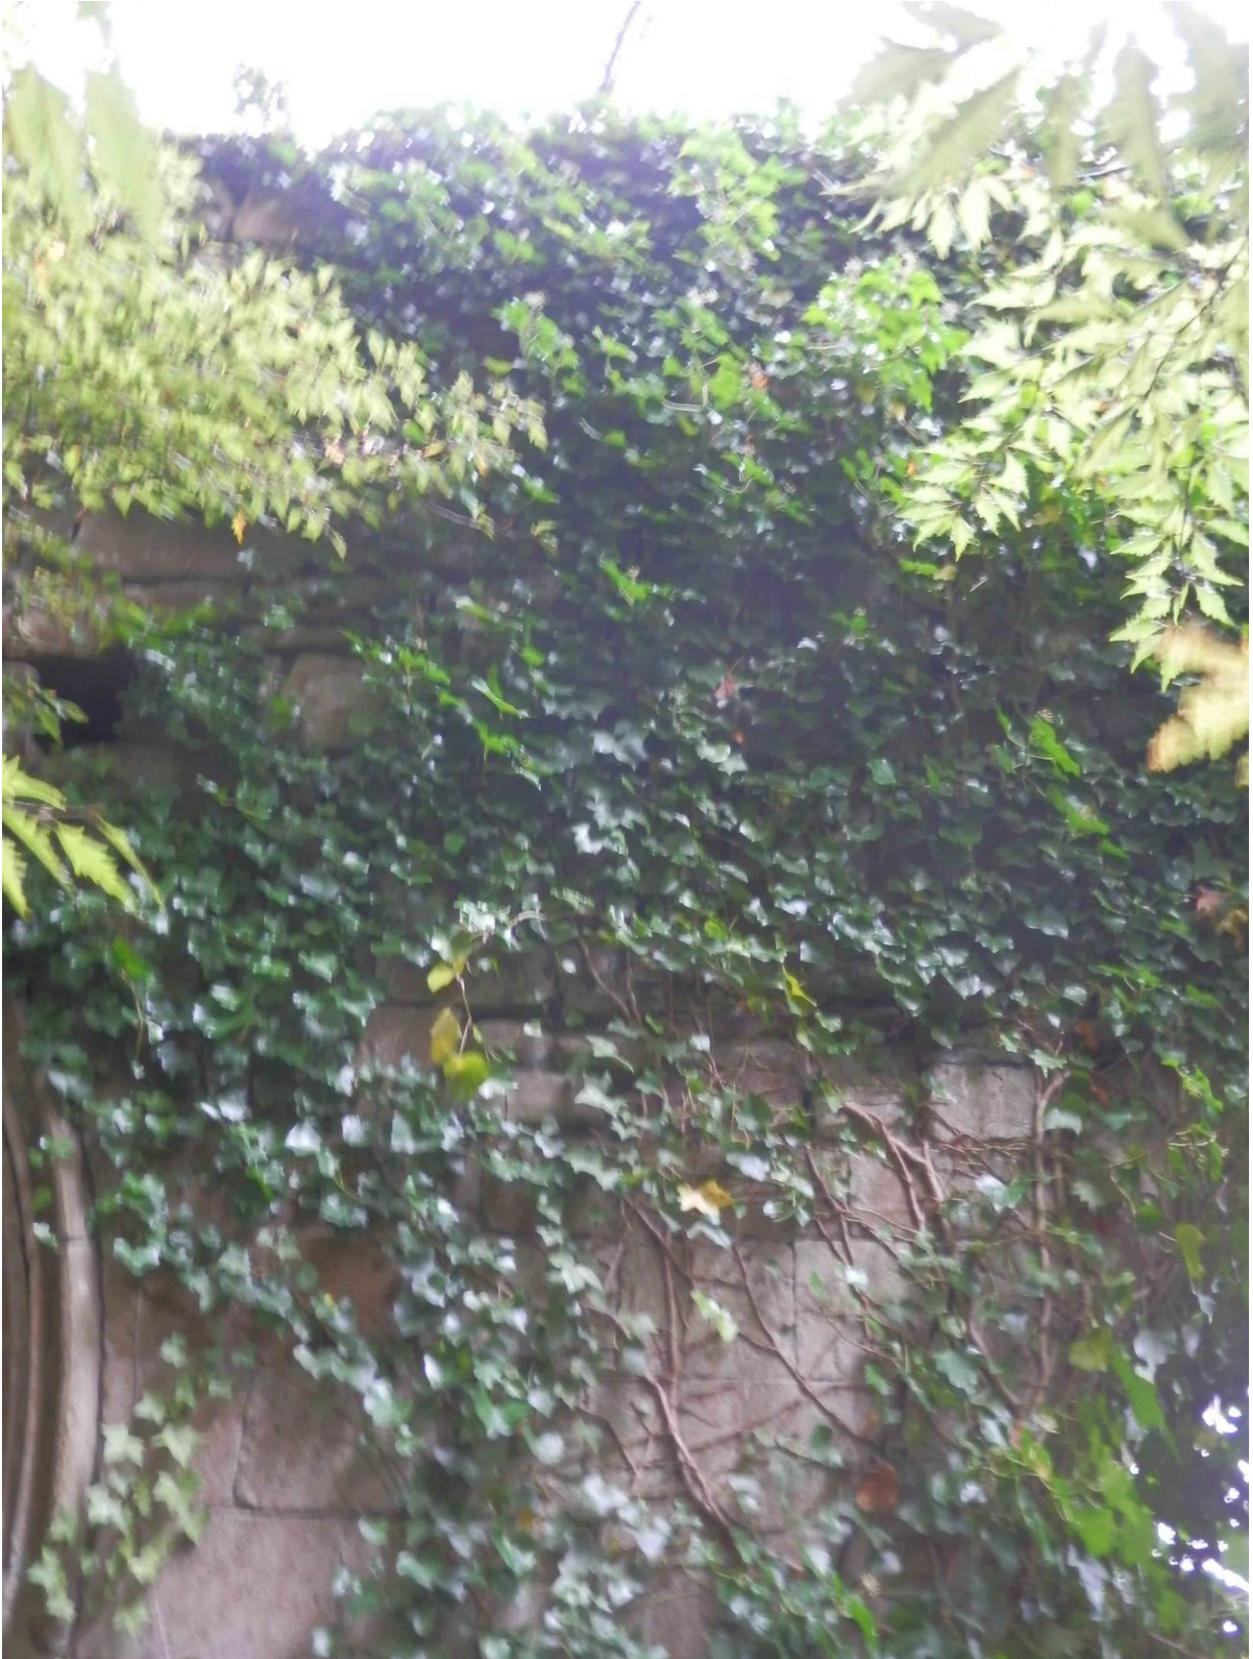
(See figure 2, figure 13 elevation 94)

ID: 135 Site Number: 748 Site Name: Margam Monastic Ruins
Wall Number: 94 Photo Number: F2/161-162-1
Location: East cloister west wall Ext. Wall between arch (93) and (95)
Description: Ashlar with chamfered corner on right side. Putlog hole second course from bottom. Masonry changes to local sandstone rubble 15 courses from bottom. Large amount of vegetation/ivy climbing up. Tree branches and leaves covering upper wall. Possible cement touch up. Some mortar remains. Some stone come away, so filled in with cement to fix. Hole drilled in base of wall. Cannot see much of top part of wall due to ivy and branches.
Condition Summary: A) Large amounts of ivy climbing the wall to top. B) Pitting of stone caused by weathering. C) Mortar missing. D) Gaps in rubblework on top. E) Tree branches (from tree in cloister) in contact with wall.
Threats: Weathering, Vegetation, tree roots, ivy
Recorded by: Sarah Baker Date: 02/10/2012
