Monastic Margam Community Survey Project

Report for Cadw
by Sam Pamment BA

GGAT report no. 2013/020
NGR: SS 8018 8626
Project no. GGAT 123

Summary

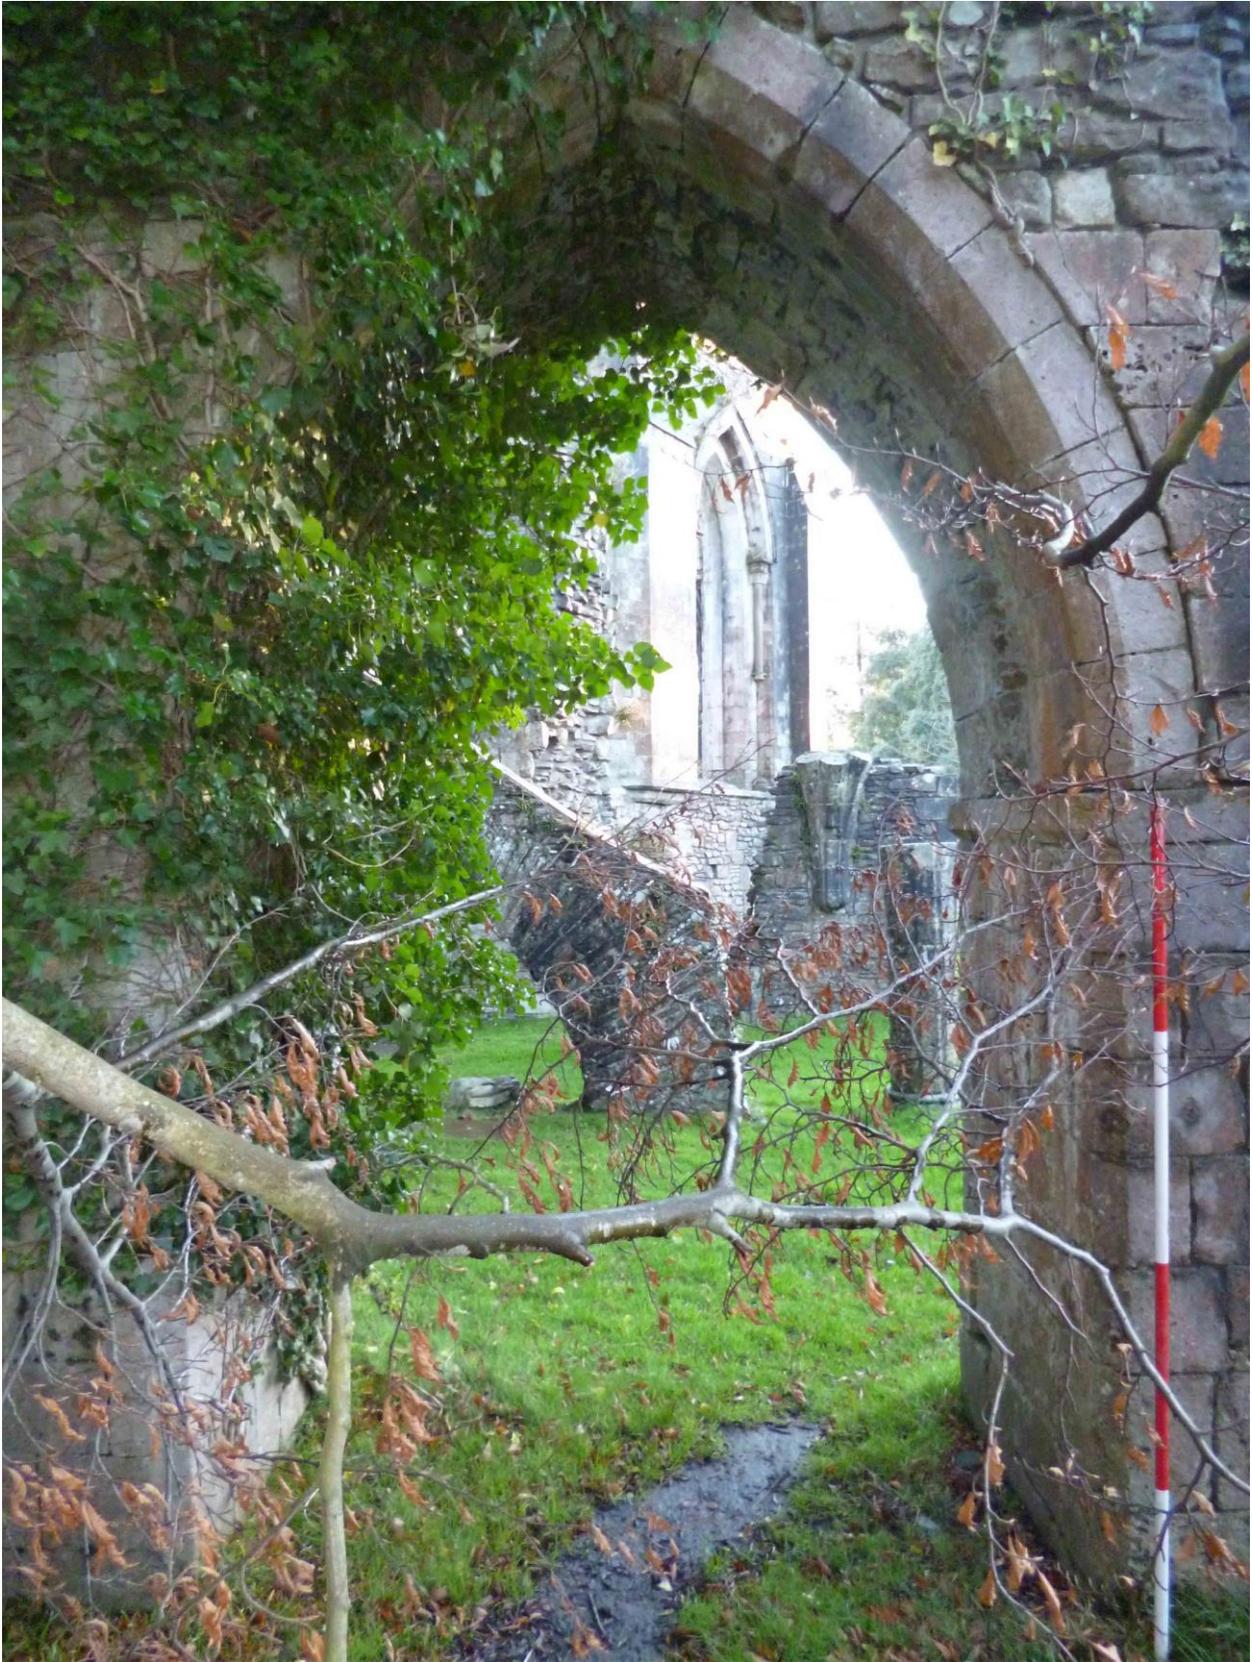
(See figure 2, figure 13 elevation 95)

ID: 136 Site Number: 748 Site Name: Margam Monastic Ruins
Wall Number: 95 Photo Number: F3/53-57
Location: East cloister west wall Ext. Right archway.
Description: Ashlar archway, chamfered with two putlog holes on right. Ashlar only goes up 3/4 of the arch above is constructed of local sandstone rubble. Outer wall face leaning forward. Top section of wall moving forward out. bracket protrudes from the second course above the springing of the arch. Ivy covered some of the archway.
Condition Summary: A) Vegetation. B) Some courses of ashlar blocks have slid forward from face of wall (see wall 96). C) Some of the blocks have cracked D) Gap between the arch and wall on the right.
Threats: Weathering, Vegetation
Recorded by: Ruth Hopkins Date: 02/10/2012

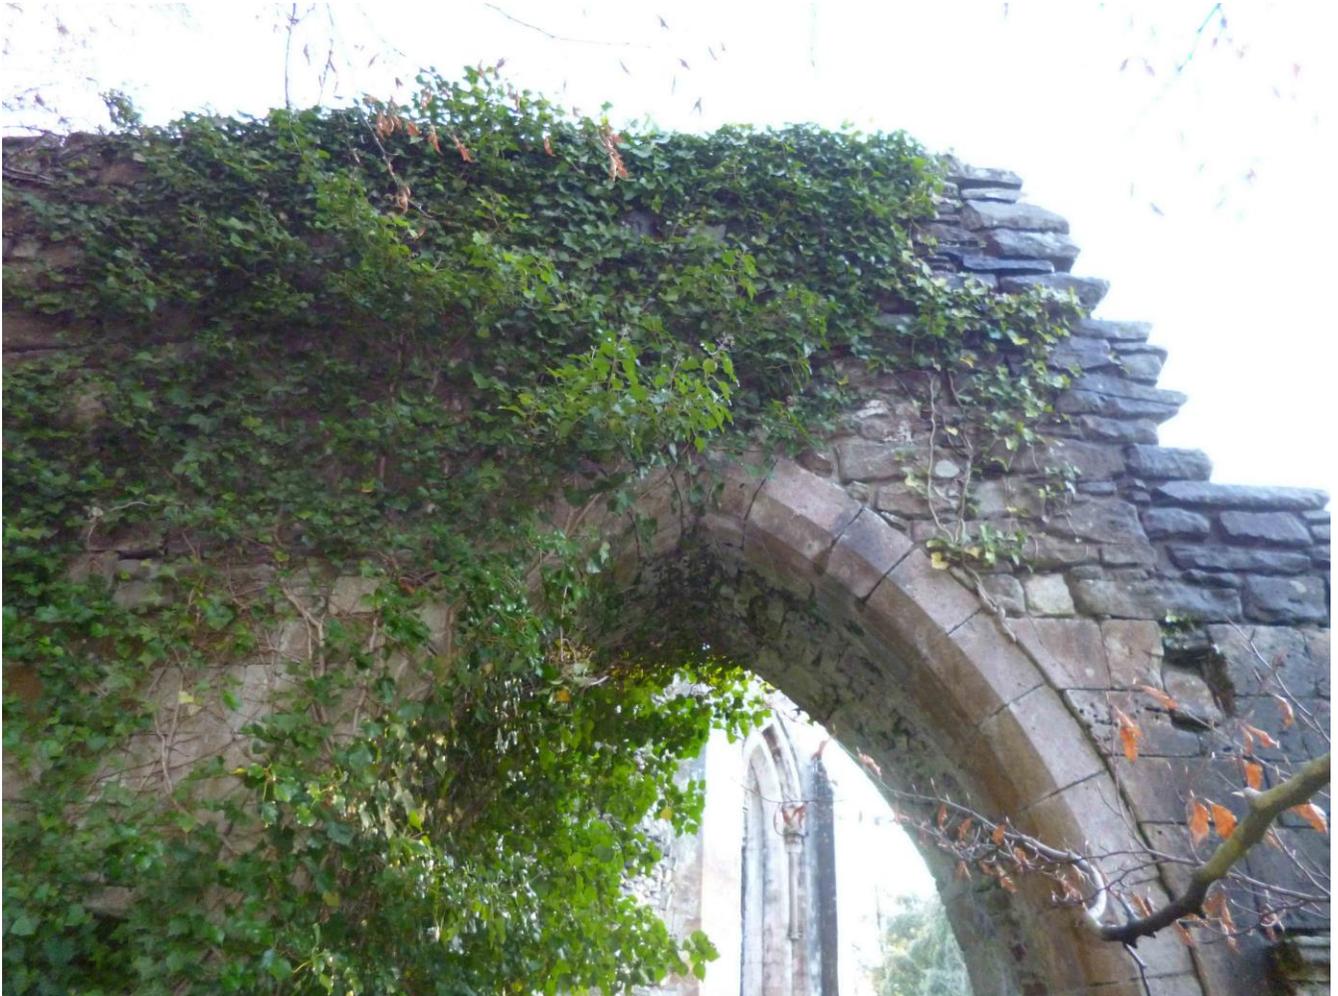
(See figure 2, figure 13 elevation 95)

ID: 137 Site Number: 748 Site Name: Margam Monastic Ruins
Wall Number: 95 Photo Number: F2/62-63-64
Location: East cloister west wall arch top
Description: Local sandstone rubble. Most of this top section is covered by ivy. Stone work has been re-pointed possibly with cement
Condition Summary: A) Vegetation. B) Possible loose stones on right of wall.
Threats: Weathering, Vegetation
Recorded by: Ruth Hopkins Date: 02/10/2012

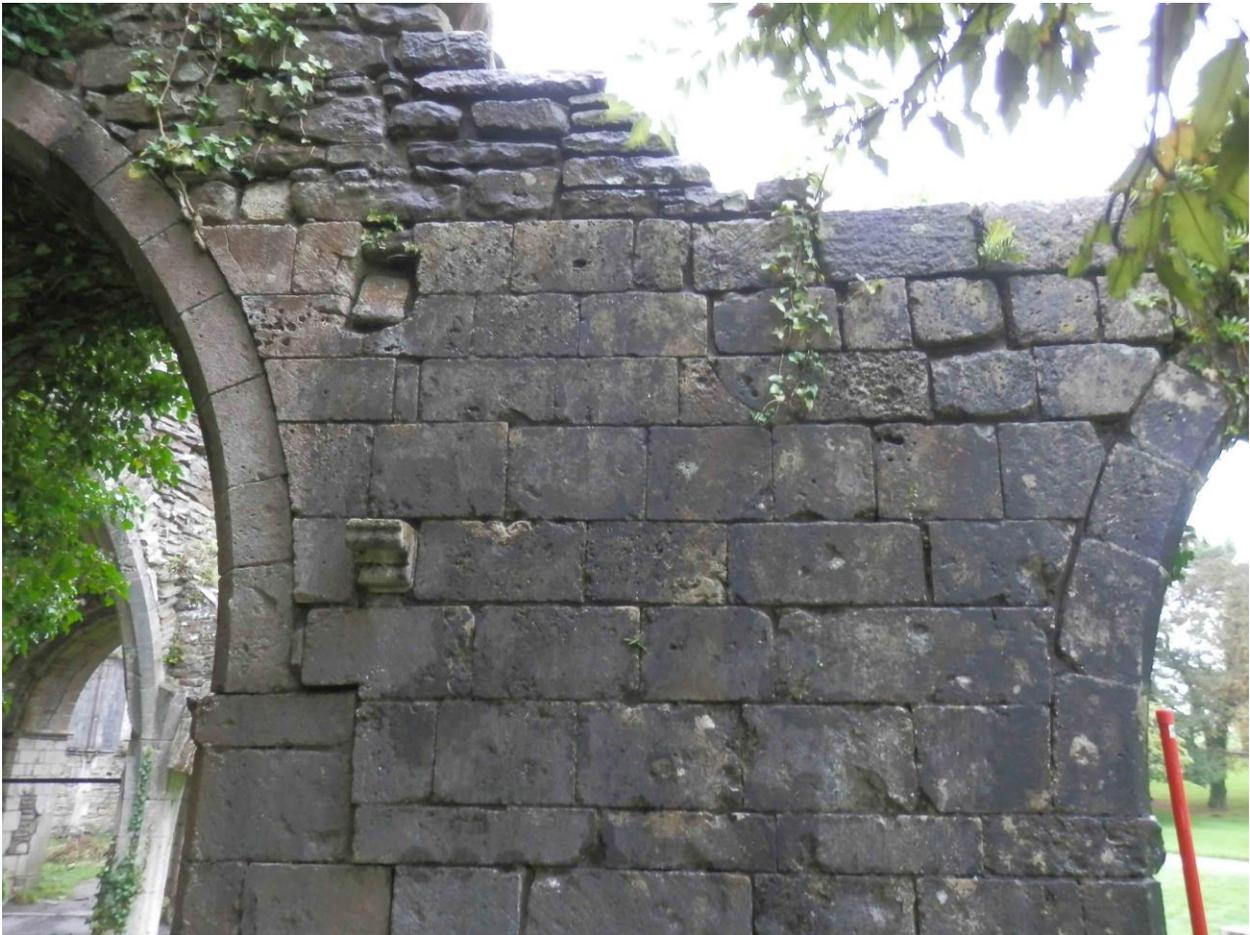
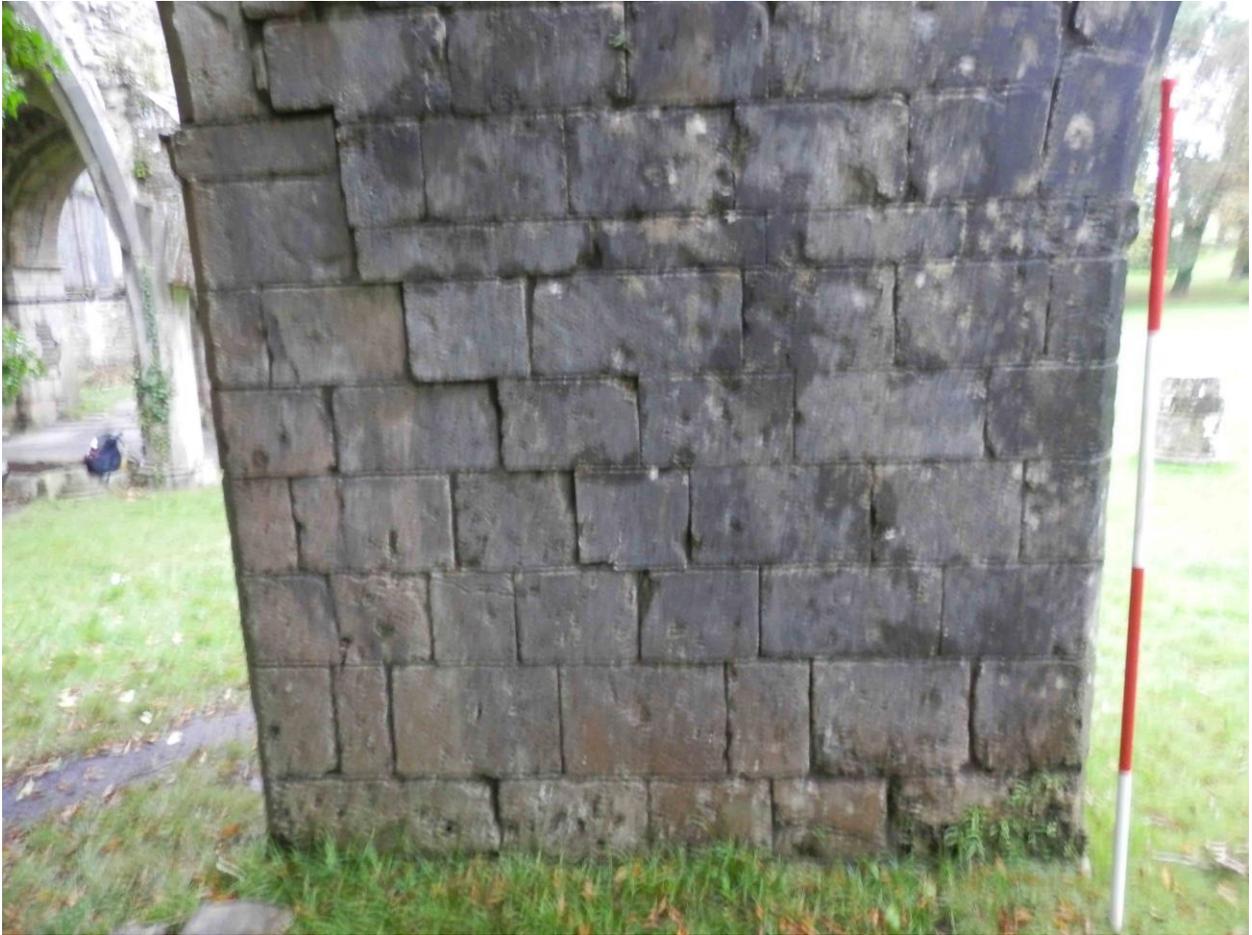
(See figure 2, figure 13 elevation 96)

ID: 138 Site Number: 748 Site Name: Margam Monastic Ruins
Wall Number: 96 Photo Number: F2/167-168
Location: East cloister west wall, wall between arches 2 and 3
Description: No vegetation. Ashlar to top of right arch 3; local sandstone rubble on top. Filled-in putlog towards top of ashlar section. Piece molding bracket protrudes from the second course above the springing of the arch (see wall 95). Right-hand side of rubble section is missing.
Condition Summary: A) Mortar missing. B) Weathered holes in stone, esp. towards bottom. C) Stones being pushed out. D) Small amount of vegetation on bottom right corner and on top, coming through gaps in mortar E) Crack in ashlar. F) Crack in stone towards top.
Threats: Weathering, Vegetation
Recorded by: Sarah Baker Date: 02/10/2012

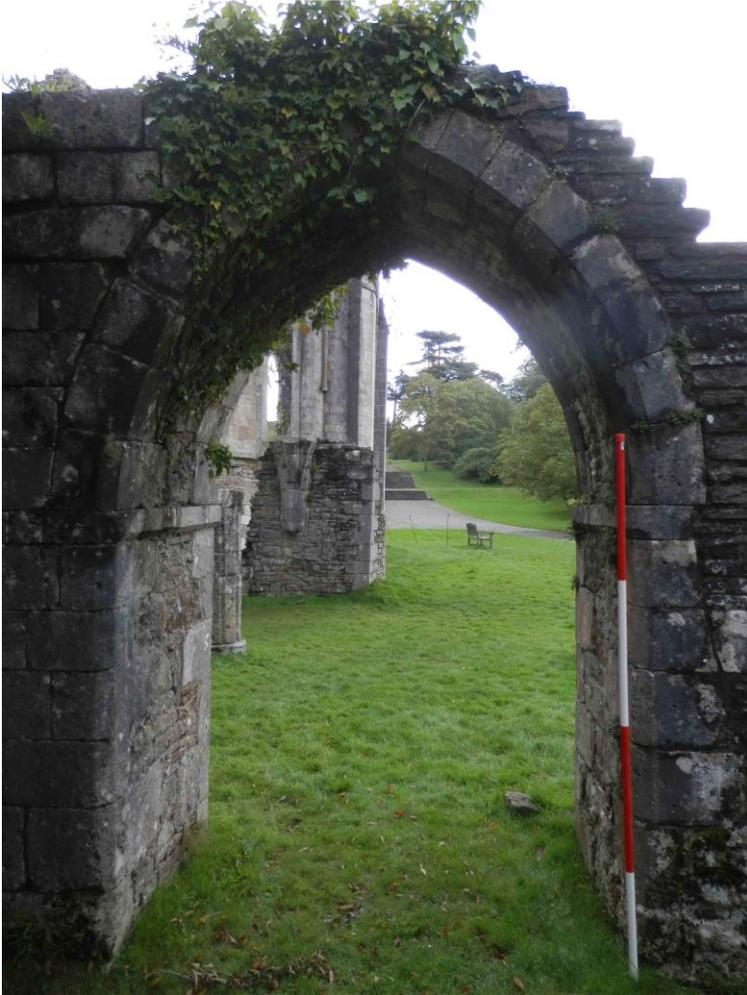
(See figure 2, figure 13 elevation 97)

ID: 139 Site Number: 748 Site Name: Margam Monastic Ruins
Wall Number: 97 Photo Number: F2/171-172
Location: East cloister west wall, external south arch
Description: Pointed arch with ashlar, string course at approx. 1.5m. Ivy at top of arch; South (right) end of wall missing. To the left of the arch, wall in ashlar wall, but to the right, beyond the dressings to the arch, the masonry is all sandstone rubble. Remains of south end of wall stand only about 0.9m. Evidence of rendering on walls. Corner of arch are chamfered.
Condition Summary: A) Some courses of ashlar blocks have slid forward from face of wall. B) Ivy vegetation causing damage to the stonework of the arch. C) Mortar missing on arch. D) Repaired crack on south jamb. E) Weathering at bottom of arch left hand side
Threats: Weathering, Vegetation, structural instability, human interaction
Recorded by: Gloria Rowles and Roy Thomas Date: 03/10/2012

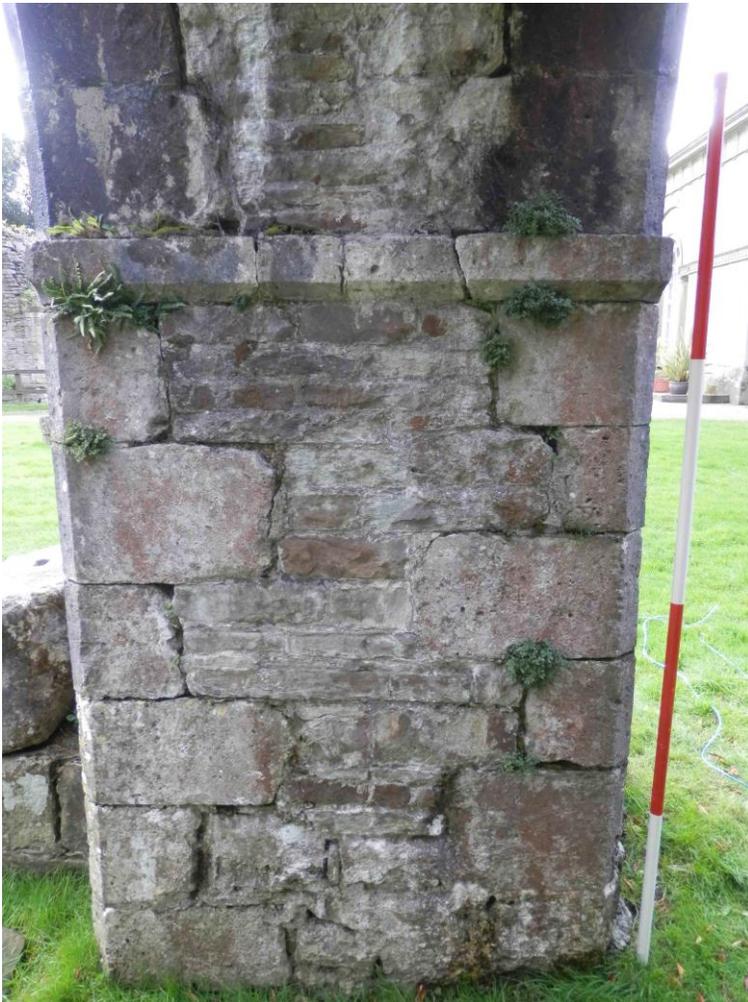
ID: 140 Site Number: 748 Site Name: Margam Monastic Ruins
Wall Number: 98.1 Photo Number: F2/173-174
Location: East Cloister West Wall south inside face of arch (wall 68).
Description: Sandstone rubble with ashlar quoins; chamfered edge on both sides. String course at springing of arch, about 1.5m up. Some lime mortar, with patches of new (cement) mortar. Remnants of render towards the bottom.
Condition summary: A) Weathering to stones at the bottom. B) Gaps between ashlar blocks where weathering has damaged mortar. C) Soft vegetation not deeply rooted as yet. D) Cracks to the string course. E) Fracture between quoins and of sandstone rubble up to the apex of the arch.
Threats: Weathering, vegetation, structural instability.
Recorded by: Gloria Rowels Date: 03/10/2012

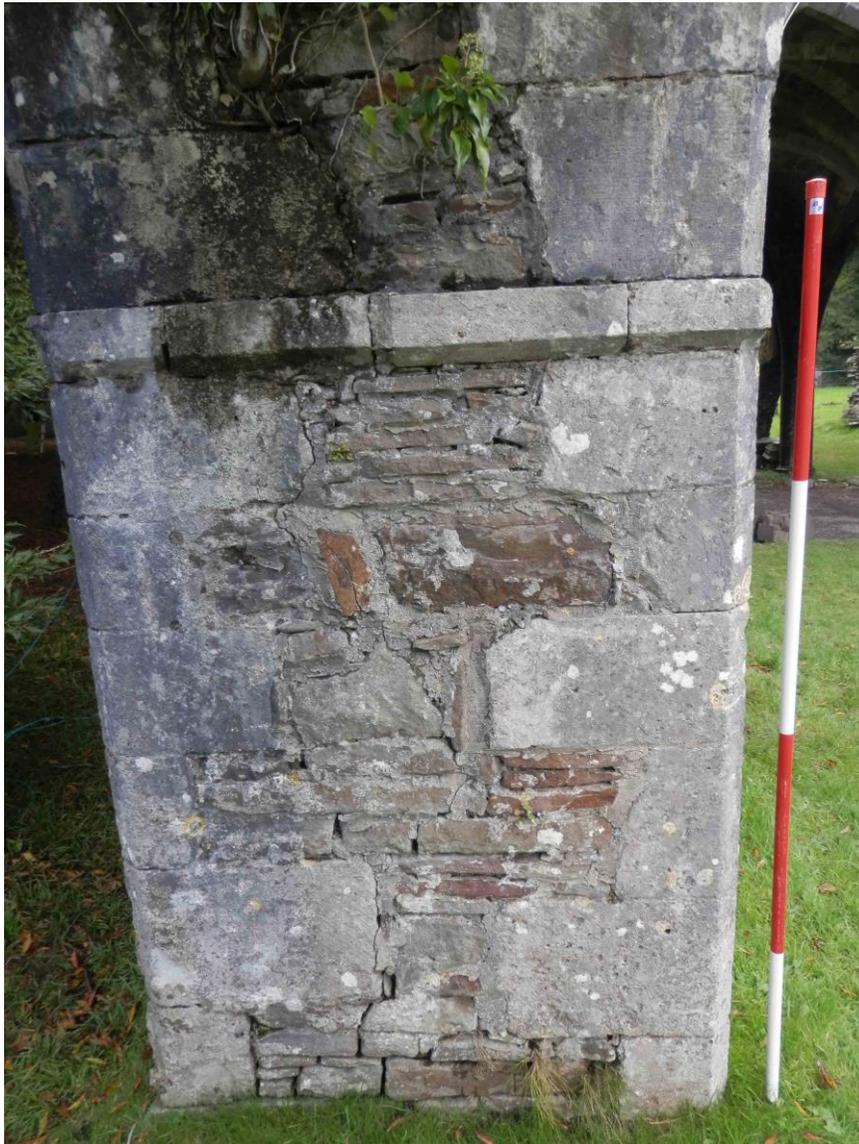
ID: 141 Site Number:748Site
Name: Margam Monastic Ruins
Wall Number: 98.2 Photo Number:F2/176-177
Location: East Cloister West Wall north inside face of arch (wall 68).
Description: Sandstone rubble with ashlar quoins; chamfered edge on both sides.
String course at springing of arch, about 1.5m up More Modern mortar
on this side
Condition summary: A) Faulting cracking all the way through. B) Ivy vegetation. C) Gaps in
mortar of string course. D) Loss of mortar at the bottom.
Threats: Weathering/loss of mortar, Vegetation, instability of structure.
Recorded by: (not filled in) Date: 03/10/2012

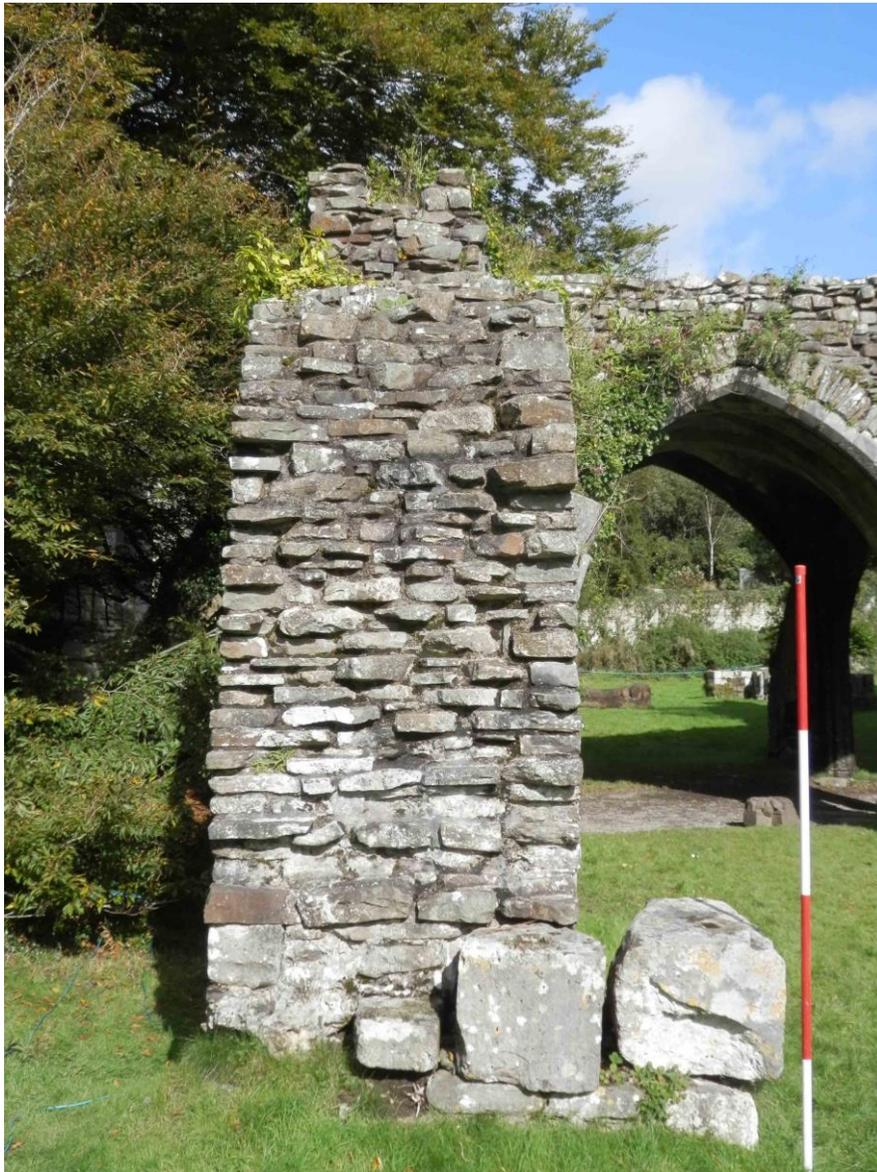
ID: 142 Site Number: 748 Site Name: Margam Monastic Ruins
Wall Number: 99 Photo Number: F2/183
Location: East cloister west wall south end, plus return to the east
Description: Terminal end of wall, no facing stones apart from at the bottom. Return consists of two large blocks, each with a slot cut into it; possibly not in their original position. Appears to be mostly original mortar.
Condition summary: A) Some weathering to blocks. B) Little vegetation.
Threats: Vegetation, weathering, human interaction and structural weakening.
Recorded by: Gloria Rowles Date: 03/10/2012

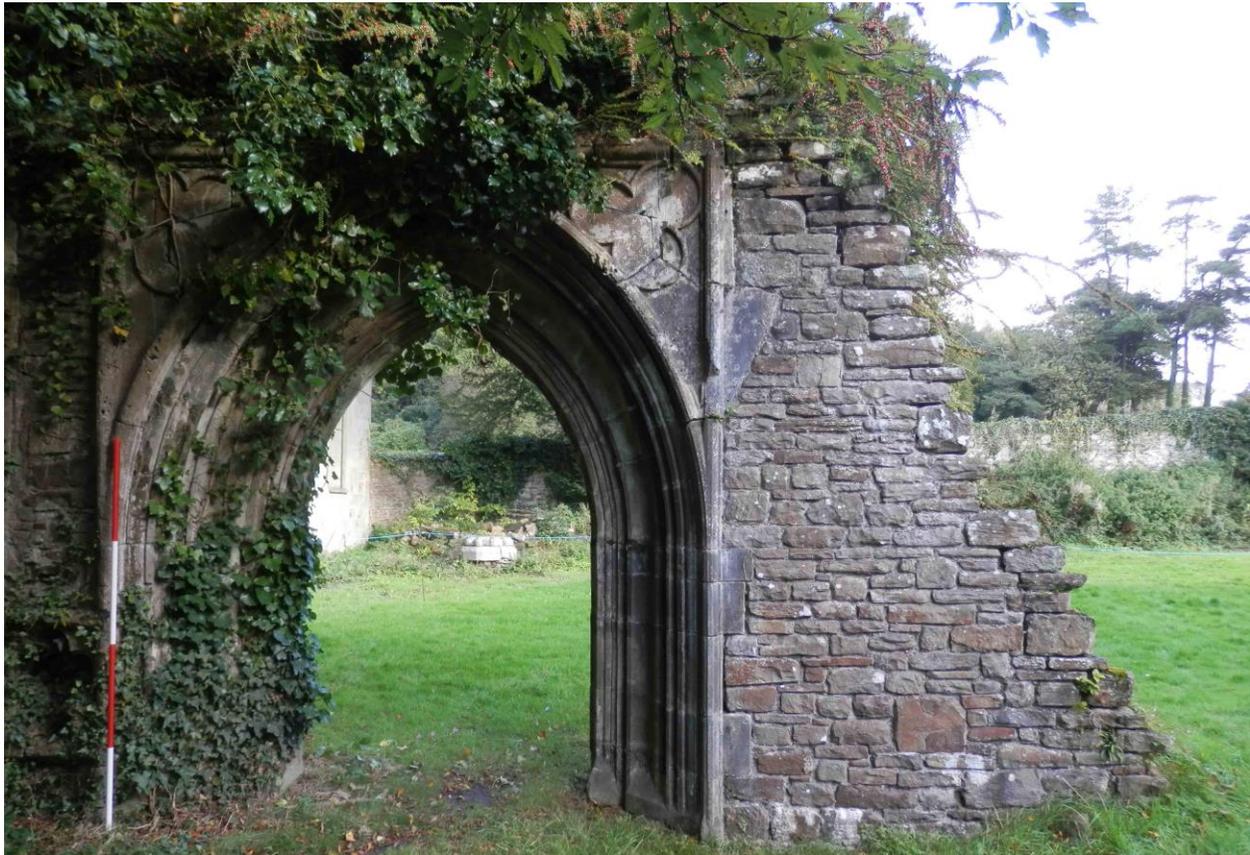
(See figure 2, figure 12 elevation 100)

ID: 143 Site Number: 748 Site Name: Margam Monastic Ruins
Wall Number: 100 Photo Number: F2/169-170
Location: North cloister, external east archway (Processional door)
Description: Archway in ashlar with attractive decoration. Mouldings run continuously up jambs and around head, meeting a rectangular moulded frame, separating the ashlar from the rubble above. There are trefoils in the spandrels doorway, moulding on face. Coursed sandstone rubble to the right hand side of doorway
Condition summary: A) The spandrels are starting to show gaps at the joints/cracks allowing penetration by vegetation. B) The gaps are starting to appear in the mouldings of the arch, again allowing penetration by vegetation. C) On the right hand side of the head of the arch there is a large gap appearing in topmost moulding. D) Vegetation (ivy) growing from bottom left hand side of doorway with thick stems following the angle of the archway, some penetrating through the gaps. E) Also vegetation growing on stone work at top of arch in a thick mass, Ivy, cotoneaster, ash. F) Pointing on the stone work to the right of arch in good condition. However stone work at the top has large gaps and require checking for stability.

Threats: Excessive vegetation, weathering
Recorded by: Jeff Jones Date: 03/10/2012

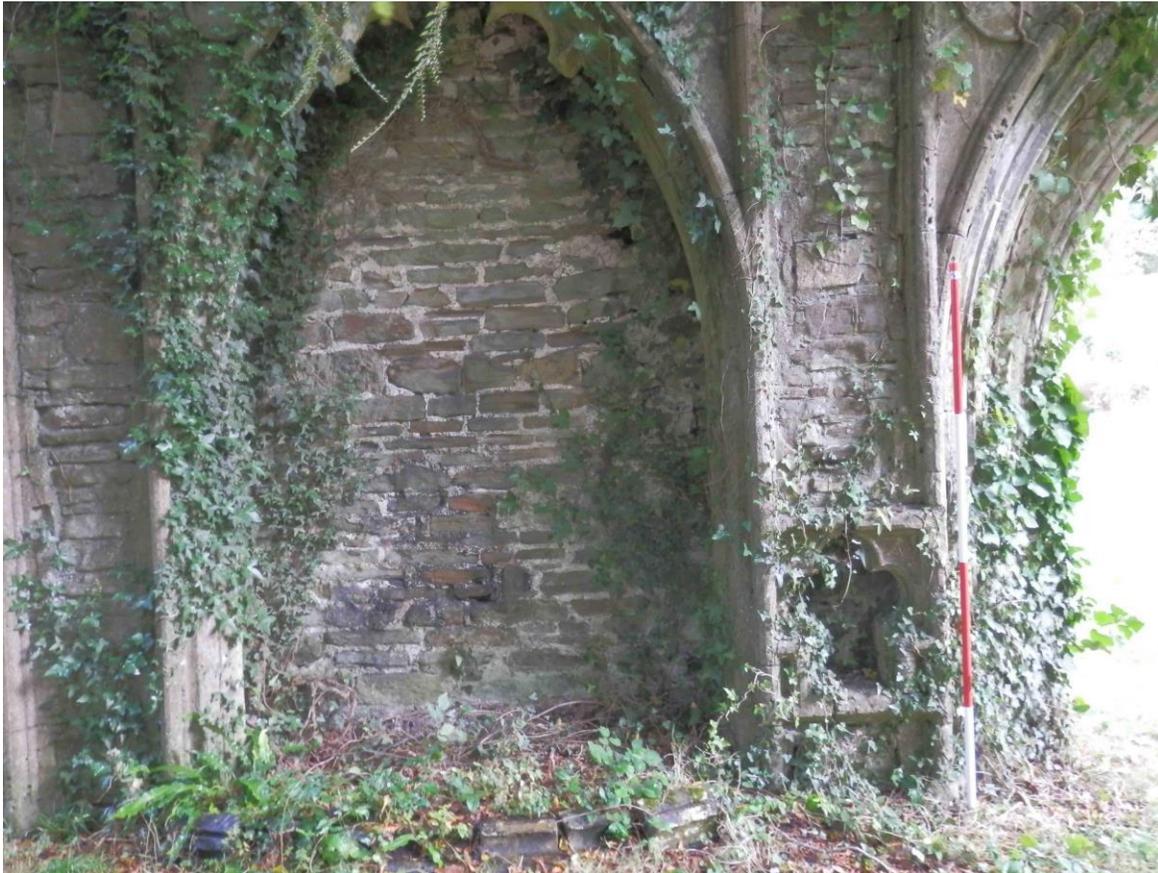
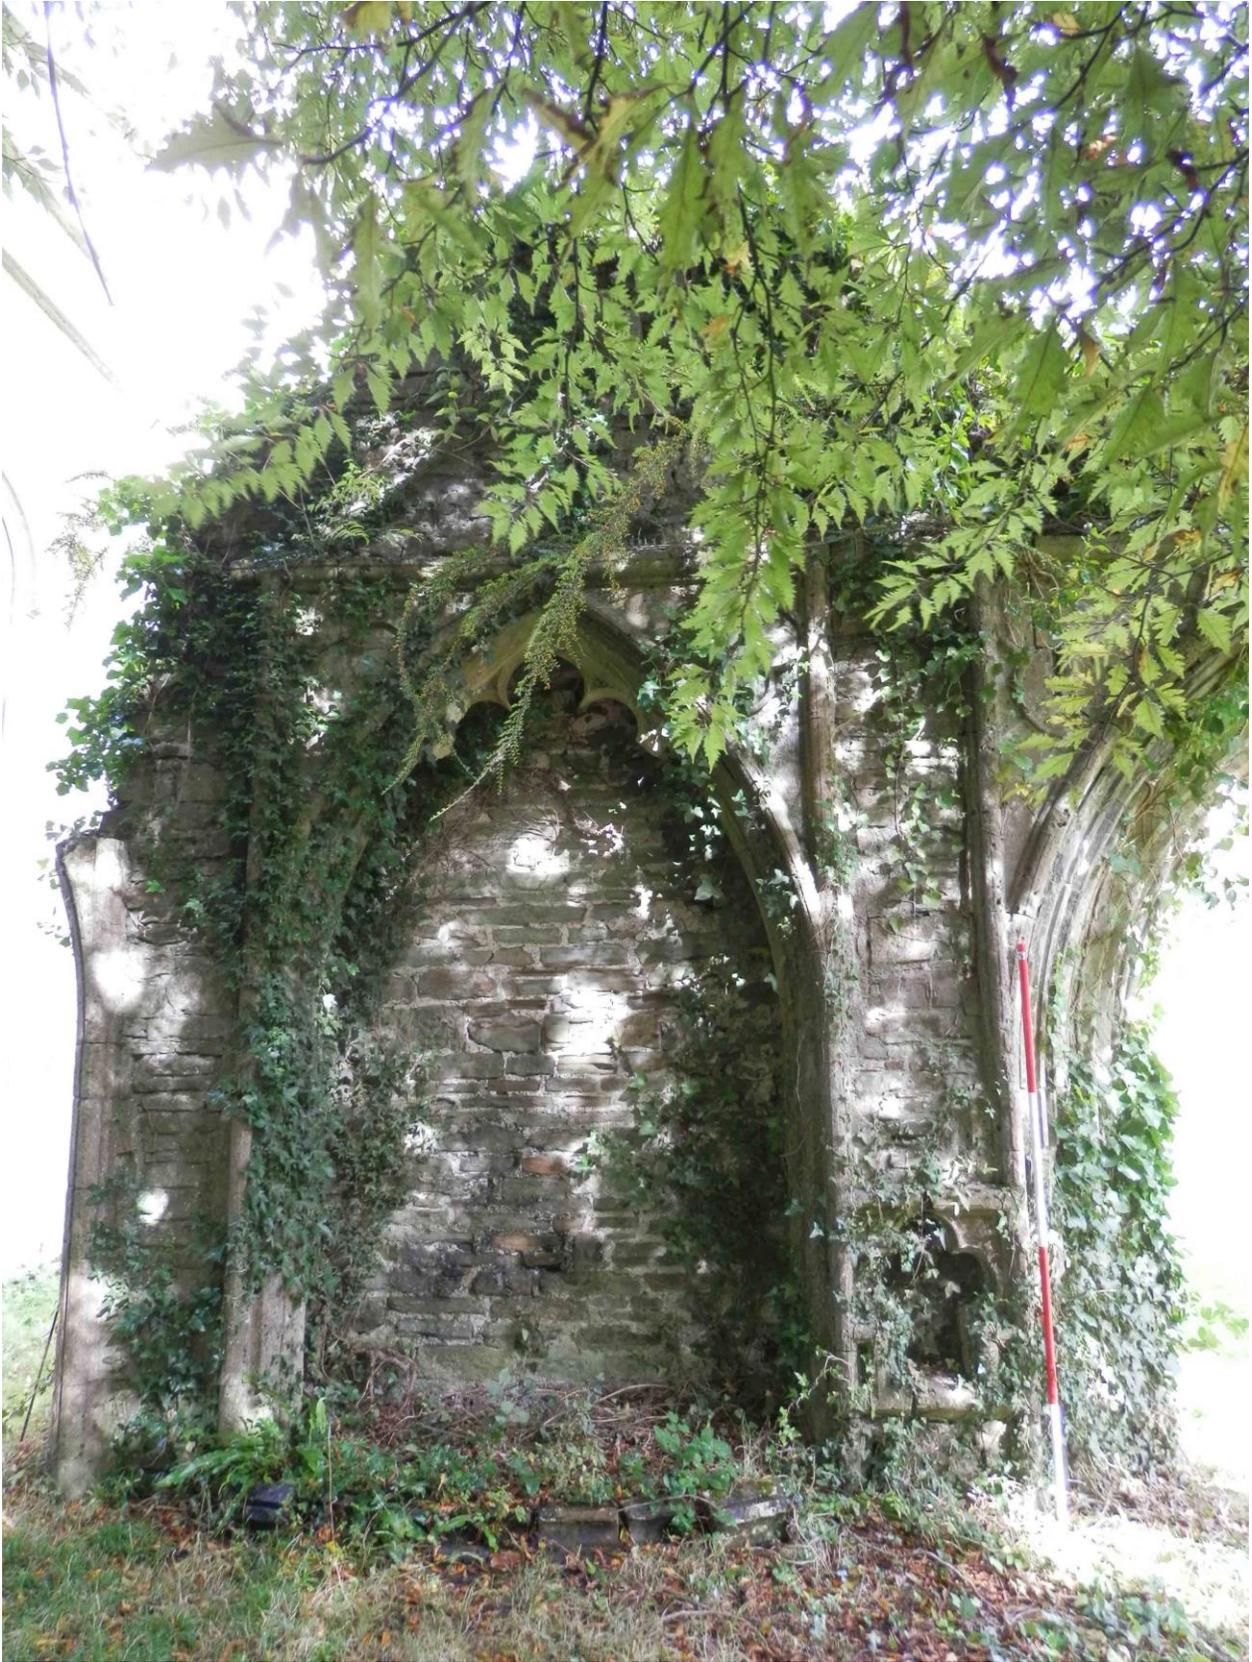
(See figure 2, figure 12 elevation 101)

ID: 144 Site Number: 748 Site Name: Margam Monastic Ruins
Wall Number: 101 Photo Number: F2/178-182
Location: North cloister wall Ext.
Description: External wall with blind (or blocked) arcade. Only complete archway in ashlar has moulding around opening, within a moulded frame with quatrefoils in the spandrels. Masonry within the arch is local sandstone rubble with ?original mortar. At base moulded ashlar blokes have been arranged in a semi-circle. Top moulding of archway damaged, parts missing. At base of wall between this arch and the previous one (wall no.100) is a rectangular moulded panel pierced by a quatrefoil. The mouldings to the right-hand jamb of the arch to the left are separated from the complete archway by a short length of sandstone rubble.
Condition summary: A) Broken moulding to top of archway. B) Missing stones in rubble within arch. C) Missing mortar back wall. D) Vegetation extensive ivy growth on top. E) weathering moulding right hand side. F) Vegetation. G) Large protruding stone to right above arch way. H) Broken moulding (to missing left-hand arch. I) Vegetation and soil.

Threats: Vegetation, weathering and human interaction.
Recorded by Maggie Cornelius Date: 04/10/2012

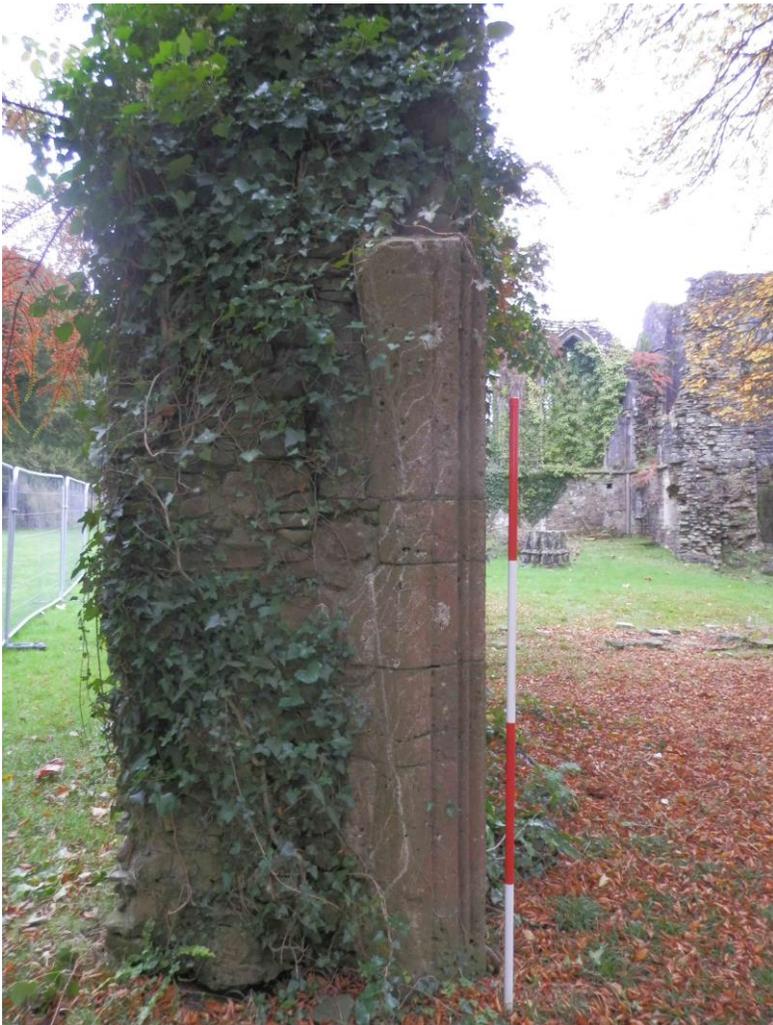
(See figure 2)

Description: Inner face of the damaged left-hand arch of wall no.101. Right-hand edge consists of the ashlar dressing to the arch, which springs forward from the face of the wall. The rest of the wall consists of rubble in local sandstone and mortar. Extensive ivy coverage.

Condition summary: A) Weathering to sandstone blocks. B) Damaged/loose of top of ashlar blocks. C) Vegetation - ivy - very loose roots. D) Mortar loose at base of wall between dressings to arch and rubble. E) Mortar missing in dressings part-way up jamb. F) Stones missing on left-hand edge of rubble. G) Vegetation (shrubs).

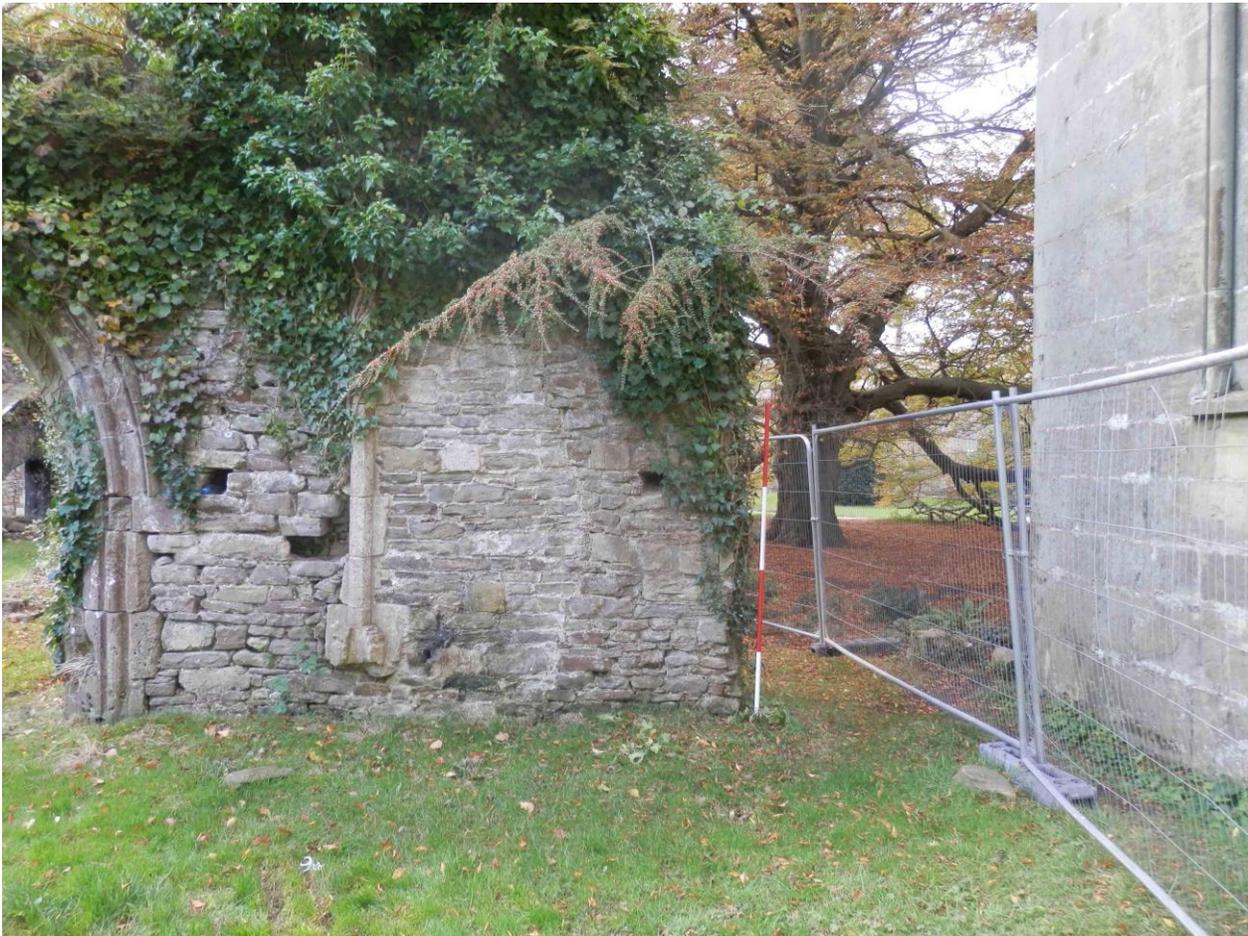
(See figure 2, figure 12 elevation 103)

ID: 146 Site Number: 748 Site Name: Margam Monastic Ruins
Wall Number: 103 Photo Number: F3/4-5
Location: South aisle south wall (east end) int. West section of standing ruins.
Description: Internal face of wall constructed mainly of local sandstone rubble. ?Original white mortar with added black bits (coal/charcoal?). A vertical moulding carved out of a series of Sutton stone blocks has been built into the middle of the wall; it terminates several courses above the present ground level in a moulded base, into which has been cut a vertical socket. Putlog holes to right-hand and left-hand sides. Large area of missing stonework. Missing mortar. Difficult to see top as covered in ivy and vegetation.
Condition summary: A) Missing stones (left of moulding). B) Missing mortar. C) Vegetation. D) Weathering to Sutton stone.
Threats: Vegetation, Weathering and human disturbance
Recorded by: Maggie Cornelius Date: 04/10/2012

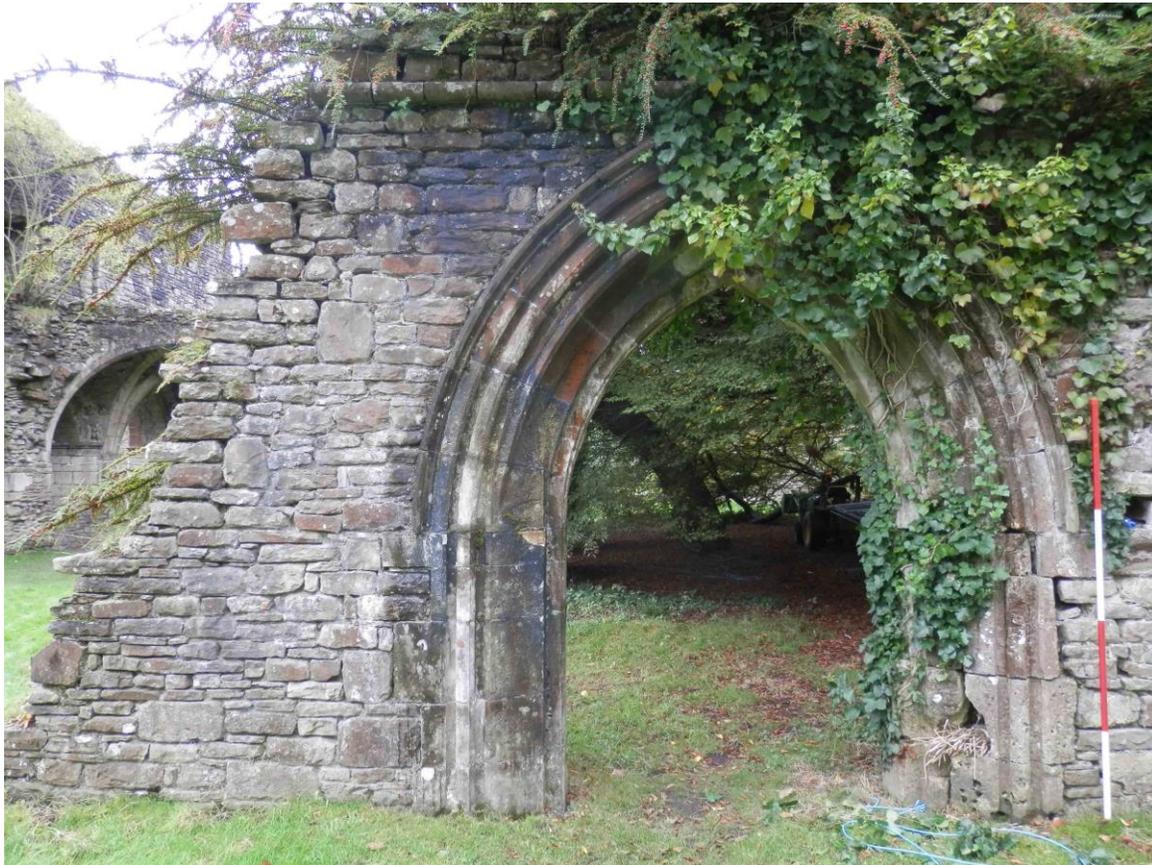
(See figure 2, figure 12 elevation 104)

ID: 147 Site Number: 748 Site Name: Margam Monastic Ruins
Wall Number: 104 Photo Number: F2/274-275
Location: Nave wall int. Archway (Processional door; reverse of wall no.100)
Description: On this side of the wall, the arch has three orders of moulding running up the jambs and over the head, but no frame. Over the top of the arch is a moulded string course. At the west side, at the top of the stone wall is a shaft which is not very noticeable (concealed by vegetation). Most of wall constructed in sandstone rubble.
Condition summary: A) West side bottom side of archway has missing mortar; some large gaps in stonework. B) Archway west side bottom excessive erosion of edge of arch and weathering at bottom. C) Pointing on rubble at both east and west sides in very poor condition, also the pointing at the top of the arch is in poor condition, required to be checked for loose stone. D) A mass of vegetation all over the top of both archway and wall - ivy, cotoneaster, yew. E) Water running down face of stonework and archway.

Threats: Vegetation, Weathering (running water)
Recorded by: Jeff Jones Date: 05/10/2012

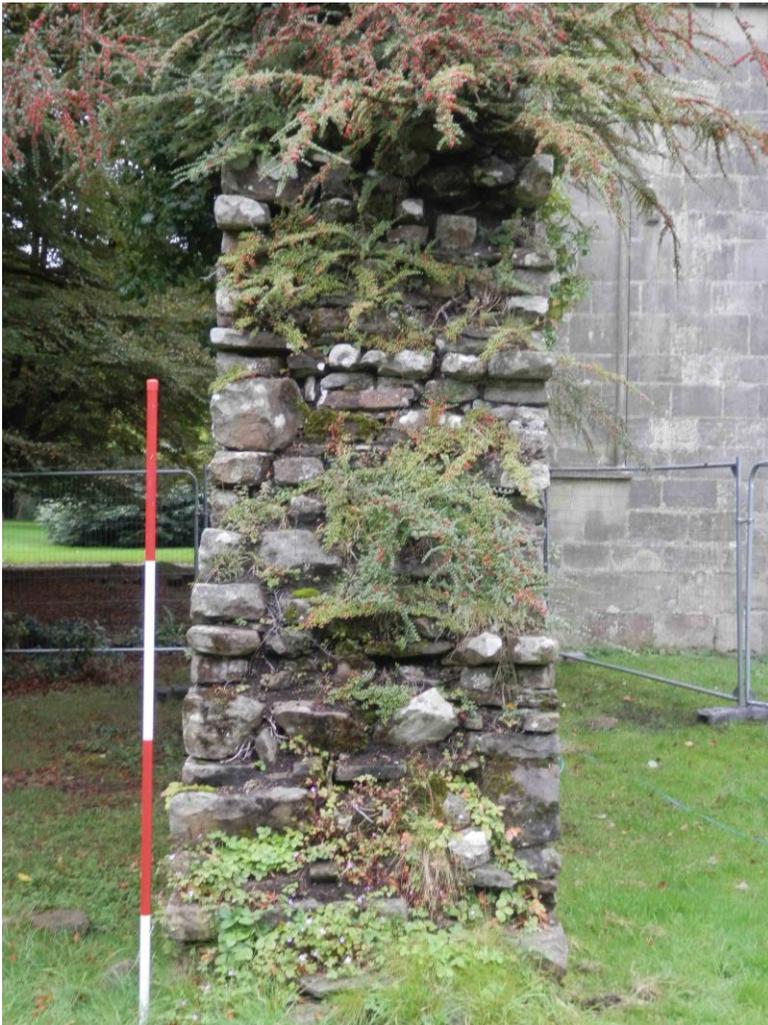
(See figure 2)

ID: 148 Site Number: 748 Site Name: Margam Monastic Ruins
Wall Number: 105 Photo Number: F2/ 276
Location: Nave wall east end
Description: Edge of wall is built of sandstone rubble. Much of mortar replaced by earth. The thickness of the wall is about 1.35m and looks to be in sound condition; however there are a couple of loose stones at the bottom. Unable to see condition of top of wall due to amount of vegetation present.
Condition summary: A) Excessive amounts of vegetation growth at top of wall and also below this in sporadic sections. Cotoneaster, wild strawberry, herb robert, grasses, mosses. B) Surface of mortar covered with layer of soil. C) Some loose stone work at base of wall.
Threats: Weathering, vegetation, loose stonework.
Recorded by: Jeff Jones Date: 05/10/2012

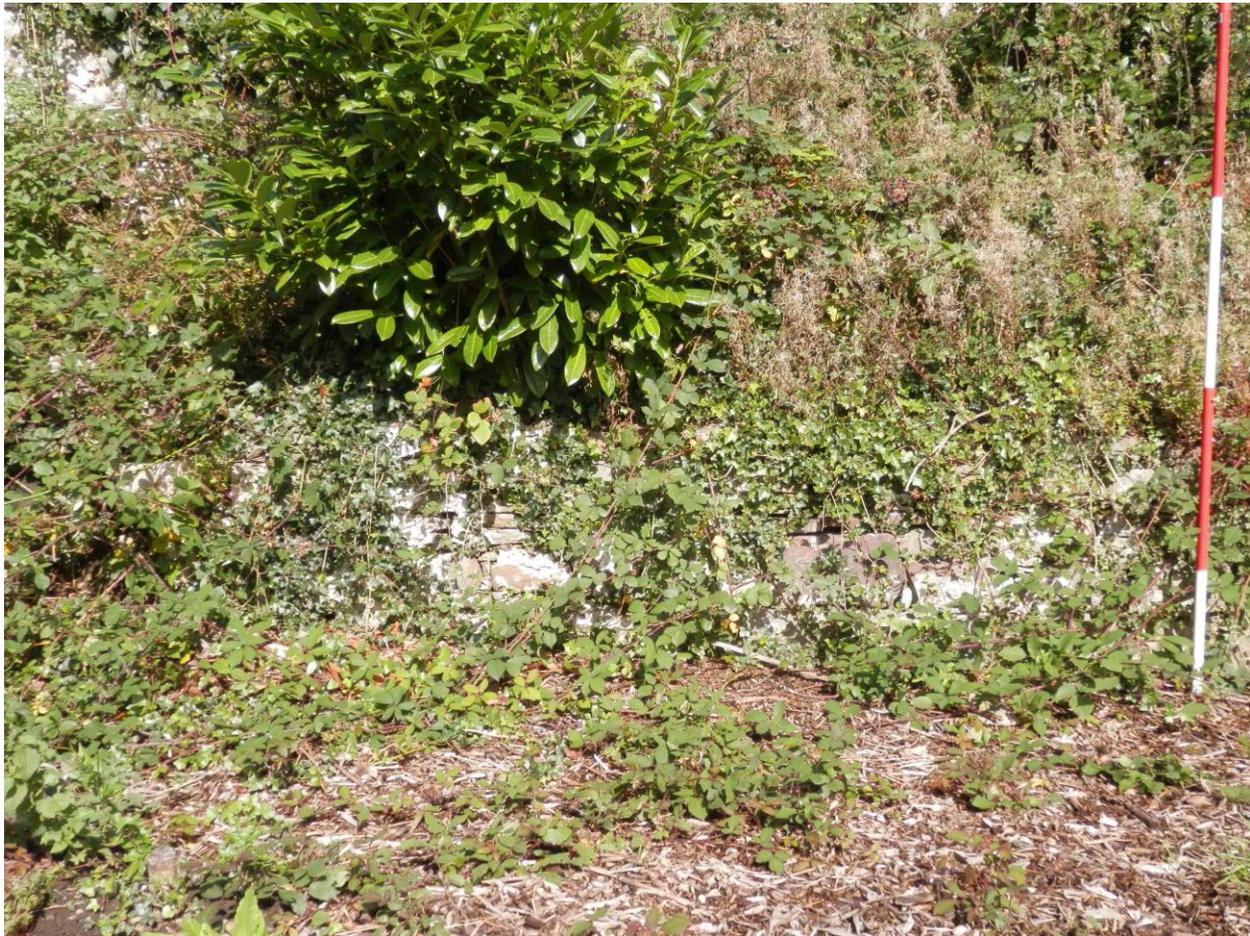
(See figure 2)

ID: 149 Site Number: 748 Site Name: Margam Monastic Ruins
Wall Number: 106 Photo Number: F2/184-186
Location: North Chancel Wall Int.
Description: Overgrown with vegetation. Stones barely visible. Remains of the base of a shaft on far right. Very little mortar remains between stones so they are very loose. Large carved stone balancing on edge of left side of wall. Wall in local sand stone rubble, except around the shaft. Remnants of lime rendering/wash on face of stones. Average height to which wall survives seems to be 2m, but more in area of shaft
Condition summary: A) Vegetation-ivy, bramble and bushes growing all over. B) Mortar disappeared between stones (weathered out). C) Vegetation displacing stones, making them fall out.
Threats: Vegetation and roots, weathering
Recorded by: Sarah Baker Date: 03/10/2012

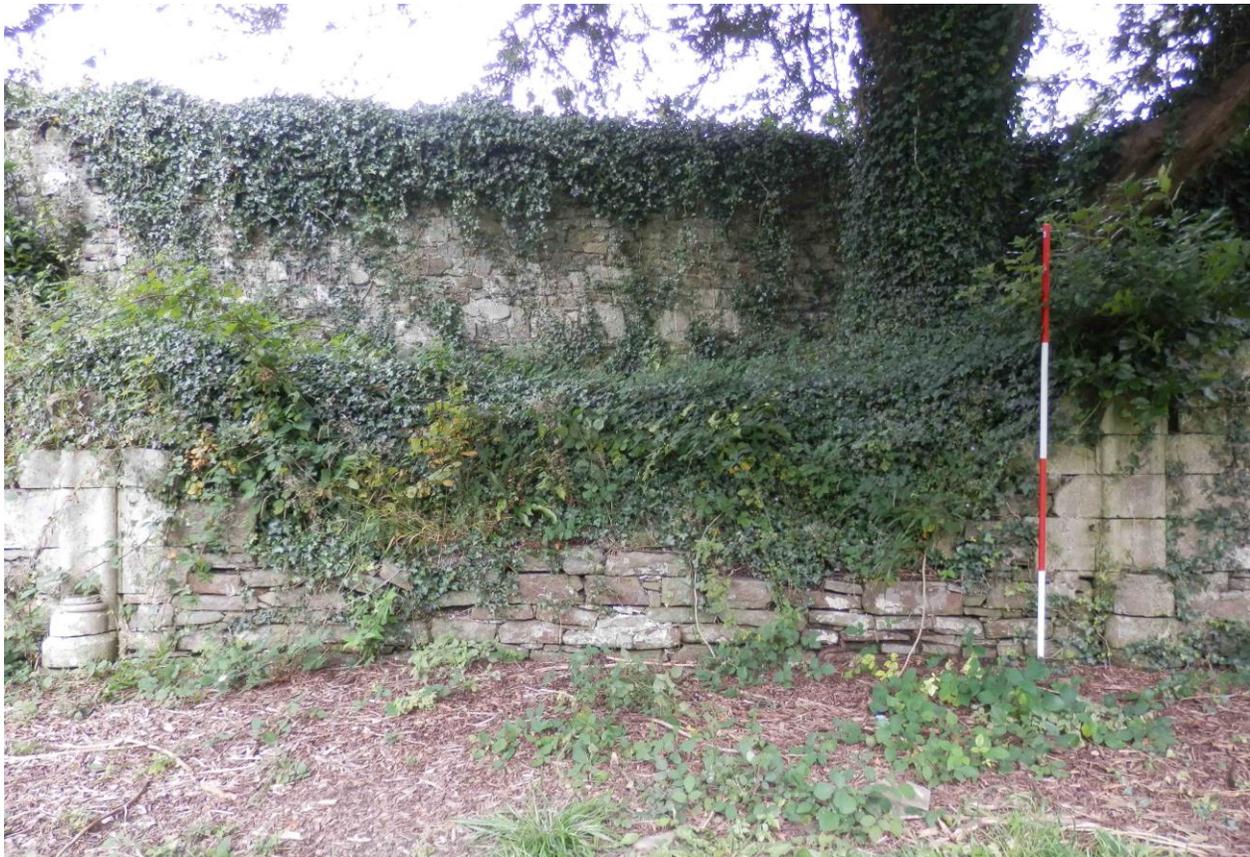
(See figure 2)

ID: 150 Site Number: 748 Site Name: Margam Monastic Ruins
Wall Number: 107 Photo Number: F2/187-188
Location: North Chancel wall Int.
Description: (Middle section, between the two shaft bases) Construction of wall around each shaft is in ashlar (shafts themselves missing apart from the bases), with sandstone rubble in between. Ashlar sections higher than rubble in between, with variable number of courses.
Condition summary: A) Collapsing wall left hand side. B) Masonry gaps in all sections. C) Vegetation encroachment across all sections. D) Yew tree roots invading wall. E) Weathering to all areas. F) People (children) climbing
Threats: Vegetation (roots), Weathering, Human action.
Recorded by: Bob Hardwick Date: 03/10/2012
