Monastic Margam Community Survey Project

Report for Cadw
by Sam Pamment BA

GGAT report no. 2013/020
NGR: SS 8018 8626
Project no. GGAT 123

Summary

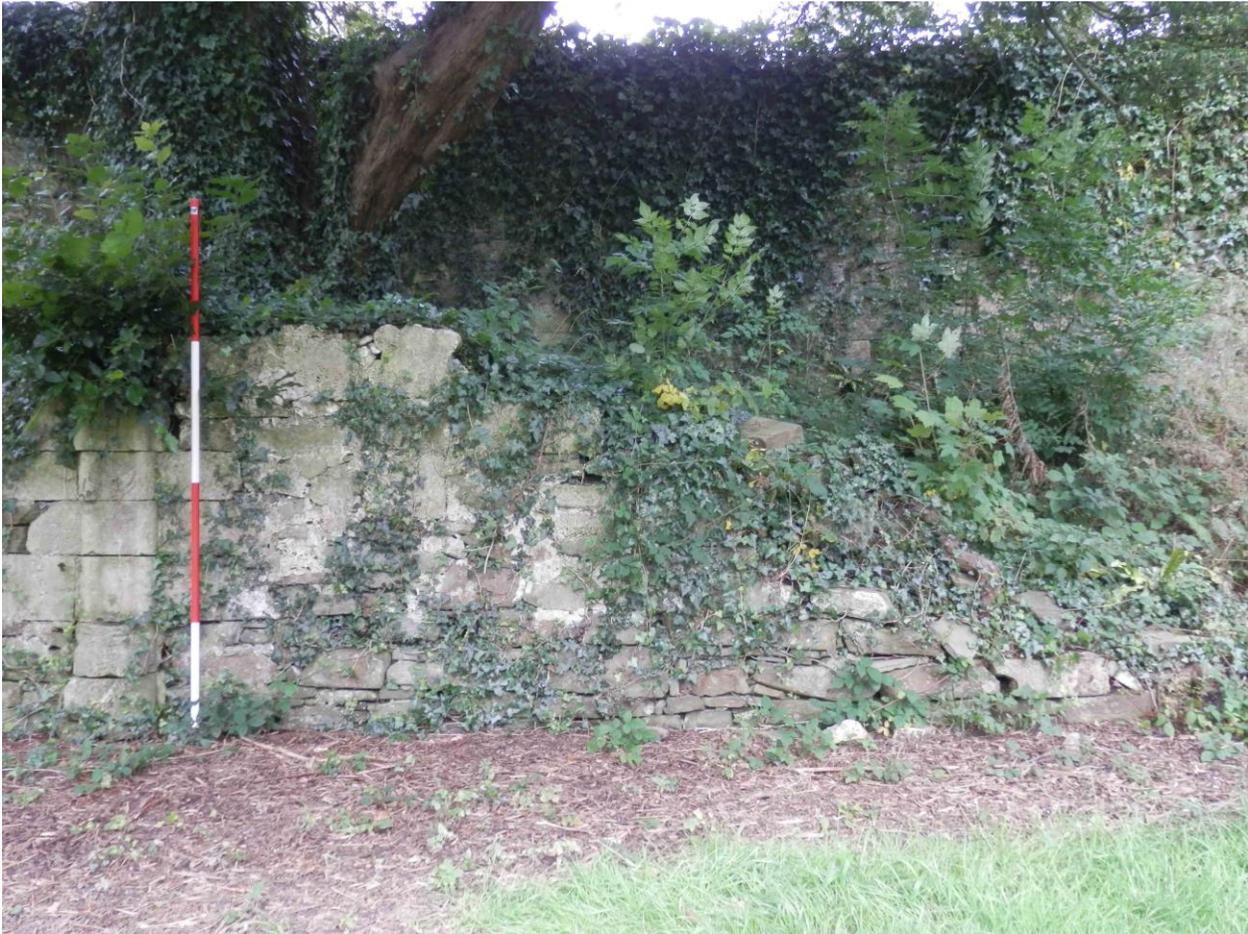
(See figure 2)

ID: 151 Site Number: 748 Site Name: Margam Monastic Ruins
Wall Number: 108 Photo Number: F2/189
Location: North Chancel Wall Int.
Description: Ashlar forming back and base of shaft (right-hand shaft of wall; 107).
Remainder of wall in sandstone rubble, with blocks of dressed stone in the
topmost surviving courses, one of which appears to be from a group of
shafts but is set on its edge of wall. E end of wall crumbling and missing.
Evidence of original mortar. Evidence of render.
Condition summary: A) Shaft missing. B) Mortar missing. C) Stones missing within
standing wall. D) Large amount of vegetation. E) Loose stones.
F) Yew tree (immediately behind wall).
Threats: Vegetation (roots), Large yew tree, Weathering
Recorded by: Gloria Rowles Date: 03/10/2012

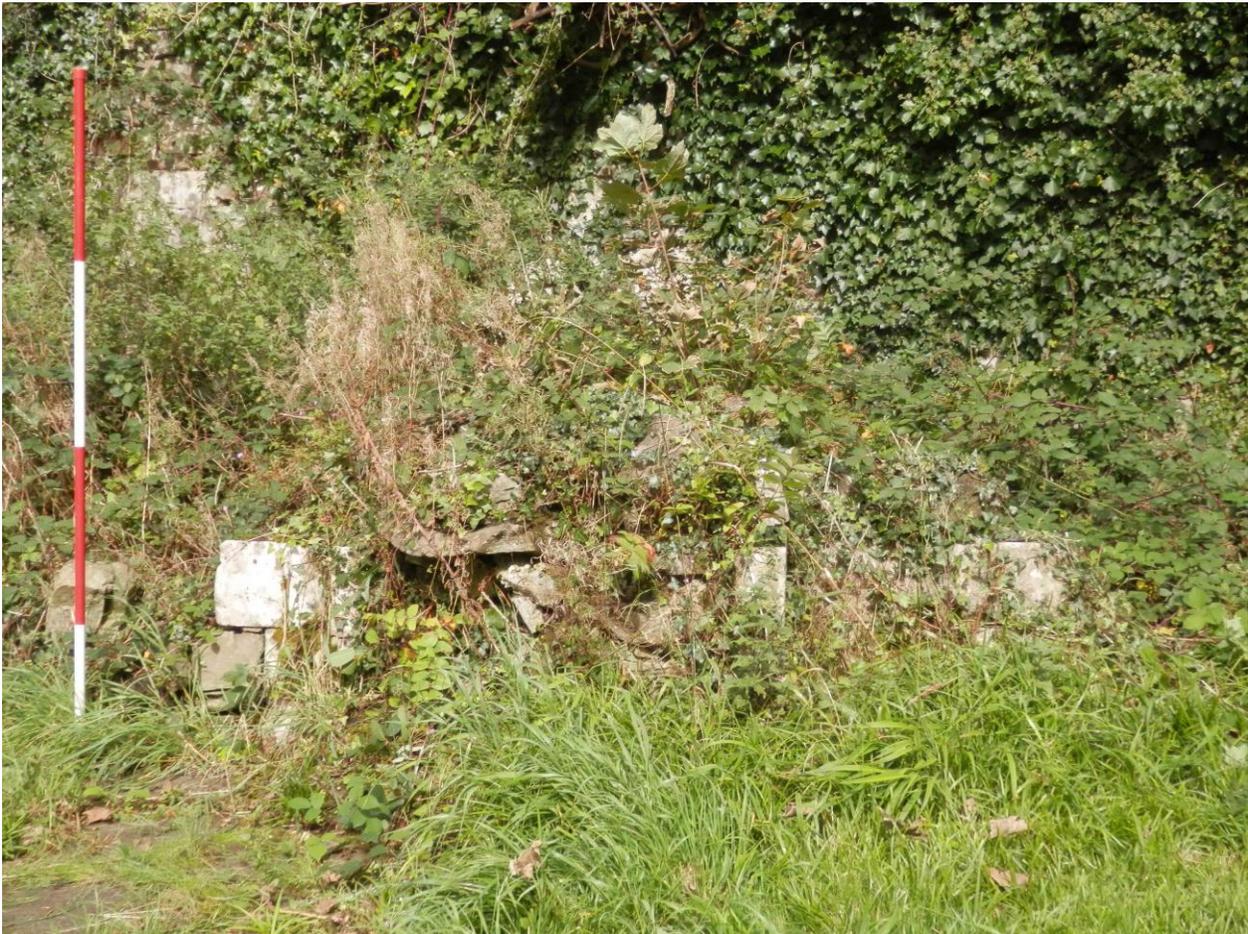
(See figure 2)

ID: 152 Site Number: 748 Site Name: Margam Monastic Ruins
Wall Number: 109 Photo Number: F2/192-196
Location: East end of North Chancel wall, with return.
Description: Shaft base of ashlar. Sandstone rubble with ashlar quoins
infill. Ashlar continues externally on the corner, suggesting either the
base for a shaft or a buttress. Very little remaining and in a fragile state
covered by vegetation and tree seedlings.
Condition summary: A) Vegetation including tree seedlings. B) Missing mortar. C) Stones
missing from remaining section of wall.
Threats: Vegetation and tree seedlings. Instability of structure.
Recorded by: Gloria Rowles Date: 03/10/2012

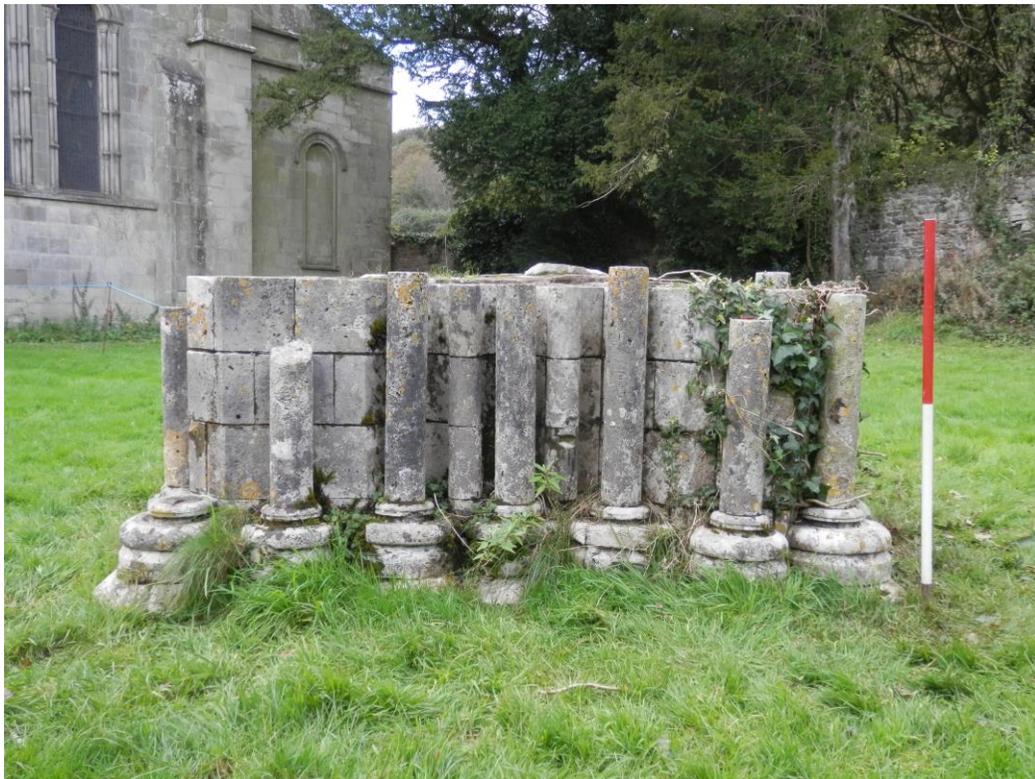
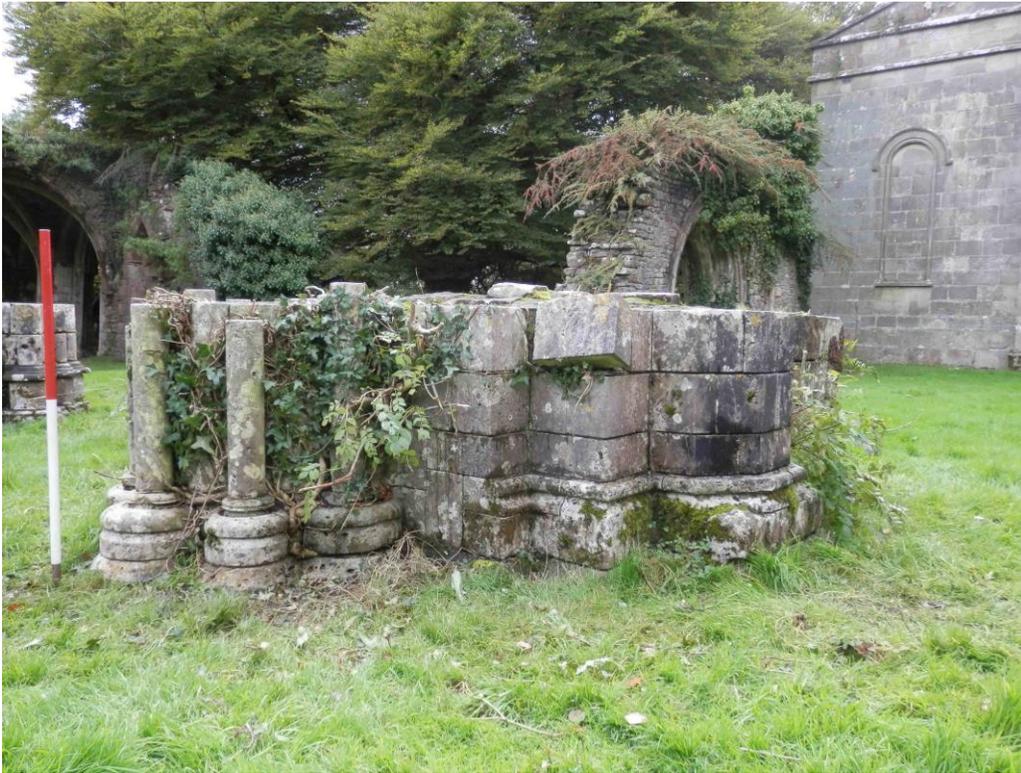
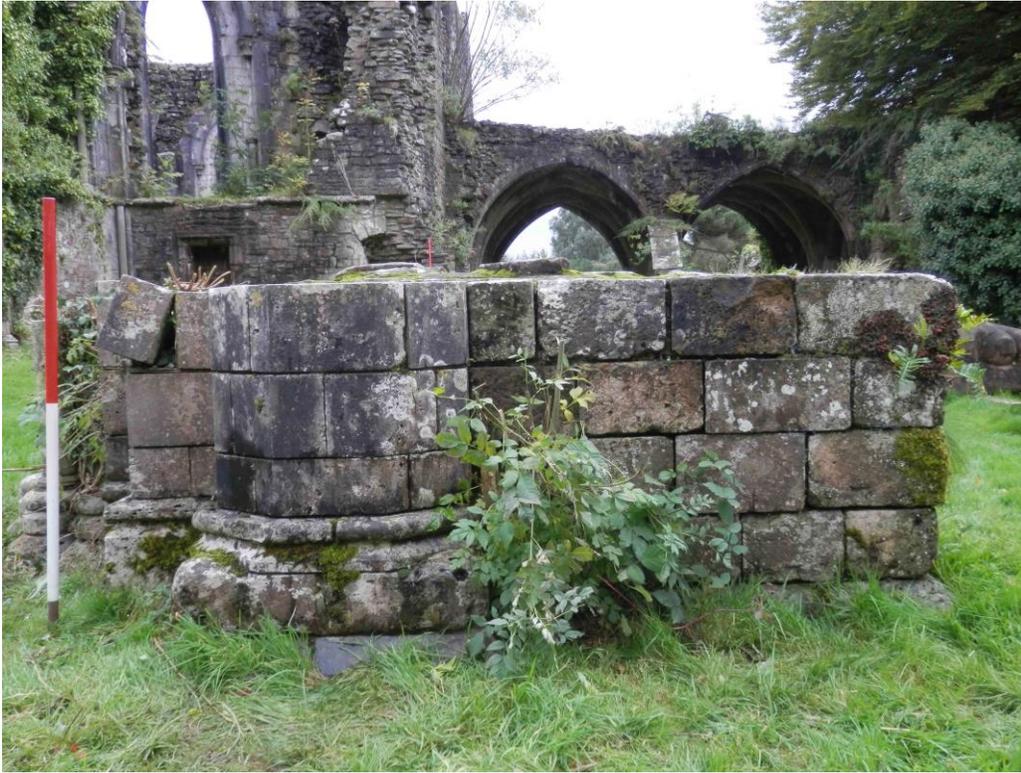
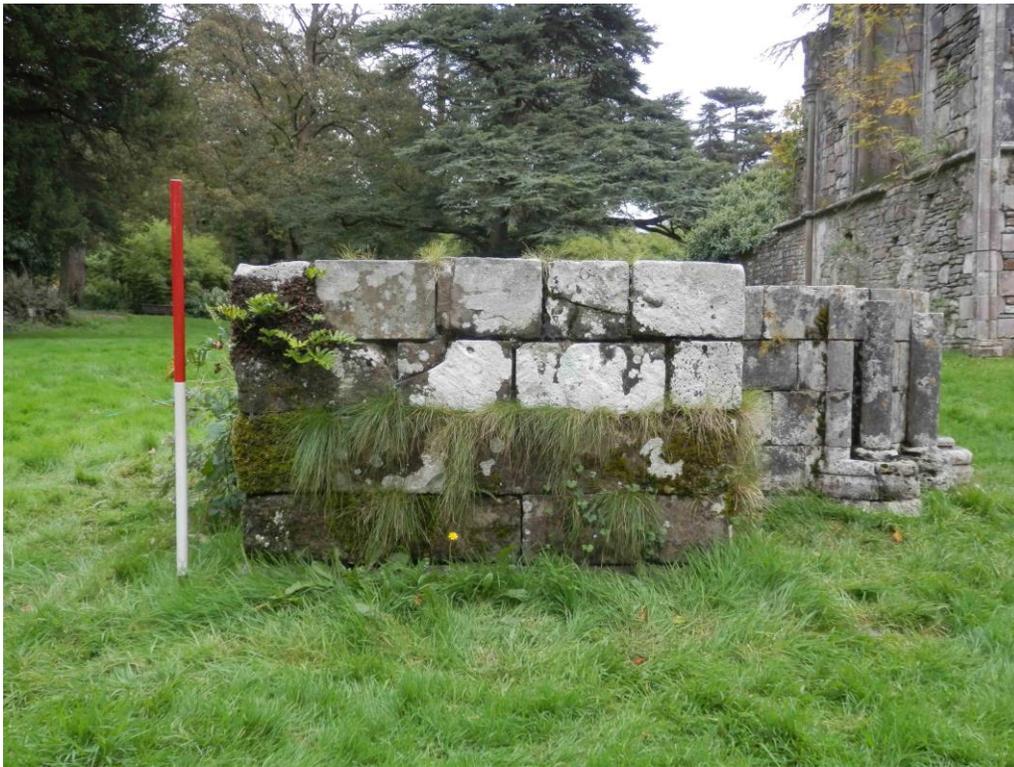
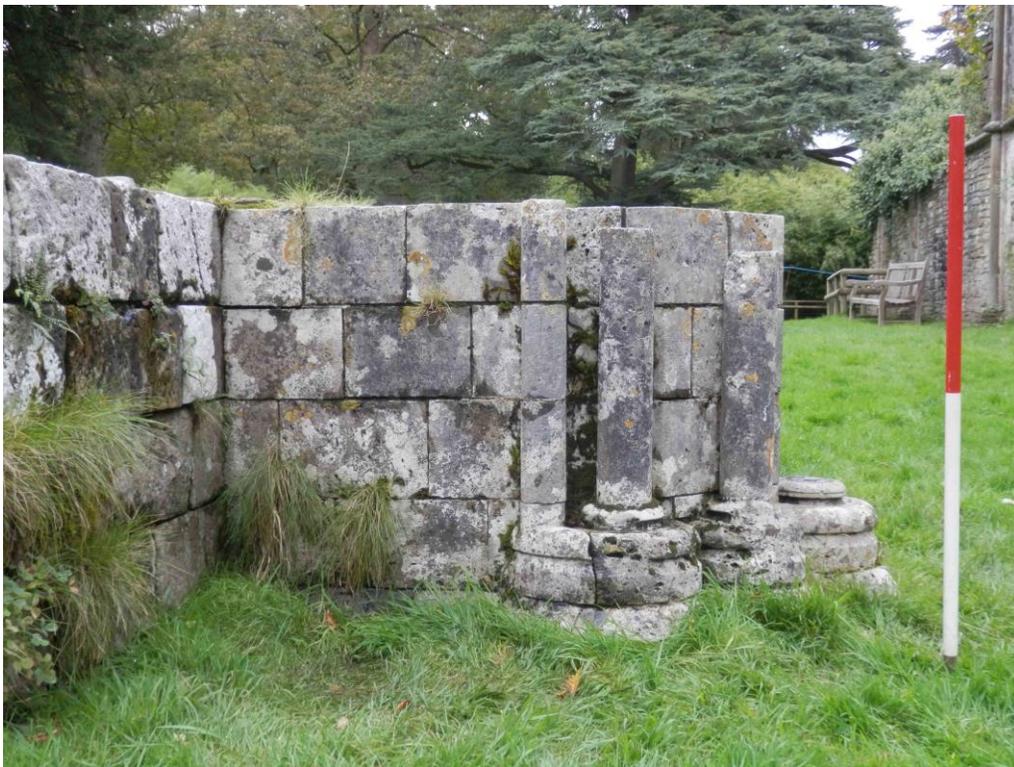
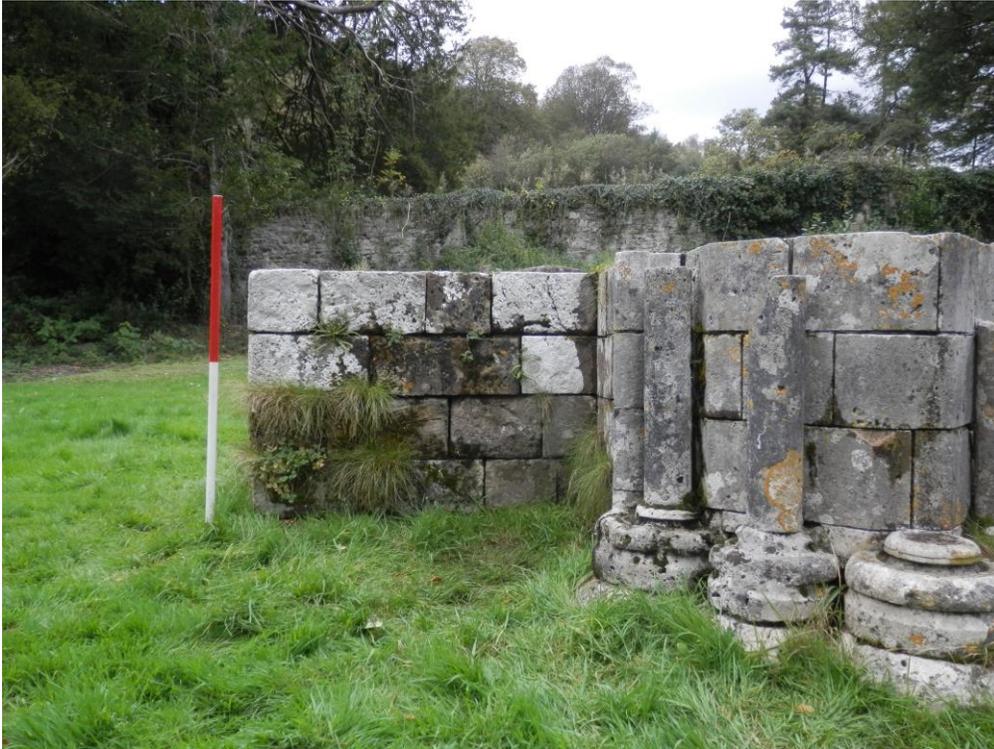
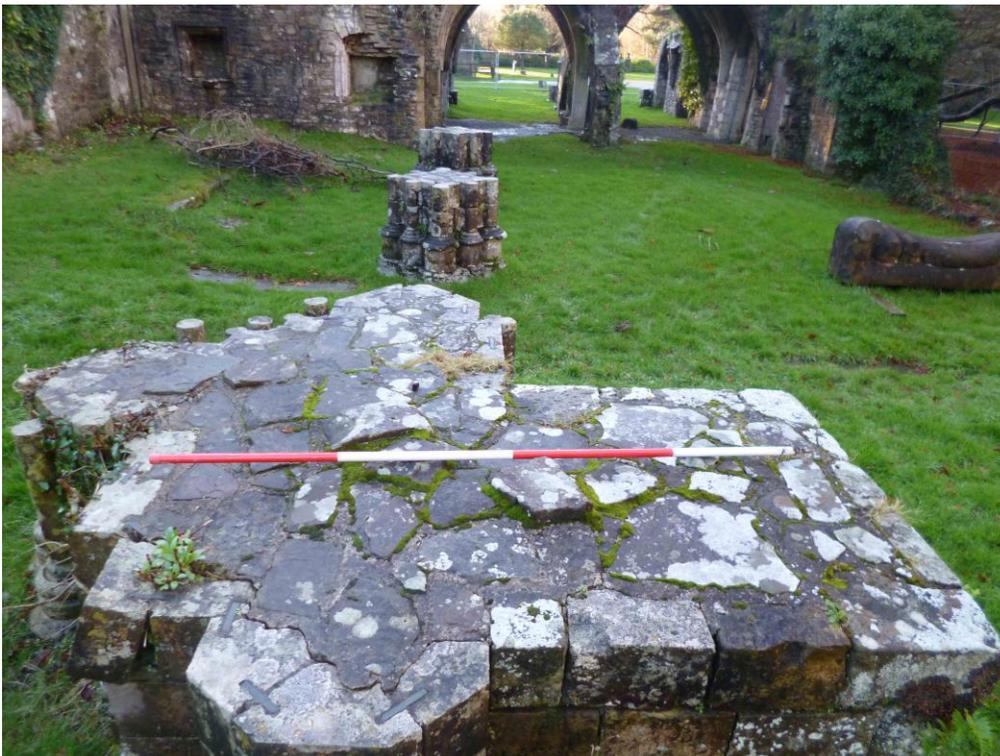
ID: 153-158 Site Number: 748 Site Name: Margam Monastic Ruins
Wall Number: 110 Photo Number: F2/207-214
Location: South Transept/Nave Large column base (top of base)
Description: (Southeast) crossing pier is polygonal; plain ashlar facing at its W end; lined with a cluster of shafts (some designed as detached) on its SE, all set on individual bases, which continue as a polygonal plinth for the NE corner. Core of local sandstone rubble, with cement mortar. Ashlar facing is held together with metal straps.
Condition summary: A) Displaced stone(top course at NE). B) Vegetation (extensive penetration of Ivy roots and growth) . C) Moss and grass growth. D) cement to hold central core in place. E) Gaps in masonry and missing Blocks. F) Damage to shafts and bases. G) Extensive weathering. H) Sapling on N side affecting corner of stonework.
Threats: Vegetation and weathering.
Recorded by: Bob Hardwick Date: 03/10/2012

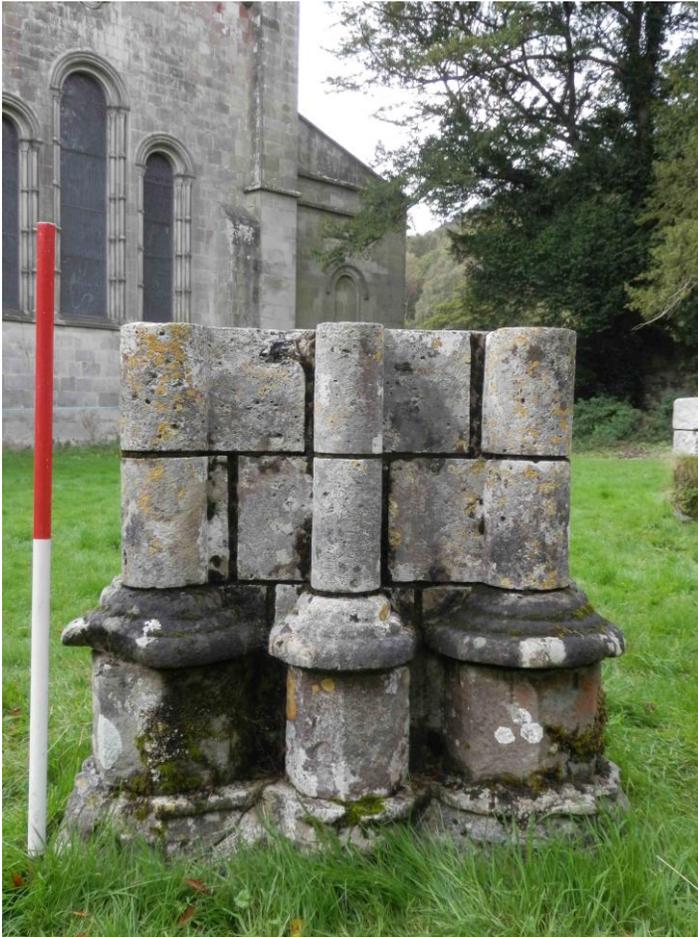
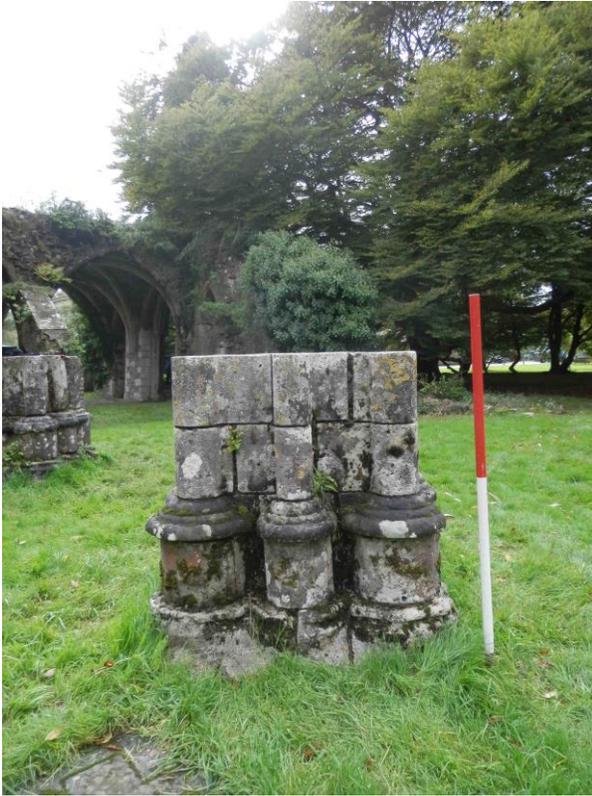
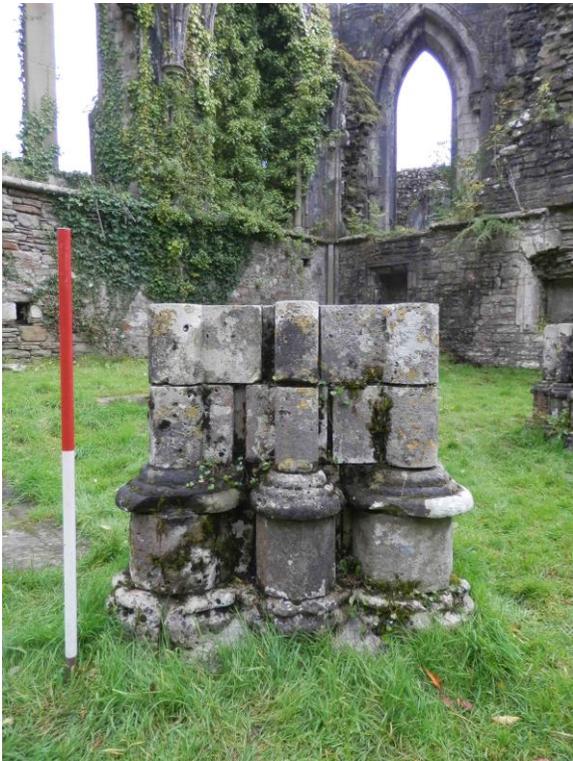
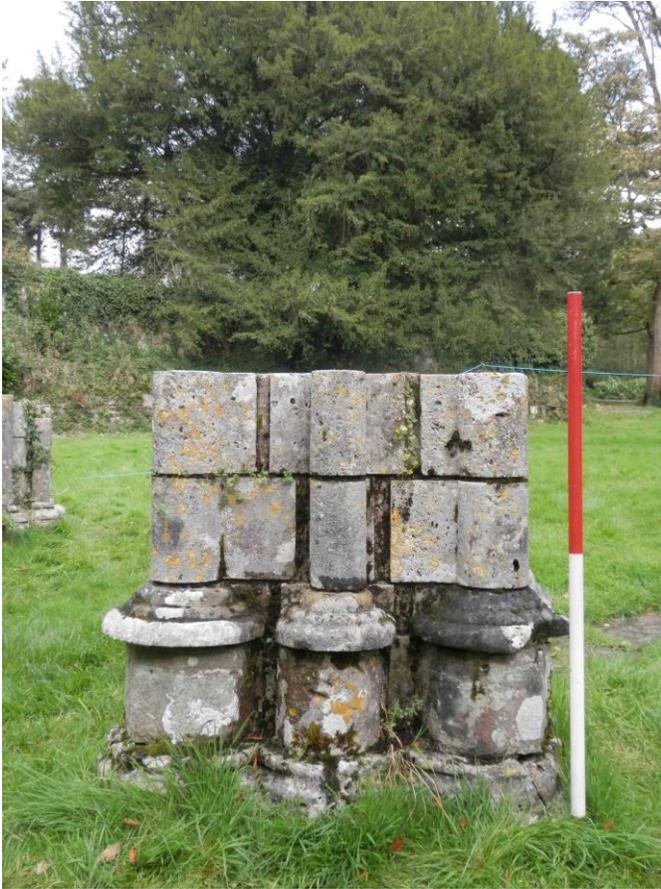
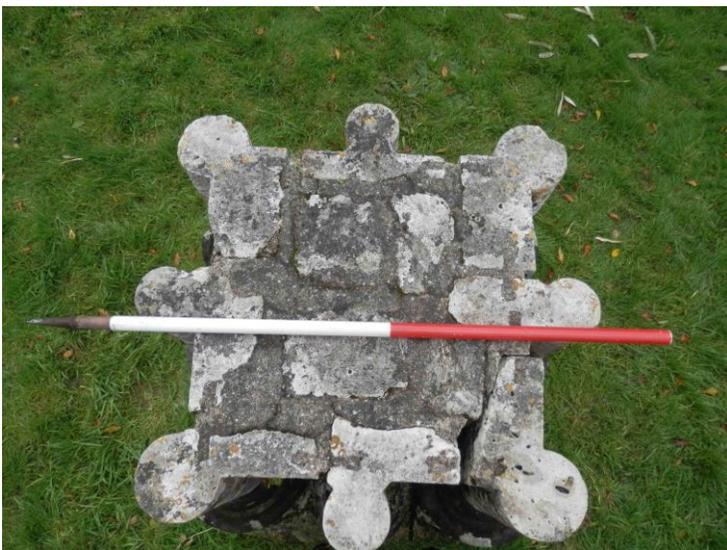
ID: 159 Site Number: 748 Site Name: Margam Monastic Ruins
Wall Number: 111 Photo Number: F2/202-206
Location: South Transept Int. Pillar 1
Description: Completely made from ashlar. Design: square in plan, a cluster of shafts - one in each corner and one in middle of each side- 8 shafts in total. Each shaft has a moulded base above the plinth. Mortar starting to disappear on sides between stones. Cement used on to strengthen. Stone on top is starting to come away on the north side. Tendency to get damp- has moss growth as a result. Some fern growing in cracks. Lichen on stones.
Condition summary: A) Weathering to column base/moulding. B) Vegetation (moss).
C) Cracks in base. D) Stone coming away (NW,NE, Top). Piece of stone coming away (SE, Top)
Threats: Vegetation, weathering and children climbing.
Recorded by: Sarah Baker Date: 03/10/2012

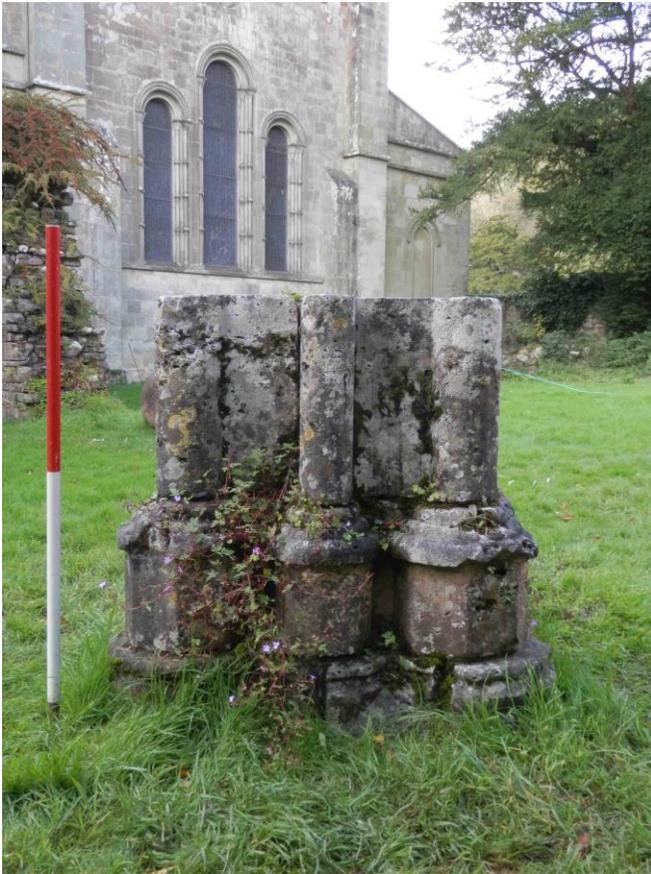
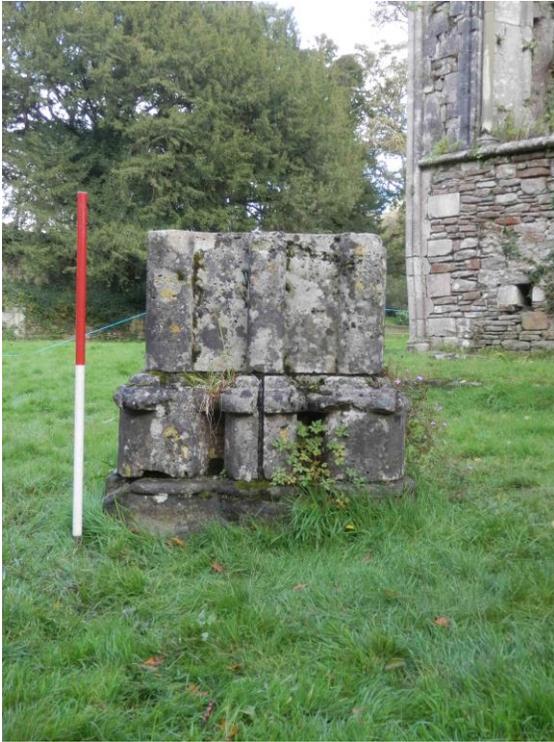
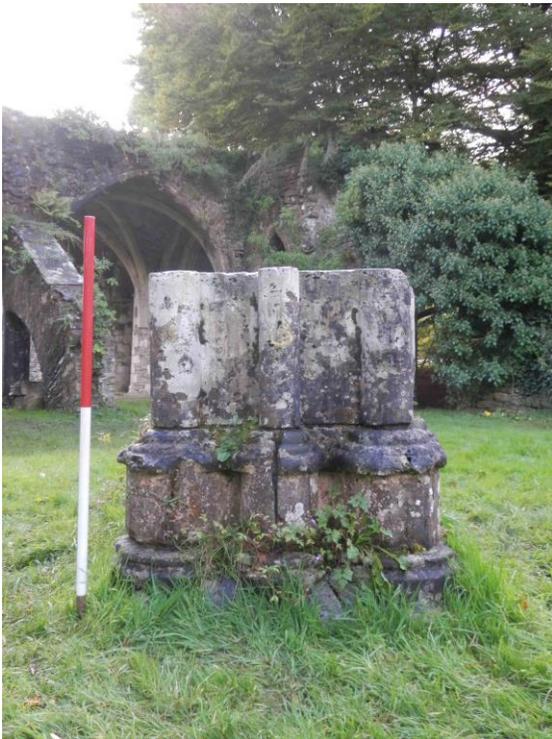
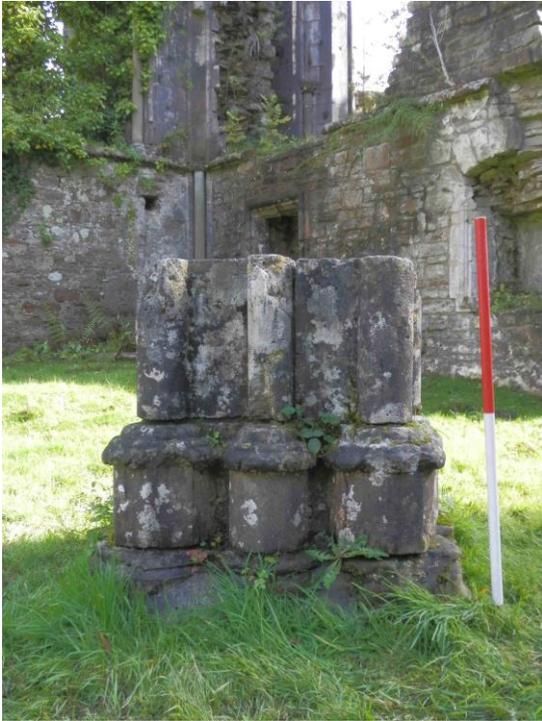
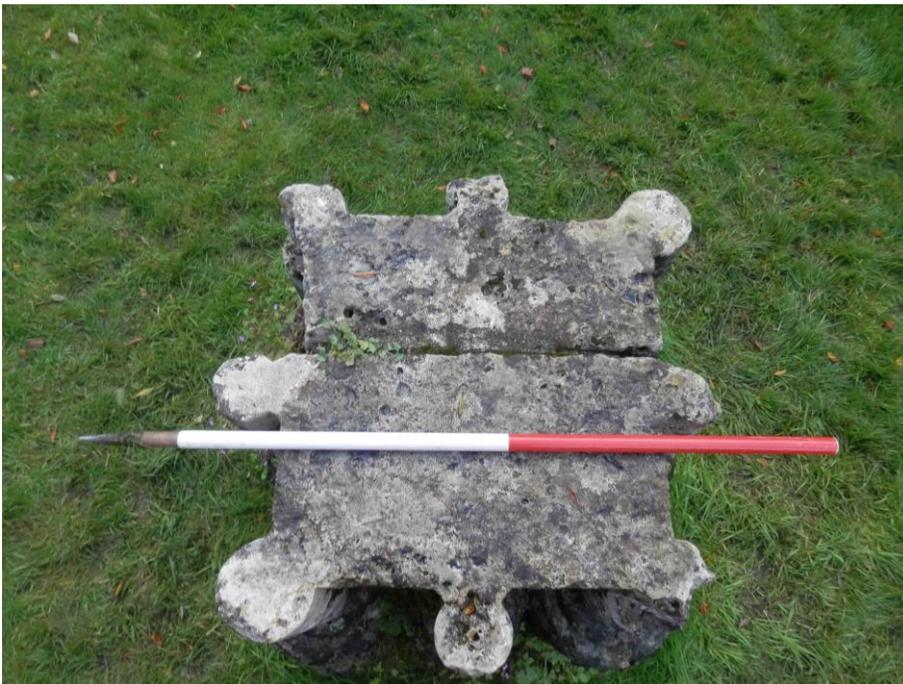
ID: 160 Site Number: 748 Site Name: Margam Monastic Ruins
Wall Number: 112 Photo Number: F2/197-201
Location: South Transept Int. Pillar 2
Description: Design as Pillar 1 (wall 111), but there is a single course surviving above the base, consisting of two blocks only, with cement in the joint. The plinth and shaft bases are also carved out of two ashlar blocks only, with 5 of the shafts on the NE-facing section, and 3 on the other. Plinth in fair condition, although missing chunks of stone and showing signs of weathering; it also has a crack. Chunk missing off top of right hand shaft. Weathering on this whole section. Damage to shafts.
Condition Summary: A) Shafts and bases damaged. B) Missing mortar in joint in bases
C) use of cement. D) Vegetation. E) Crack in base.
Threats: Vegetation, weathering, human interaction
Recorded by: Gloria Rowles Date: 03/10/2012

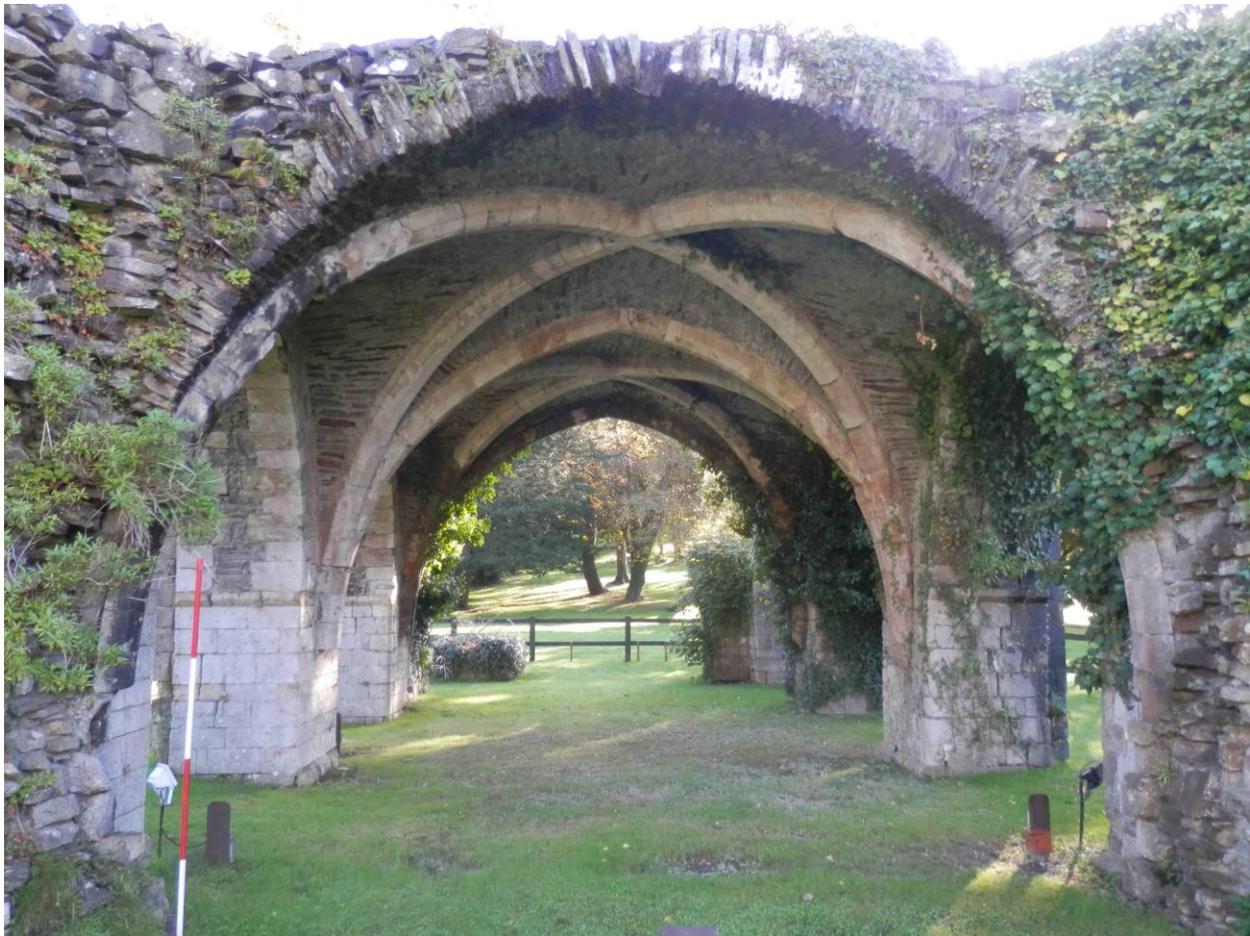
(See figure 2)

ID: 161 Site Number: 748 Site Name: Margam Monastic Ruins
Wall Number: 113 Photo Number: F2/215
Location: Undercroft west wall Ext.
Description: Arch in rubble with ashlar dressing, although the dressings are missing. except in very few places. Only sandstone rubble voussoirs survive in head of arch (rib is missing). Carved ornament at springing of internal vault right hand side [?string course]. Missing left hand side. Sandstone arch very wet. Vegetation encroaching particularly from south side. Vaulting showing signs of weathering and is very wet. Outside stones on S side leaning out, blocks in dressings really loose where mortar is missing.
Condition summary: A) Vegetation. B) Uneven rough sand stone walls both sides.
C) Missing mortar on vaulting, also loose mortar. D) Water damage
Threats: Vegetation and weathering
Recorded by: Gloria Rowles Date: 03/10/2012

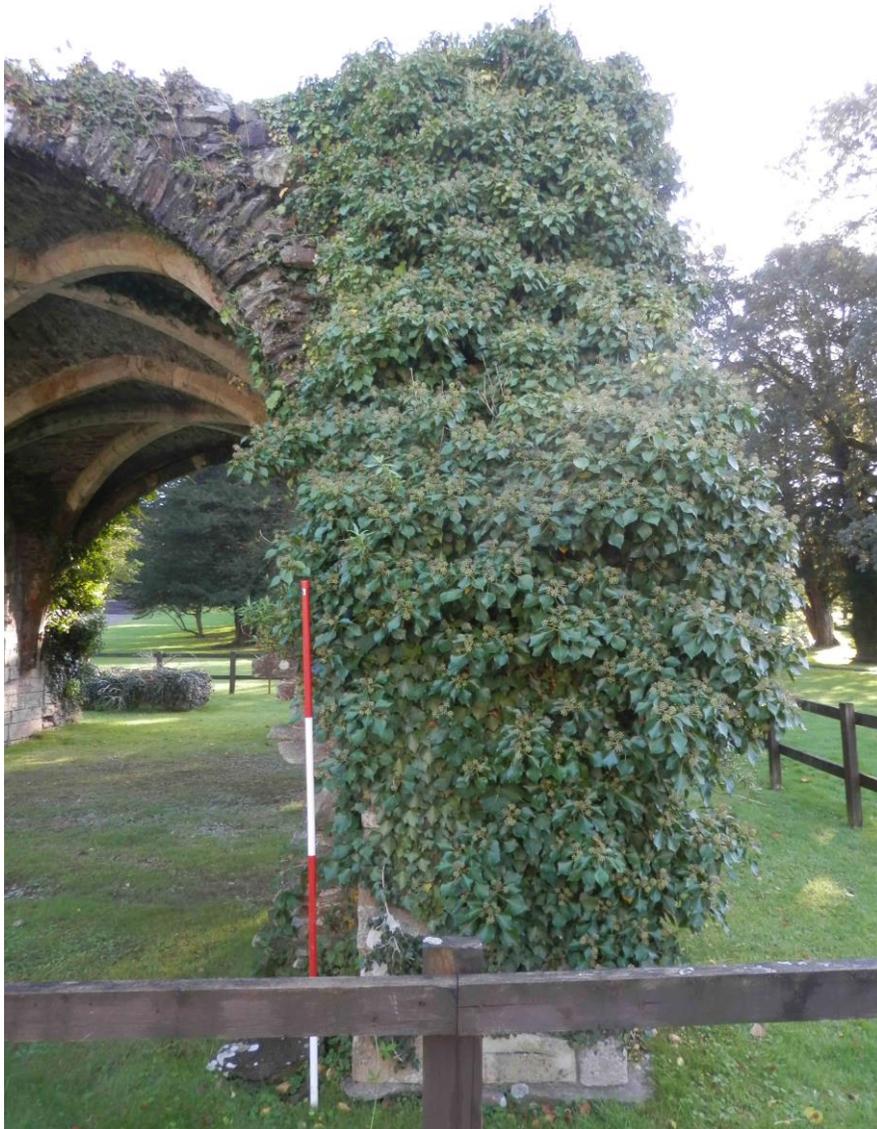
(See figure 2)

ID: 162 Site Number: 748 Site Name: Margam Monastic Ruins
Wall Number: 114 Photo Number: F2/216
Location: Undercroft west wall Ext. corner
Description: Wall has ashlar at base (only two courses visible); sandstone rubble at the top.
99% ivy coverage.
Condition summary: A) Ivy B) no visible damage apart from weathering on dressed stone at bottom.
Threats: Vegetation and weathering
Recorded by: Bob Hardwick Date: 04/10/2012

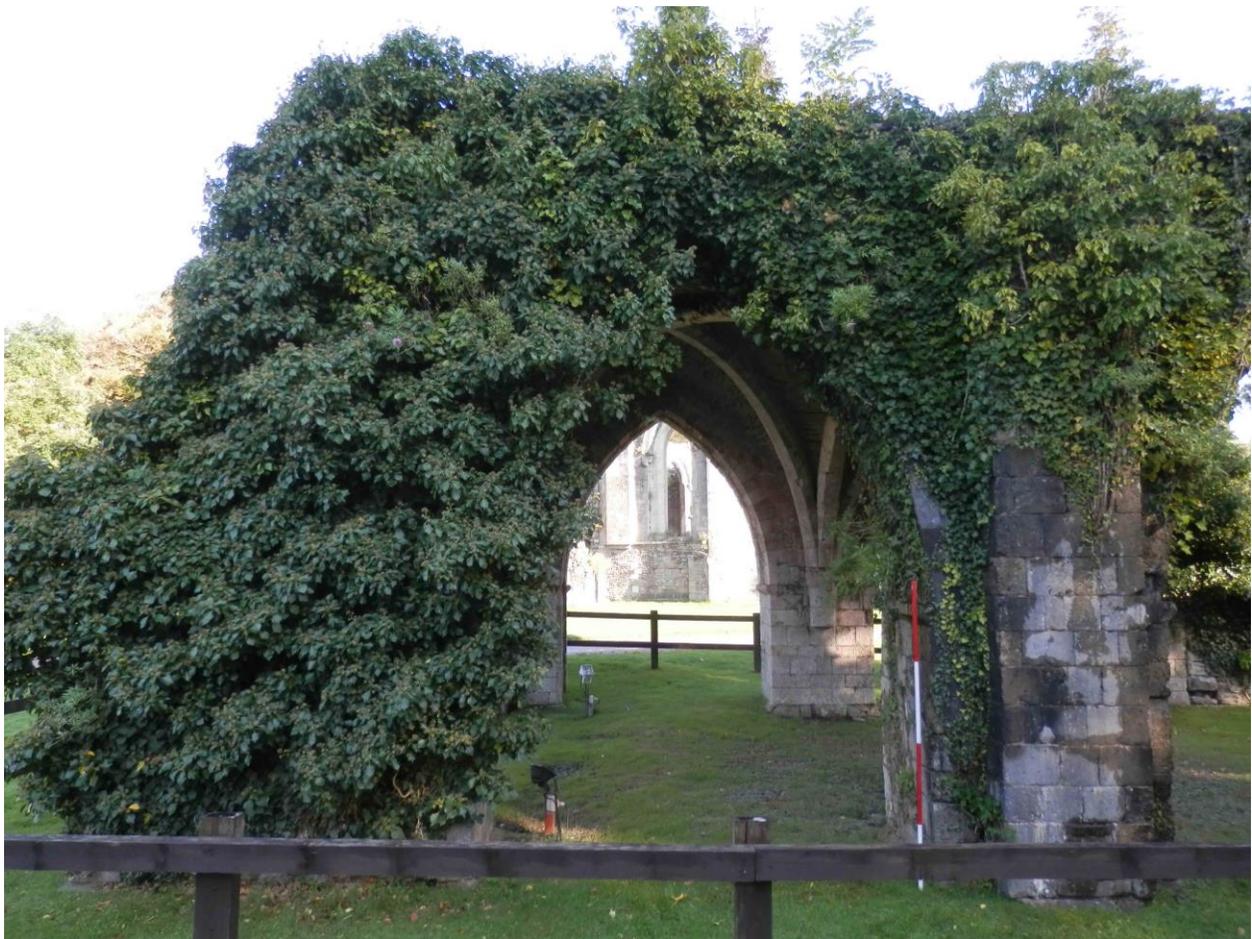
(See figure 2, figure 14 elevation 115)

ID: 163 Site Number: 748 Site Name: Margam Monastic Ruins
Wall Number: 115 Photo Number: F2/217-220
Location: Undercroft south wall ext. west arch
Description: Only base visible rest completely covered with ivy. Wall corner all in ashlar. String course at springing of arch. Archway retains dressed stone voussoirs. Base of arch and piers have chamfered corners.
Condition summary: A) Large crack from base of corner. B) Weathering of stones.
C) Vegetation completely covering left hand side of wall and archway.
Threats: Vegetation and Weathering.
Recorded by: Maggie Cornelius Date: 04/10/2012

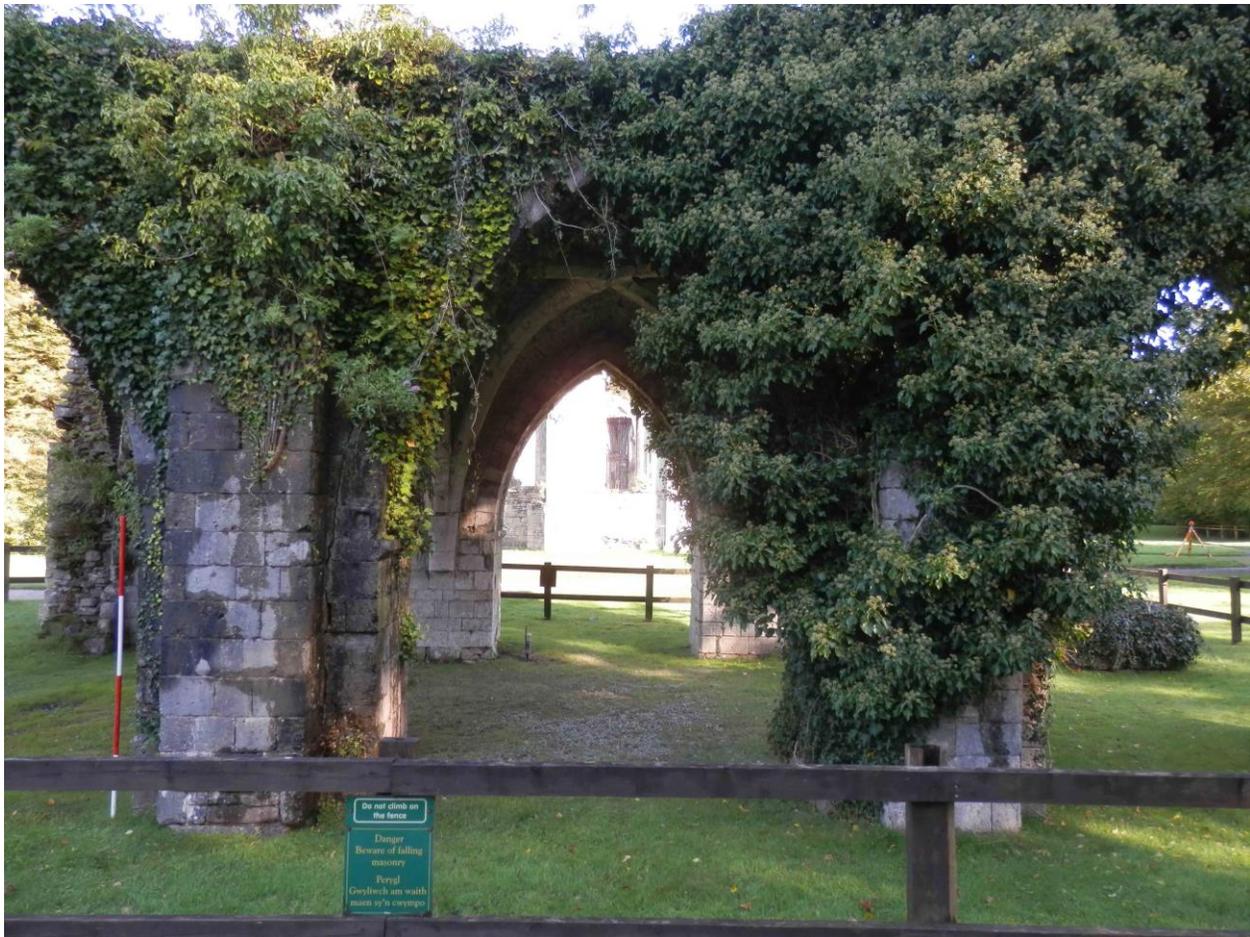
(See figure 2, figure 14 elevation 116)

ID: 164 Site Number: 748 Site Name: Margam Monastic Ruins
Wall Number: 116 Photo Number: F2/221
Location: Undercroft, south wall, centre arch
Description: Arch and adjoining buttress: mainly ashlar; with a little coursed sandstone rubble at base of left-hand buttress. Left hand side arch has string course and putlog hole (or beam slot) above it. Right hand side arch heavily obscured by vegetation.
Condition summary: A) Left hand side arch mortar missing, cracks (fracture between stones). B) Damage to stone in arch. C) Vegetation.
Threats: Vegetation, weathering
Recorded by: Paul Minton Date: 04/10/2012

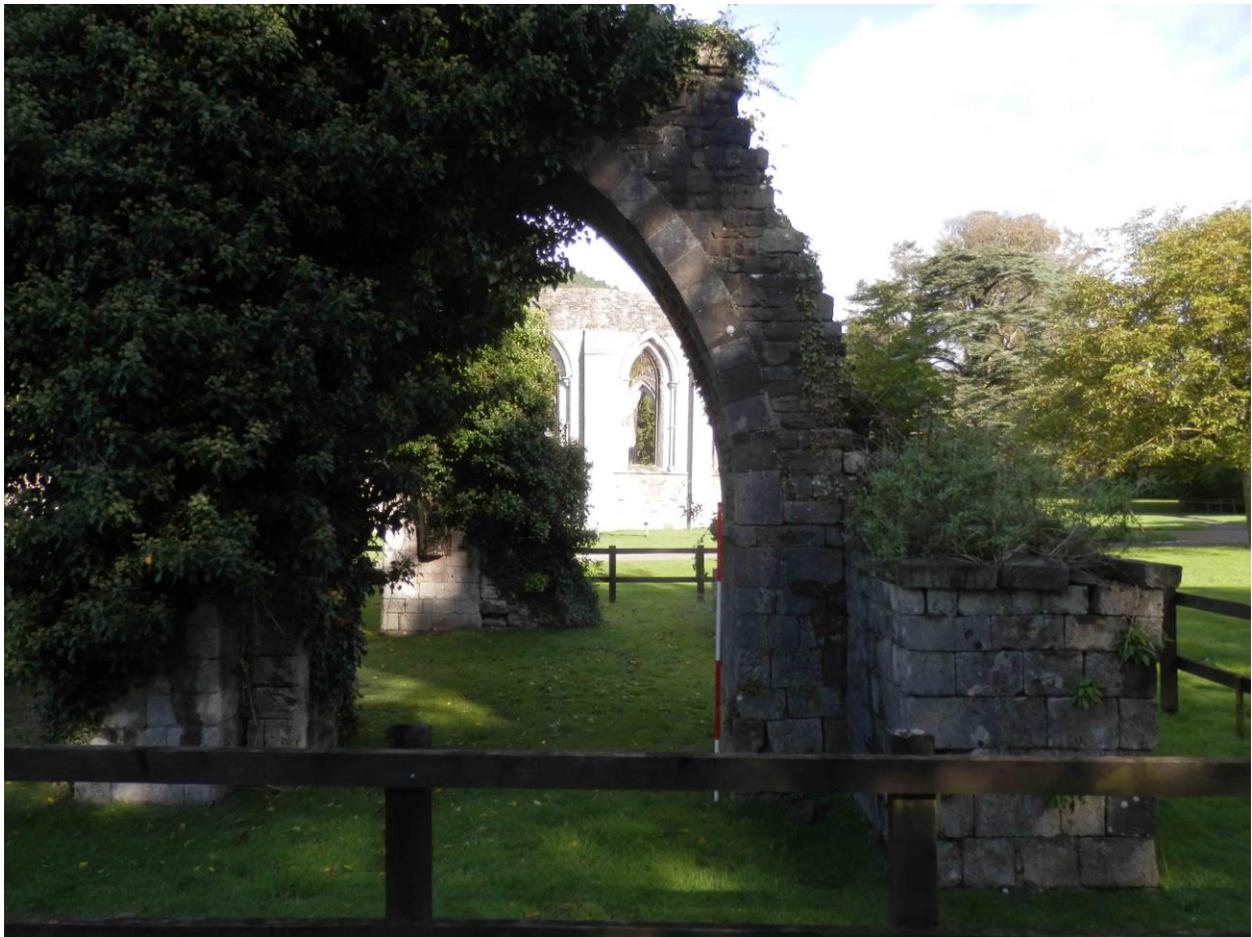
(See figure 2, figure 14 elevation 117)

ID: 165 Site Number: 748 Site Name: Margam Monastic Ruins
Wall Number: 117 Photo Number: F2/222-224
Location: Undercroft, south wall, east arch, with thick stub wall against it on the south side.
Description: Bottom half of wall, arch, and wall running south off undercroft are all in ashlar. Rest of wall in sandstone rubble. Left hand side of buttress and arch covered in ivy, hiding features and damage.
Condition summary: A) Ivy coverage. B) Cracks, broken stone, misplaced stone. C) Other vegetation.
Threats: Vegetation, weathering
Recorded by: Bob Hardwick Date: 04/10/2012

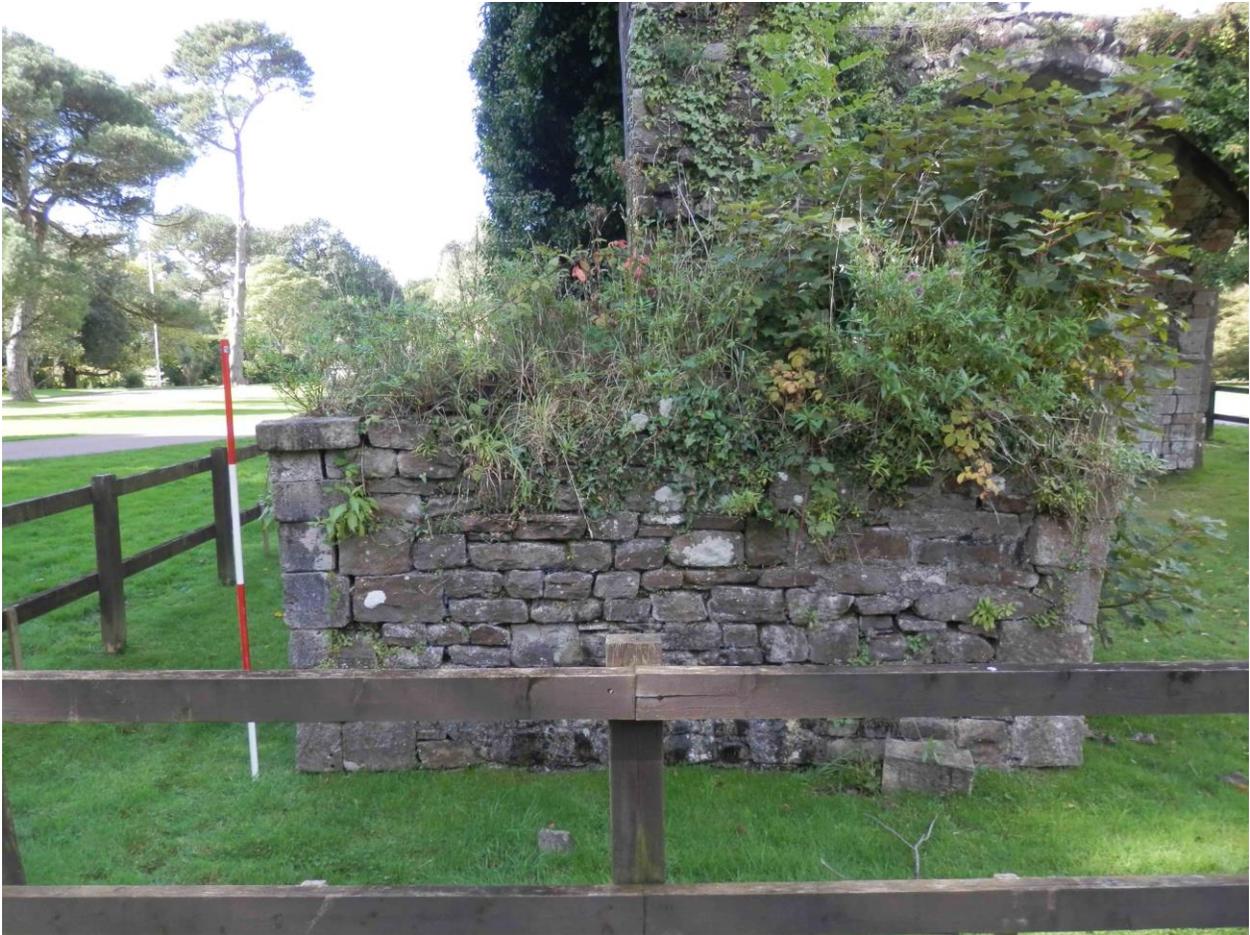
(See figure 2)

ID: 166 Site Number: 748 Site Name: Margam Monastic Ruins
Wall Number: 118 Photo Number: F2/225-227,
Location: Undercroft east wall ext.
Description: External wall of undercroft survives to 8 courses high, in local stone rubble with ashlar quoins. Mortar missing in stonework. Vegetation growing from top. One stone block on ground..
Condition summary: A) Loose mortar. B) Cracks between quoins (both sides) and rest of face of wall - leaning outwards. Vegetation and small trees. on top of wall
C) Missing block. D) Missing stones.
Threats: Vegetation, weathering and loose mortar
Recorded by: Maggie Cornelius Date: 04/10/2012

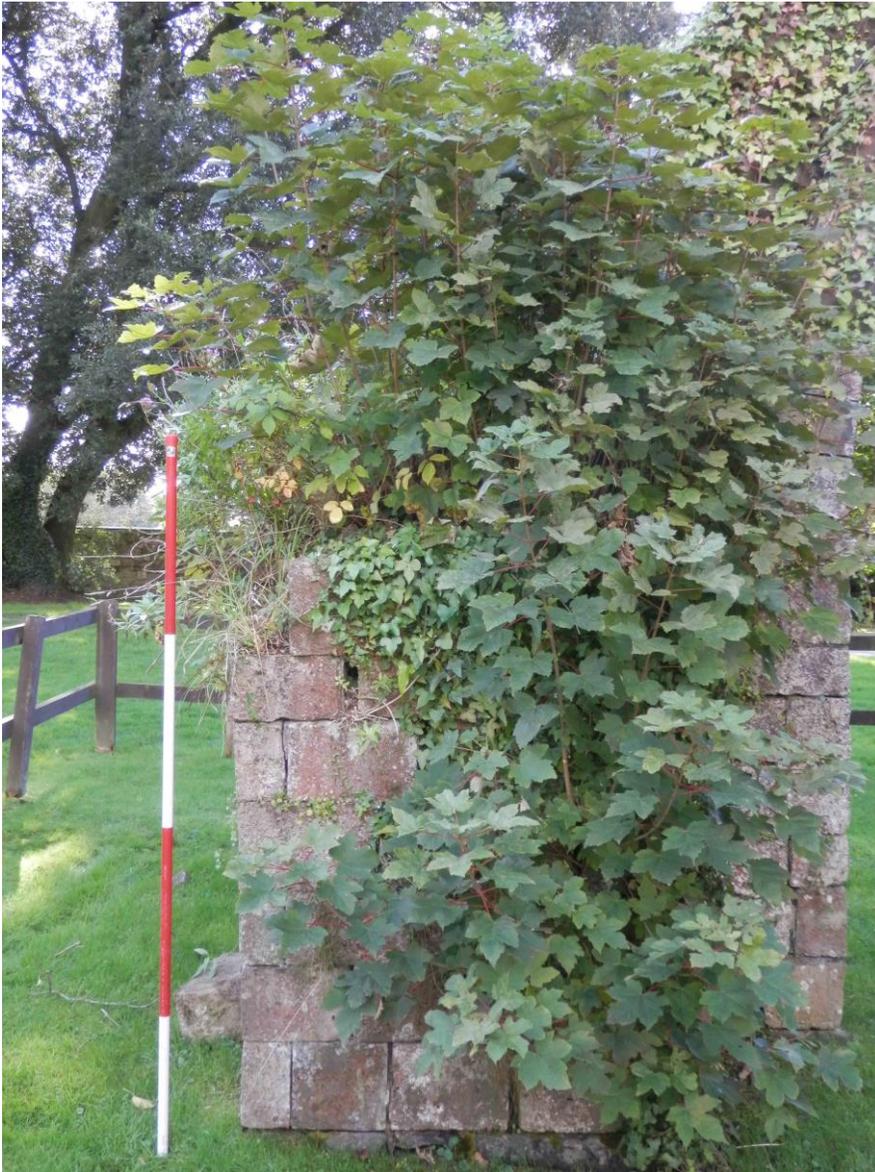
ID: 167 Site Number: 748 Site Name: Margam Monastic Ruins
Wall Number: 119 Photo Number: F2/228
Location: Undercroft east side int.
Description: Ashlar face heavily obscured by vegetation including mini forest of sycamore on top.
Condition summary: A) Mortar missing. B) Vegetation damage-stones loose. C) Vegetation
Threats: Vegetation
Recorded by: (not filled in) Date: 4/10/2012
