Monastic Margam Community Survey Project

Report for Cadw
by Sam Pamment BA

GGAT report no. 2013/020
NGR: SS 8018 8626
Project no. GGAT 123

Summary

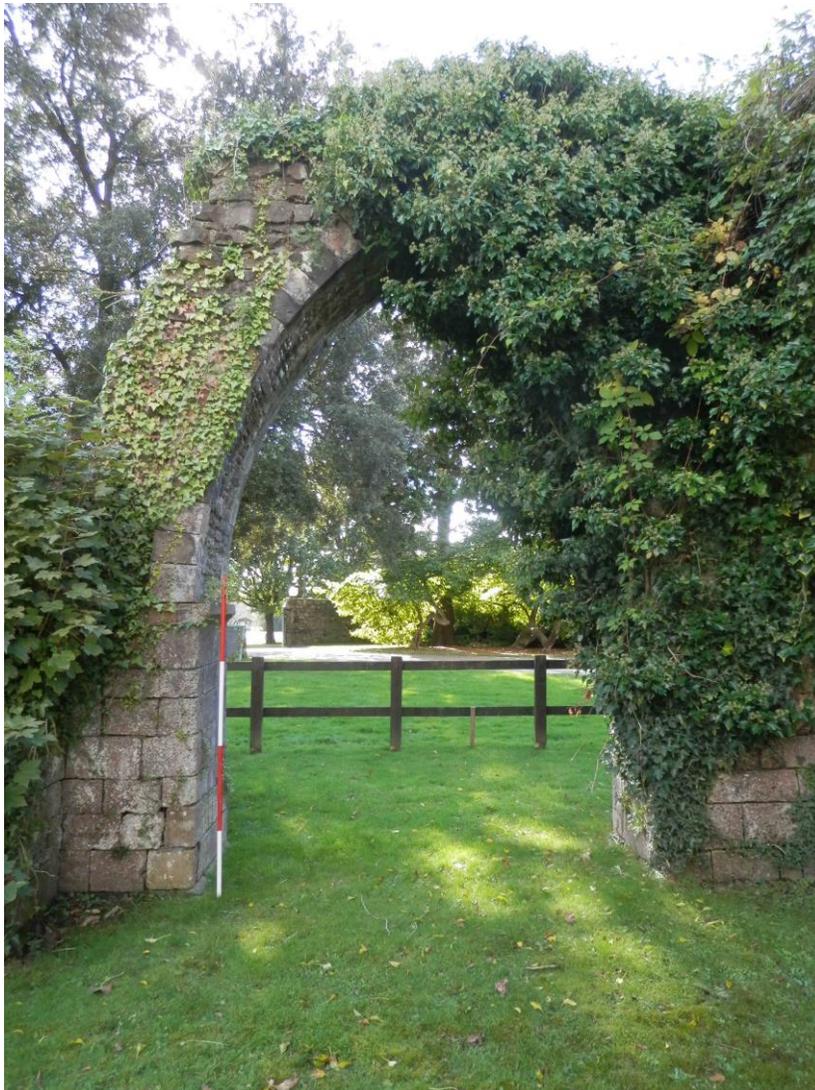
ID: 168 Site Number: 748 Site Name: Margam Monastic Ruins
Wall Number: 120 Photo Number: F2/230-231
Location: Undercroft south wall internal east arch (reverse of wall 117)
Description: Piers of arch in ashlar, which continues upwards to quoin the inside face of arch, which is otherwise in local sandstone rubble. To the left of the arch the remains of wall are in local sandstone rubble. Left hand side of arch still visible; right hand side of arch and pier obscured by ivy, which hides some additional feature.
Condition summary: A) Mortar deterioration (missing). B) Vegetation. C) Loose blocks.
Threats: Vegetation
Recorded by: Paul Minton Date: 4/10/2012

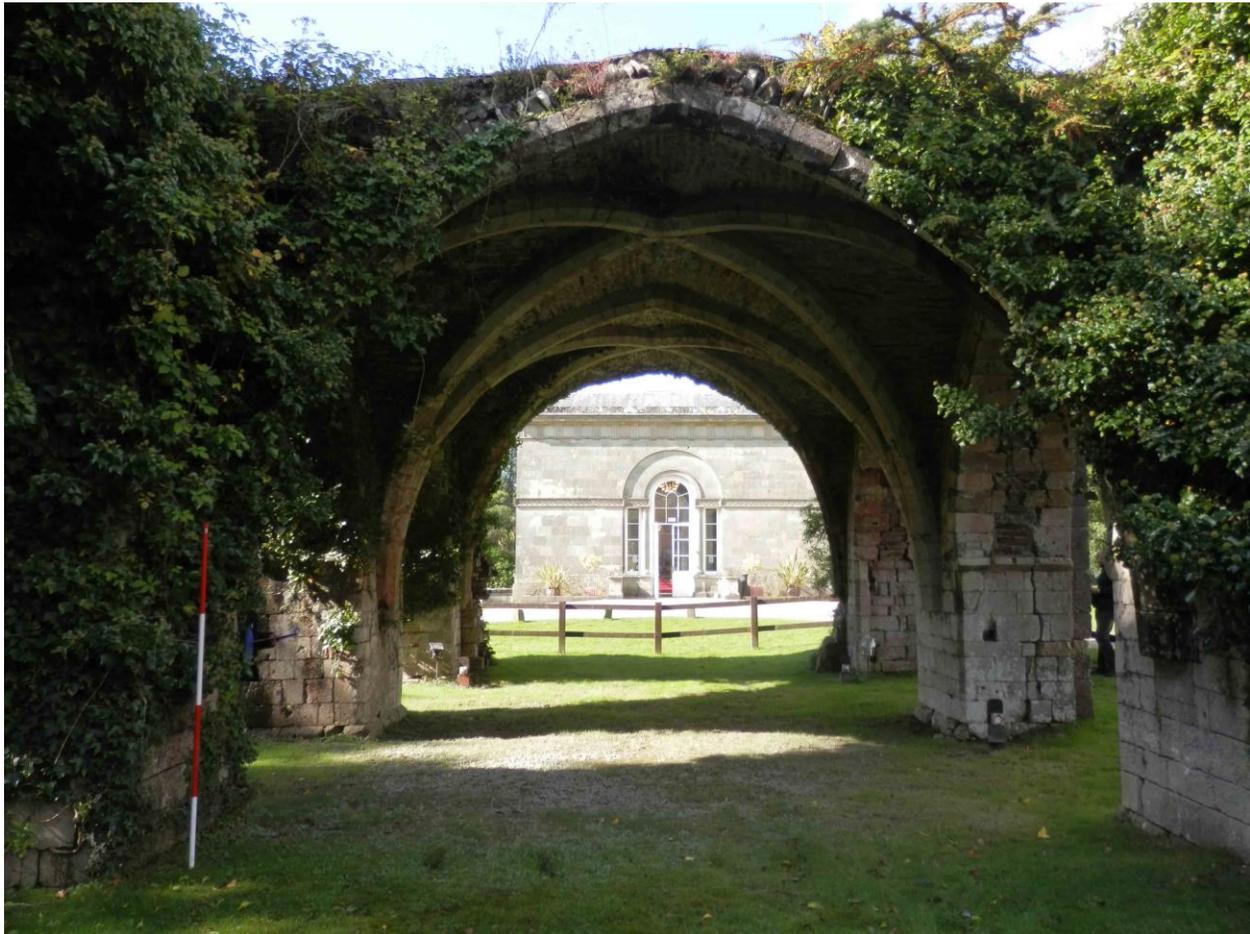
ID: 169 Site Number: 748 Site Name: Margam Monastic Ruins
Wall Number: 121 Photo Number: F2/231
Location: Undercroft east wall ext. arch
Description: Ashlar piers and around inside of arch. Rest of wall sandstone rubble.
Top edge of arch heavily covered in ivy and other vegetation.
Condition summary: A) Visible broken stones in several places. B) 98% ivy and other
vegetation coverage.
Threats: Vegetation
Recorded by: Bob Hardwick Date: 04/10/2012

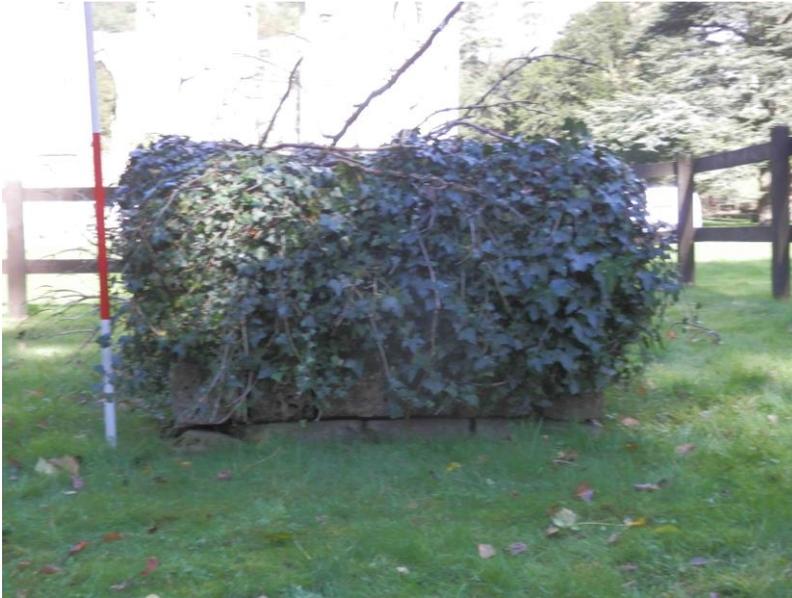
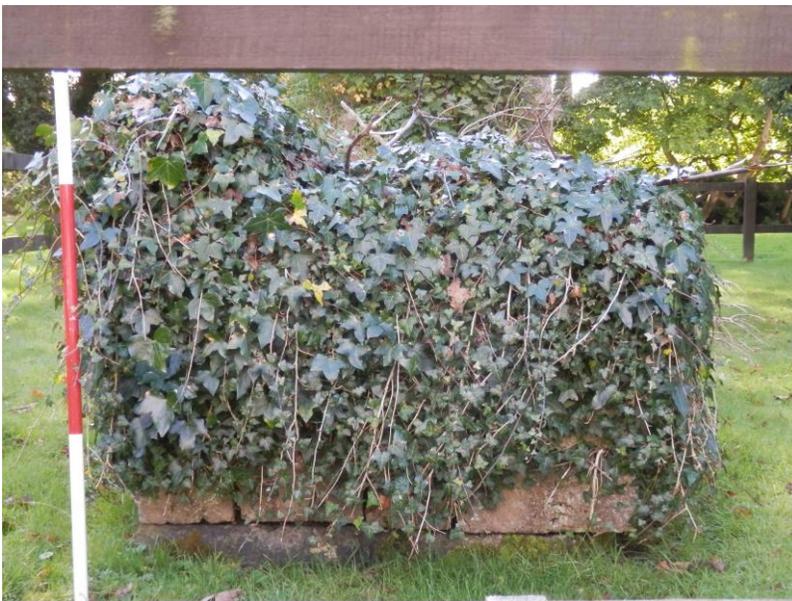
(See figure 2)

ID: 170 Site Number: 748 Site Name: Margam Monastic Ruins
Wall Number: 122 Photo Number: F2/232-235
Location: Undercroft east wall (isolated section at north end)
Description: Very little stone visible, rest covered in ivy. Bottom of wall ashlar with one battered course visible, presumably represented the top of the plinth
Condition summary: A) Loose mortar. B) Ivy covering.
Threats: Vegetation
Recorded by: Maggie Cornelius Date: 04/10/2012

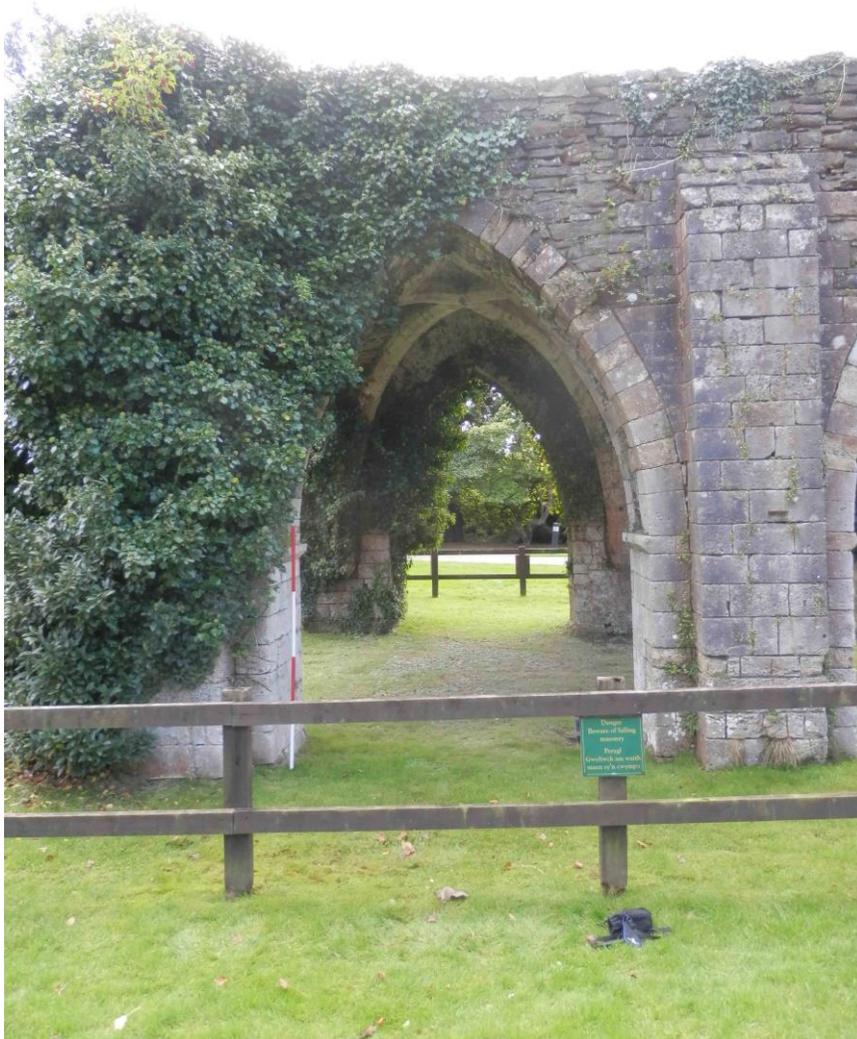
ID: 171 Site Number: 748 Site Name: Margam Monastic Ruins
Wall Number: 123 Photo Number: F2/236-237
Location: Undercroft north wall ext. east arch
Description: All ashlar except section above top of arch and above left-hand and right-hand buttresses, which consists of sandstone rubble. Damage to buttresses and piers. Ivy covers left-hand side, including half of left-hand side of arch. Some vegetation on right-hand arch and walls.
Condition summary: A) Cracks on both walls and pillars and missing, damaged stonework.
B) Ivy coverage 50%; other vegetation.
Threats: Vegetation
Recorded by: Bob Hardwick Date: 04/10/2012

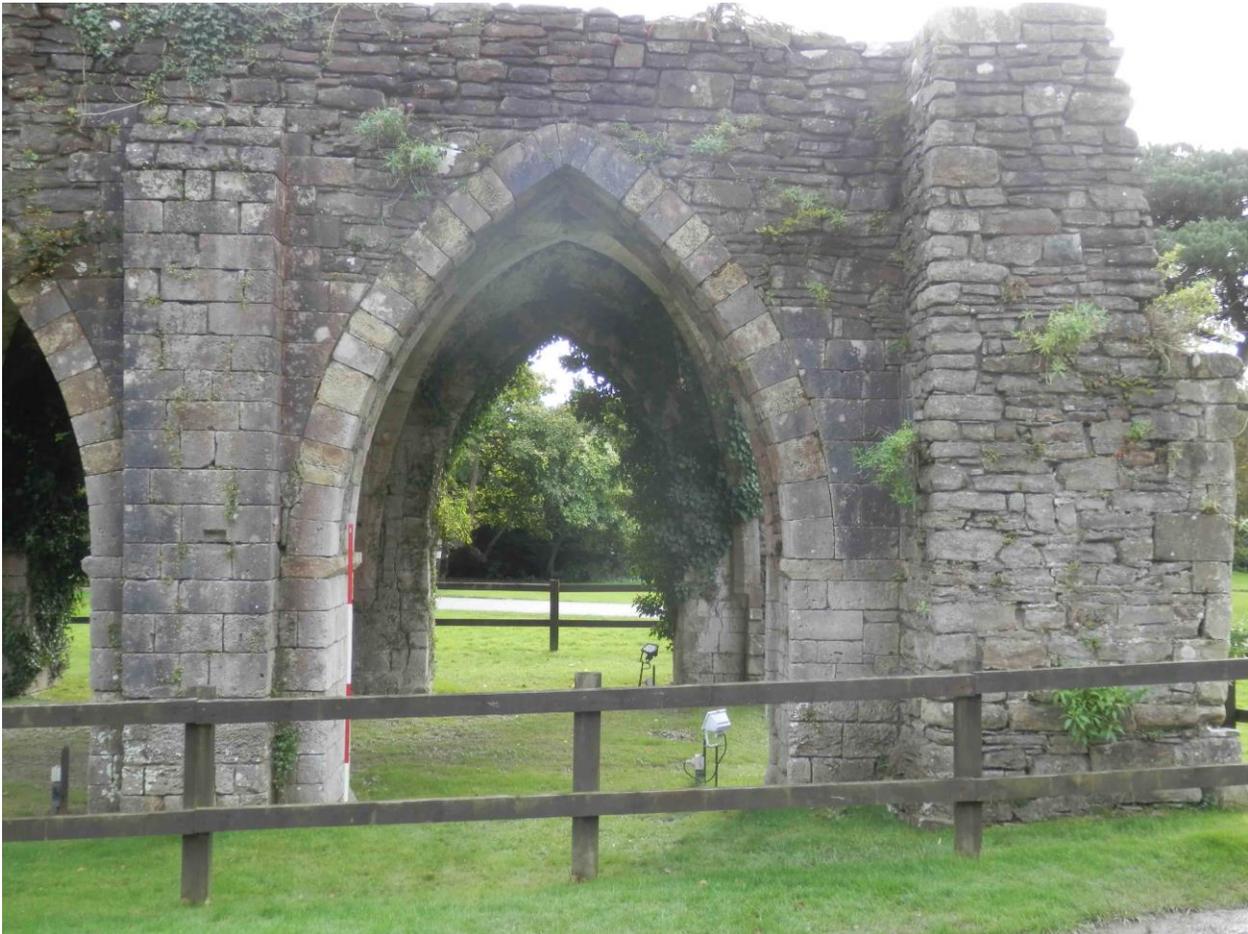
ID: 172 Site Number: 748 Site Name: Margam Monastic Ruins
Wall Number: 124 Photo Number: F2/238-239
Location: Undercroft north wall ext. west arch
Description: Ashlar arch, pier and left-hand buttress. String course at springing of left-hand side of arch. Local sandstone rubble above the arch and extending around on right hand side. Socket possibly for a beam in buttress on the left Right hand side arch appears to have recess about 1.7m high from base (see wall 135.2). Springing of arch on left side above string course appears to have been previously restored.
Condition summary: A) Cracks or fissures, mortar missing in ashlar on left-hand side buttress wall. B) Weathered masonry. C) Loose stones in rubble at top of wall. D) Mortar and masonry damaged by vegetation.
Threats: Vegetation and weathering
Recorded by: Paul Minton Date: 04/10/2012

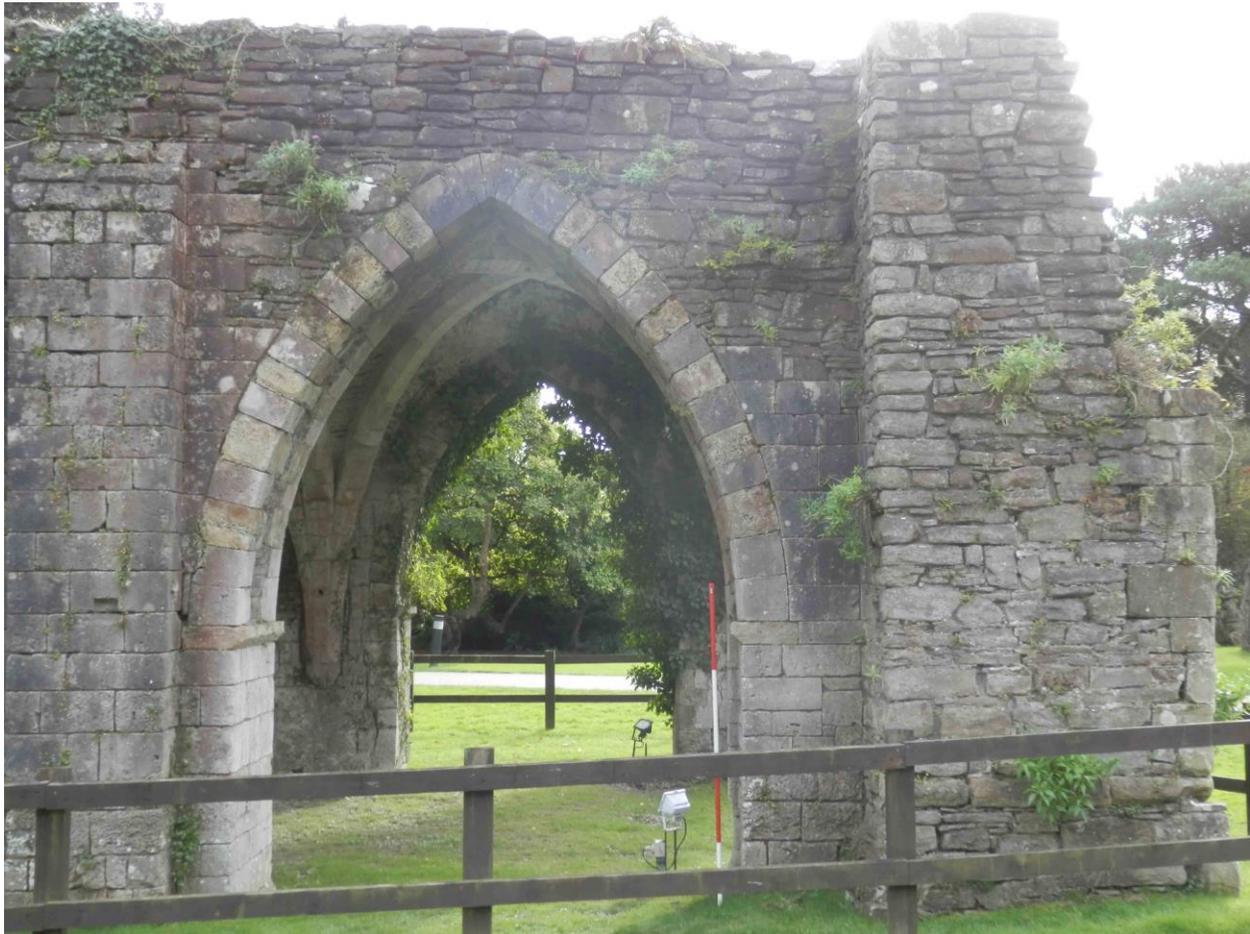
Condition summary: A) Both N and E faces of the buttress have mortar missing between many of the stones. B) Both have some vegetation. C) Right-hand (W) side of buttress has potentially loose stones including on top of wall. D) Cracks, fissures

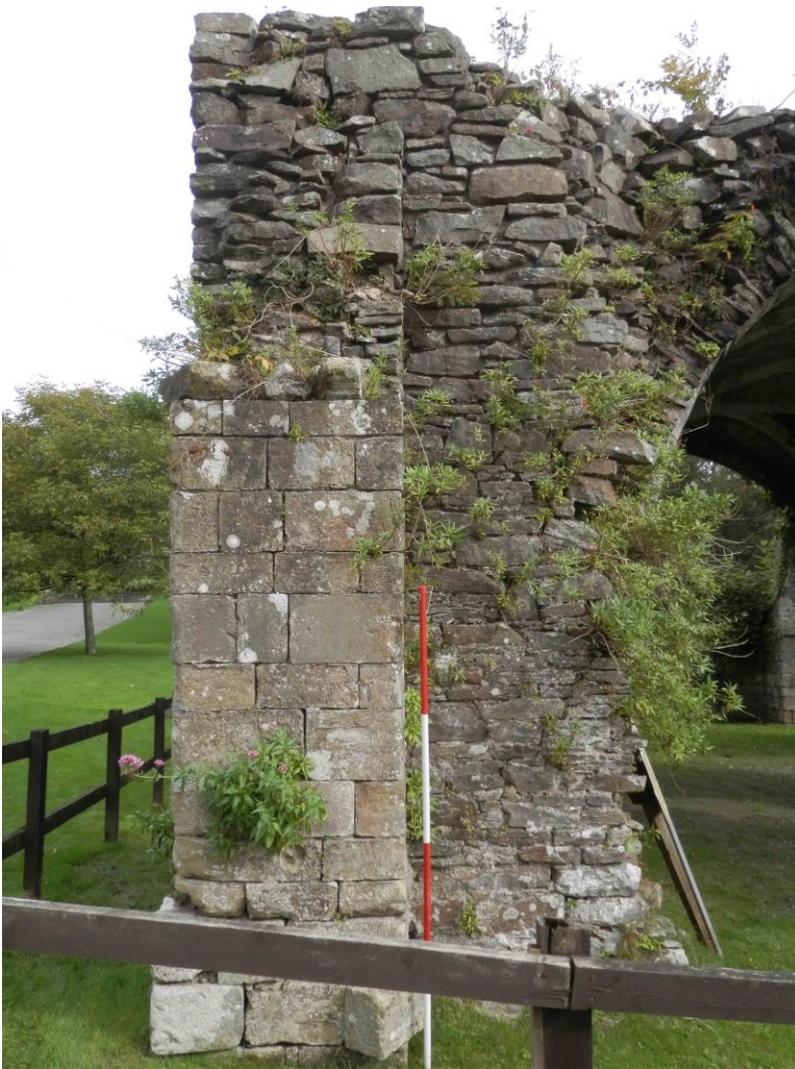
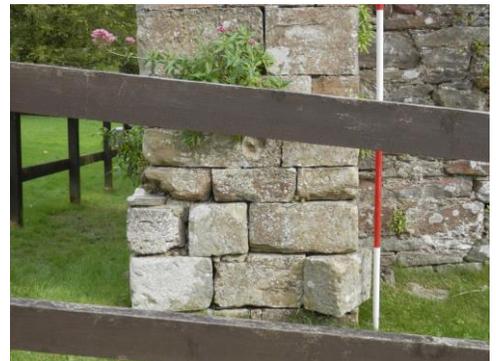
ID: 174 Site Number: 748 Site Name: Margam Monastic Ruins
Wall Number: 125 Photo Number: F2/240-241
Location: Undercroft west wall Ext. Northwest buttress west face.
Description: Face in ashlar; corner stone dislodged but still in position; missing stone and mortar. Above surviving section of face, core of local sandstone rubble is visible. Vegetation causing loss of mortar, stones loose.
Condition summary: A) Stone dislodged at base. B) Missing mortar. C) Missing blocks. D) Vegetation. E) Falling stones
Threats: Vegetation, weathering, human interaction.
Recorded by: Maggie Cornelius Date: 04/10/2012

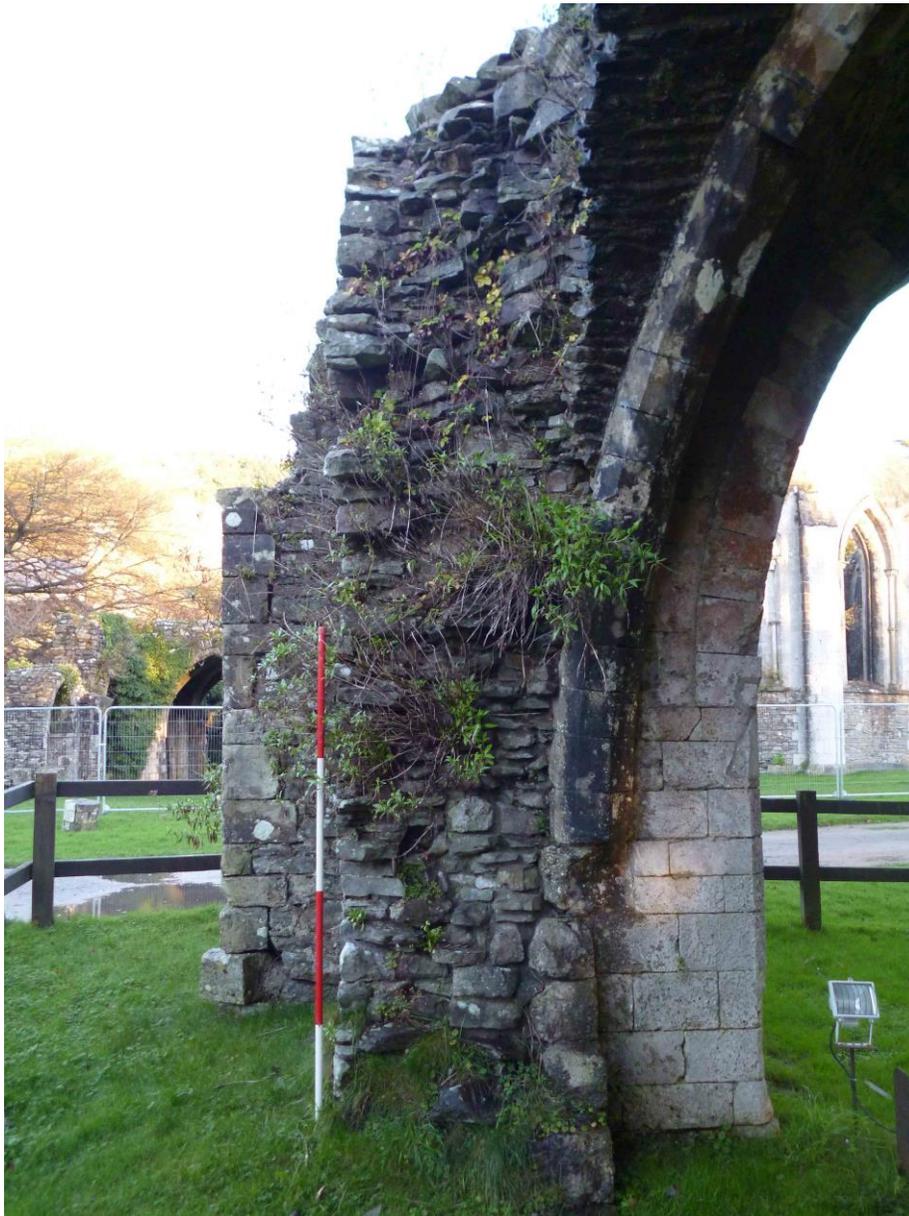
ID: 175 Site Number: 748 Site Name: Margam Monastic Ruins
Wall Number: 126.1 Photo Number: F3/50
Location: Undercroft west wall inside of arch north face
Description: Ashlar rib to sandstone rubble vault. Pier has lost facing, revealing rubble core. Some vegetation outside arch.
Condition summary: A) Rough uneven sandstone wall. B) Damaged to rib. C) Vegetation. D) Weathering.
Threats: Vegetation, weathering.
Recorded by: Bob Hardwick Date: 04/10/2012

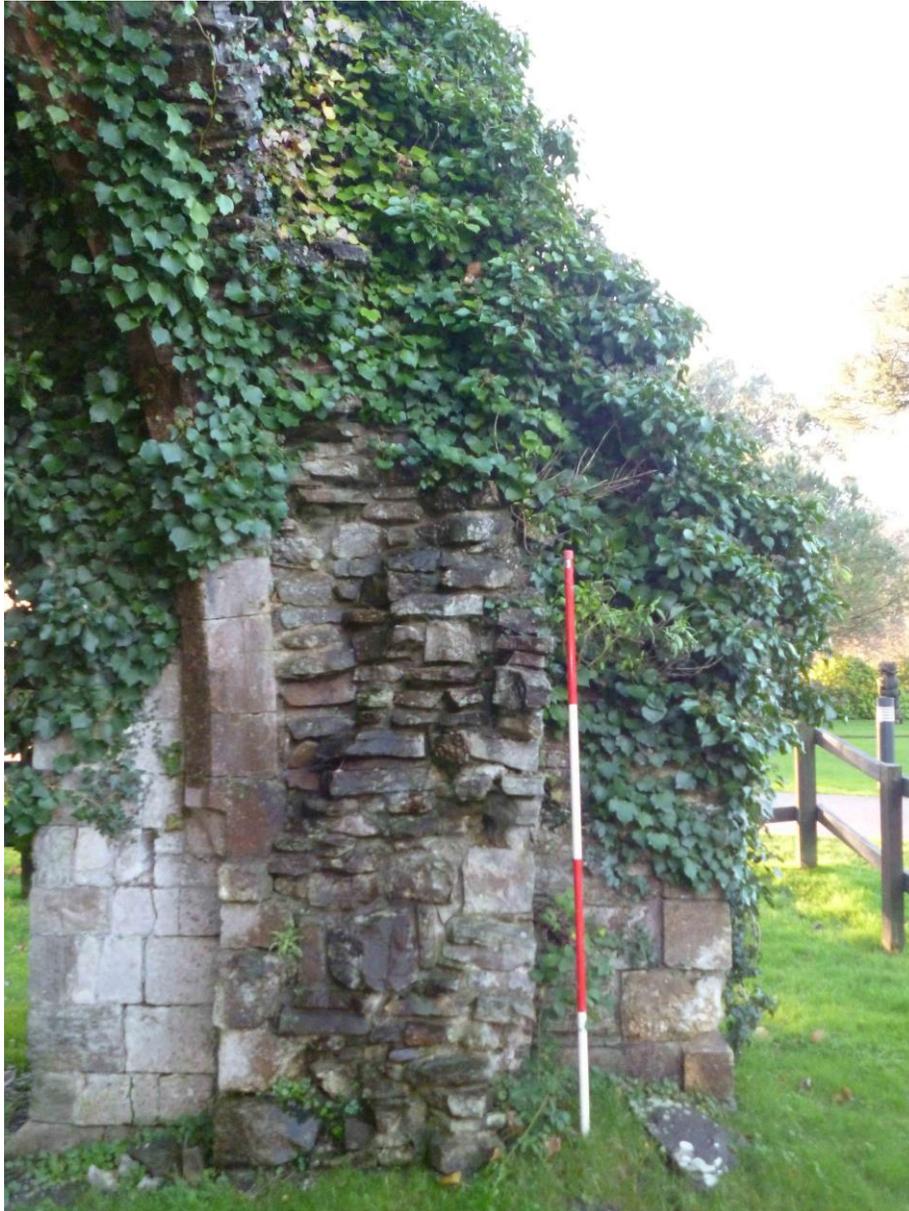
ID: 176 Site Number: 748 Site Name: Margam Monastic Ruins
Wall Number: 126.2 Photo Number: F3/51-52
Location: Undercroft west wall inside of arch south face
Description: Ashlar rib to sandstone rubble vault . Pier has lost facing, revealing rubble core. Cracking on pier left hand side of rib. Extensive ivy coverage.
Condition summary: A) Cracked dressed stone. B) Uneven sand stone wall. C) Extensive ivy coverage. D) Weathering
Threats: Vegetation, weathering
Recorded by: Bob Hardwick Date: 04/10/2012

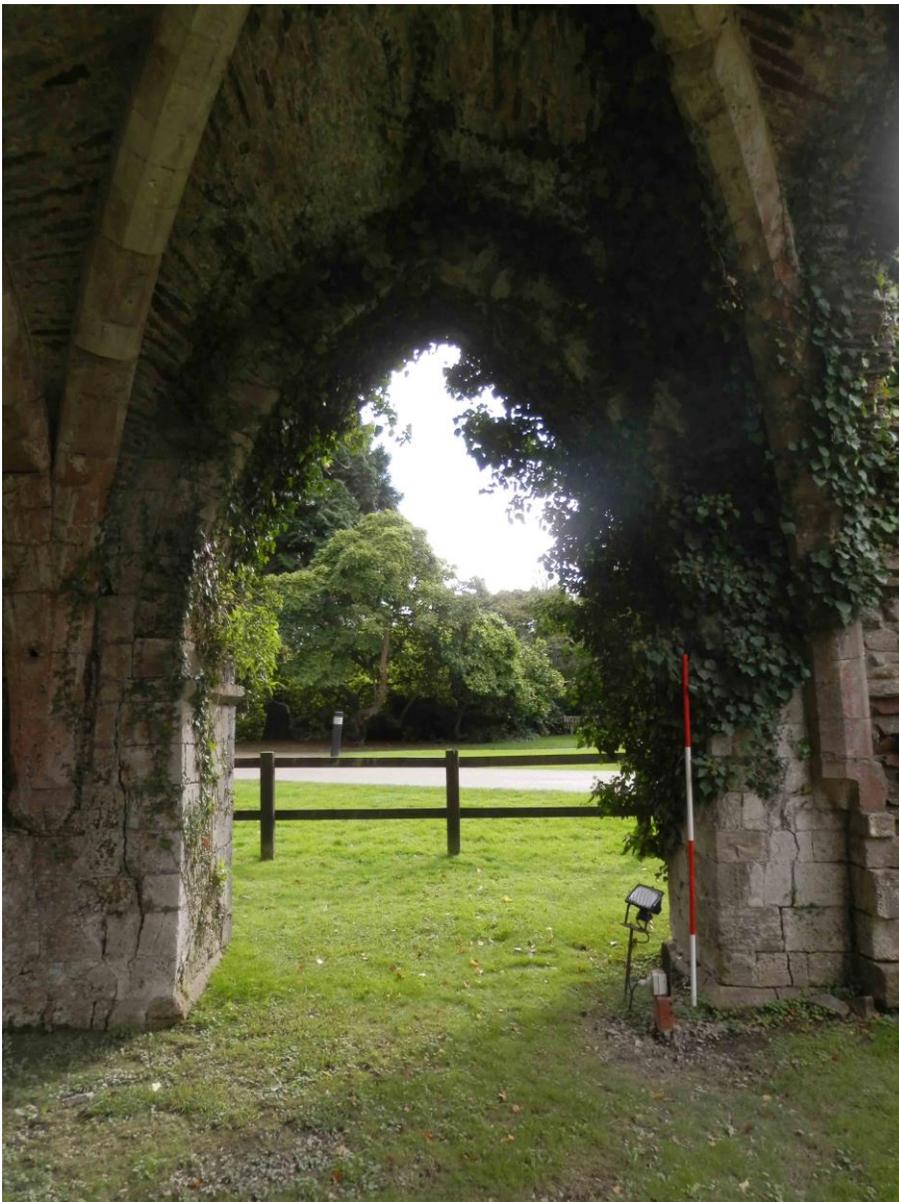
ID: 177 Site Number: 748 Site Name: Margam Monastic Ruins
Wall Number: 127 Photo Number: F2/242-243
Location: Undercroft south wall int. west arch
Description: Inside face of west arch. Ashlar piers (up to 2.4m approx in height), and ashlar rib to sandstone rubble vault.
Condition summary: A) Cracks in piers. B) Damage to left-hand and right-hand ribs.
C) Ivy coverage inside arch and above on right-hand side.
D) Cracks; piers buckling and bulging (also inside face of arch
E) Weathering.
Threats: Vegetation, weathering, structural weakening (buckling of wall)
Recorded by: Bob Hardwick Date: 04/10/2012

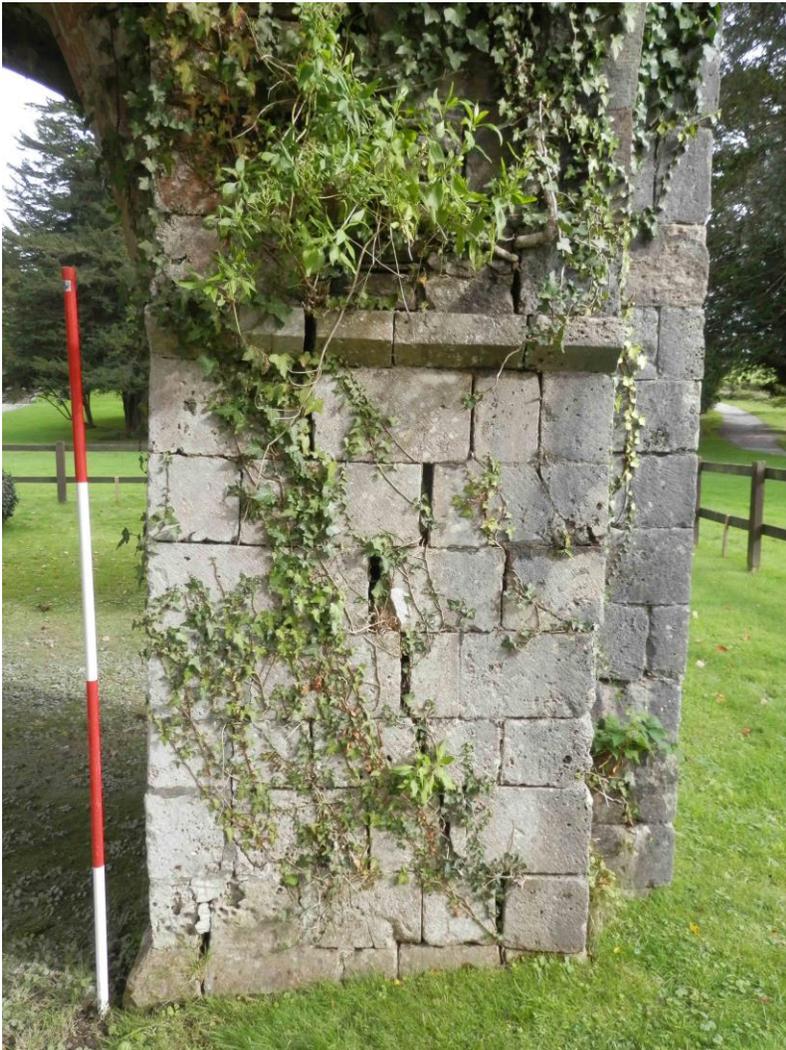
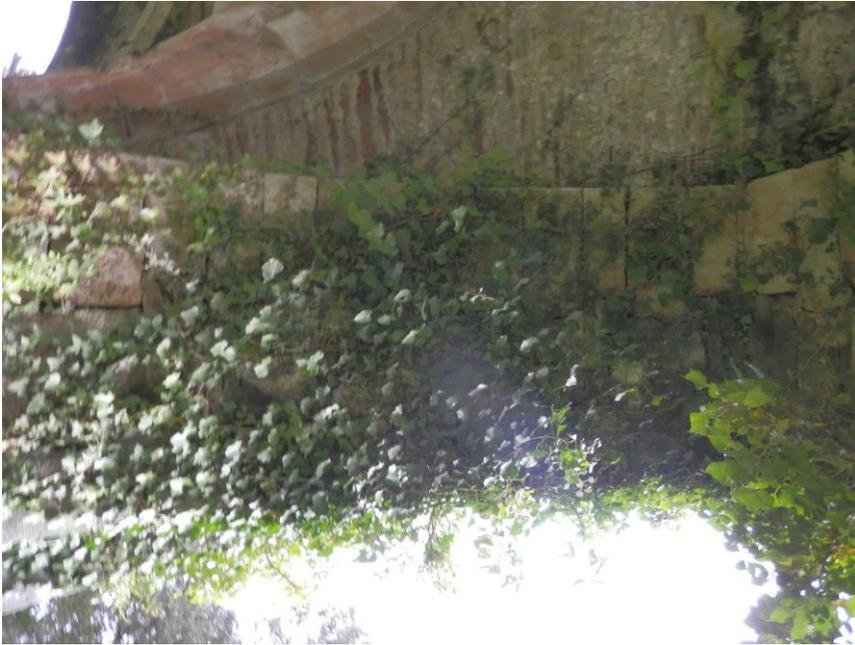
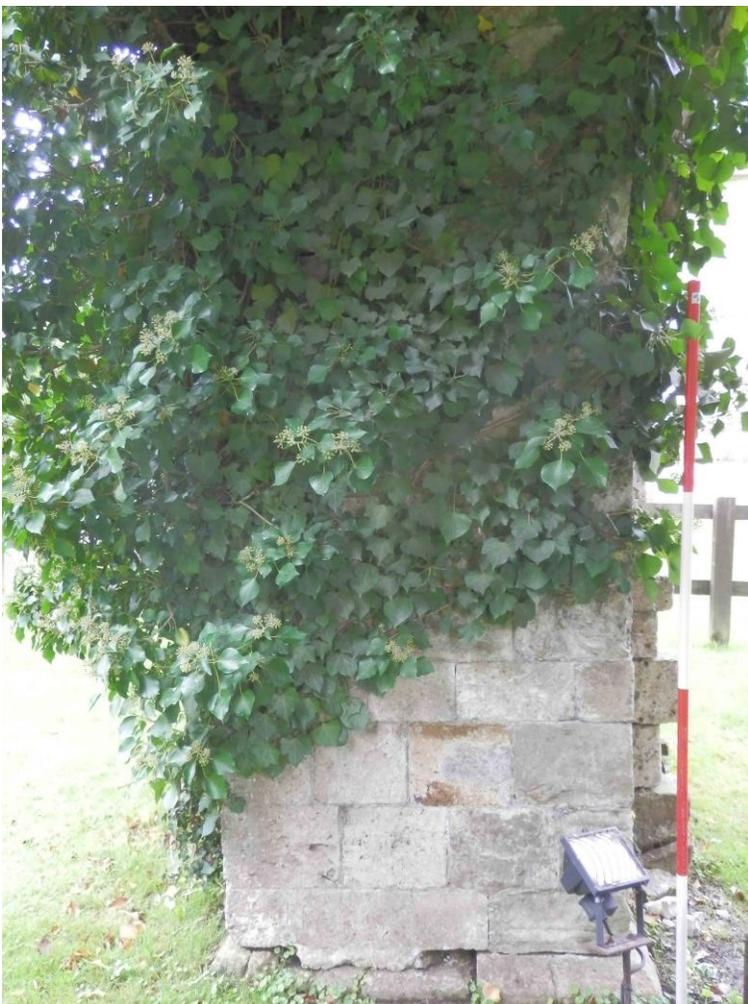
ID: 178 Site Number: 748 Site Name: Margam Monastic Ruins
Wall Number: 128 Photo Number: F2/244-247
Location: Undercroft south wall, west arch inside arch walls
Description: Inside faces of west arch way. Ashlar construction. Heavy ivy.
Extensive cracking and misalignment of stone blocks. Severe cracks
Condition summary: (East face) A) Ivy extensive coverage. B) Large cracks.
C) Misalignment of stone blocks (leaning to right hand side). D) Buckling
of blocks at ground level. (West face) A) Ivy extensive coverage.
B) Missing stones. C) Wall leaning south.
Threats: Vegetation, weathering and potential structural failure
Recorded by: Bob Hardwick Date: 04/10/2012

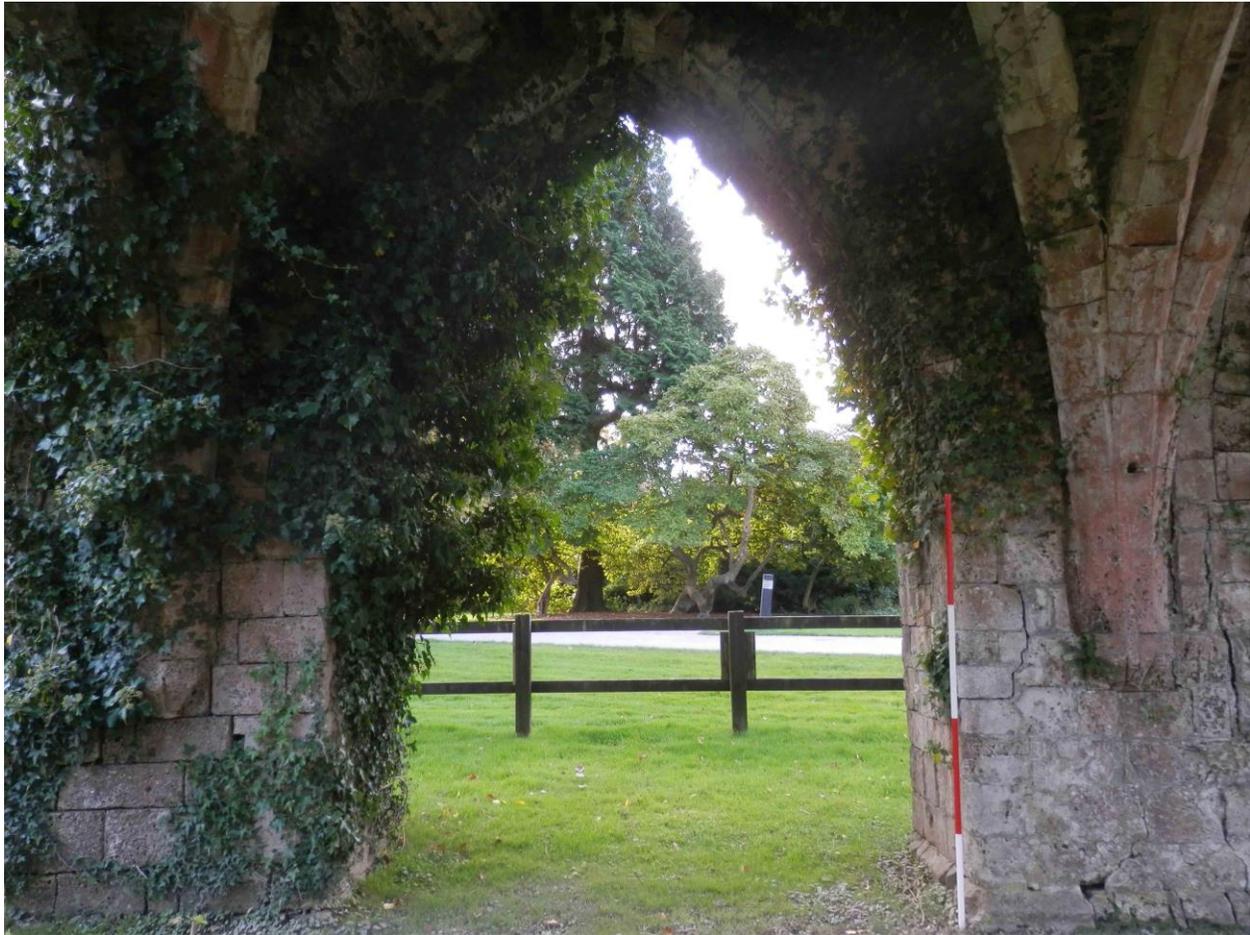
ID: 179 Site Number: 748 Site Name: Margam Monastic Ruins
Wall Number: 129 Photo Number: F3/14-15
Location: Undercroft south wall int. centre arch
Description: Inside face of undercroft south wall central arch. Ashlar blocks up to
Approx 2.4m high on walls and ashlar rib to sandstone rubble vaults.
Condition summary: A) Severe cracks left-hand side; worse cracks right-hand side wall and
bottom of right hand side. B) Extensive ivy coverage.
Threats: Vegetation Weathering and structural weakening
Recorded by: Bob Hardwick Date: 04/10/2012

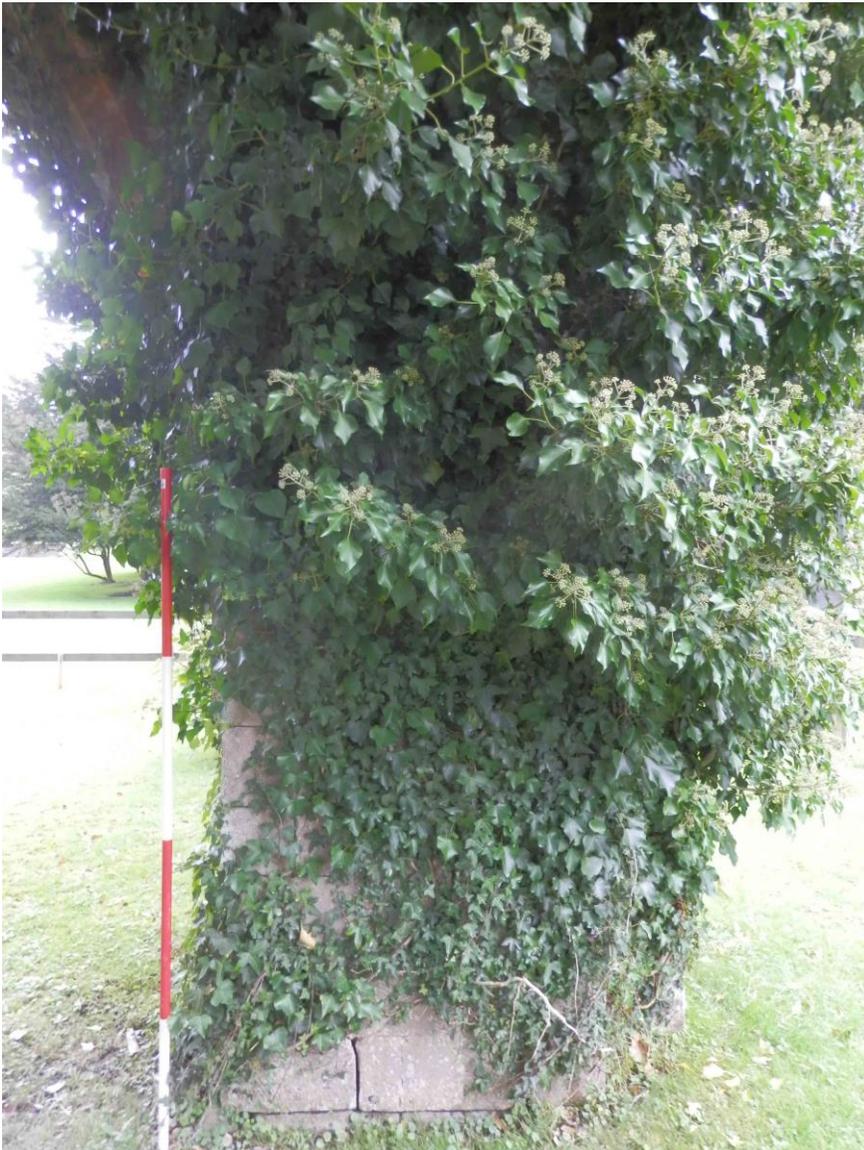
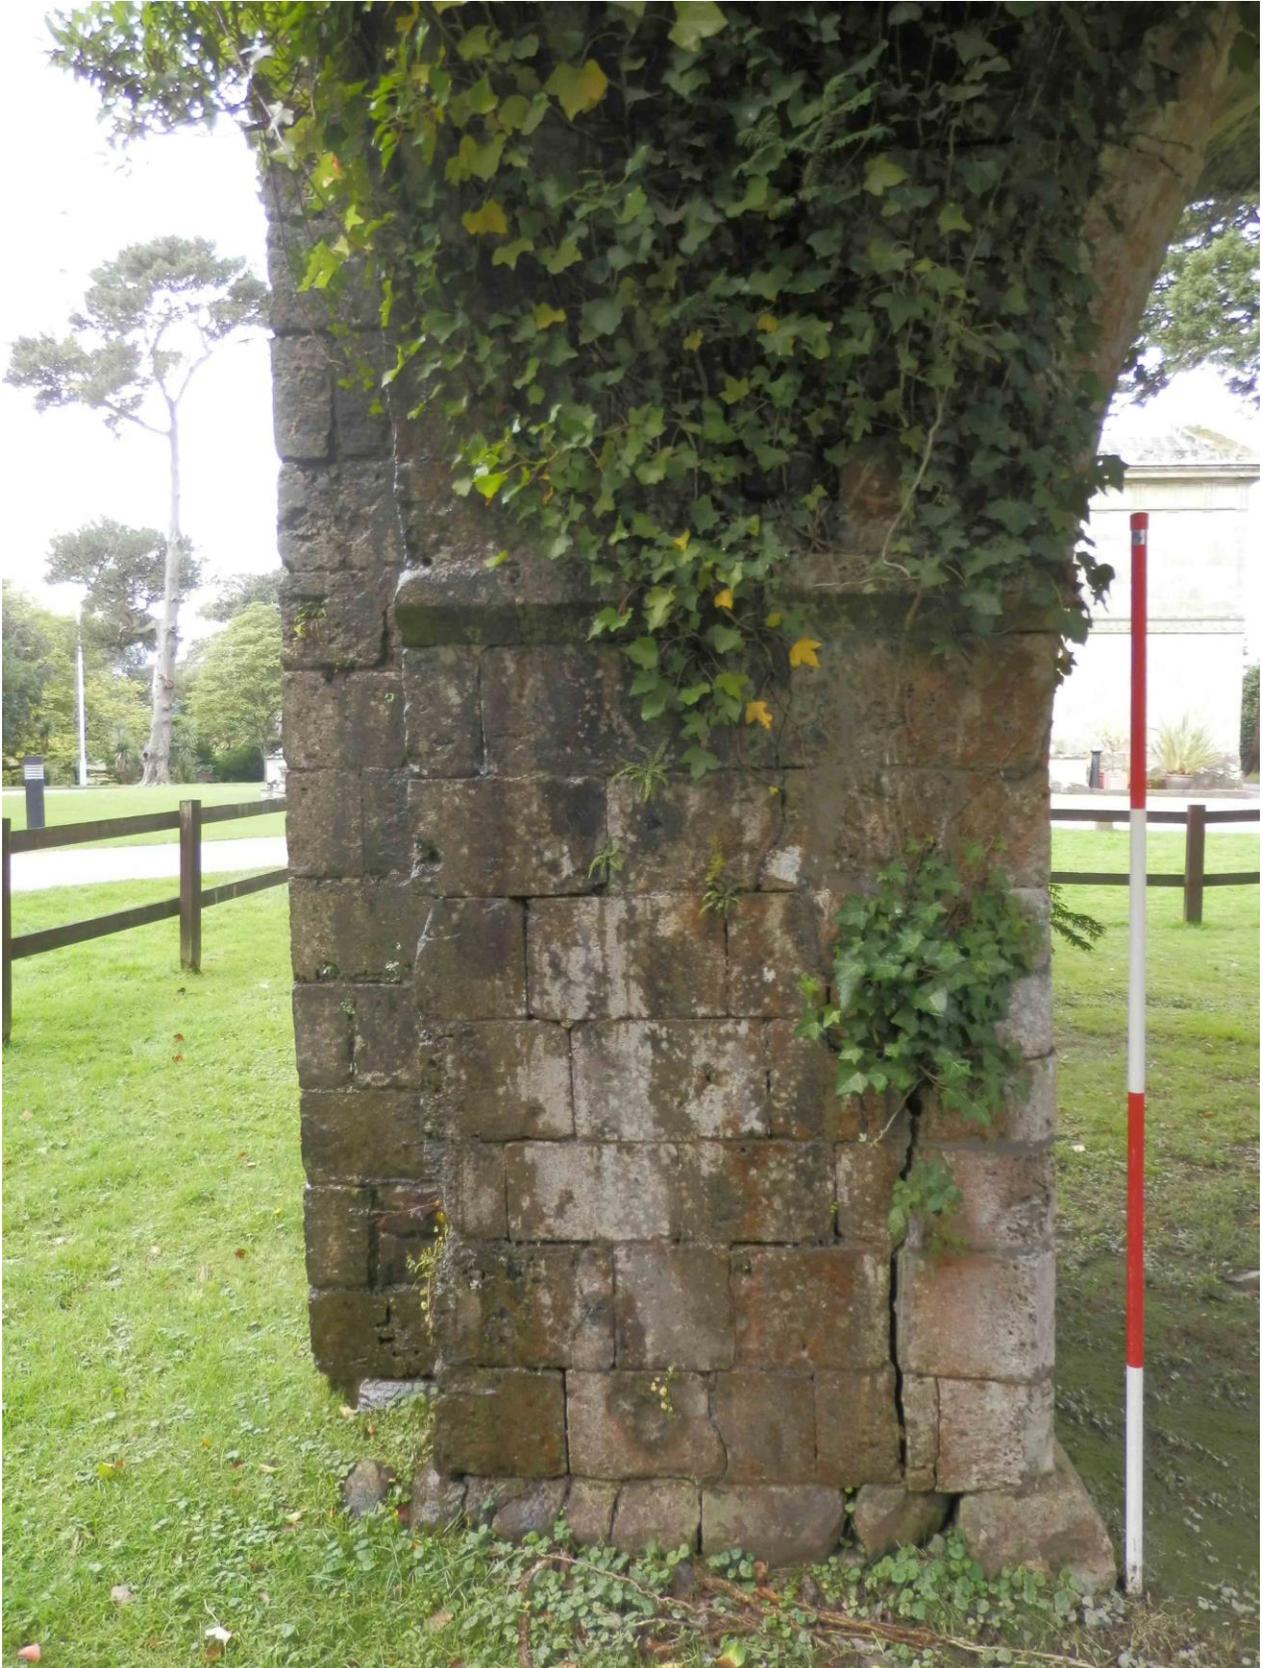
ID: 180 Site Number: 748 Site Name: Margam Monastic Ruins
Wall Number: 130 Photo Number: F2/130
Location: Undercroft south wall inside face of central arch.
Description: Both piers and arch constructed of ashlar. Right-hand side inner arch the west side has severe cracking and crumbling of stone at base. Right-hand side inner wall the east side has cracking at bottom of wall.
Condition summary: (East face) A) Cracking lower wall. B) Extensive ivy coverage. (West face) C) Deep wide cracks (multiple). D) Crumbling base stones. E) Extensive ivy coverage.
Threats: Vegetation, weathering, structural weakening.
Recorded by: Bob Hardwick Date: 04/10/2012

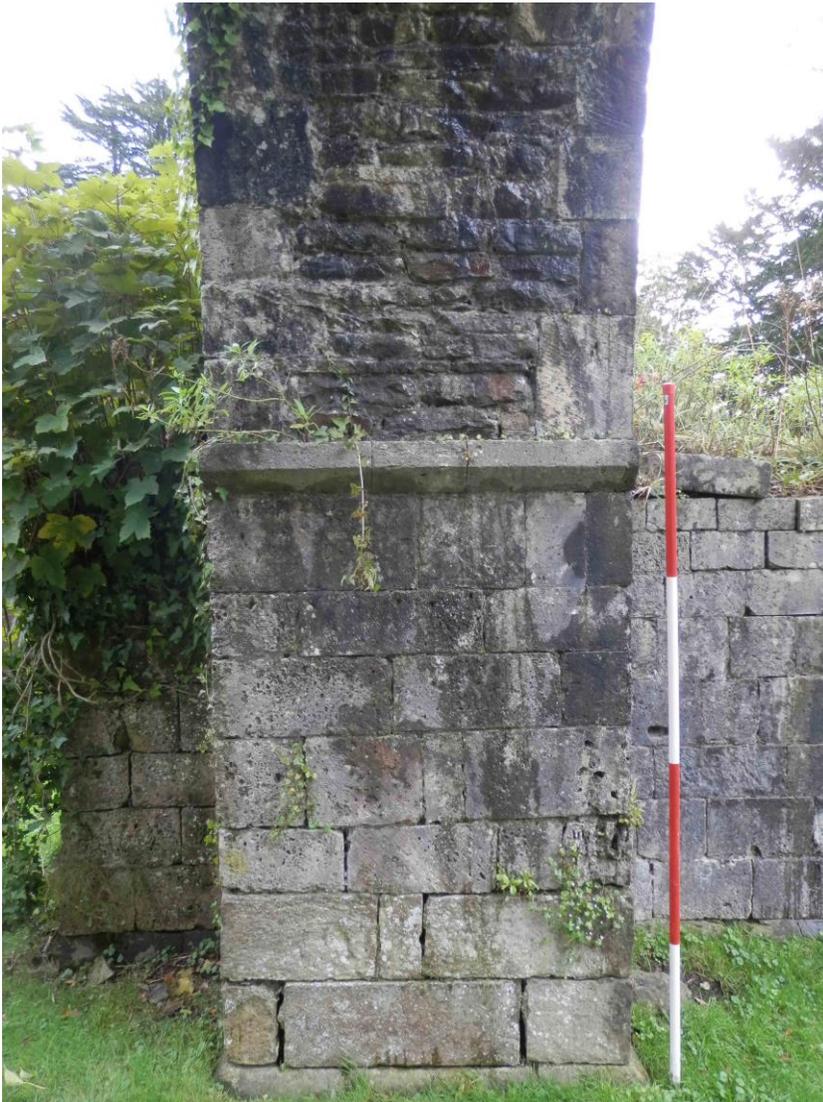
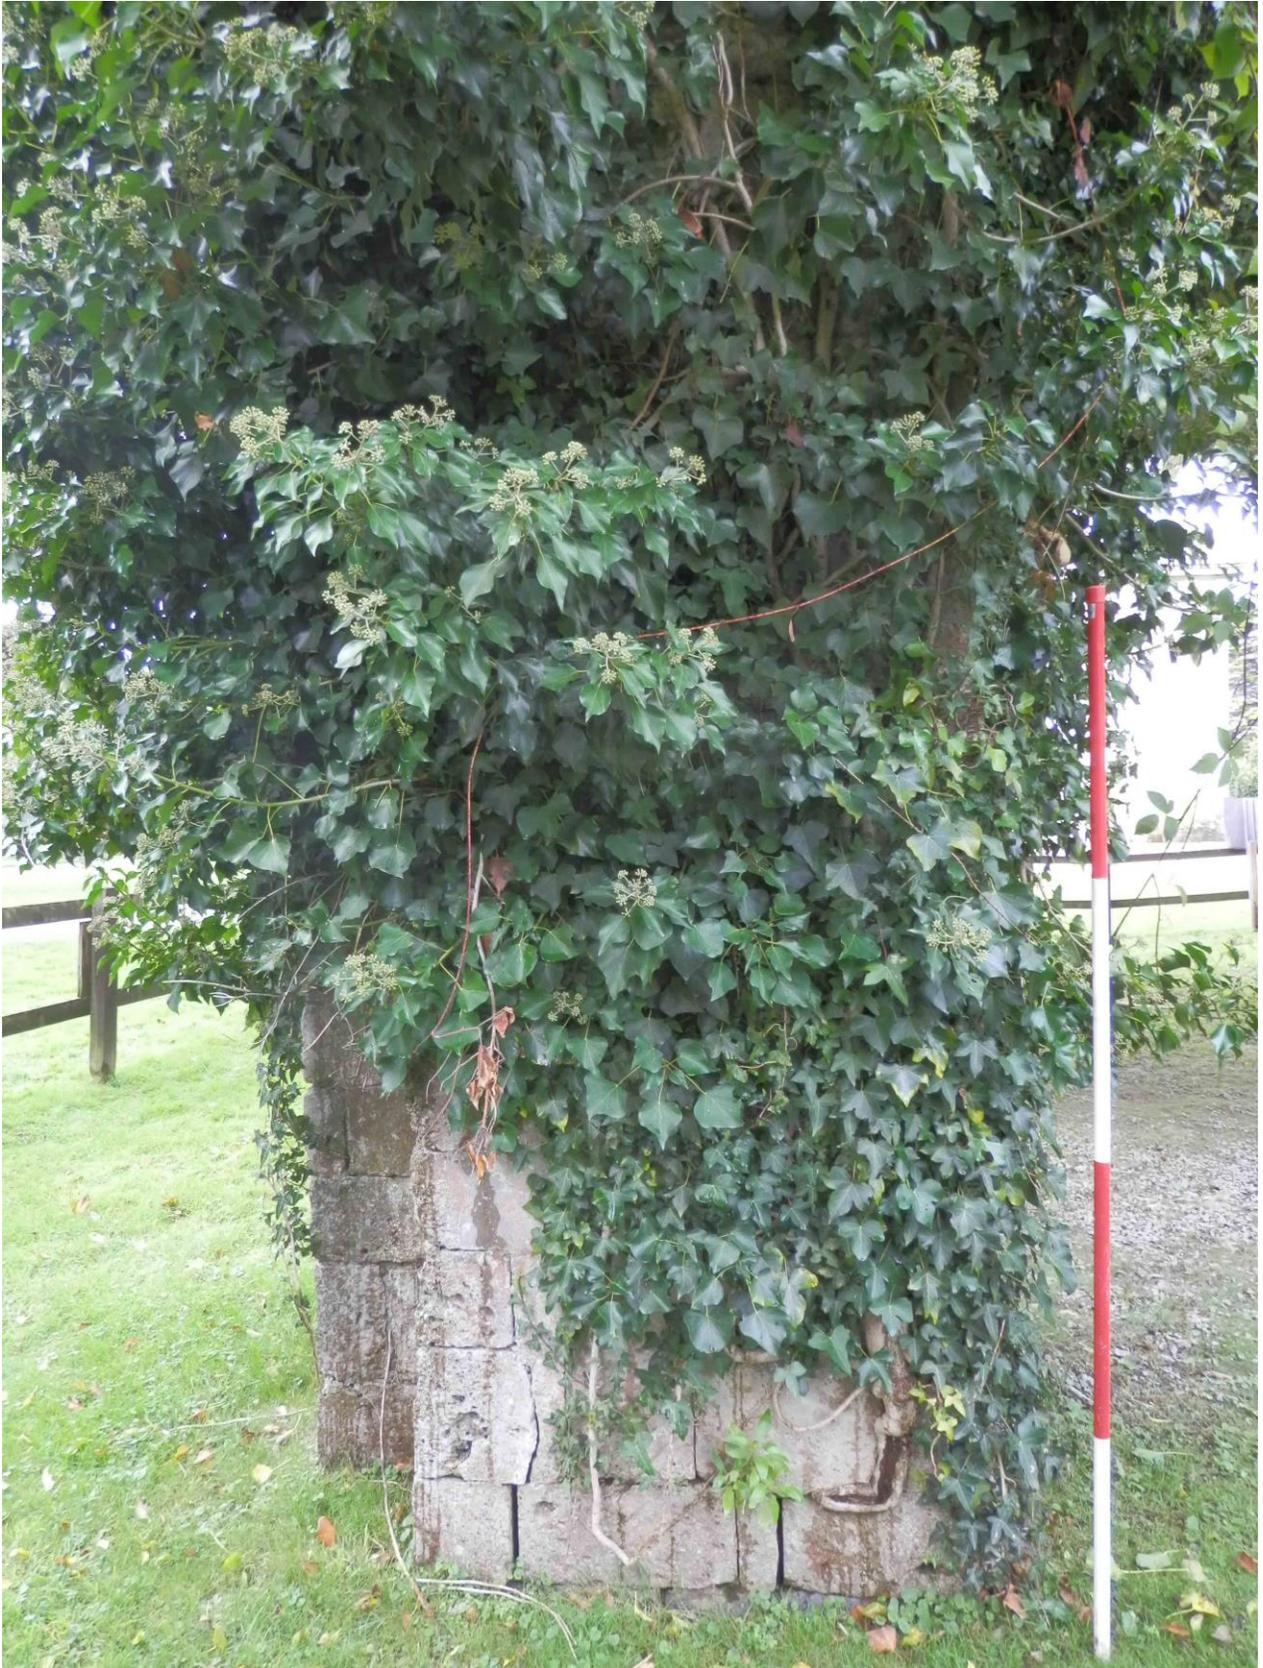
ID: 181 Site Number: 748 Site Name: Margam Monastic Ruins
Wall Number: 131 Photo Number: F2/253-256
Location: Undercroft south wall inner wall of east arch
Description: Inside faces of east arch of south wall. Ashlar ribs to sandstone rubble vault.
Condition summary: (East face) A) Loose, displaced blocks. B) Badly chipped blocks.
C) Minor vegetation. D) Some gaps in masonry. (West face) E) Cracks on the bottom left hand corner. F) Ivy causing cracks right hand corner. G) Extensive ivy coverage.
Threats: Weathering, vegetation, structural damage and human interaction.
Recorded by: Bob Hardwick Date: 04/10/2012
