Monastic Margam Community Survey Project

Report for Cadw
by Sam Pamment BA

GGAT report no. 2013/020
NGR: SS 8018 8626
Project no. GGAT 123

Summary

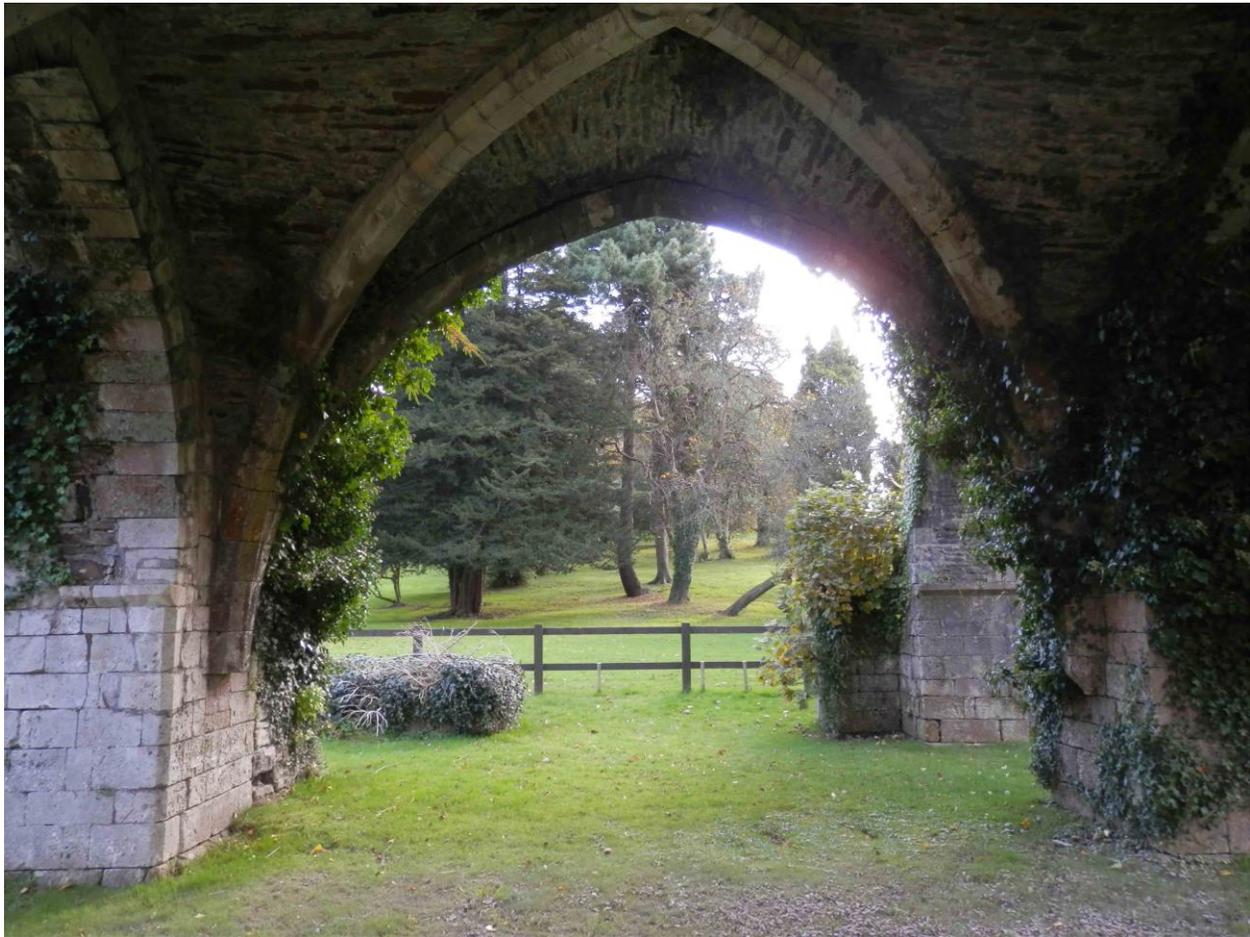
ID: 182 Site Number: 748 Site Name: Margam Monastic Ruins
Wall Number: 132 Photo Number: F3/16-17
Location: Undercroft east wall int. Arch
Description: Ashlar piers; ashlar ribs to sandstone rubble vault.
Condition summary: A) Cracks between rib and rubble of vault. B) Missing stonework at the base of the left-hand pier. Cracks filled with cement. C) Broken edging, coping D) Ivy coverage in most areas.
Threats: Weathering. Vegetation
Recorded by: Bob Hardwick Date: 05/10/2012

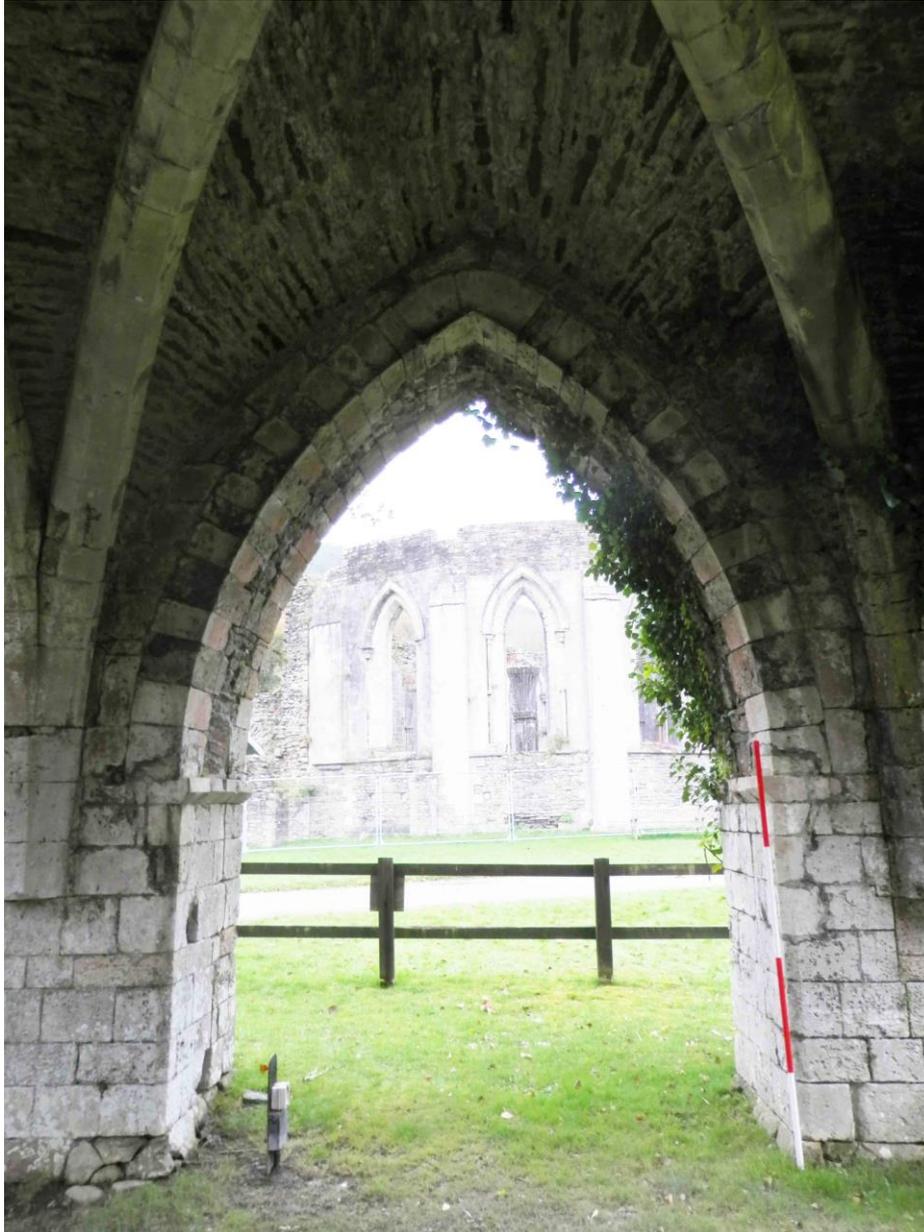
ID: 183 Site Number: 748 Site Name: Margam Monastic Ruins
Wall Number: 133 Photo Number: F2/257-258
Location: Undercroft north side int. east arch.
Description: Ashlar piers, and ashlar ribs to sandstone rubble vault.
Condition summary: A) Patched up cracks with cement. B) Broken stones at base of left-hand side of wall. C) Ivy covering right hand side of arch.
Threats: Weathering, Vegetation.
Recorded by: Bob Hardwick Date: 05/10/2012

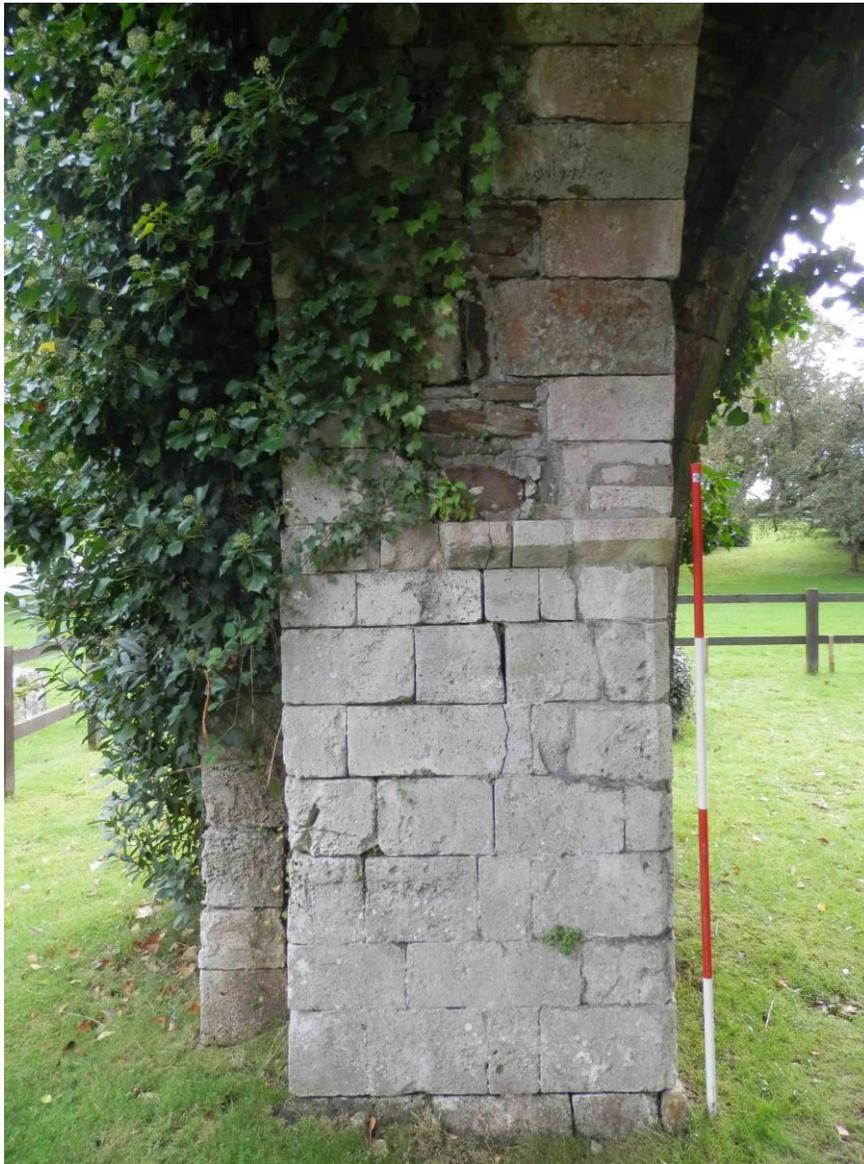
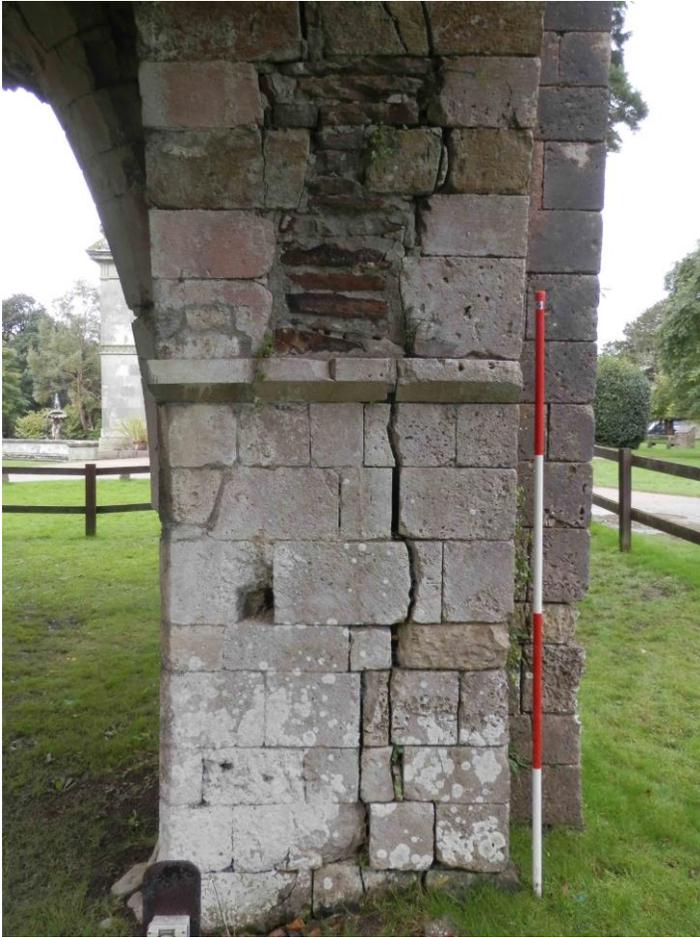
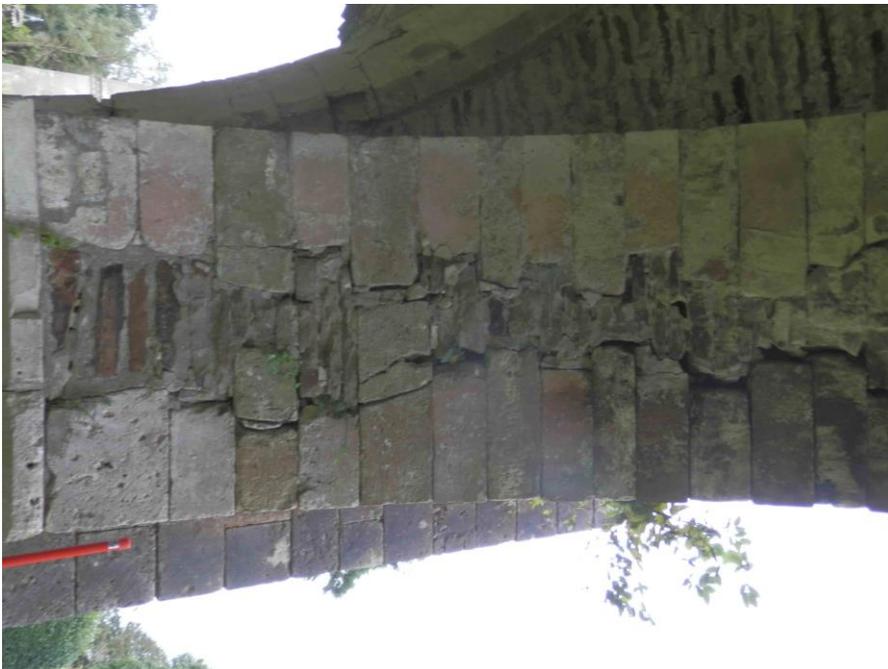
ID: 184 Site Number: 748 Site Name: Margam Monastic Ruins
Wall Number: 134 Photo Number: F2/259-261
Location: Undercroft north side interior east arch inside face
Description: Ashlar piers, and ashlar ribs to sandstone rubble vault.
Condition summary: (West face) A) Major crack in wall. B) Patched up crack with cement.
C) Damaged stones. (East face) D) Damaged string course.
E) Central crack. F) Damaged stonework. G) Ivy coverage.
Threats: Weathering, Vegetation
Recorded by: Bob Hardwick Date: 05/10/2012

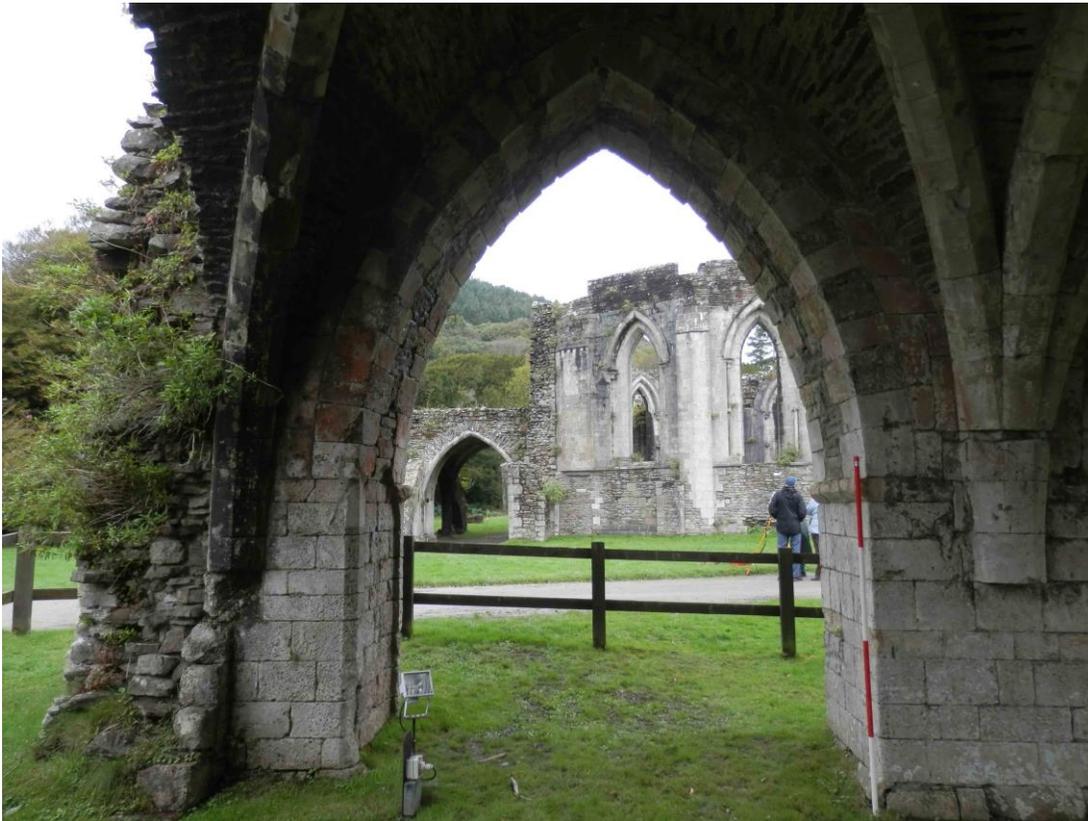
ID: 185 Site Number: 748 Site Name: Margam Monastic Ruins
Wall Number: 135.1 Photo Number: F2/263-264
Location: Undercroft north face int. west arch.
Description: Ashlar piers, and ashlar ribs to sandstone rubble vault.. Left hand side pier shows signs of previous restoration. Lower stones affected by weathering.. Base of ribs missing. Mortar is missing in base of both piers and stones are loose. Section of vault to left-hand side of pier has broken away. String course missing on left side of pier.
Condition summary: A) Restoration to damaged stones (left-hand pier). B) Base of ribs. C) Base of piers damaged, loose masonry. D) Potential loose stones on damaged section of vault. E) Damage to ribs on right-hand side vault. F) Vegetation.
Threats: Weathering, Vegetation and structural movement.
Recorded by: Paul Minton Date: 05/10/2012

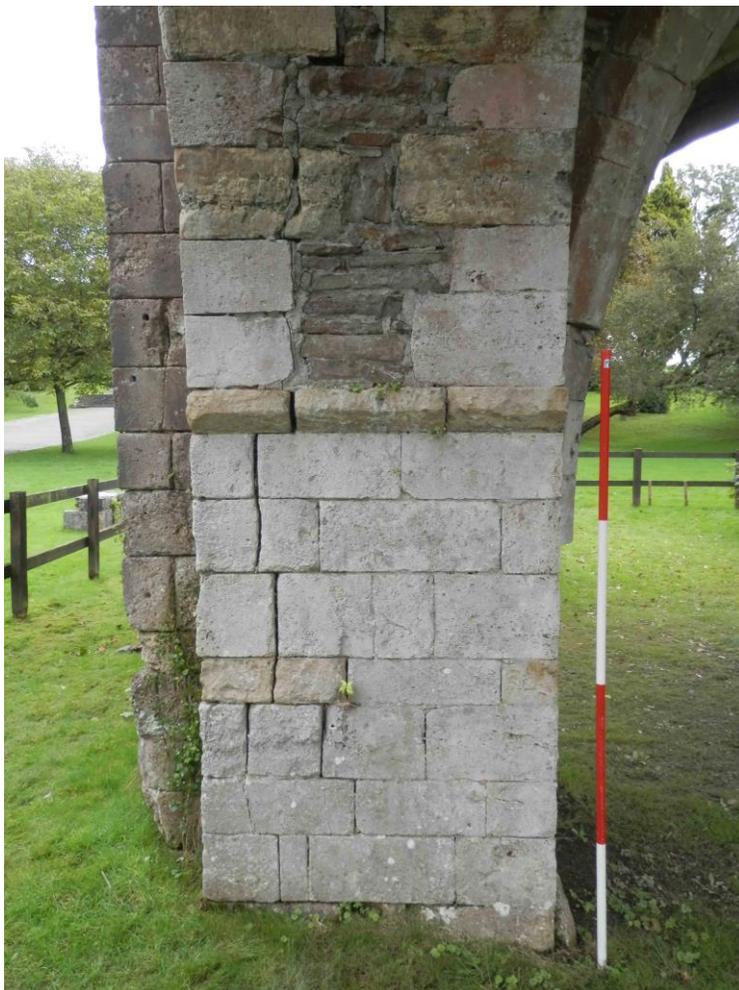
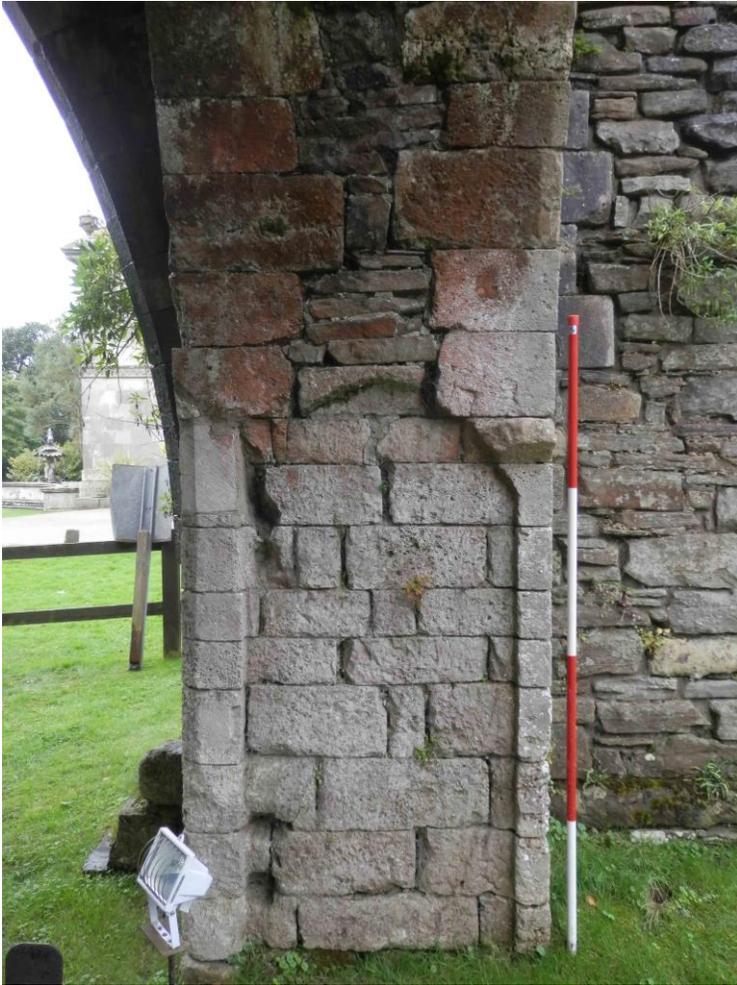
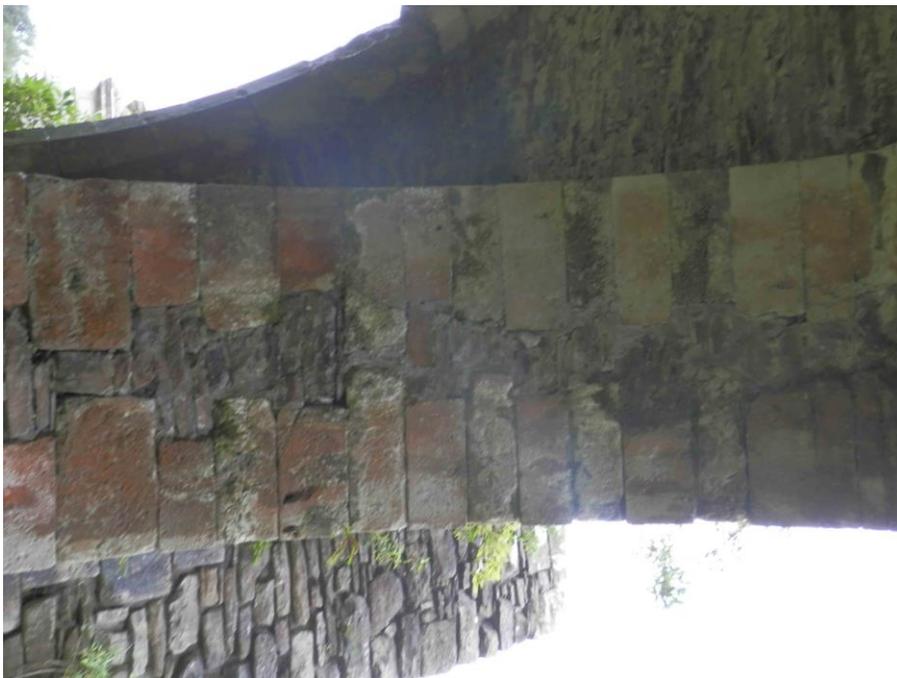
ID: 186 Site Number: 748 Site Name: Margam Monastic Ruins
Wall Number: 135.2 Photo Number: F2/265-268
Location: Undercroft north side internal west arch inner faces
Description: Ashlar piers, and ashlar ribs to sandstone rubble vault.
sandstone. On the inner face of the western pier there is a niche (or
blocked doorway) with arched head, approx 0.045m deep and 1.5m high.
Back of niche/blocking in ashlar. Holes at left-hand side. The inner face of the
eastern pier is of plain ashlar. Both incorporate yellowish blocks
Condition summary: (West face) A) Damaged masonry. B) Mortar missing. C) Vegetation.
D) Cracks in masonry. (East face) E) Cracks/fissures. F) Cracked mortar
G) Potential for loose masonry
Threats: Structural movement, weathering, Vegetation.
Recorded by: Paul Minton Date: 05/10/2012

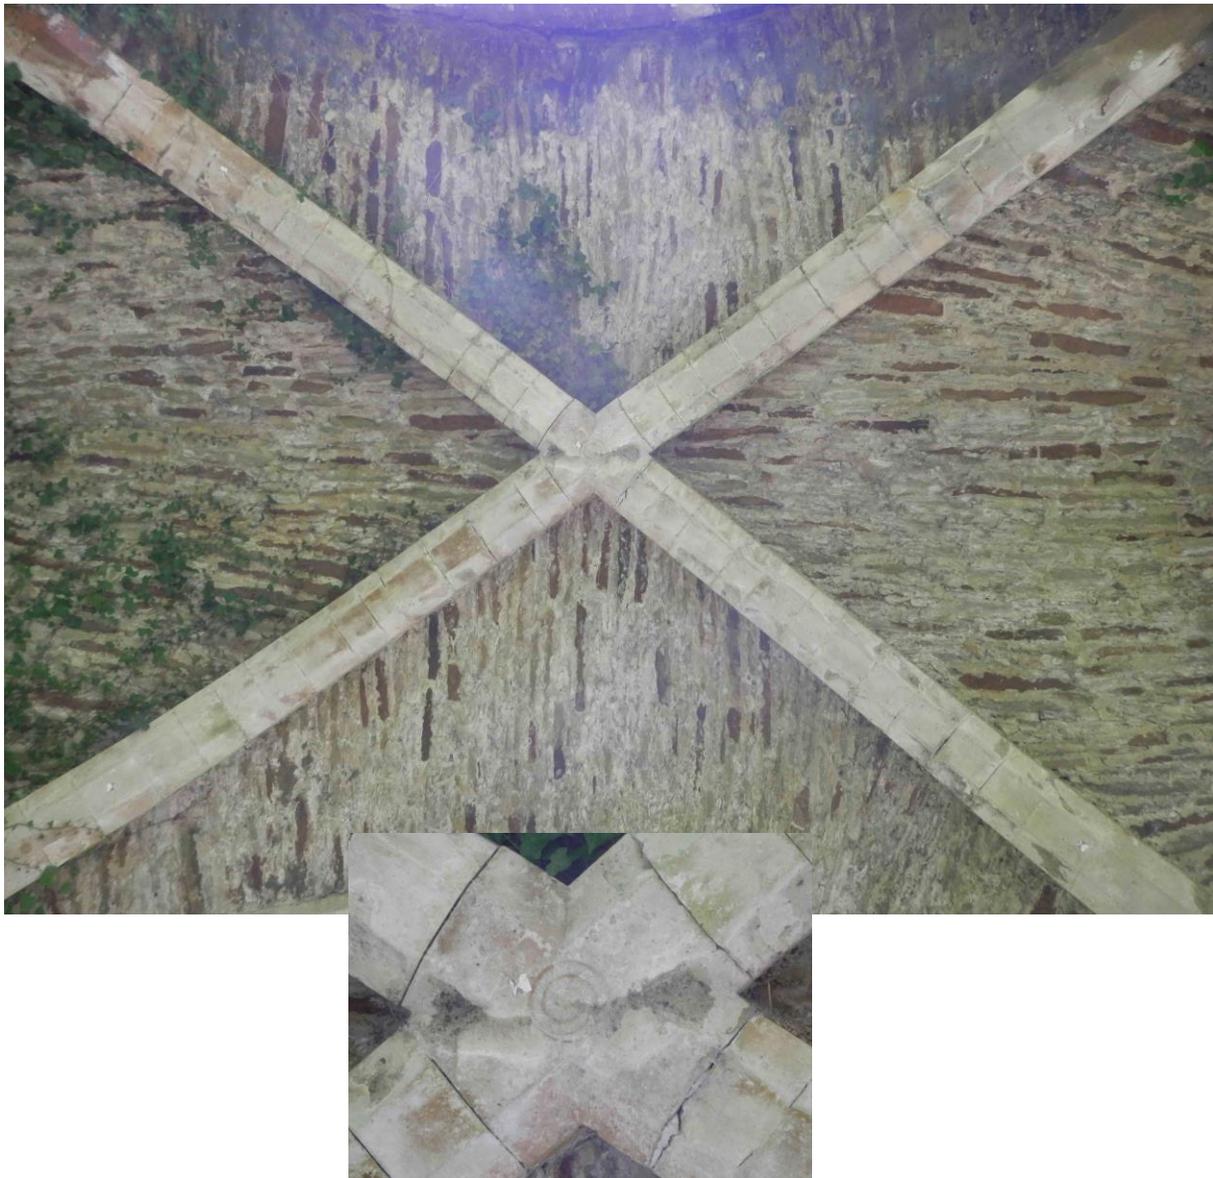
ID: 187 Site Number: 748 Site Name: Margam Monastic Ruins
Wall Number: 136.1 Photo Number: F2/269-271
Location: Undercroft Internal Vaulted ceiling east.
Description: Ashlar piers, and ashlar ribs to sandstone rubble vault. Spiral design carved at junction of ribs
Condition summary: A) Some stone damage to vault ribs. B) Ivy cover in some areas.
D) Crack right across edge of arch (main) east.
Threats: Weathering, vegetation, collapse of surrounding walls
Recorded by: Bob Hardwick Date: 05/10/2012

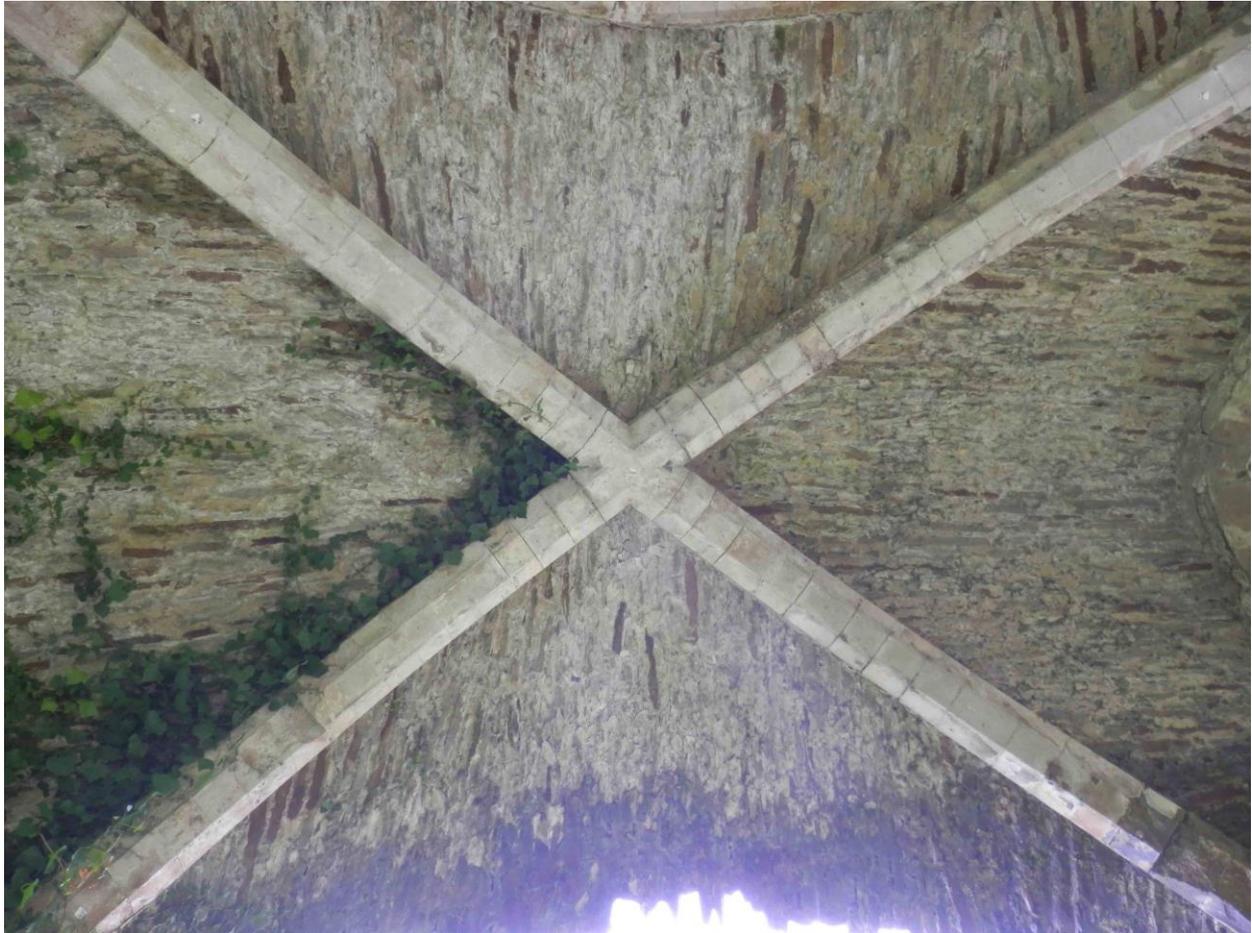
ID: 188 Site Number: 748 Site Name: Margam Monastic Ruins
Wall Number: 136.2 Photo Number: F2/272-273
Location: Undercroft internal vaulted ceiling west.
Description: Ashlar piers, and ashlar ribs to sandstone rubble vault.
Condition summary: A) Damage to W edge of vault. B) Damage to vault ribs. C) Ivy
Threats: Vegetation and weathering.
Recorded by: Bob Hardwick Date: 05/10/2012

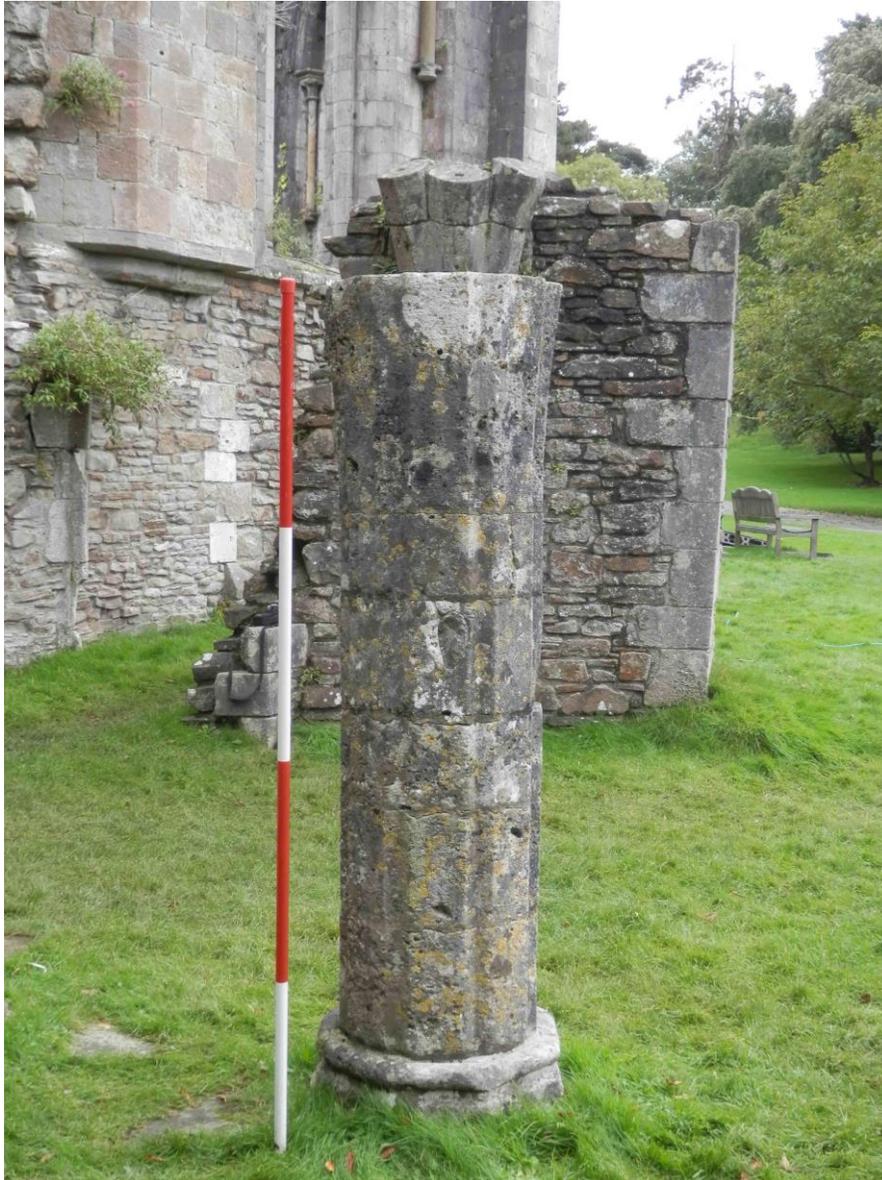
ID: 189 Site Number: 748 Site Name: Margam Monastic Ruins
Wall Number: 137 Photo Number: F2/281-283
Location: East Cloister South. Pillar 1
Description: Octagonal pillar with moulded base; all dressed stone. 'New' concrete between blocks. Tapers outwards at top
Condition summary: A) Blocks pitted and weathered. B) Blocks damaged.
Threats: Weathering.
Recorded by: Paul Minton Date: 05/10/2012

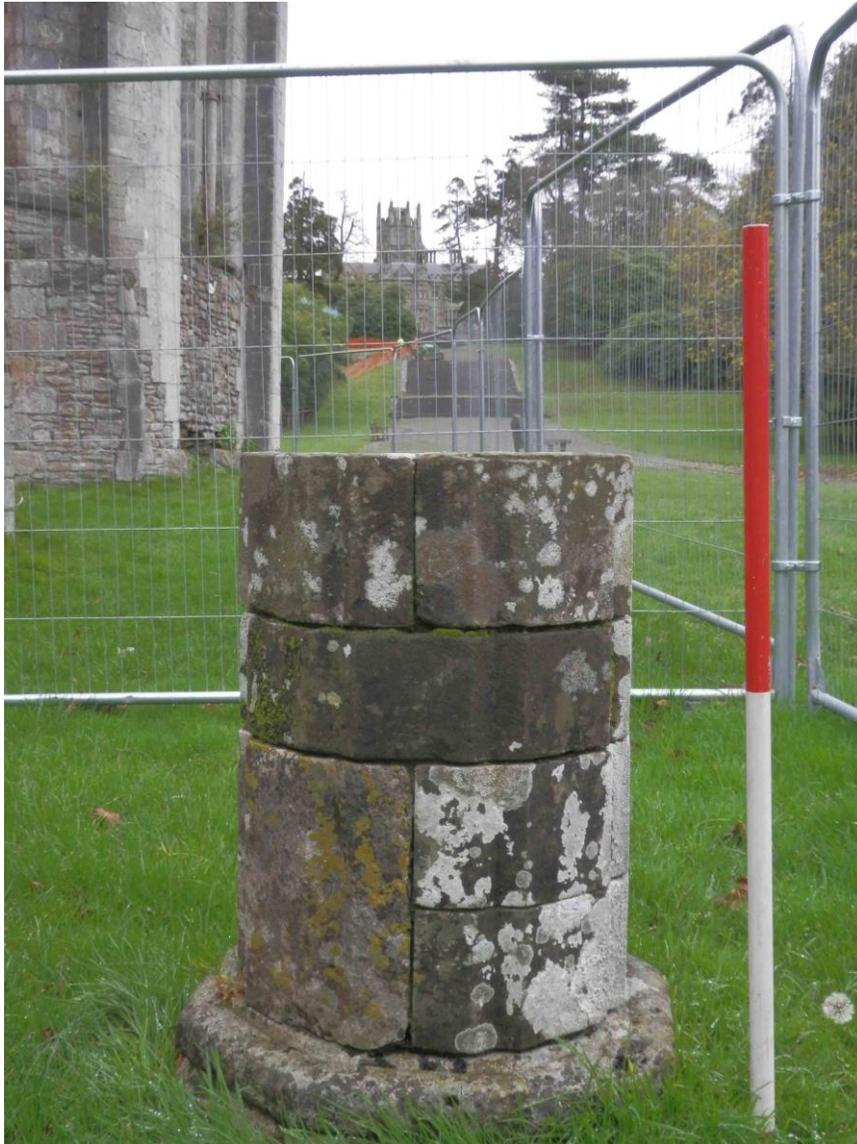
ID: 190 Site Number: 748 Site Name: Margam Monastic Ruins
Wall Number: 138 Photo Number: F3/36-38 44
Location: East Cloister South Pillar 2
Description: Octagonal pillar with moulded base; all dressed stone, only three courses high.
Condition summary: A) Damage on west side bottom of base. B) Weathering.
Threats: Weathering.
Recorded by: Bob Hardwick Date: 05/10/2012

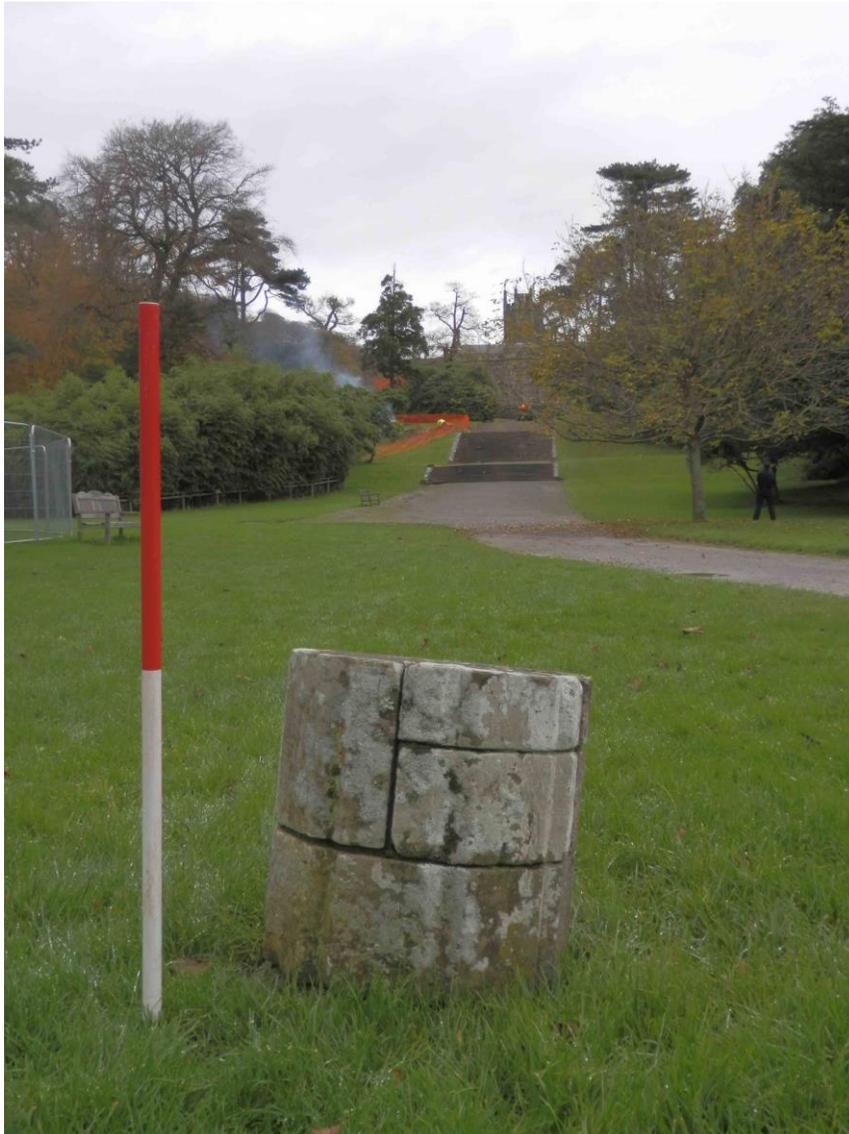
ID: 191 Site Number: 748 Site Name: Margam Monastic Ruins
Wall Number: 139 Photo Number: F3/39-43
Location: East Cloister South Pillar 3
Description: Two courses of an octagonal pillar in dressed stone; no base. Leans out of true.
Concrete
Condition summary: A) Leaning. B) Weathering. C) Fissure.
Threats: Weathering. Falling
Recorded by: Paul Minton Date: 05/10/2012

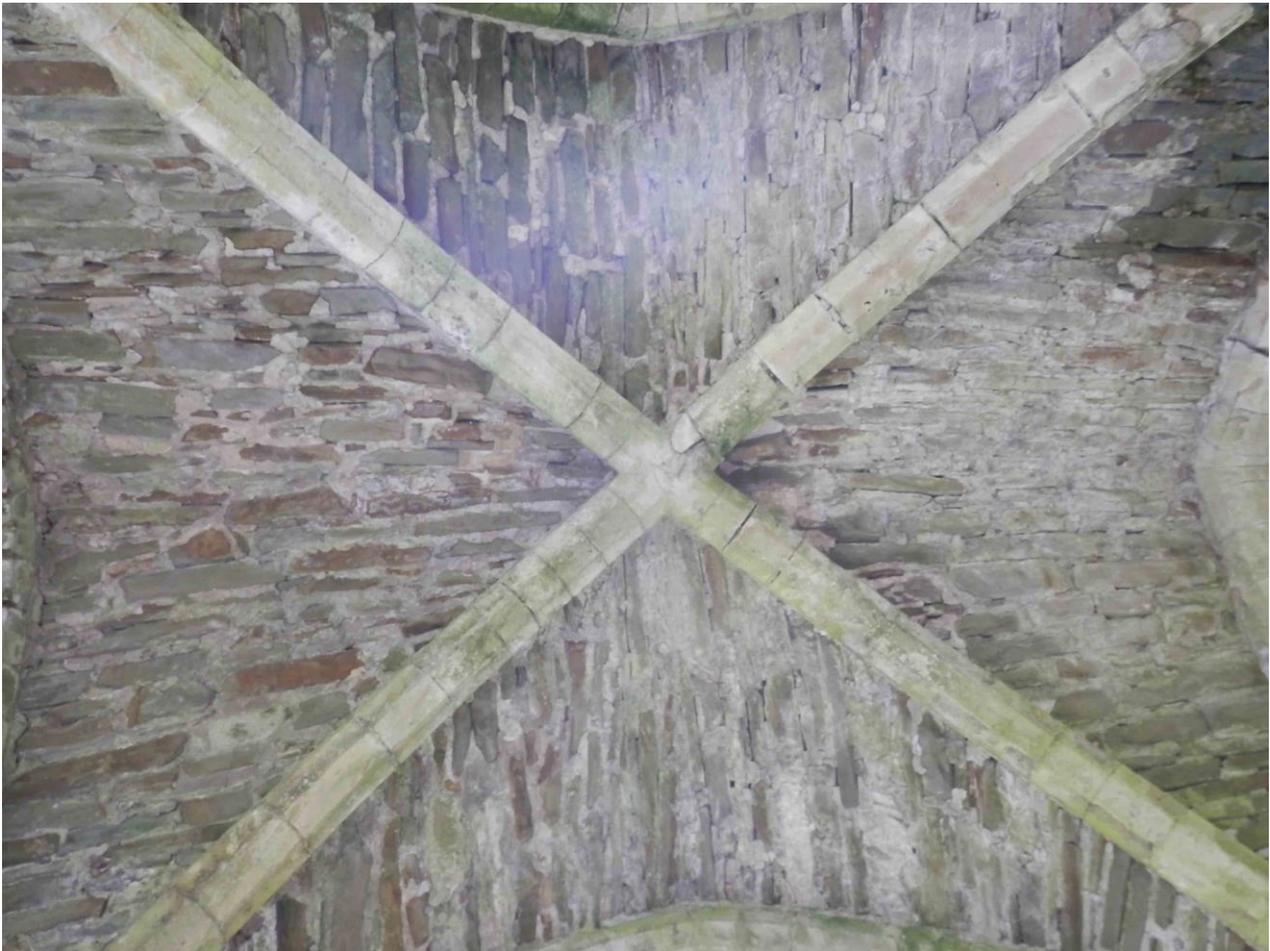
ID: 192 Site Number: 748 Site Name: Margam Monastic Ruins
Wall Number: 140 Photo Number: F2/277
Location: East Cloister Int. vaulted ceiling north end east side
Description: Ashlar piers, and ashlar ribs to sandstone rubble vault.
Condition summary: A) Wet, Damp. B) 2 stones in ribs out of alignment, probably loose.
C) stone in rib cracked, moved away from key stone. Mortar cracked, missing.
Threats: Weathering, structural weakening.
Recorded by: Paul Minton Date: 05/10/2012

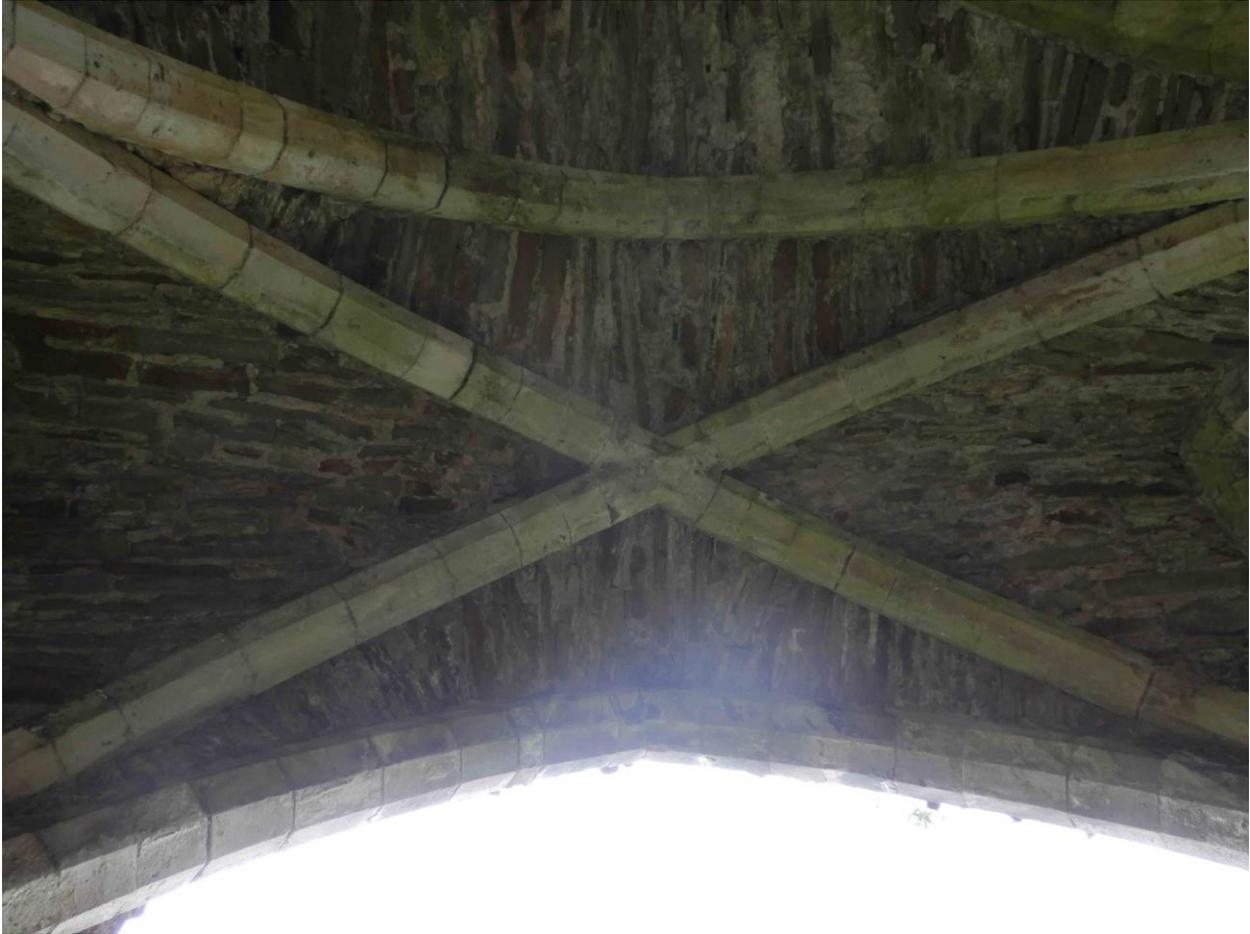
ID: 193 Site Number: 748 Site Name: Margam Monastic Ruins
Wall Number: 141 Photo Number: F2/279
Location: East Cloister Int. vaulted ceiling south end east side.
Description: Ashlar piers, and ashlar ribs to sandstone rubble vault.
Condition summary: A) Stone damage. B) Mortar missing. C) Fissure (movement of stone).
D) Loose mortar.
Threats: Weathering (damp), structural movement.
Recorded by: Paul.Minton Date: 05/10/2012

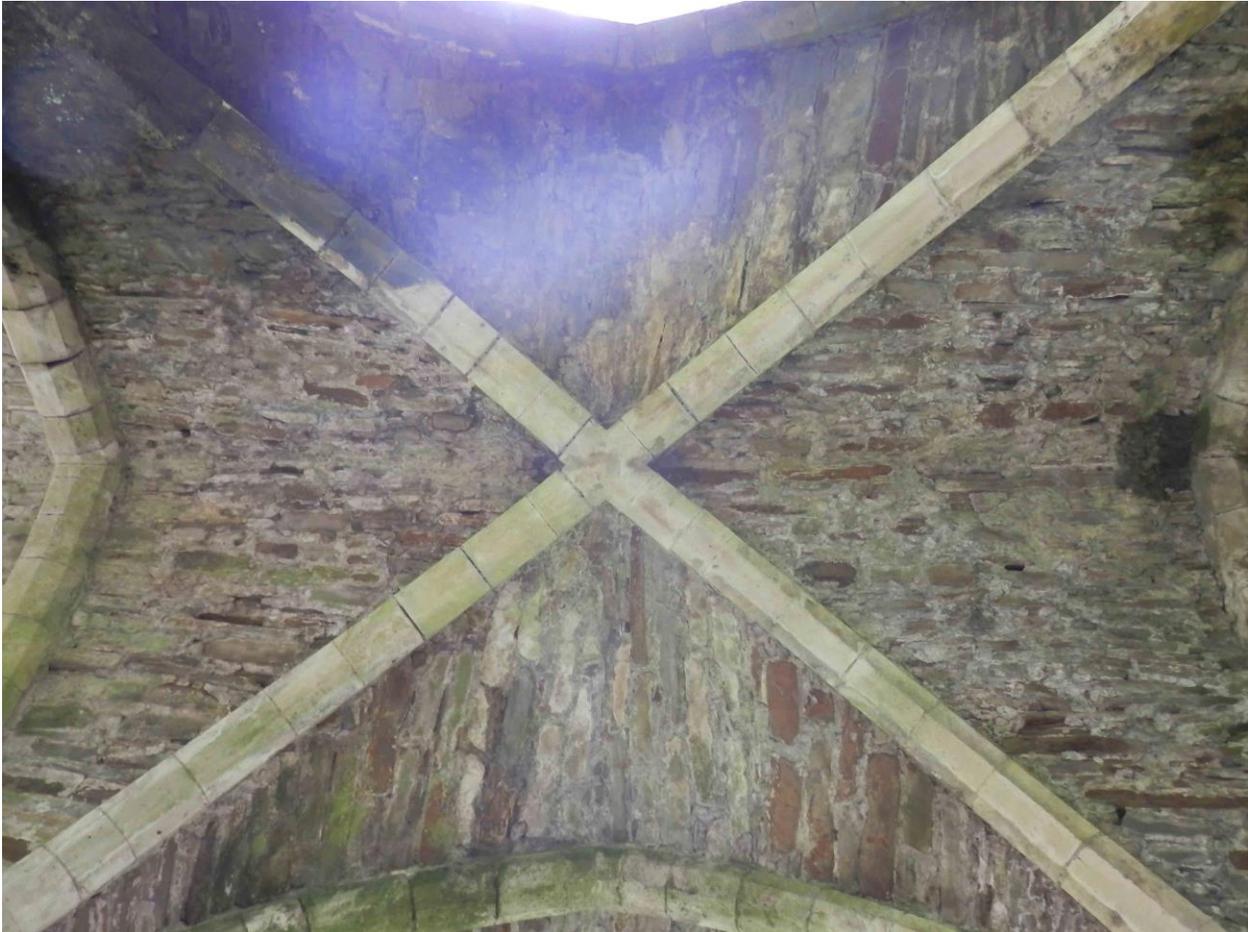
ID: 194 Site Number: 748 Site Name: Margam Monastic Ruins
Wall Number: 142 Photo Number: F2/278
Location: East Cloister Int. vaulted ceiling north end west side.
Description: Ashlar piers, and ashlar ribs to sandstone rubble vault.
Condition summary: A) Gaps in ashlar vaulting. B) Some cracks filled with cement.
C) Arch leaning northwards. D) Damage to central pillar (east side).
Threats: Weathering
Recorded by: Bob Hardwick Date: 05/10/2012

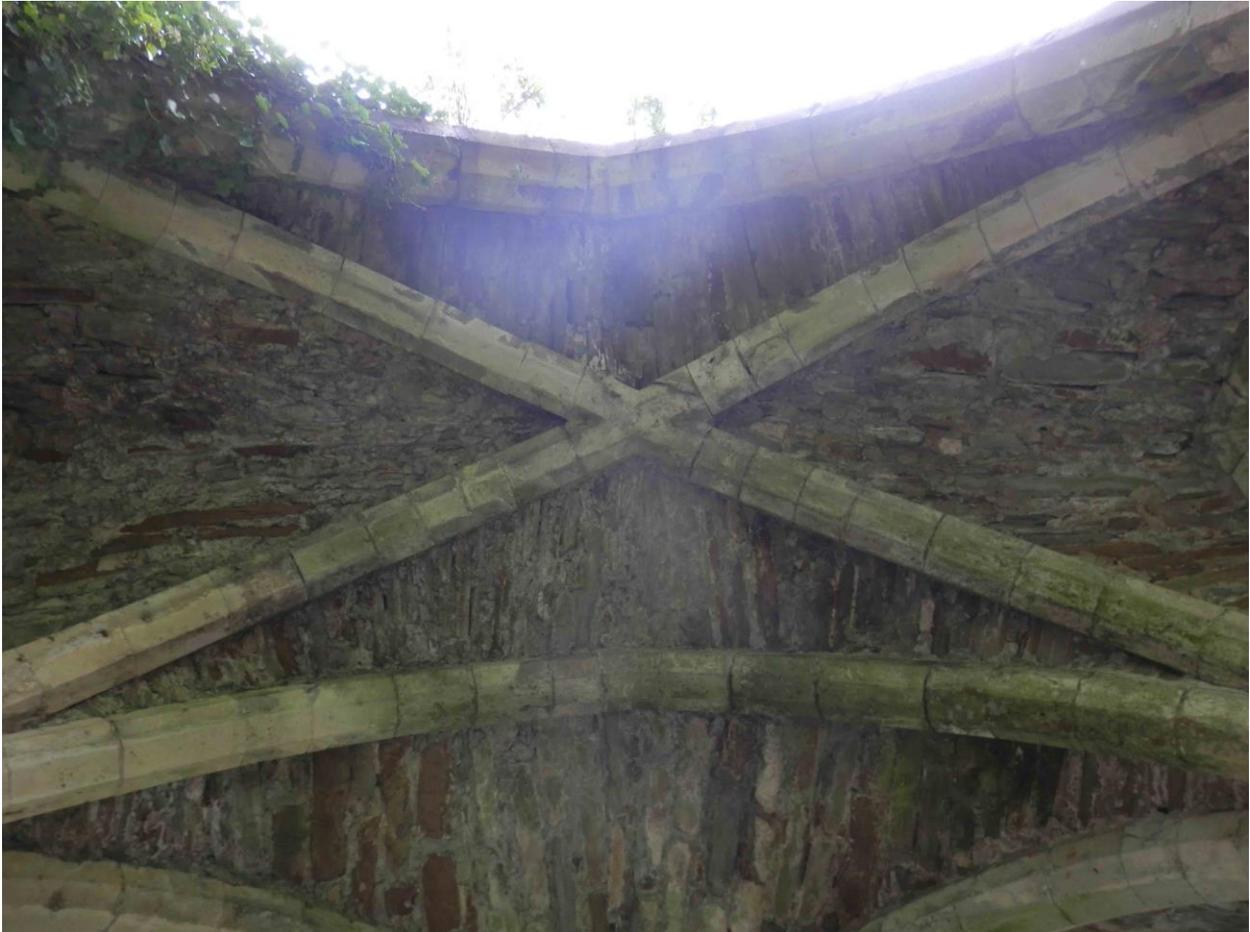
ID: 195 Site Number: 748 Site Name: Margam Monastic Ruins
Wall Number: 143 Photo Number: F2/280
Location: East Cloister Int. vaulted ceiling south end west side.
Description: Ashlar piers, and ashlar ribs to sandstone rubble vault.
Condition summary: A) Ivy coverage. B) Weathering. C) Some gaps in stonework.
D) Some damage to vault ribs
Threats: Weathering, Vegetation
Recorded by: Bob Hardwick Date: 05/10/2012

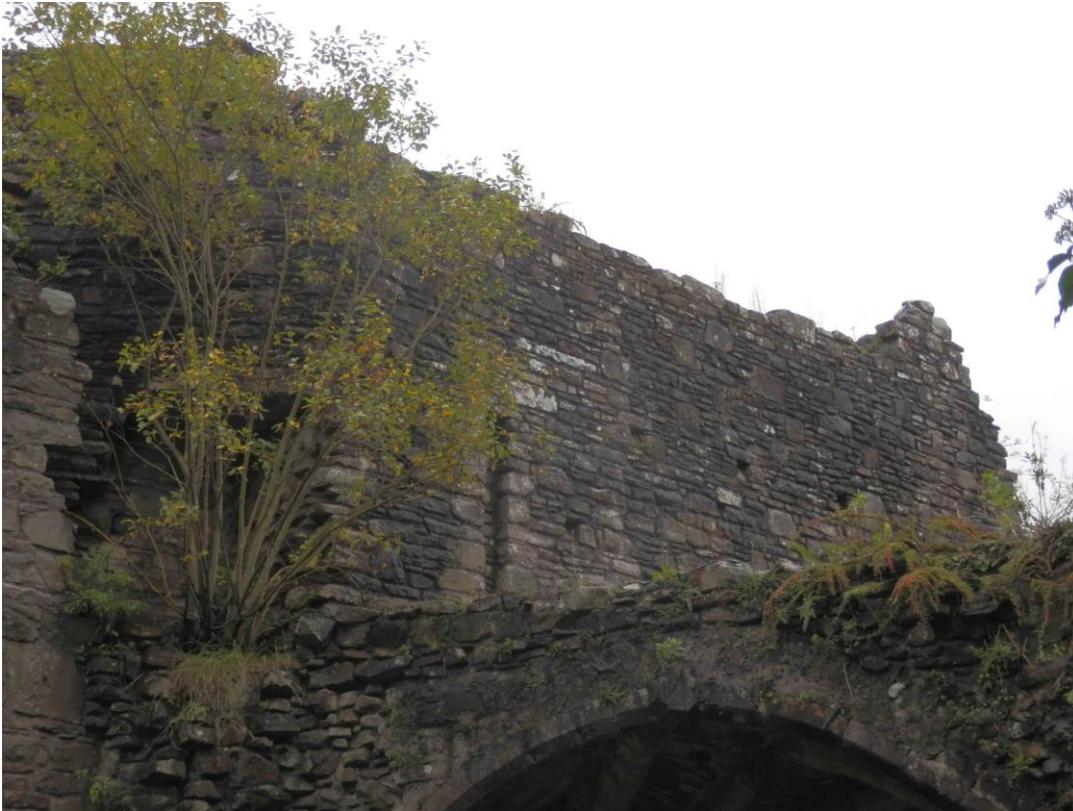
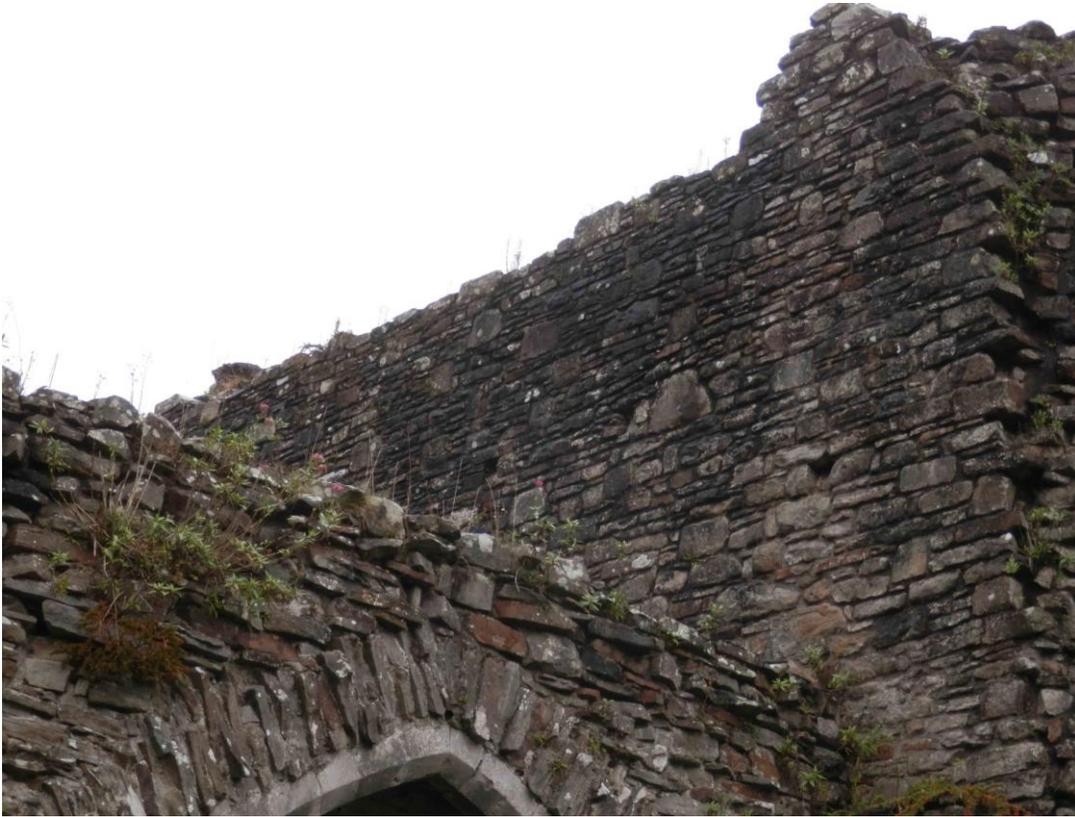
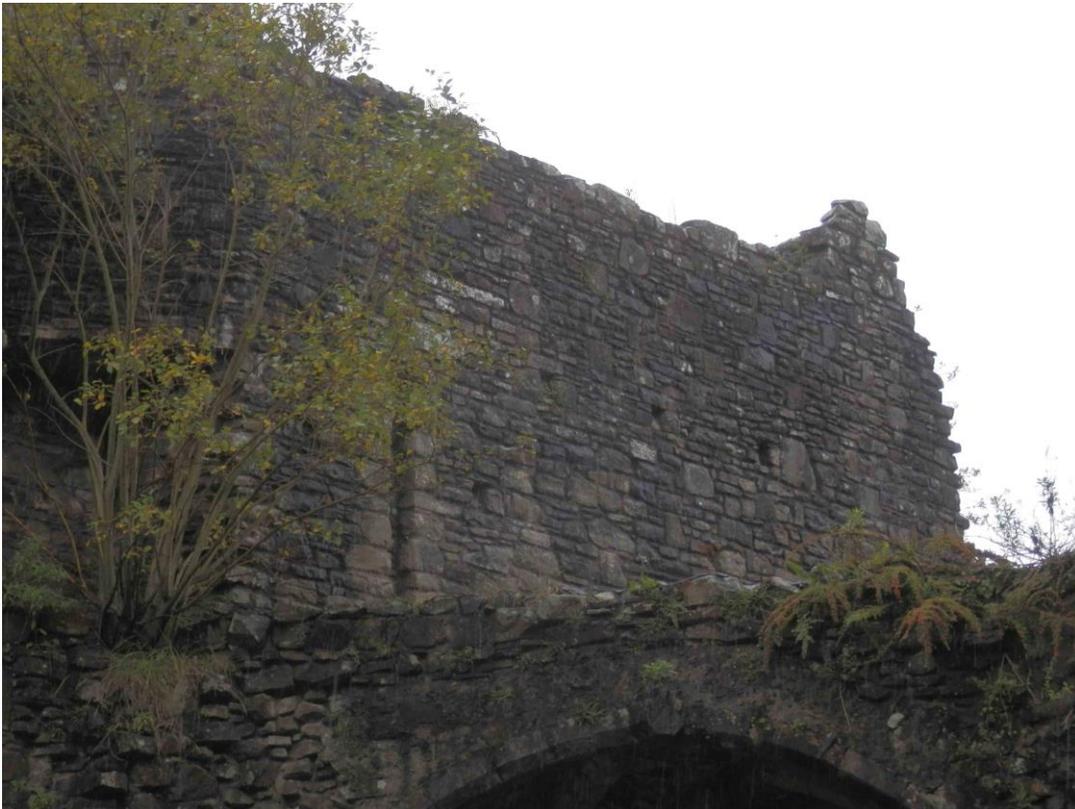
ID: 196 Site Number: 748 Site Name: Margam Monastic Ruins
Wall Number: 144 Photo Number: F2/286-289
Location: Chapter house wall ext. Upper west wall (above cloister vault)
Description: The wall consists of a sandstone rubble, with rather larger rubble blocks in a different stone around a blocked up slit window. Also a number of putlog holes, and there is evidence of what might have been a doorway on the north side of the wall. The pointing looks to be in good condition, however the stonework at the top of the wall should be inspected to determine if any are loose. The apparent square shape does not seem to be in accord with the rest of the chapter house
Condition summary: A) Although pointing between the stonework looks sound it is suggested that it should be inspected particularly at the top of the wall where loose stones could be present. B) There is a large tree present at the base of the wall at the north end. C) Vegetation starting to take root in other areas of the wall.

Threats: Vegetation, Weathering
Recorded by: Jeff Jones Date: 05/10/2012
