Monastic Margam Community Survey Project

Report for Cadw
by Sam Pamment BA

GGAT report no. 2013/020
NGR: SS 8018 8626
Project no. GGAT 123

Summary

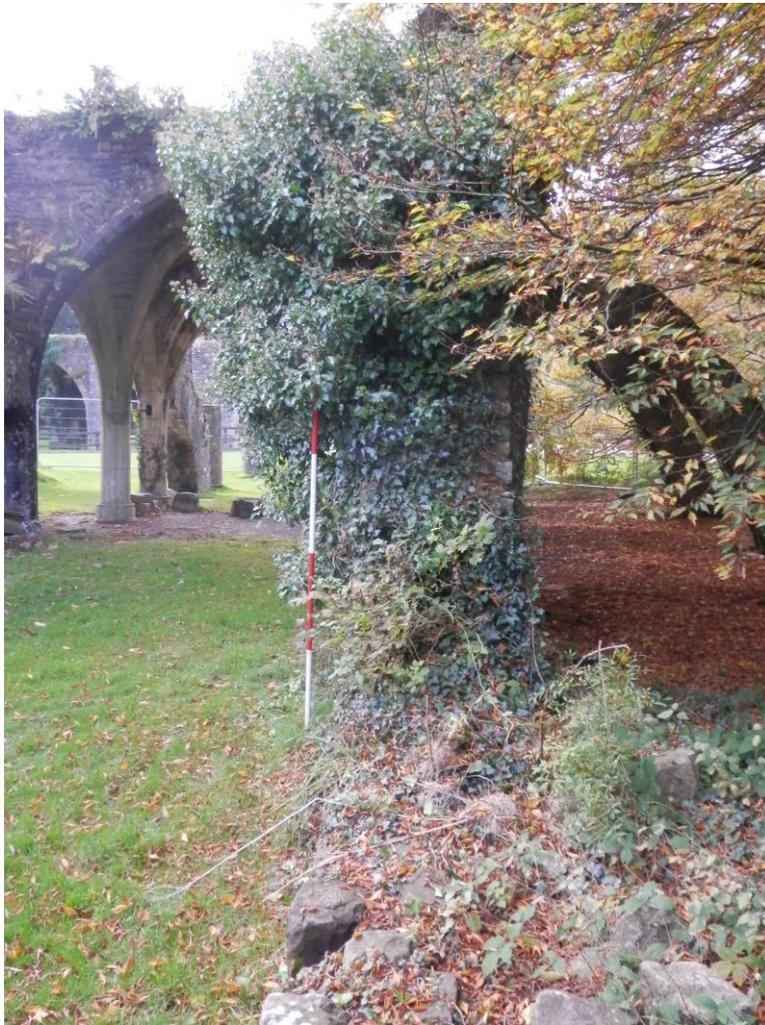
ID: 197 Site Number: 748 Site Name: Margam Monastic Ruins
Wall Number: 145 Photo Number: F3/10-11
Location: East Cloister west wall north end
Description: Wall Consists of evenly cut stone blocks about 0.9m thick. The wall terminates at the N doorway of the cloister walk/cloister. The remains of the rest of the wall runs north, but here it is only one course high, with large gaps in places.
Condition summary: A) Wall at north end, a lot of loose stone on the ground. B) Mass of vegetation growing out of entire wall (ivy). C) Pointing between stones not in very good condition. Unable to determine if any stonework at top of wall is loose.
Threats: Vegetation, Weathering
Recorded by: Jeff Jones Date: 25/10/2012
